ASBESTOS SURVEY REPORT FOR POUNDLAND, HIGH STREET WEST, SUNDERLAND, SR1 3AA.

Asbestos Register for

**Poundland, High Street West, Sunderland,
SR1 3BN**

Date: 03 February 2026

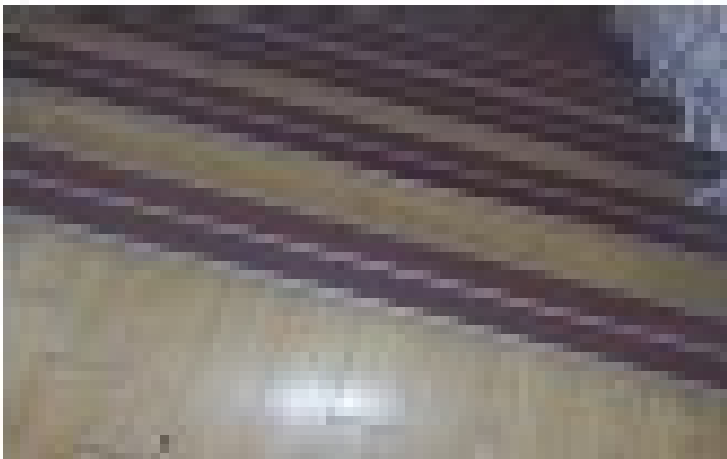
2	OU003277	Composite stair nosing	019 Stairwell 1/001	No Risk

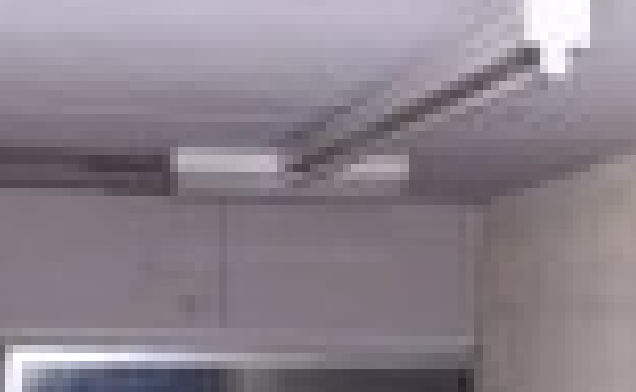
31	As OU003301	Insulating board door header	Café Stairwell 1/007	No Risk

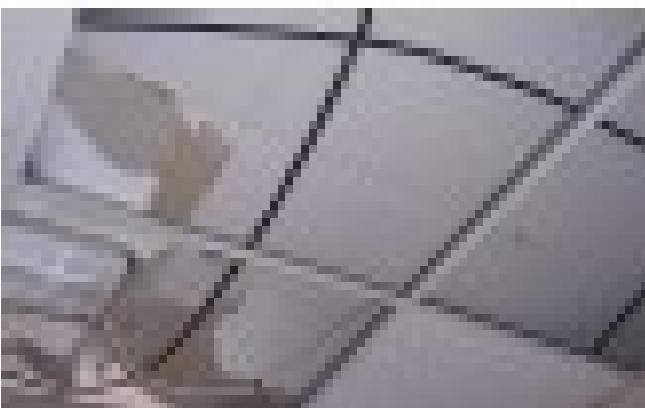
40	OU003308	Insulating board ceiling tiles	Female WC 1/013	Medium Risk
