ASBESTOS SURVEY REPORT FOR ARTS CENTRE WASHINGTON, FATFIELD, WASHINGTON

*Control of Asbestos
Regulations 2012*

Asbestos Register for

**ARTS CENTRE WASHINGTON,
FATFIELD, WASHINGTON**

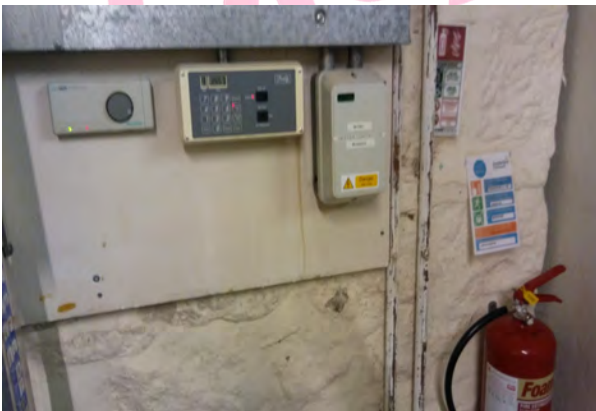
Item 42 Ref: 349632-3

The panel to electrical mounting board in the Store (Room 006) does not contain asbestos.

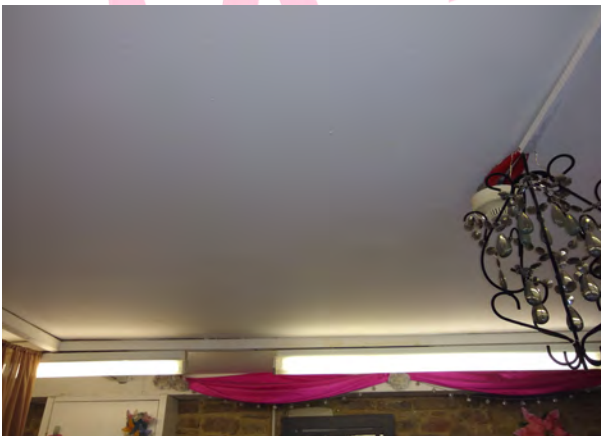
Item 48 Ref: 371873-5

The ceiling in Studio 12 (Rm 055) does contain asbestos.

Any change in appearance should be reported to Property Services.

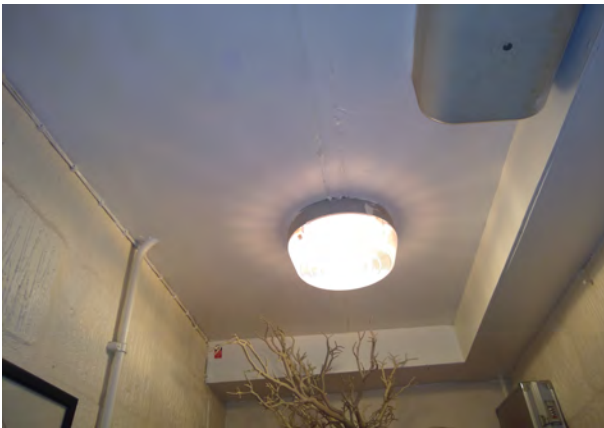
Item 50 Ref: 371873-4

The ceiling in Studio 12 WC and vestibule (Rm 056) does contain asbestos.

Any change in appearance should be reported to Property Services.

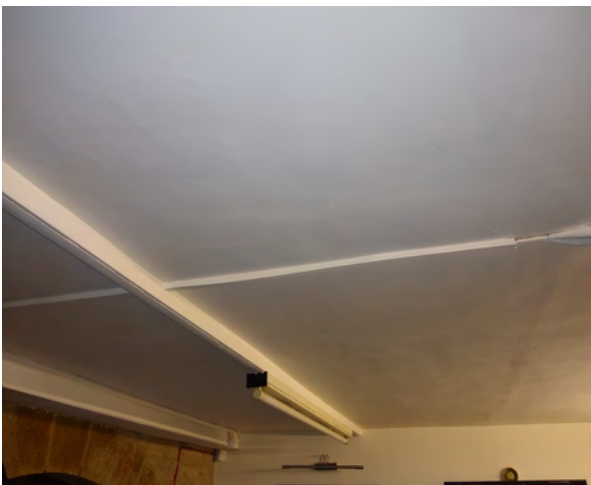
Item 53 Ref: As 371873-5

The ceiling in Studio 10 (Rm 066) does contain asbestos.

Any change in appearance should be reported to Property Services.

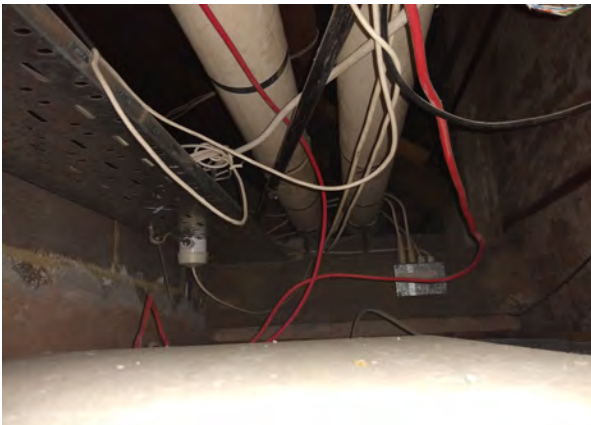
Item 54 Ref: 76353-1

The pipe lagging in the cleaners store void above fixed ceiling (Rm 002) does not contain asbestos.

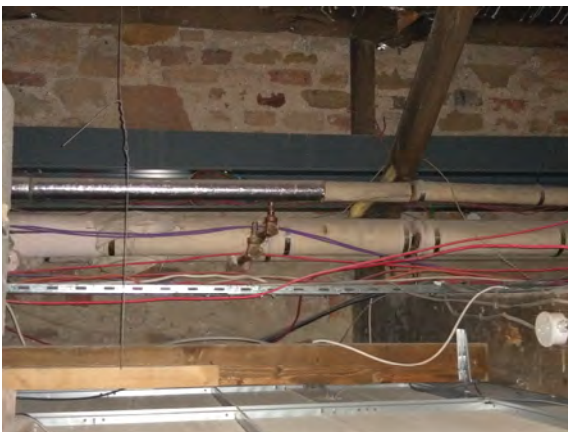
Item 57 Ref: As 76353-1

The pipe lagging (Rm 005/Corridor void above) does not contain asbestos.

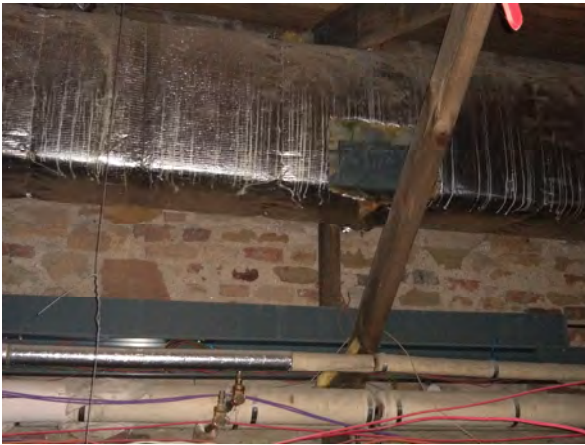
Item 58 Ref: As 76353-2

The mastic to ductwork (Rm 005/Corridor void above) does not contain asbestos.

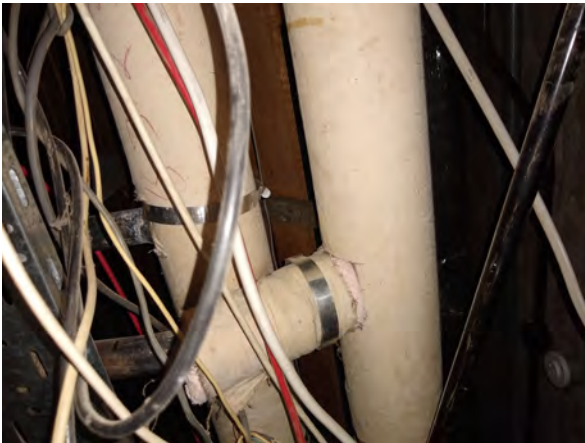
Item 61 Ref: 76353-3

The pipe lagging (Rm 011/Corridor void above) does not contain asbestos.

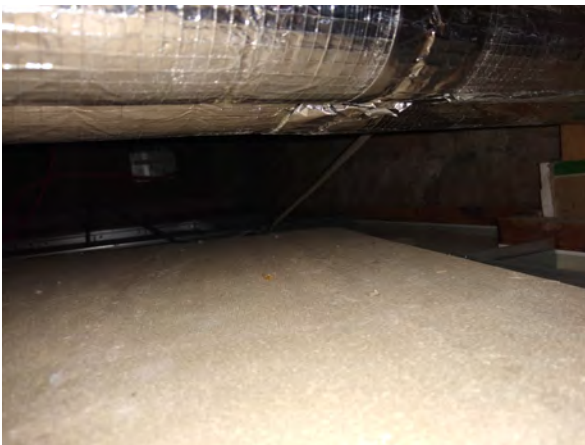
Item 62 Ref: As 76353-4

The calsil debris to topside of fixed ceiling (Rm 011/Corridor void above) does not contain asbestos.

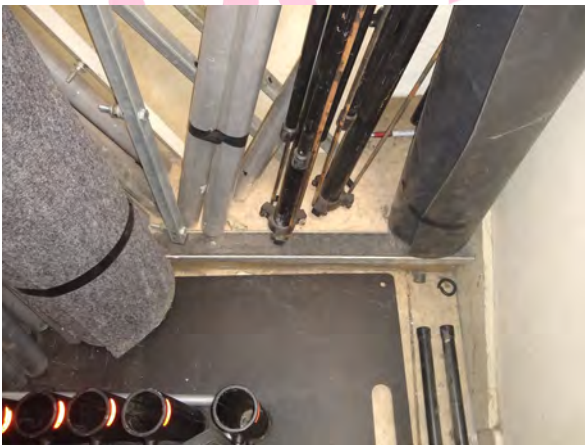
Item 63 Ref: 76353-6

The stair nosing (Rm 013/Corridor) does not contain asbestos.

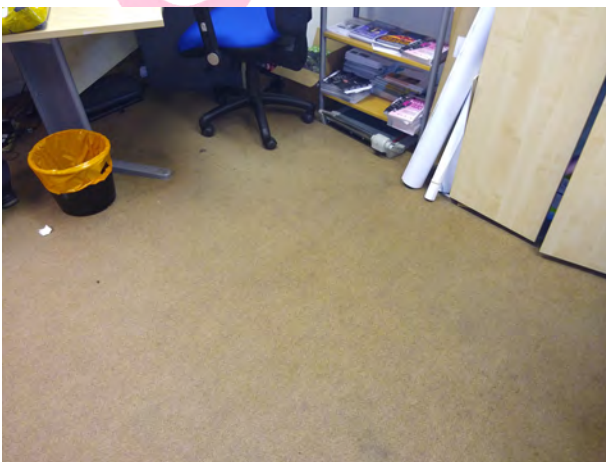
Item 66 Ref: 76353-9

The floor covering below carpet (Rm 017/Reception and office) does not contain asbestos.

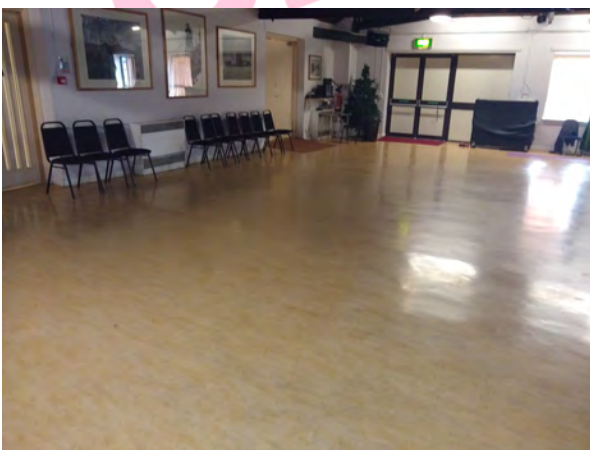
Item 69 Ref: 76353-20

The floor covering (Rm 024/large hall) does not contain asbestos.

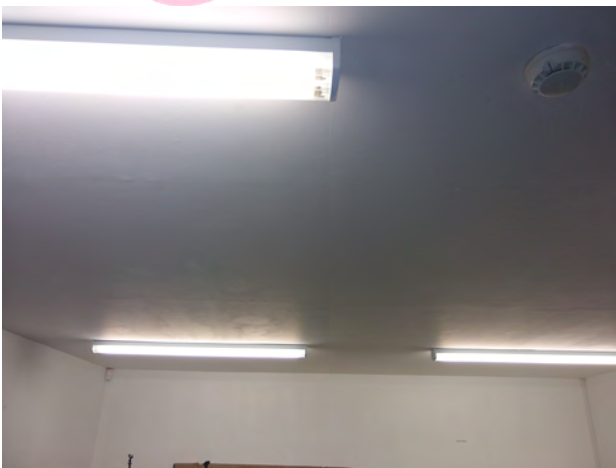
Item 73 Ref: As 371873-8

The ceiling (Rm 057/Studio1 and void above) does not contain asbestos.

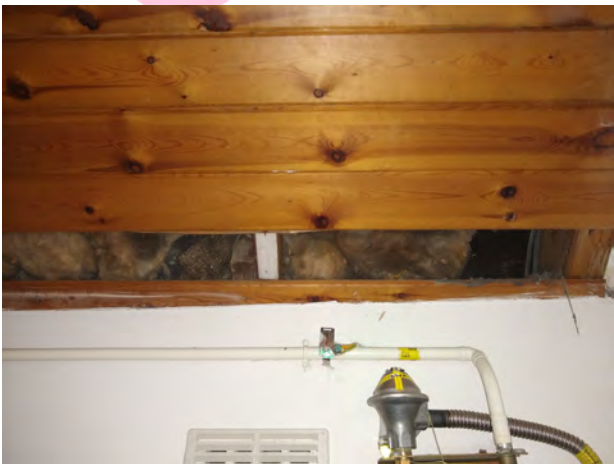
Item 76 Ref: As 371873-6

The sarking (Rm 060/Studio 1 Entrance Lobby) does not contain asbestos.

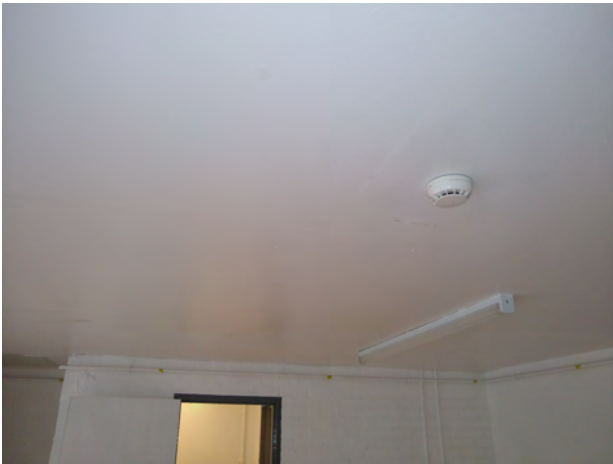
Item 77 Ref: 371873-7

The ceiling (Rm 061/Studio 5) does not contain asbestos.

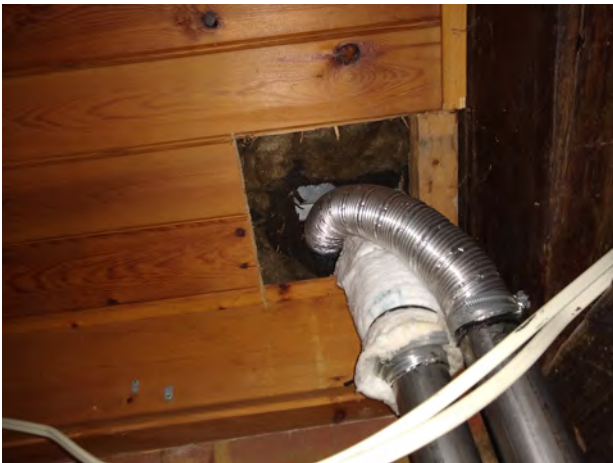
Item 78 Ref: As 371873-6

The sarking (Rm 061/Studio 5 void above) does not contain asbestos.

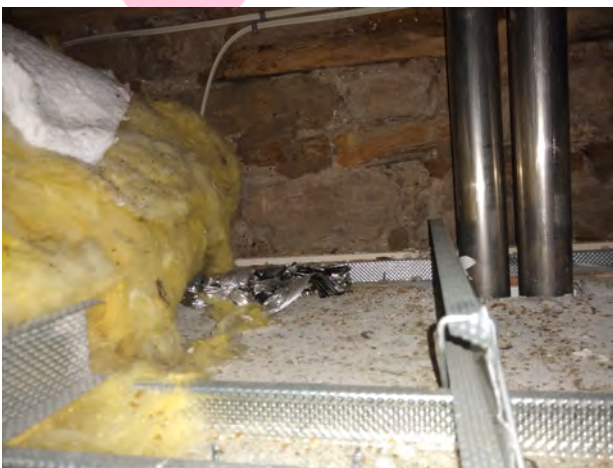
Item 79 Ref: 371873-7

The floor (Rm 61/Studio 5 void above) does not contain asbestos.

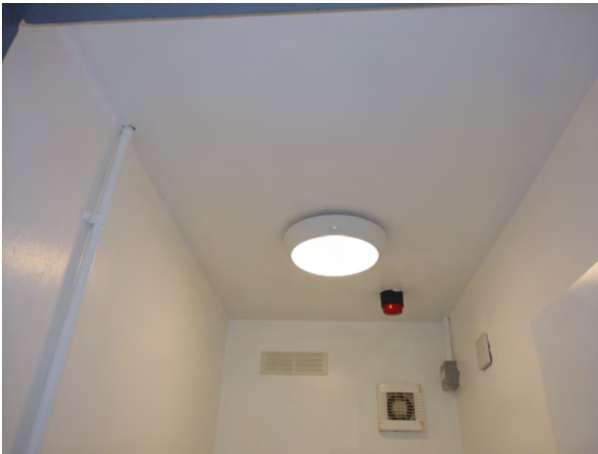
Item 80 Ref: As 371873-7

The ceiling (Rm 062/Studio 5 WC) does not contain asbestos.

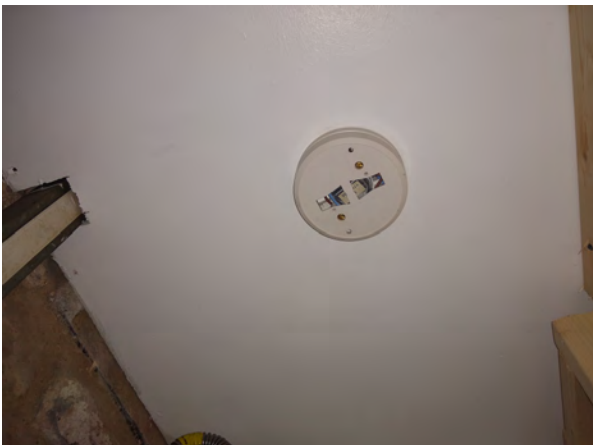
Item 81 Ref: As 371873-7

The ceiling (Rm 063/Studio 5 electric cupboard) does not contain asbestos.

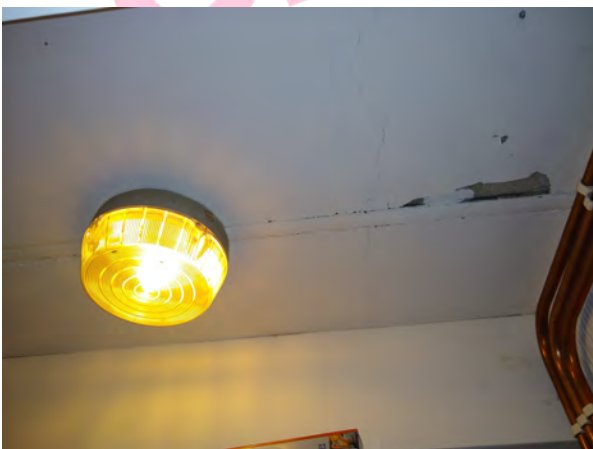
Item 82 Ref: As 371873-4

The ceiling (Rm 064/Studio 10 boiler cupboard) does contain asbestos.

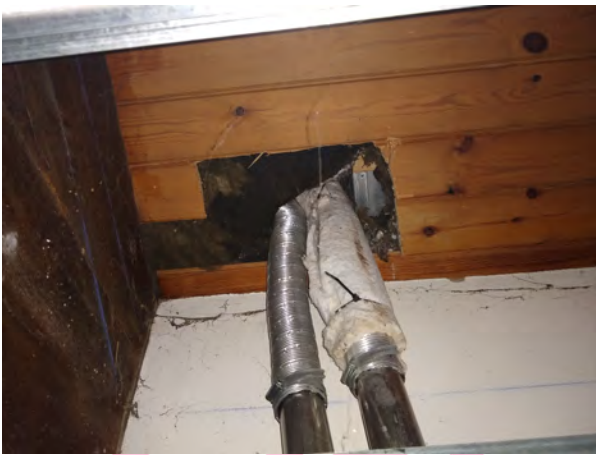
Item 84 Ref: As 371873-6

The sarking (Rm 067/ukulele music room void above) does not contain asbestos.

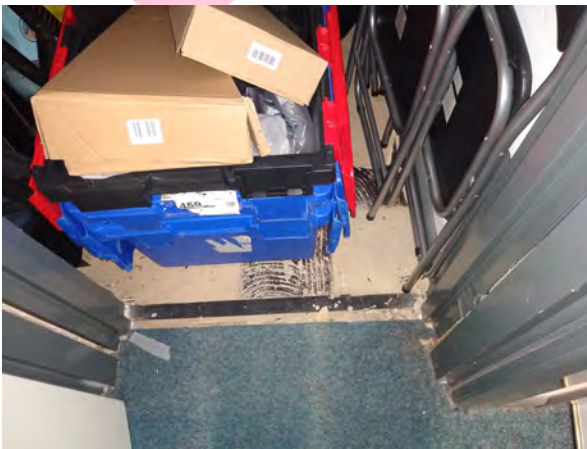
Item 85 Ref: As 371873-9

The floor covering (Rm 068/ukulele music room store) does contain asbestos.

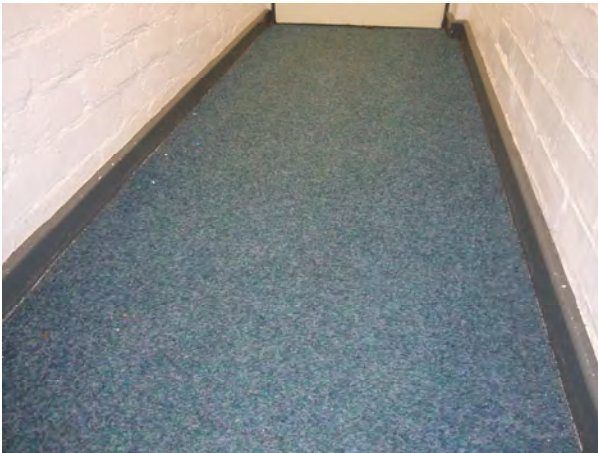
Item 87 Ref: As 371873-9

The floor covering (Rm 070/ukulele music room WC lobby) does contain asbestos.

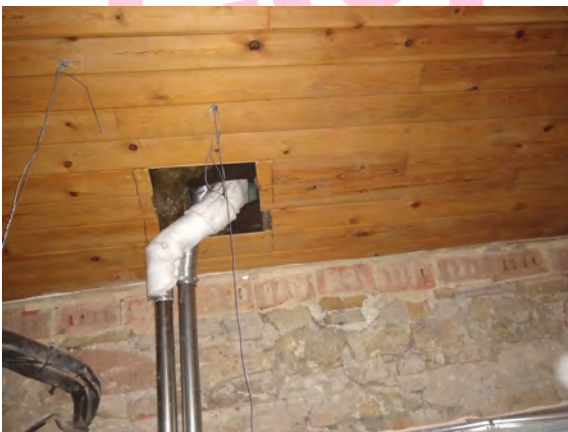
Item 91 Ref: As 371873-6

The sarking (Rm 077/void above areas 075-076) does not contain asbestos.

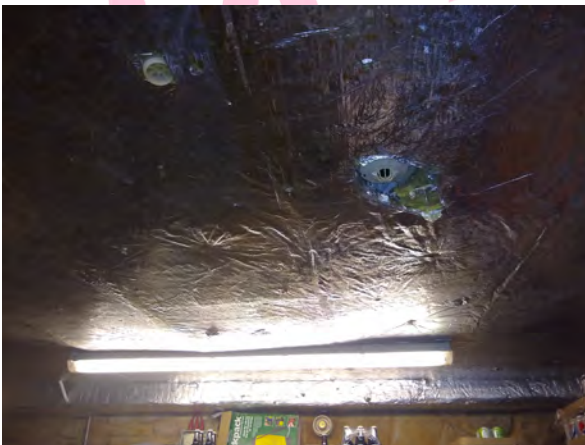
Item 94 Ref: 371873-11

The ceiling (Rm 095/Cellar) does contain asbestos.

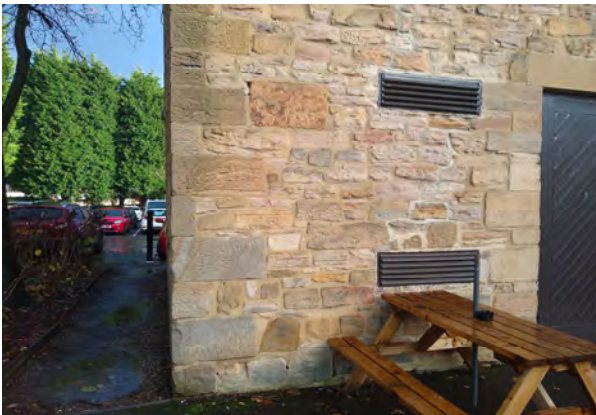
Item 96 Ref: 371873-12

The packers within wall of 025 boiler room (External) does contain asbestos.

Any change in appearance should be reported to Property Services.

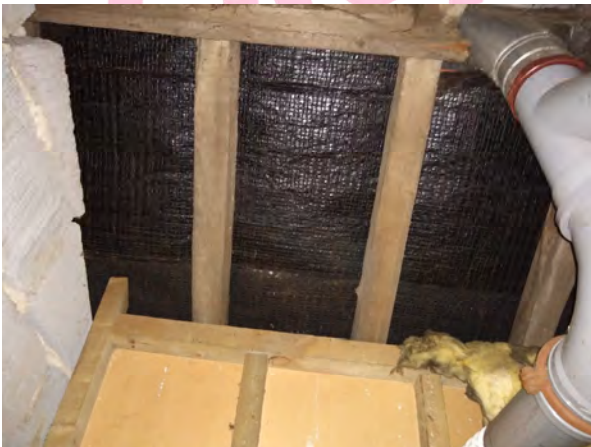
Item 97 Ref: 371873-10

The sarking (Rm 1/008/Kitchen) does not contain asbestos.

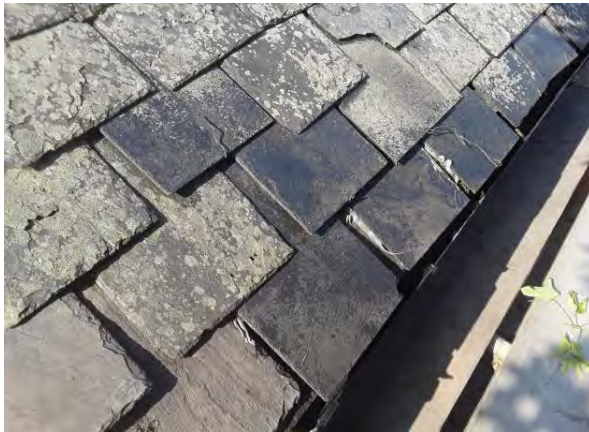
Item 105 Ref: 21-36502-1

The roof - replacement tiles (Cement) (Room/Area: 2 - External) does not contain asbestos.

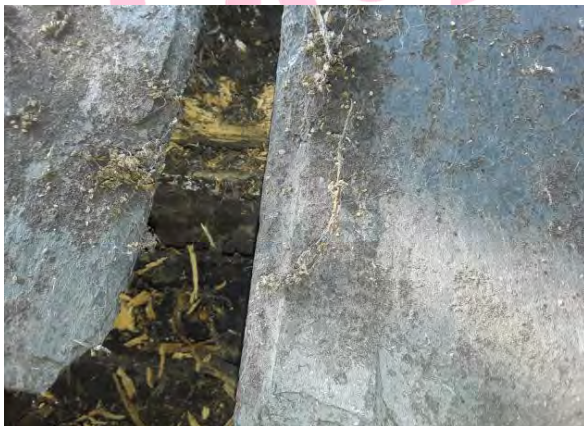
Item 106 Ref: 21-36502-1

The roof - sarking felt (Bitumen) (Room/Area: 2 - External) does not contain asbestos.

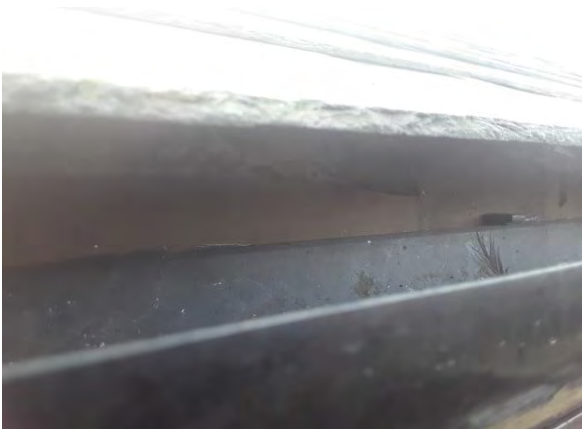
Item 107 Ref: 20-378903-1

The roof sarking felt (Bitumen) (Area 1/Roof Area 1) does not contain asbestos.

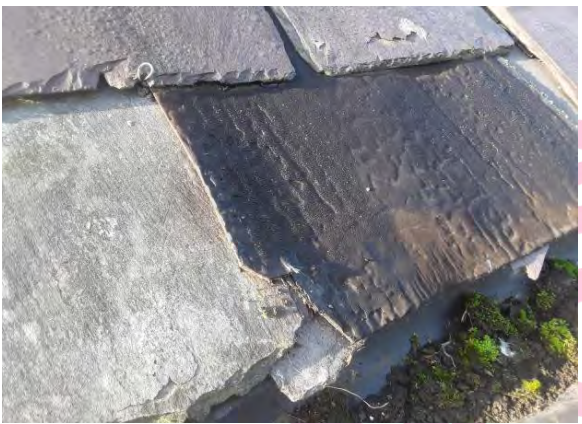
Item 108 Ref: 21-378903-3

The roof sarking felt (Bitumen) (Area 2/Roof Area 2) does not contain asbestos.

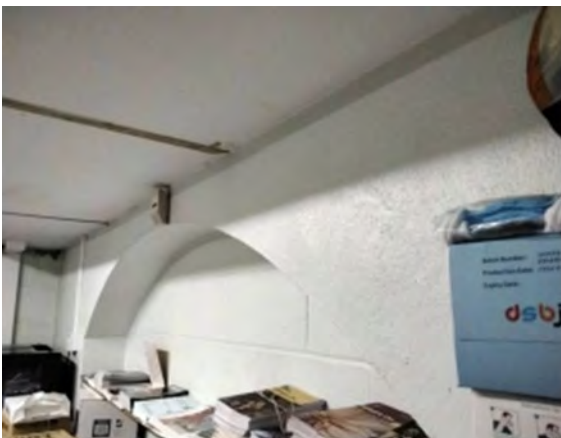
Item 112 Ref: KX001130

The textured coating to the walls in the Reception (Room 17) does not contain asbestos.

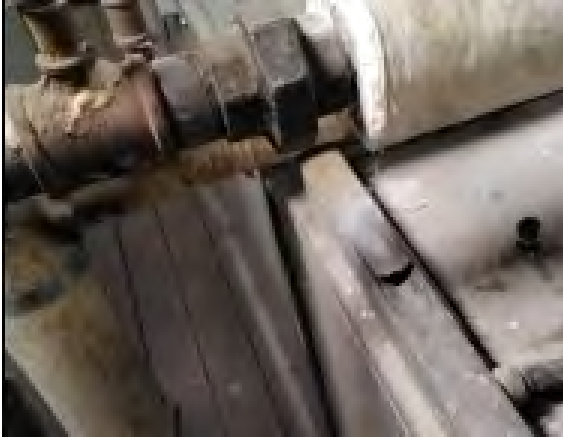
Item 116 Ref: SC004278

The debris to air handling unit topside in Plant Room does not contain asbestos.

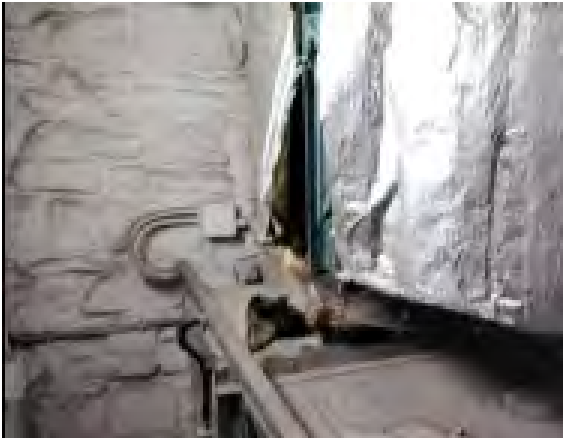
Item 117 Ref: SC004281

The debris to ducting topside in Plant Room does not contain asbestos.

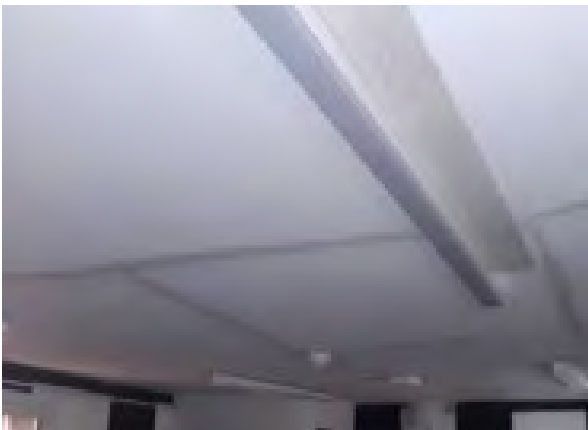
Item 120 Ref: NZ001288

The ceiling G/001 Office does not contain asbestos.

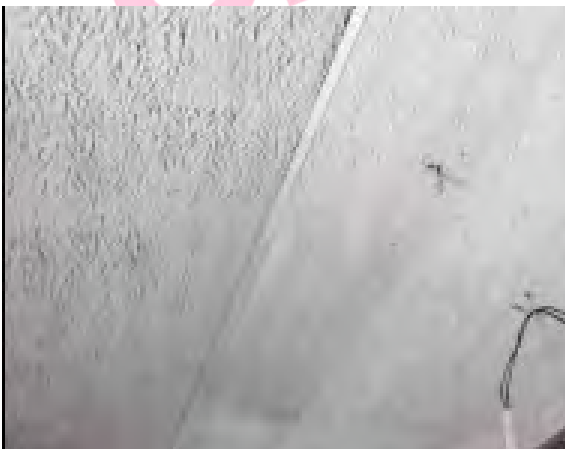
Item 121 Ref: AW005887

The ceiling tile – suspended in Studio 8 does not contain asbestos.

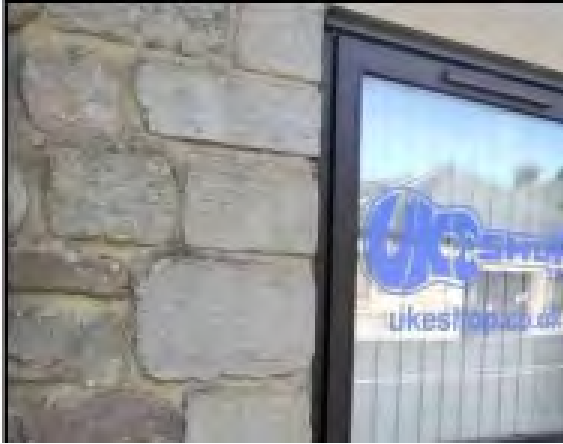
Item 122 Ref: AW005884

The window remains of old sealant External to Studio Building does not contain asbestos.

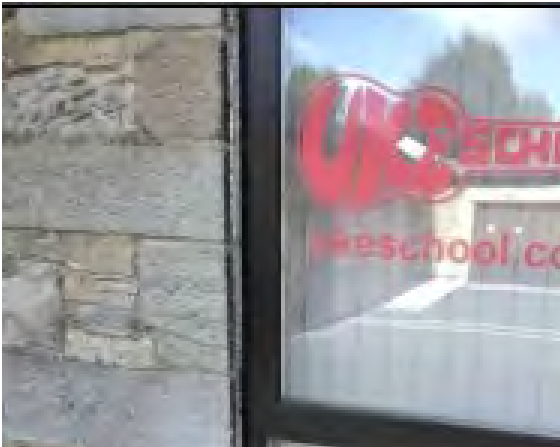
Item 123 Ref: AW005885

The window remains of old sealant External to Studio Building does not contain asbestos.

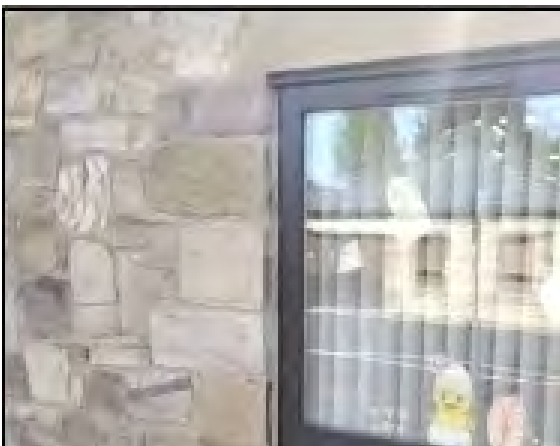
Item 124 Ref: AW005886

The window remains of old sealant External to Studio Building does not contain asbestos.

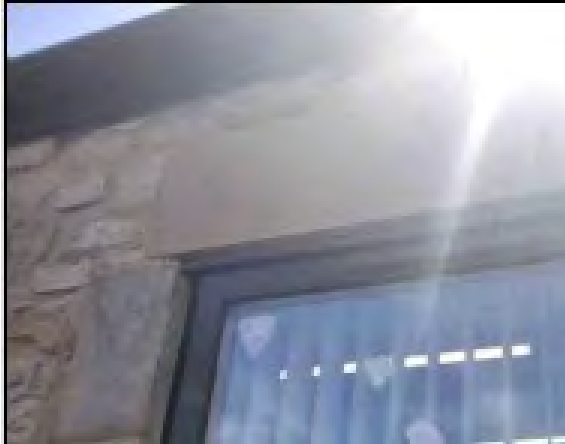
Item 125 Ref: AW005888

The window sealant External to Studio Building does not contain asbestos.

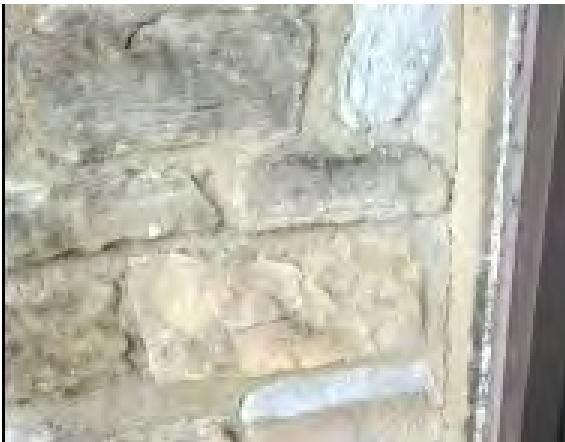
Item 126 Ref: AW005889

The door remains of old sealant External to Studio Building does not contain asbestos.

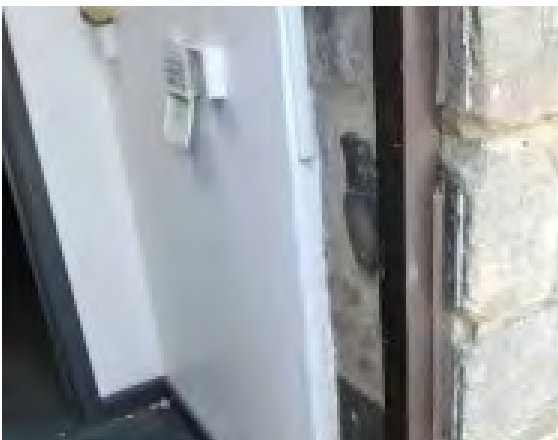
Item 127 Ref: AW005890

The brown door frame sealant External to Studio Building does not contain asbestos.

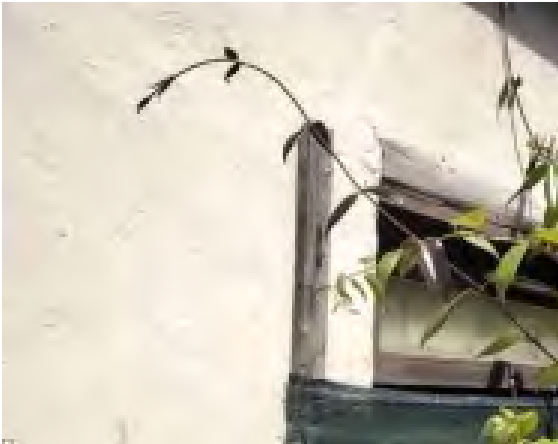
Item 129 Ref: AW005892

The window remains of old sealant External to Studio Building does not contain asbestos.

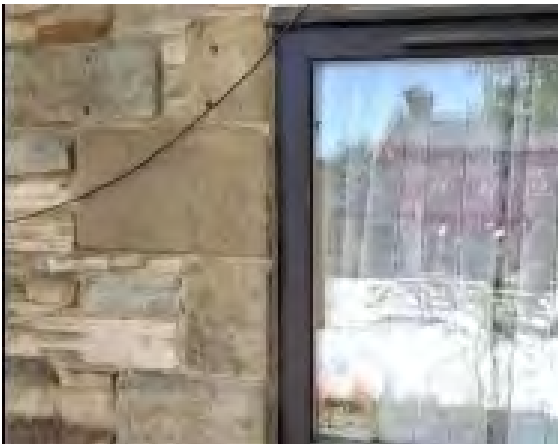
Item 130 Ref: AW005893

The window remains of old sealant External to Main Building does not contain asbestos.

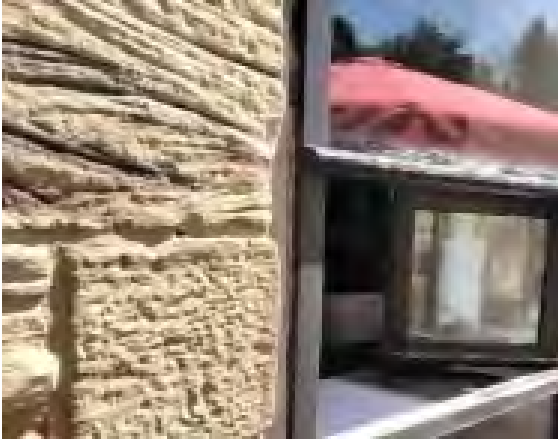
Item 134 Ref: AW005897

The window brown sealant
External to Main Building
does not contain asbestos.

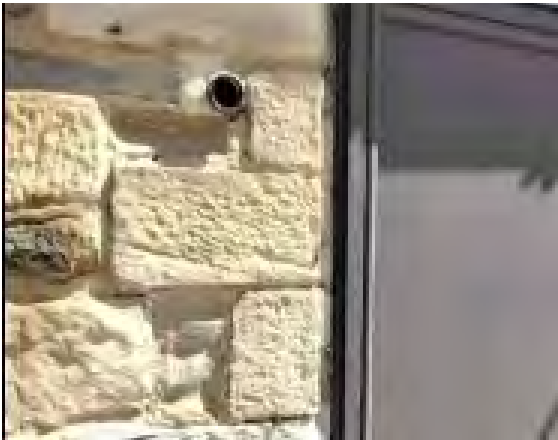
Item 135 Ref: AW005898

The door frame sealant
External to Main Building
does not contain asbestos.

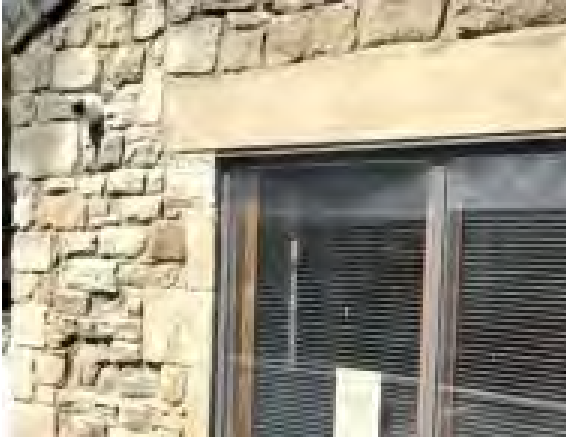
Item 137 Ref: AW005900

The window remains of old sealant External to Main Building does not contain asbestos.

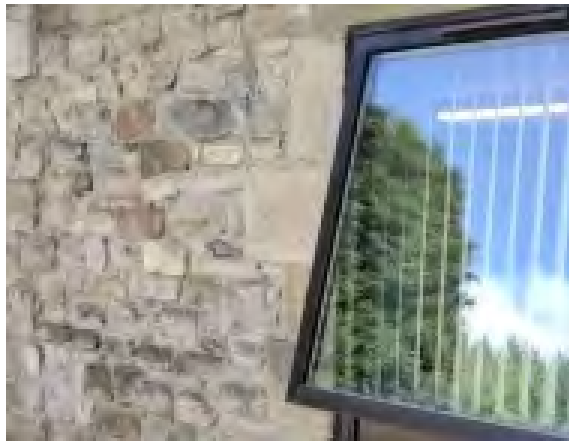
Item 141 Ref: AW005904

The door brown sealant External to Main Building does not contain asbestos.
