### ASBESTOS SURVEY REPORT FOR ARTS CENTRE WASHINGTON, FATFIELD, WASHINGTON

*Control of Asbestos  
Regulations 2012*

**ARTS CENTRE WASHINGTON,  
FATFIELD, WASHINGTON**

**Date: 16 March 2026**

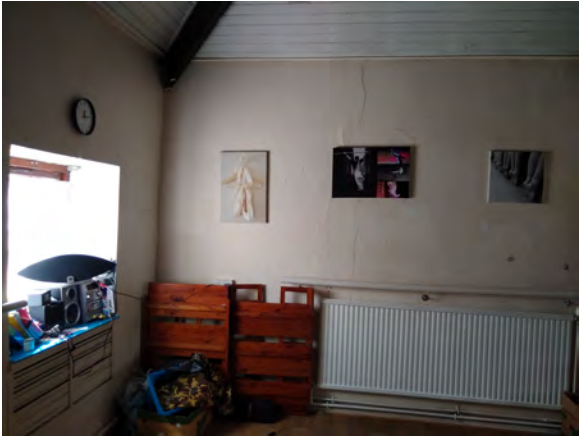
### **Item 37: 333363-1**

The textured coating to the walls in Studio 2 (Room 001) does not contain asbestos.

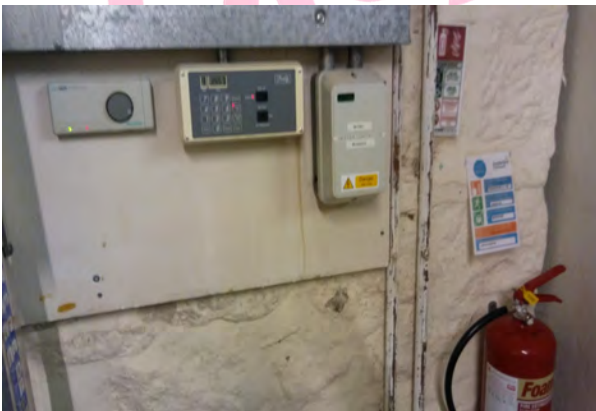
### **Item 42 Ref: 349632-3**

The panel to electrical mounting board in the Store (Room 006) does not contain asbestos.

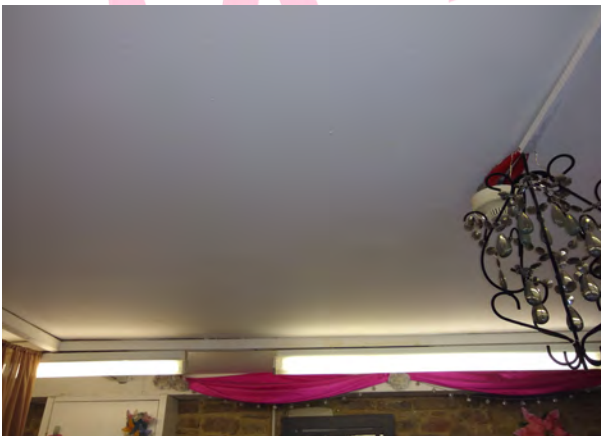
### **Item 48 Ref: 371873-5**

The ceiling in Studio 12 (Rm 055) does contain asbestos.

Any change in appearance should be reported to Property Services.

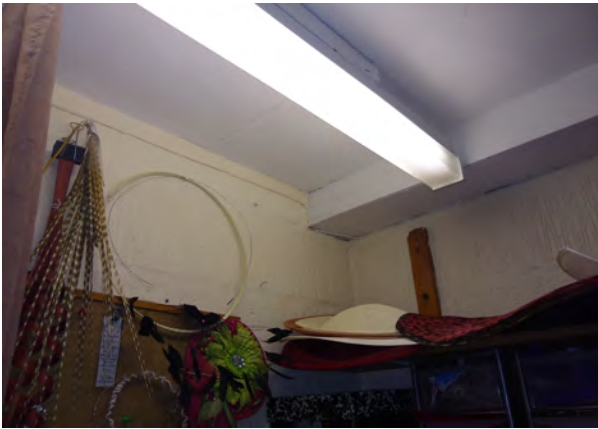
### **Item 49 Ref: As 371873-4**

The ceiling within workshop area adjacent to WC in Studio 12 (Rm 055) does contain asbestos.

Any change in appearance should be reported to Property Services.

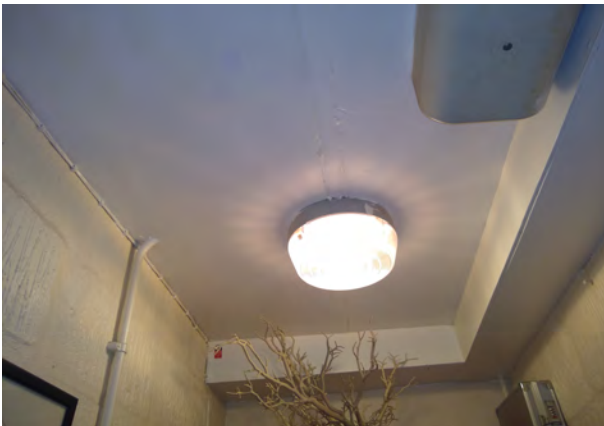
### **Item 50 Ref: 371873-4**

The ceiling in Studio 12 WC and vestibule (Rm 056) does contain asbestos.

Any change in appearance should be reported to Property Services.

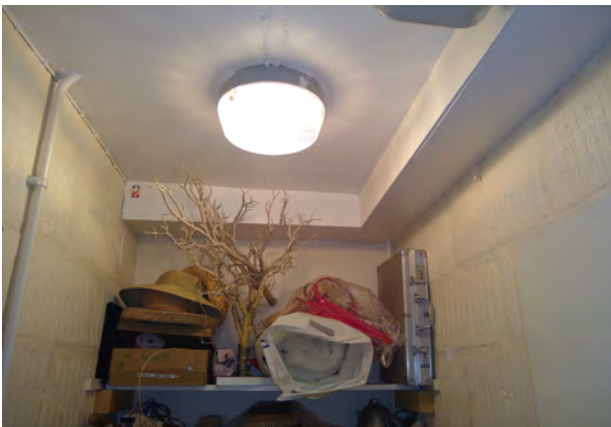
### **Item 51 Ref: Presumed**

The product within timber pipework boxing in Studio 10 WC and vestibule (Rm 065) is presumed to contain asbestos.

Further investigation is required in this area.

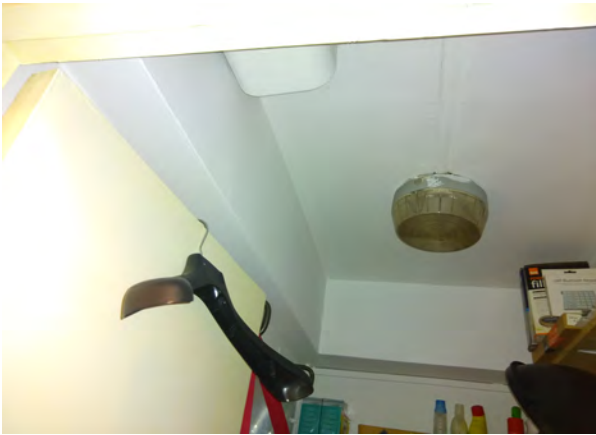
### **Item 52 Ref: As 371873-4**

The ceiling in Studio 10 WC and vestibule (Rm 065) does contain asbestos.

Any change in appearance should be reported to Property Services.

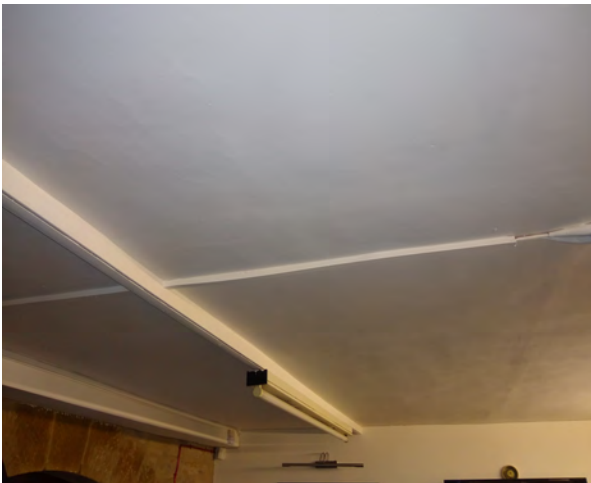
### **Item 53 Ref: As 371873-5**

The ceiling in Studio 10 (Rm 066) does contain asbestos.

Any change in appearance should be reported to Property Services.

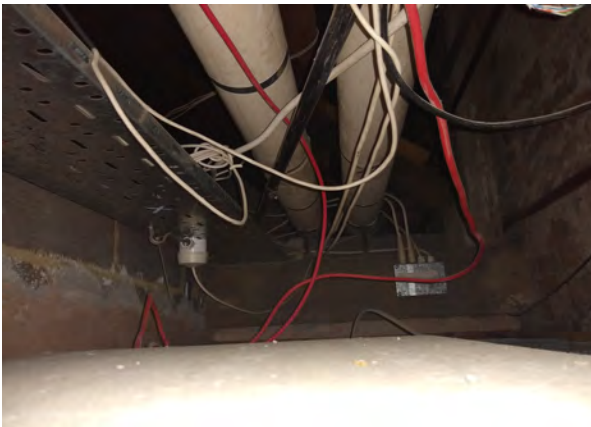
### **Item 54 Ref: 76353-1**

The pipe lagging in the cleaners store void above fixed ceiling (Rm 002) does not contain asbestos.

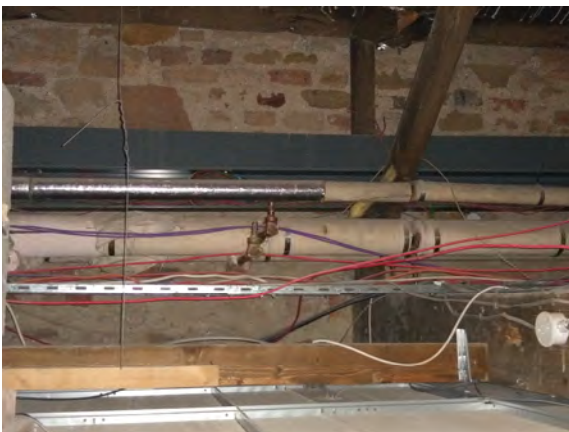
**Item 57 Ref: As 76353-1**

The pipe lagging (Rm 005/Corridor void above) does not contain asbestos.

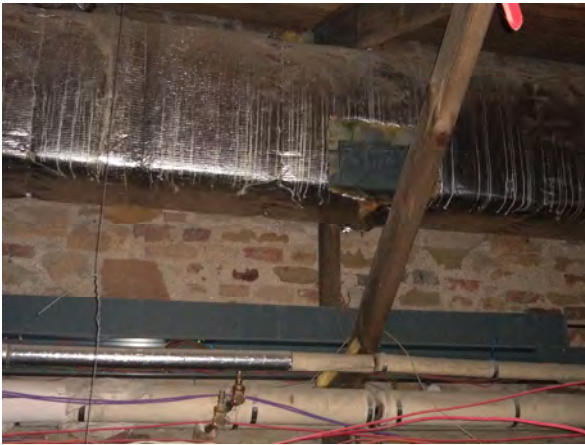
### **Item 58 Ref: As 76353-2**

The mastic to ductwork (Rm 005/Corridor void above) does not contain asbestos.

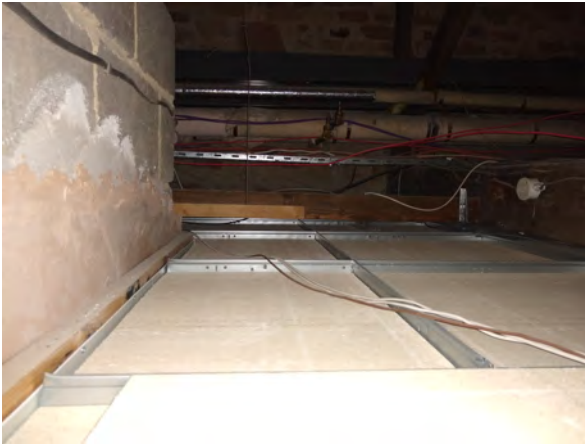
### **Item 59 Ref: 76353-4**

The calsil debris to top of suspended ceiling (Rm 005/Corridor void above) does not contain asbestos.

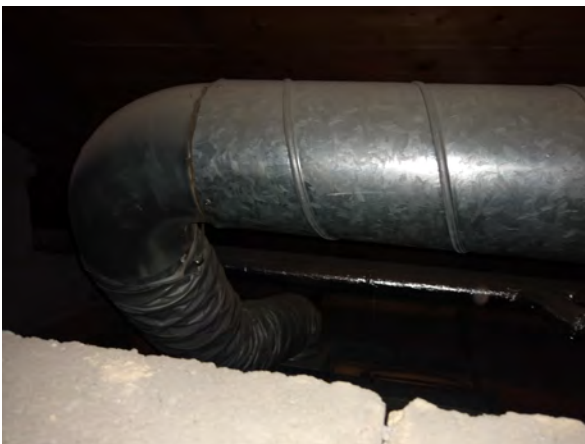
### **Item 60 Ref: As 76353-2**

The mastic to ductwork (Rm 006/Accessible WC void above) does not contain asbestos.

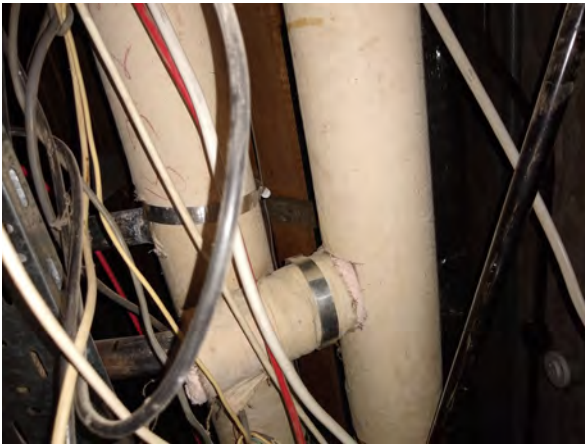
### **Item 61 Ref: 76353-3**

The pipe lagging (Rm 011/Corridor void above) does not contain asbestos.

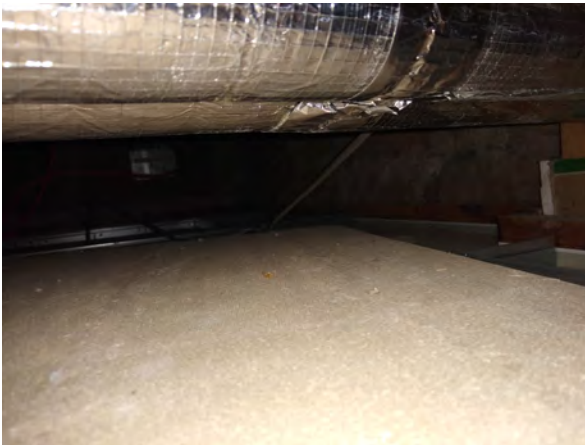
### **Item 62 Ref: As 76353-4**

The calsil debris to topside of fixed ceiling (Rm 011/Corridor void above) does not contain asbestos.

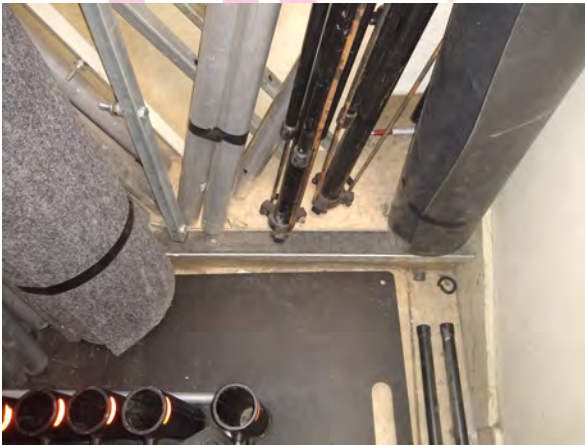
### **Item 63 Ref: 76353-6**

The stair nosing (Rm 013/Corridor) does not contain asbestos.

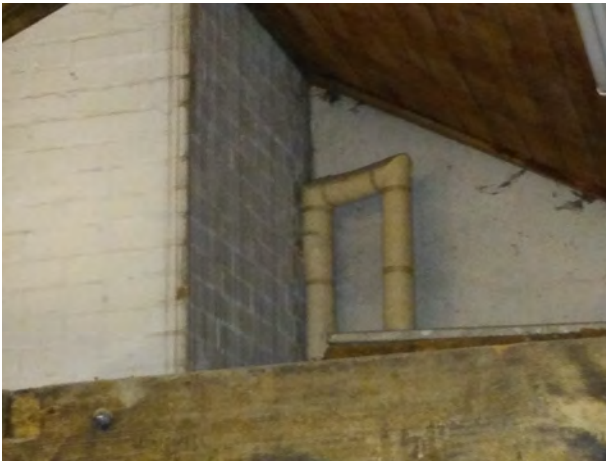
### **Item 64 Ref: As 76353-1**

The pipe lagging (Rm 014/Backstage and area above plant room) does not contain asbestos.

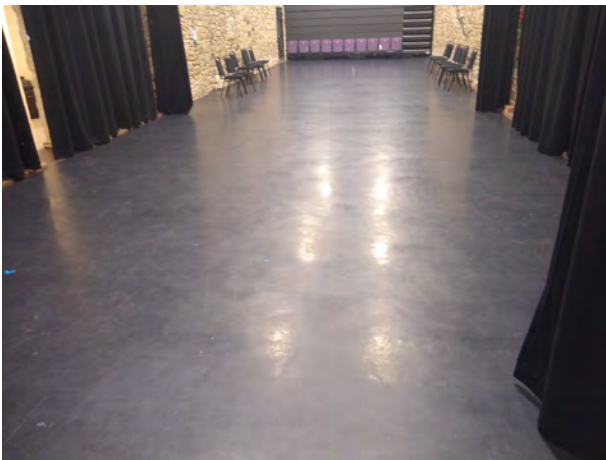
### **Item 65 Ref: 76353-17**

The floor covering (Rm 015/Auditorium and stage) does not contain asbestos.

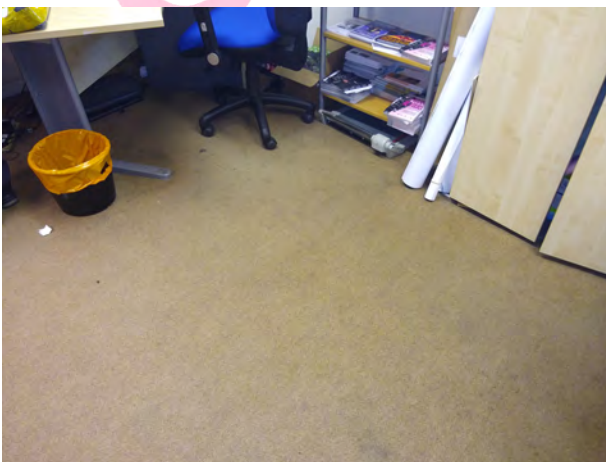
### **Item 66 Ref: 76353-9**

The floor covering below carpet (Rm 017/Reception and office) does not contain asbestos.

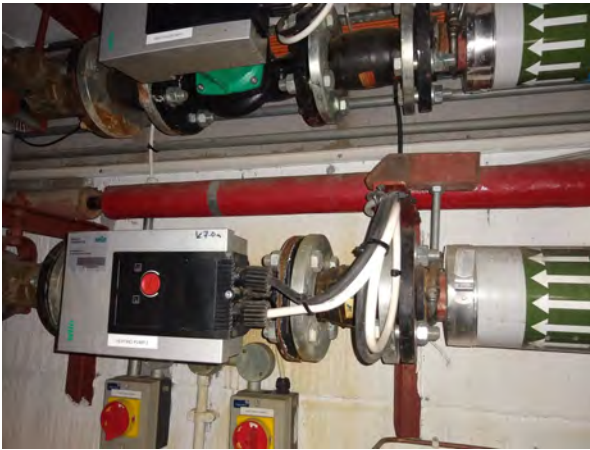
### **Item 67 Ref: 76353-11**

The pipework gaskets (Rm 019/Plant Room) does not contain asbestos.

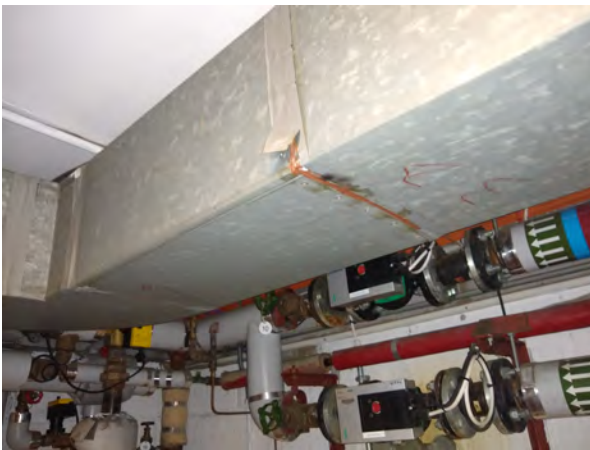
### **Item 68 Ref: 76353-10**

The ductwork mastic (Rm 019/Plant Room) does not contain asbestos.

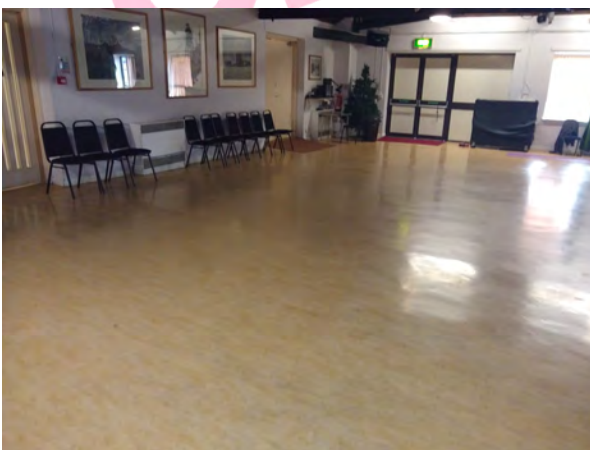
### **Item 69 Ref: 76353-20**

The floor covering (Rm 024/large hall) does not contain asbestos.

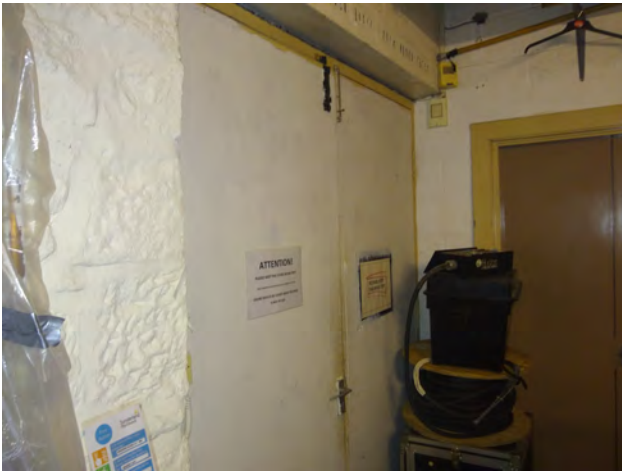
### **Item 71 Ref: 371873-2**

The panels to doors (Rm 037/Store) do not contain asbestos.

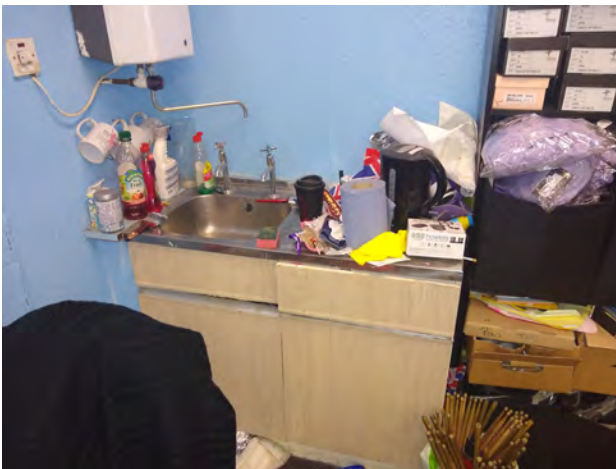
### **Item 72 Ref: 371873-3**

The sink pad (Rm 045/Dance Studio) does not contain asbestos.

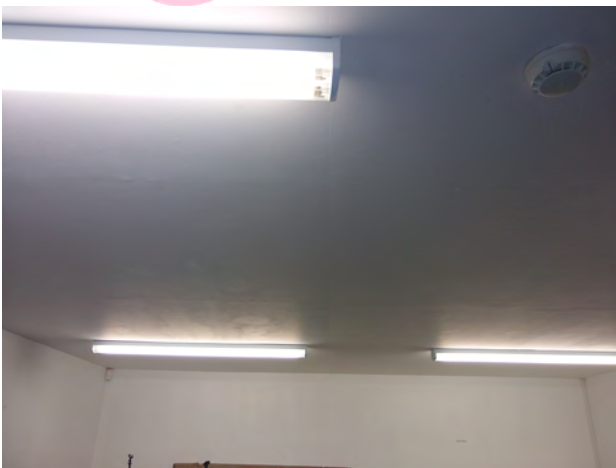
### **Item 73 Ref: As 371873-8**

The ceiling (Rm 057/Studio1 and void above) does not contain asbestos.

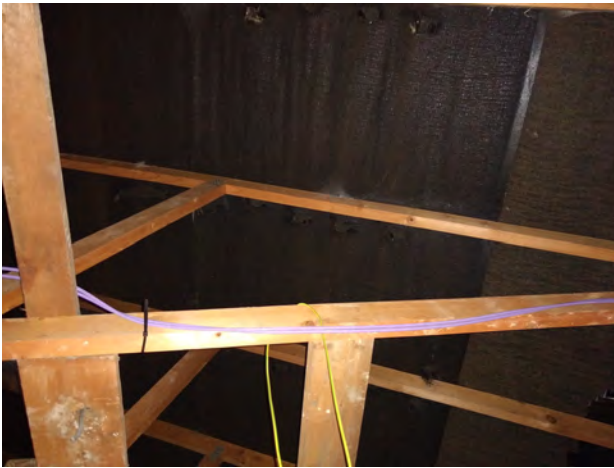
**Item 74 Ref: 371873-6**

The sarking (Rm 057/Studio 1 void above) does not contain asbestos.

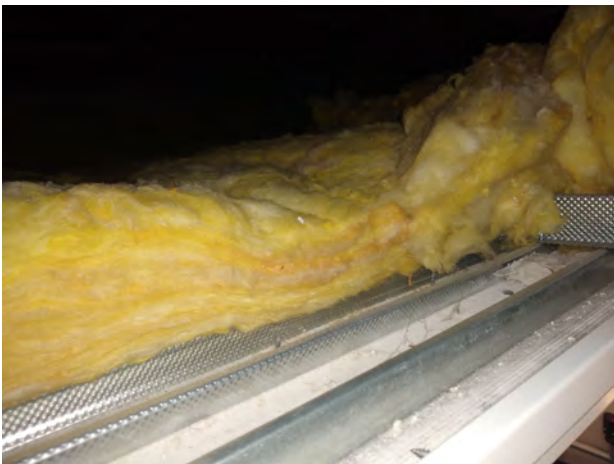
**Item 75 Ref: 371873-8**

The floor (Rm 057/Studio1 void above) does not contain asbestos.

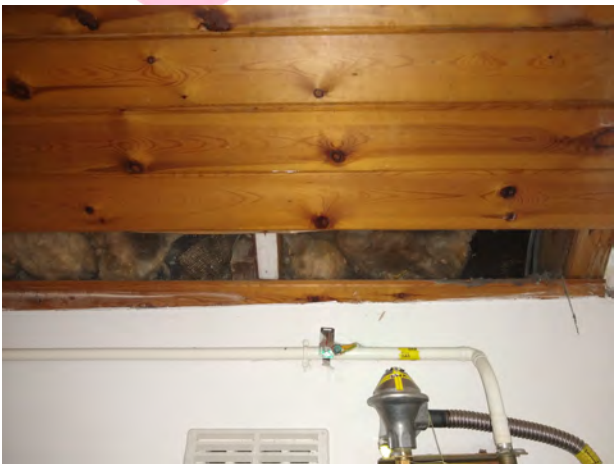
**Item 76 Ref: As 371873-6**

The sarking (Rm 060/Studio 1 Entrance Lobby) does not contain asbestos.

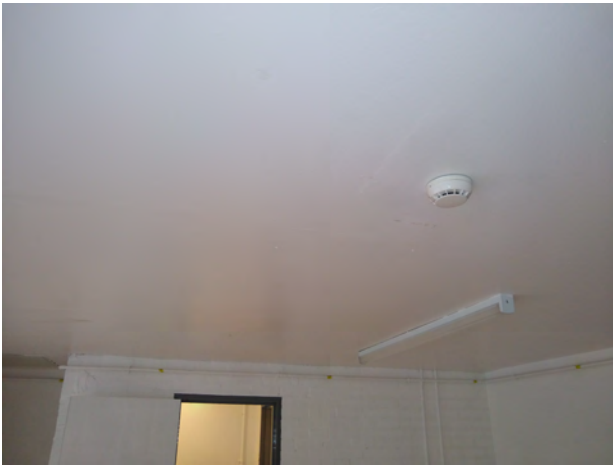
### **Item 77 Ref: 371873-7**

The ceiling (Rm 061/Studio 5) does not contain asbestos.

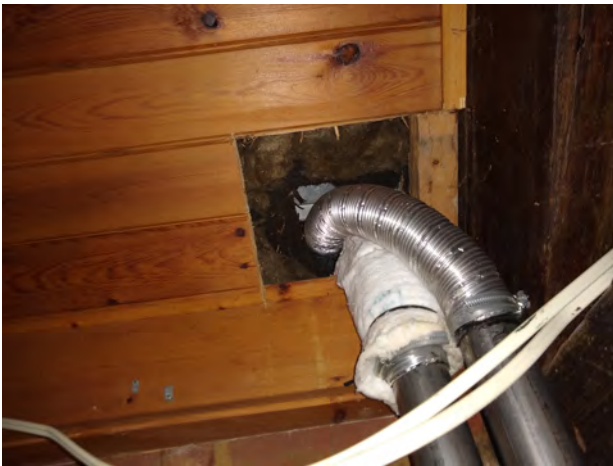
### **Item 78 Ref: As 371873-6**

The sarking (Rm 061/Studio 5 void above) does not contain asbestos.

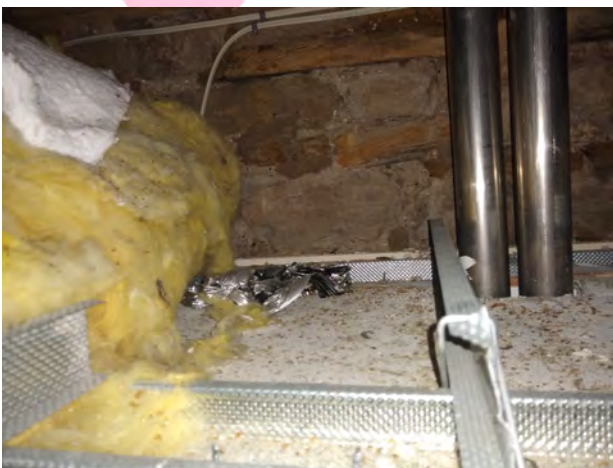
### **Item 79 Ref: 371873-7**

The floor (Rm 61/Studio 5 void above) does not contain asbestos.

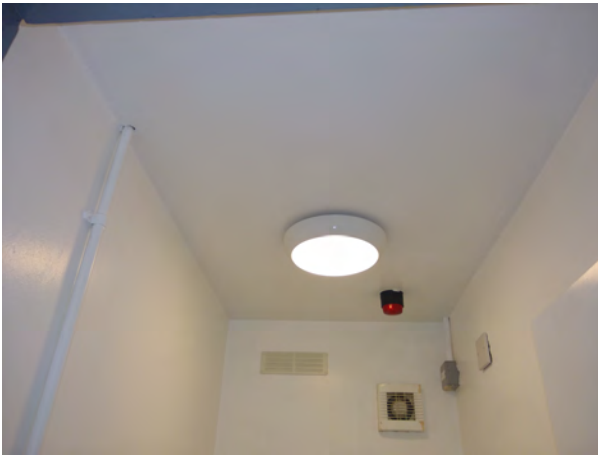
### **Item 80 Ref: As 371873-7**

The ceiling (Rm 062/Studio 5 WC) does not contain asbestos.

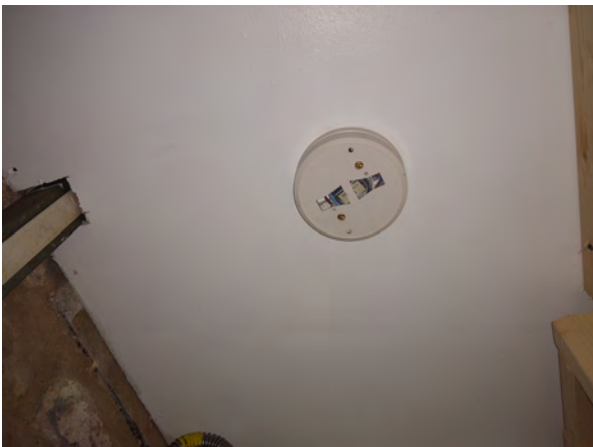
### **Item 81 Ref: As 371873-7**

The ceiling (Rm 063/Studio 5 electric cupboard) does not contain asbestos.

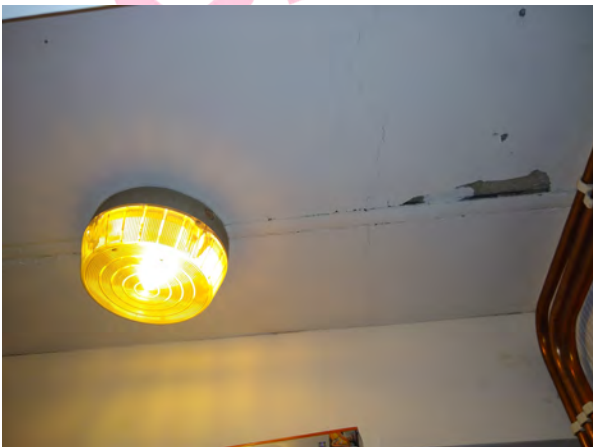
### **Item 82 Ref: As 371873-4**

The ceiling (Rm 064/Studio 10 boiler cupboard) does contain asbestos.

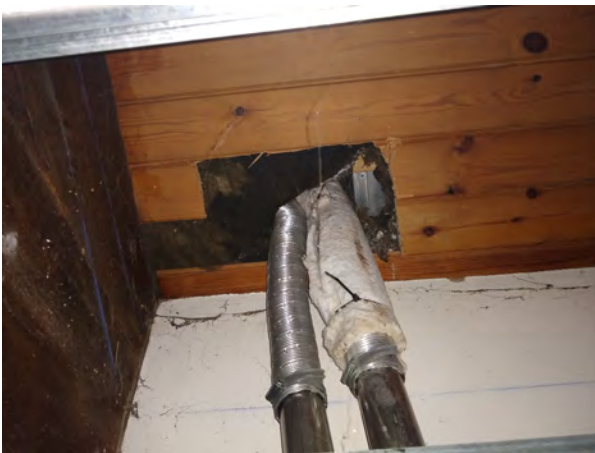
### **Item 84 Ref: As 371873-6**

The sarking (Rm 067/ukulele music room void above) does not contain asbestos.

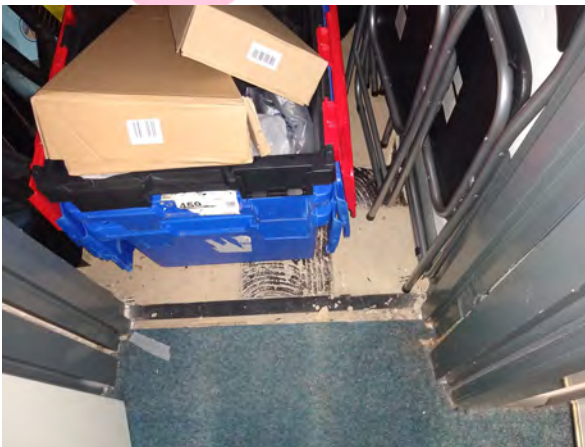
### **Item 85 Ref: As 371873-9**

The floor covering (Rm 068/ukulele music room store) does contain asbestos.

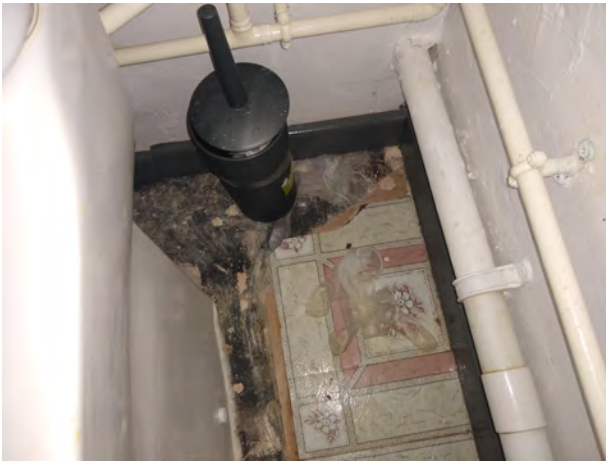
### **Item 86 Ref: As 371873-9**

The floor covering (Rm 069/ukulele music room WC and vestibule) does contain asbestos.

*Removed October 2020*

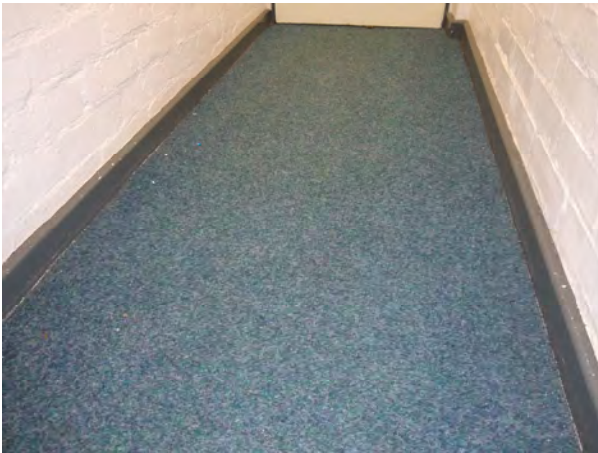
### **Item 87 Ref: As 371873-9**

The floor covering (Rm 070/ukulele music room WC lobby) does contain asbestos.

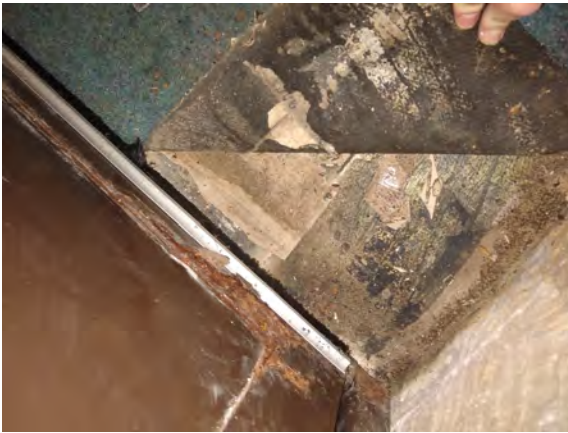
### **Item 89 Ref: As 371873-9**

The floor covering (Rm 072/ukulele music room entrance lobby) does contain asbestos.

Any change in appearance should be reported to Property Services.

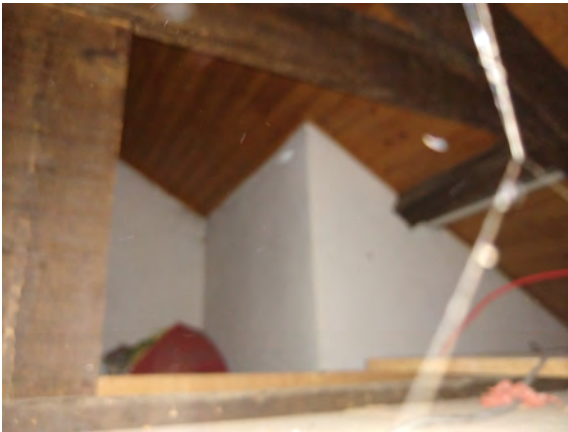
### **Item 90 Ref: As 371873-6**

The sarking (Rm 073/ukulele music room void above areas 068-071) does not contain asbestos.

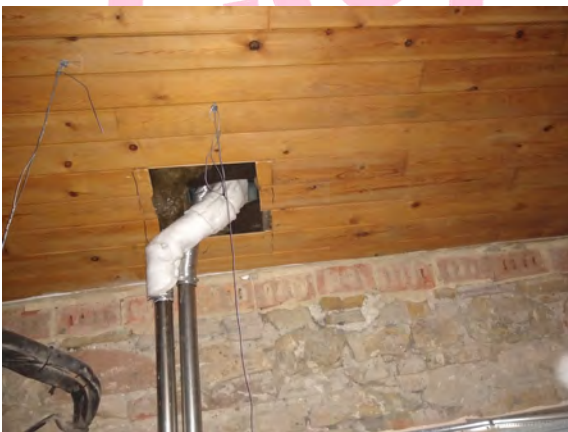
### **Item 91 Ref: As 371873-6**

The sarking (Rm 077/void above areas 075-076) does not contain asbestos.

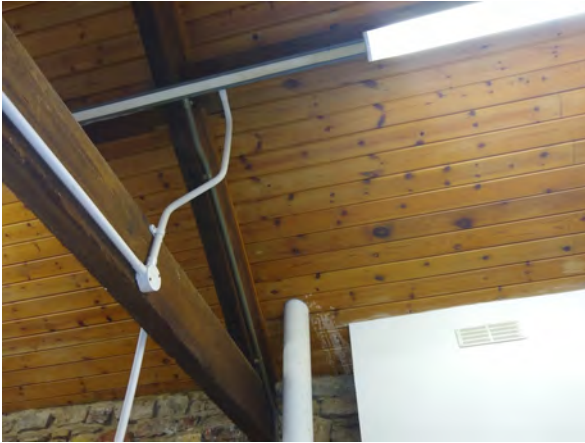
### **Item 92 Ref: As 371873-6**

The sarking above wood ceiling (Rm 078/Studio 3) does not contain asbestos.

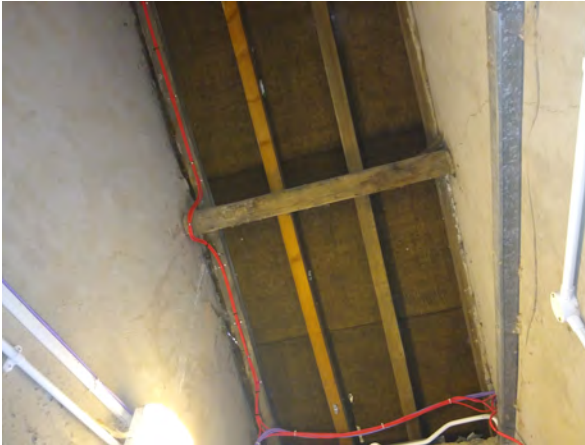
### **Item 93 Ref: As 371873-6**

The sarking (Rm 082/Stores corridor) does not contain asbestos.

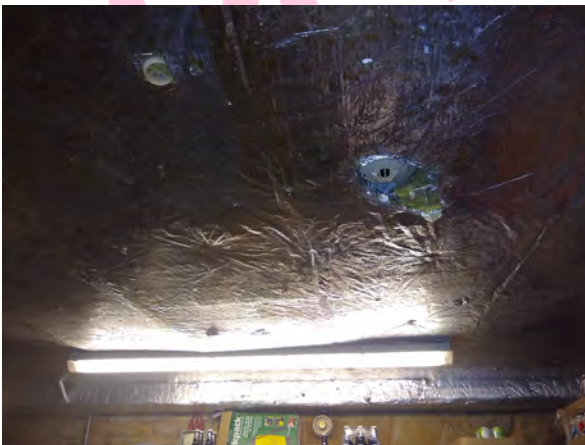
### **Item 94 Ref: 371873-11**

The ceiling (Rm 095/Cellar) does contain asbestos.

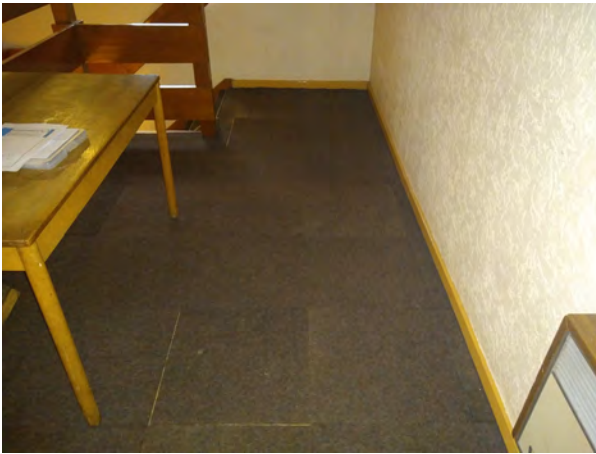
### **Item 95 Ref: 371873-18**

The debris within void below suspended floor (Rm 1/004/Stairwell landing) does contain asbestos.

*Removed Feb 2020.*

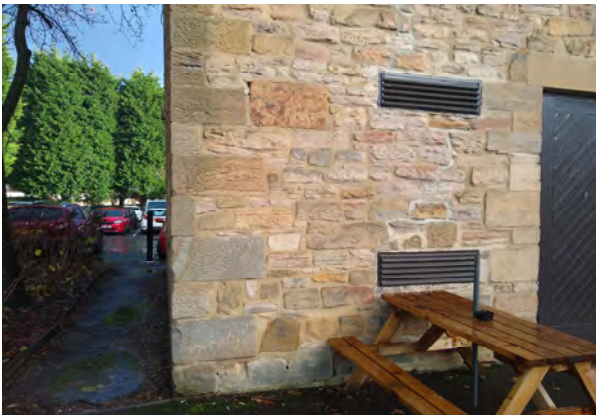
### **Item 96 Ref: 371873-12**

The packers within wall of 025 boiler room (External) does contain asbestos.

Any change in appearance should be reported to Property Services.

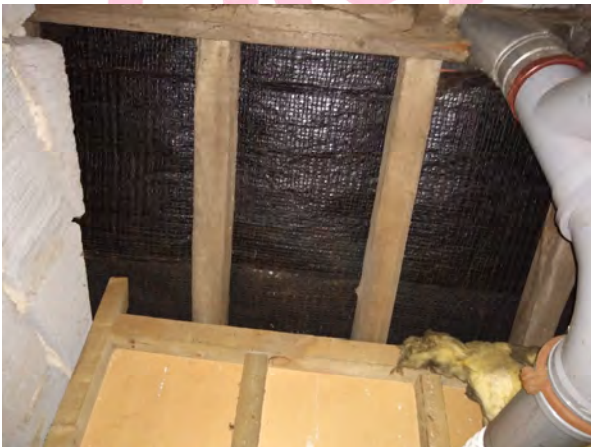
### **Item 97 Ref: 371873-10**

The sarking (Rm 1/008/Kitchen) does not contain asbestos.

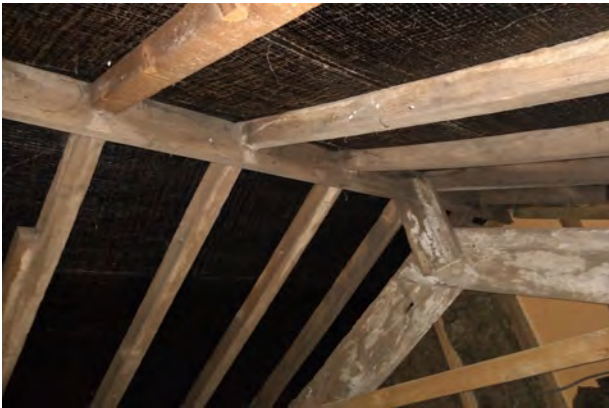
**Item 98 Ref: 371873-10**

The sarking (Rm 1/015/Bedroom lobby void above) does not contain asbestos.

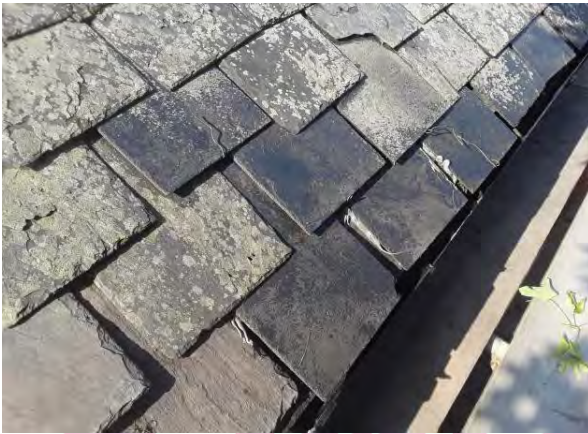
**Item 105 Ref: 21-36502-1**

The roof - replacement tiles (Cement) (Room/Area: 2 - External) does not contain asbestos.

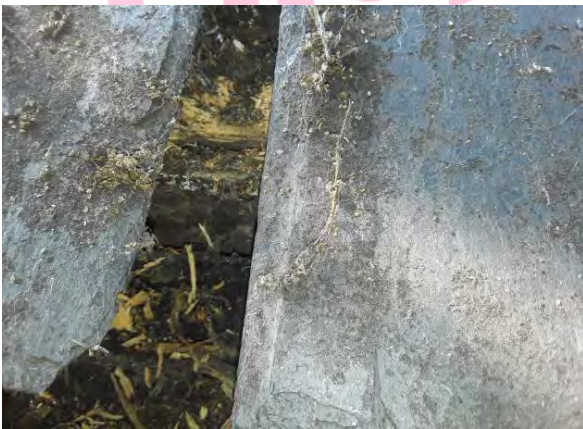
**Item 106 Ref: 21-36502-1**

The roof - sarking felt (Bitumen) (Room/Area: 2 - External) does not contain asbestos.

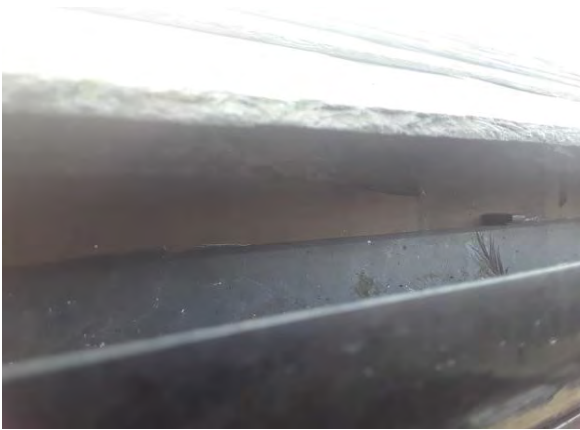
**Item 107 Ref: 20-378903-1**

The roof sarking felt (Bitumen) (Area 1/Roof Area 1) does not contain asbestos.

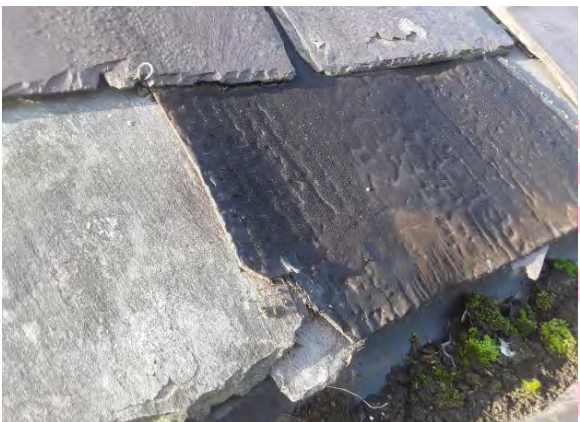
**Item 108 Ref: 21-378903-3**

The roof sarking felt (Bitumen) (Area 2/Roof Area 2) does not contain asbestos.

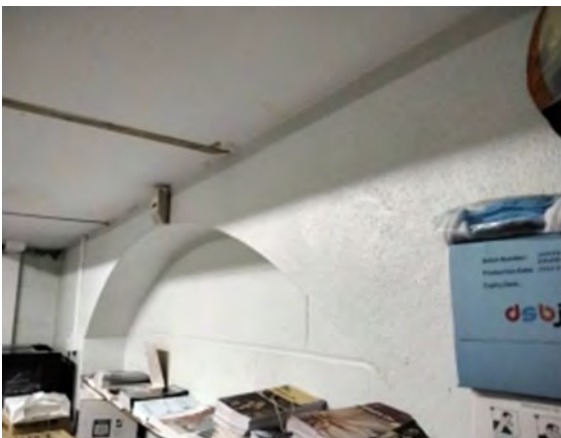
**Item 112 Ref: KX001130**

The textured coating to the walls in the Reception (Room 17) does not contain asbestos.

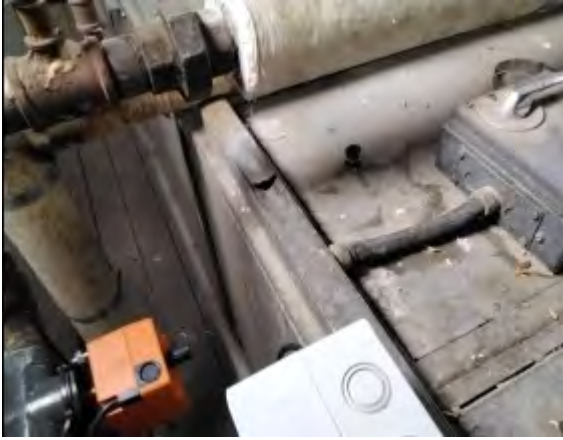
**Item 116 Ref: SC004278**

The debris to air handling unit topside in Plant Room does not contain asbestos.

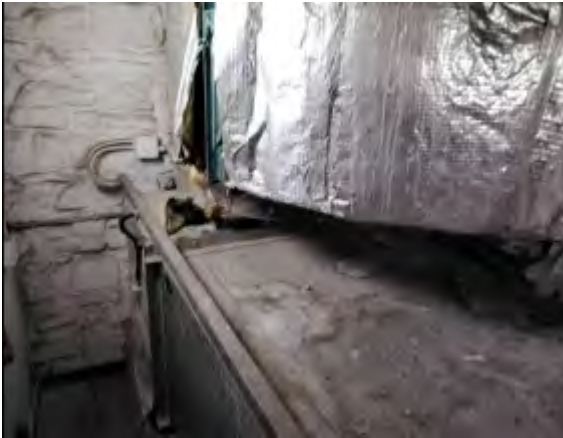
**Item 117 Ref: SC004281**

The debris to ducting topside in Plant Room does not contain asbestos.

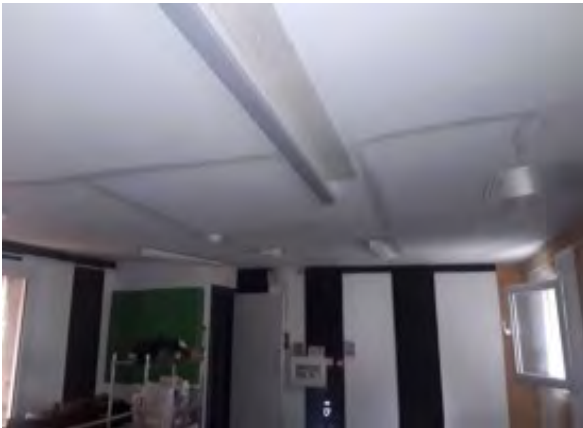
**Item 120 Ref: NZ001288**

The ceiling G/001 Office does not contain asbestos.

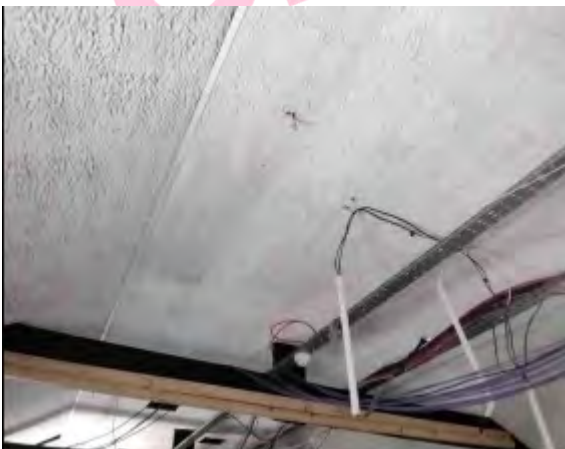
**Item 121 Ref: AW005887**

The ceiling tile – suspended in Studio 8 does not contain asbestos.

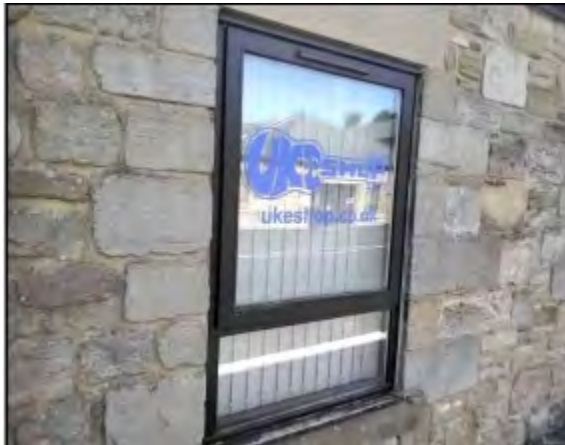
**Item 122 Ref: AW005884**

The window remains of old sealant External to Studio Building does not contain asbestos.

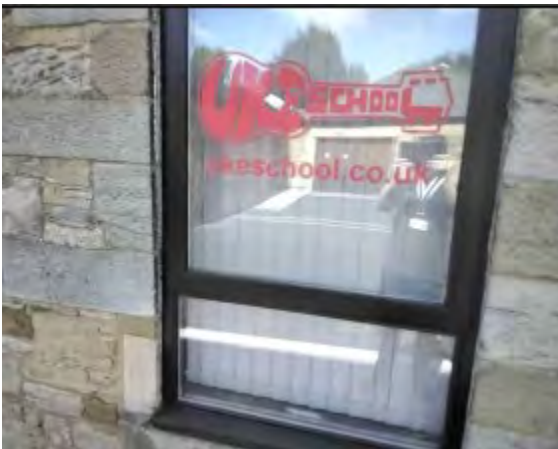
**Item 123 Ref: AW005885**

The window remains of old sealant External to Studio Building does not contain asbestos.

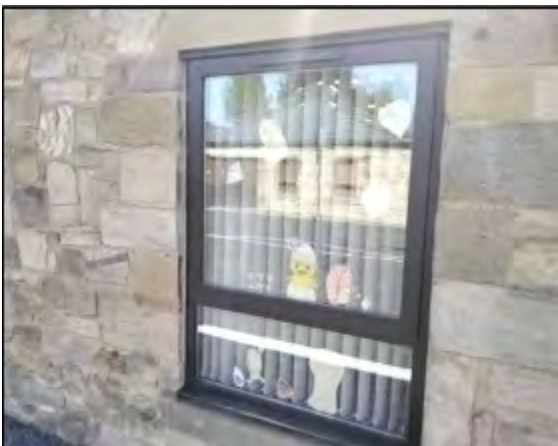
**Item 124 Ref: AW005886**

The window remains of old sealant External to Studio Building does not contain asbestos.

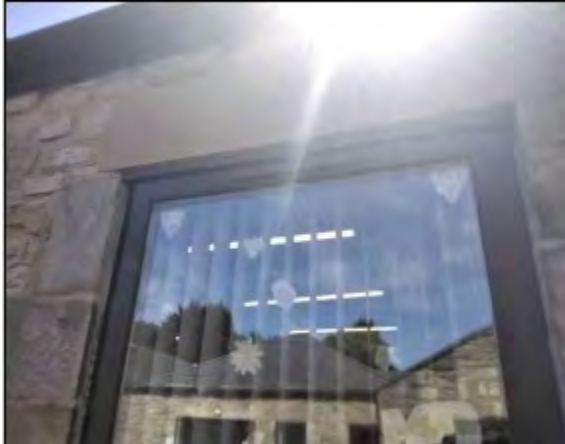
**Item 125 Ref: AW005888**

The window sealant External to Studio Building does not contain asbestos.

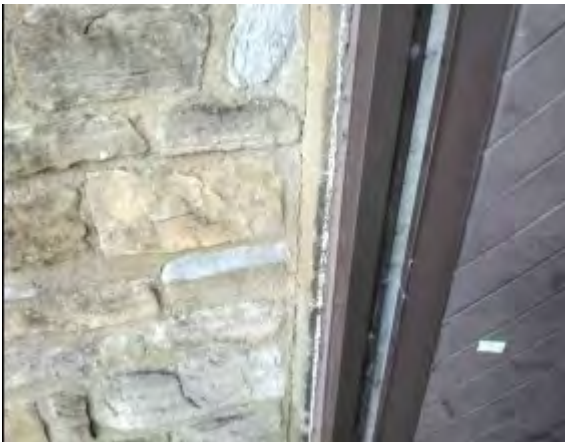
**Item 126 Ref: AW005889**

The door remains of old sealant External to Studio Building does not contain asbestos.

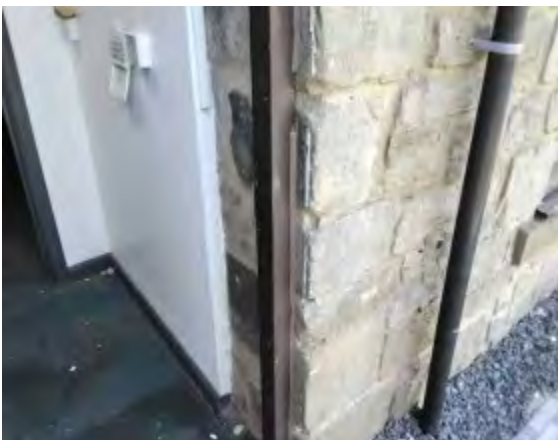
**Item 127 Ref: AW005890**

The brown door frame sealant External to Studio Building does not contain asbestos.

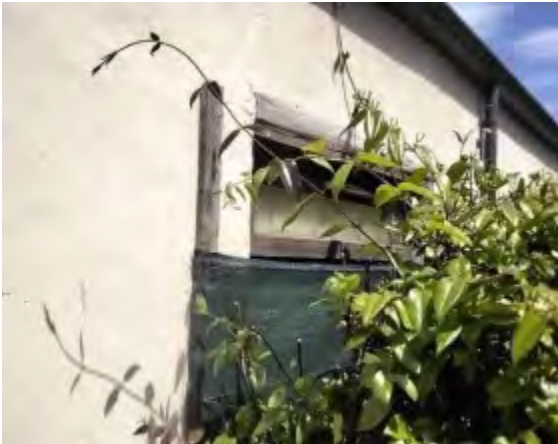
**Item 129 Ref: AW005892**

The window remains of old sealant External to Studio Building does not contain asbestos.

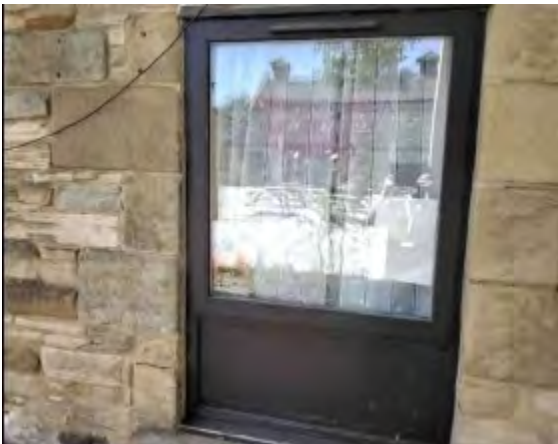
**Item 130 Ref: AW005893**

The window remains of old sealant External to Main Building does not contain asbestos.

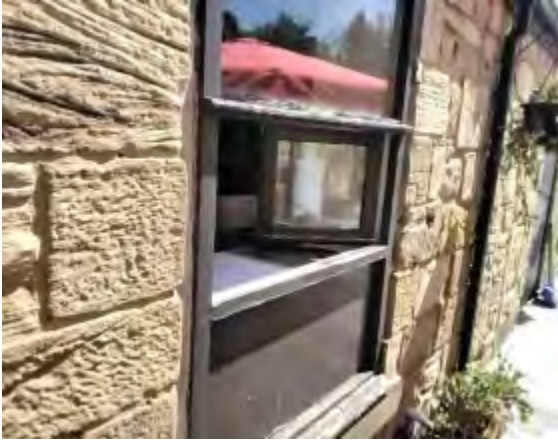
**Item 134 Ref: AW005897**

The window brown sealant  
External to Main Building  
does not contain asbestos.

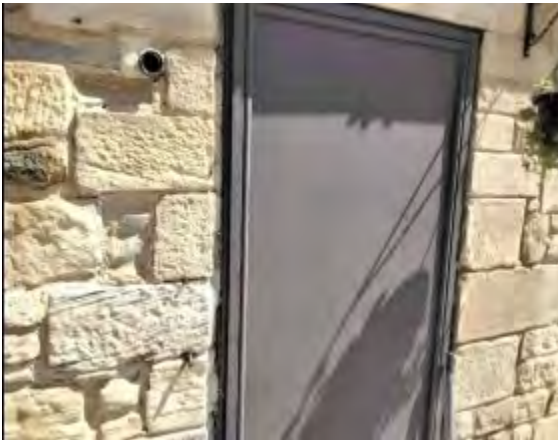
**Item 135 Ref: AW005898**

The door frame sealant  
External to Main Building  
does not contain asbestos.

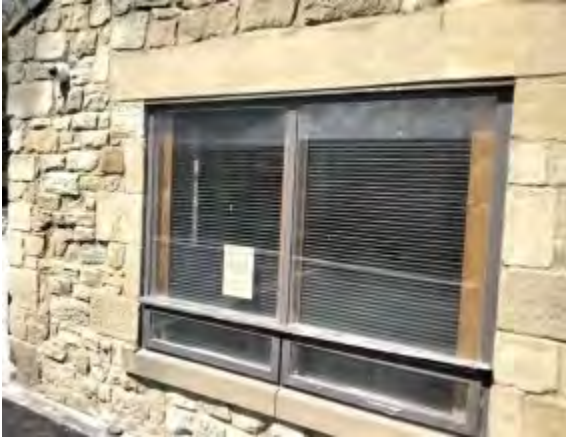
**Item 137 Ref: AW005900**

The window remains of old sealant External to Main Building does not contain asbestos.

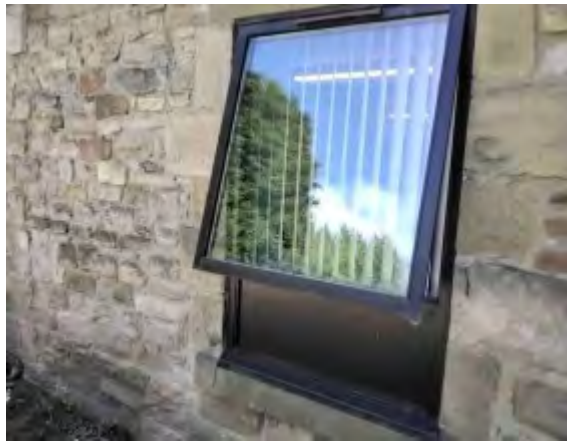
**Item 141 Ref: AW005904**

The door brown sealant External to Main Building does not contain asbestos.
