ASBESTOS SURVEY REPORT FOR HENDON HEALTH CENTRE, MEABURN TERRACE, SUNDERLAND, SR1 2RN

Asbestos Register for

Hendon Health Centre, Meaburn Terrace, Sunderland

Date: 30 January 2026

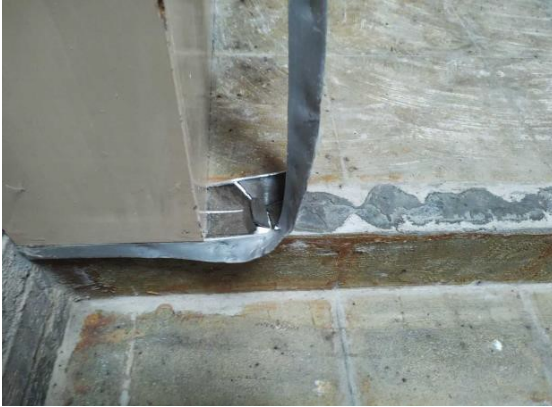
Item 1 Ref: 21-40548-1

- (Item 1) Ref: 21-40548-1 Remaining noising treads to floor (Area 4/Landing and Stairs) – Removed no wcn however noted on survey J125328
- (Item 2) Ref: 21-40548-2 – Sink pad (Area 20/Kitchen and Cupboard) – No Risk

The remaining noising treats to floor (Area 4/Landing and Stairs) contain asbestos.

Removed no wcn however noted on survey J125328

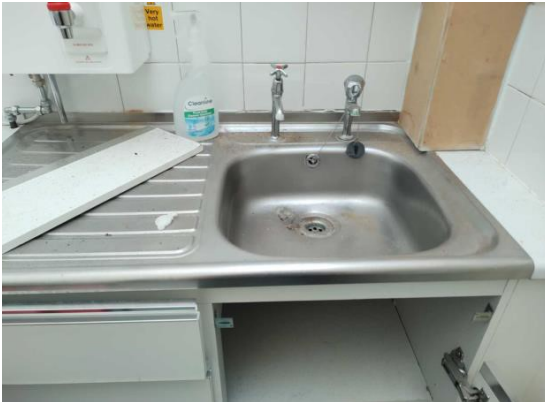
Item 2 Ref: 21-40548-2

The sink pad (Area 20/Kitchen and Cupboard) does not contain asbestos.

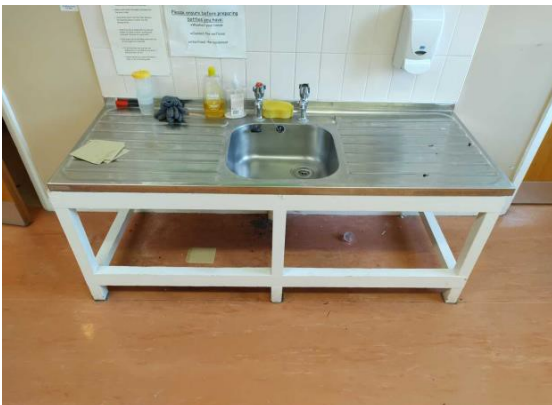
Item 3 Ref: 21-40548-3

The sink pad (Area 22/Playroom) does not contain asbestos.

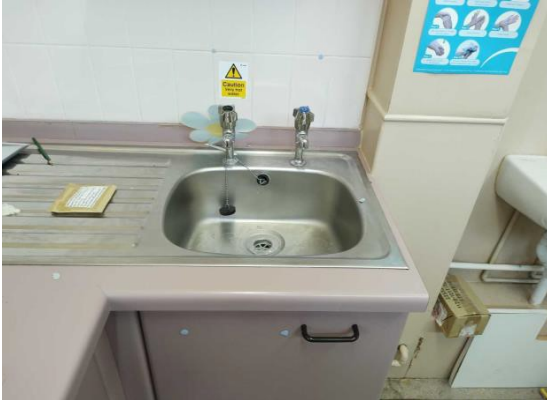
Item 4 Ref: 21-40548-4

The sink pad (Area 23/Children's WC) does not contain asbestos.

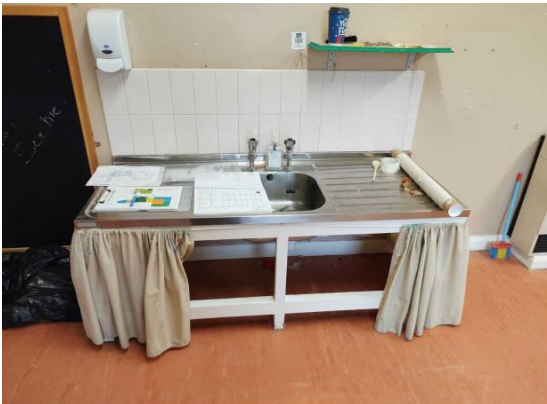
Item 5 Ref: 21-40548-4

The sink pad (Area 25/Playroom 2) does not contain asbestos.

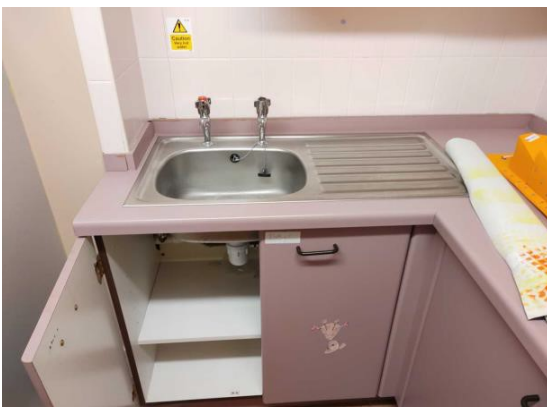
Item 6 Ref: 21-40548-4

The sink pad (Area 27/Children's WC 2) does not contain asbestos.

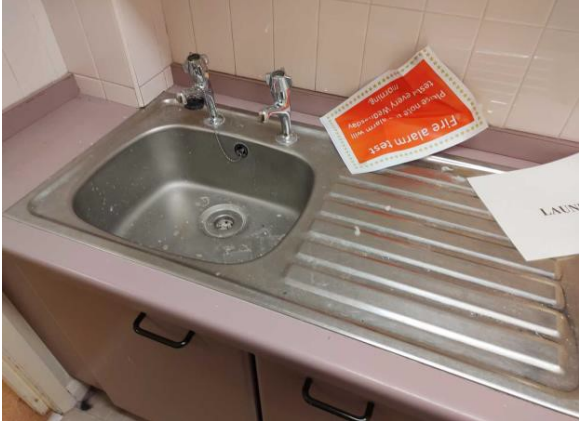
Item 7 Ref: 21-40548-5

The sink pad (Area 29/Laundry) does not contain asbestos.

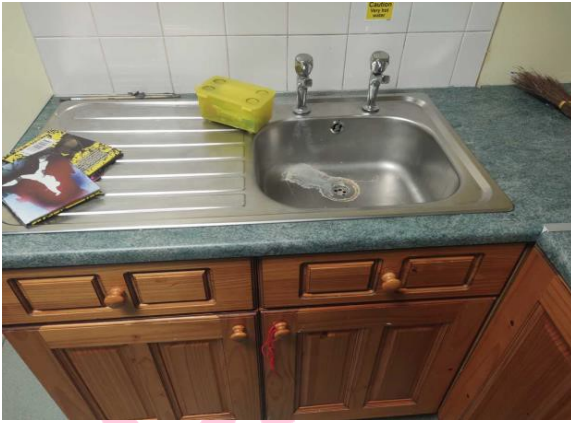
Item 8 Ref: 21-40548-6

The sink pad (Area 35/Family Room) does not contain asbestos.

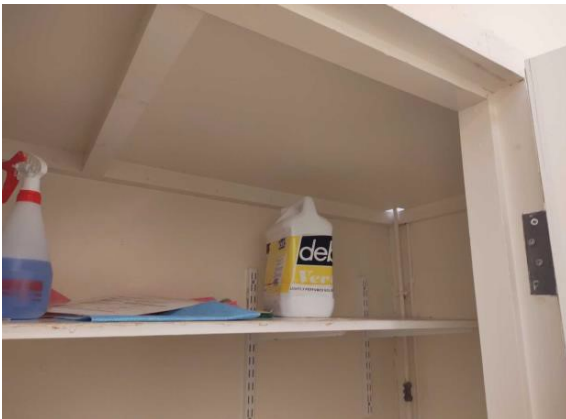
Item 9 Ref: 21-40548-7

The cupboard ceiling (Area 42/Male WC and Cupboard) does not contain asbestos.

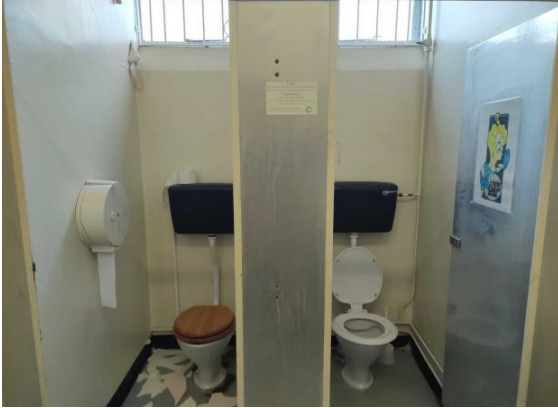
Item 10 Ref: 21-40548-8

The toilet (Area 43/Female WC) does not contain asbestos.

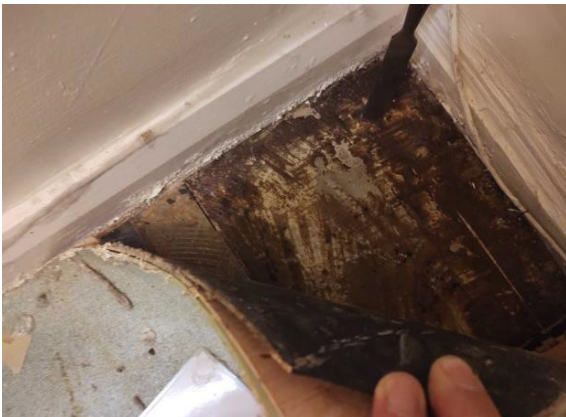
Item 11 Ref: 21-40548-9

The floor tiles and adhesive (Area 44/Store Cupboard) does not contain asbestos.

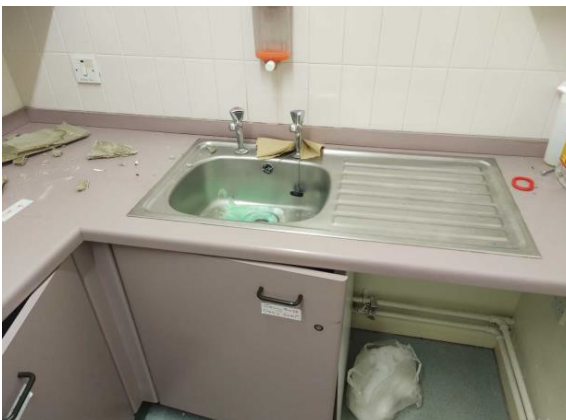
Item 12 Ref: 21-40548-10

The sink pad (Area 48/Kitchen young mums) does not contain asbestos.

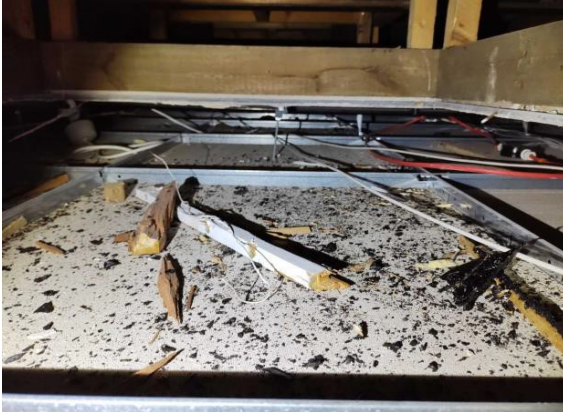
Item 13 Ref: 21-40548-11

The debris to tops of suspended ceiling tiles from flat roof above (Area 56/Cloaks) contains asbestos.

Removed February 2022

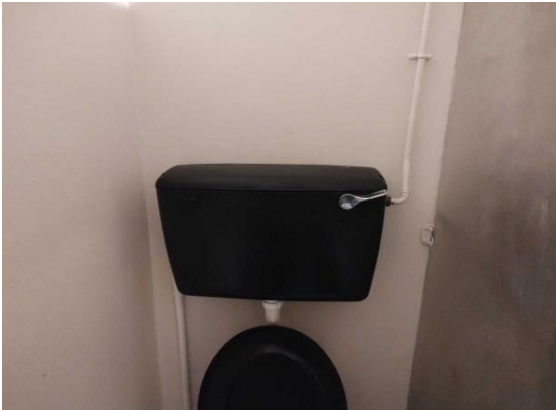
Item 14 Ref: 21-40548-8

The toilet (Area 58/Male WC) does not contain asbestos.

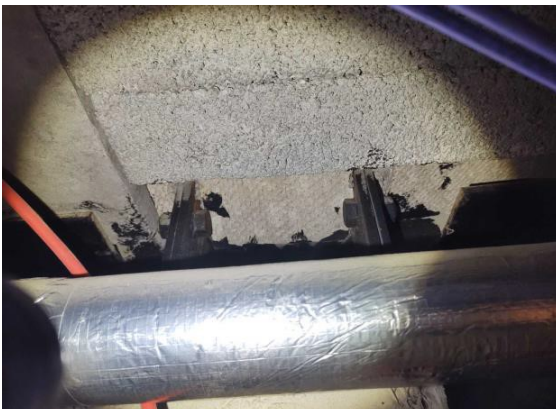
Item 15 Ref: Presumed

- (Item 15) Presumed – Cement shuttering within ceiling void (Area 62/Corridor 2) – Very Low Risk
- (Item 16) Presumed – Ceiling (Area 64/Main entrance) – Very Low Risk

The cement shuttering within ceiling void (Area 62/Corridor 2) is presumed to contain asbestos.

Any change in its appearance should be recorded and passed to Property Services.

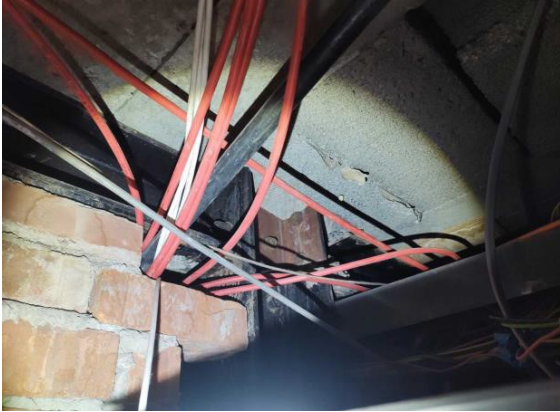
Item 16 Ref: Presumed

The ceiling (Area 64/Main entrance) is presumed to contain asbestos.

Any change in its appearance should be recorded and passed to Property Services.

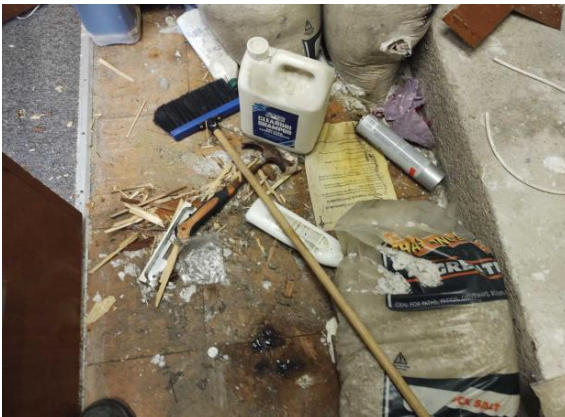
Item 17 Ref: 21-40548-13

The floor tiles and adhesive (Area 65/Switch Room) do not contain asbestos.

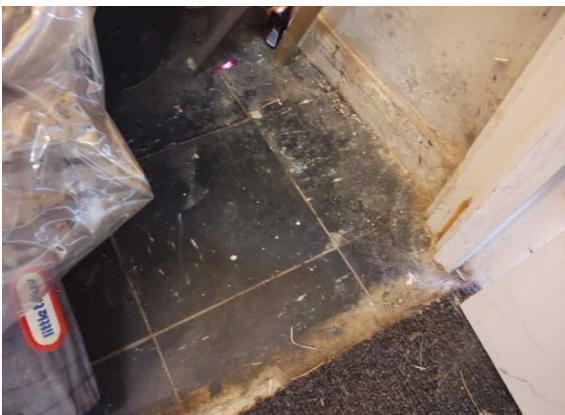
Item 18 Ref: 21-40548-14

The floor tiles and adhesive (Area 66/Main Entrance Store) do not contain asbestos.

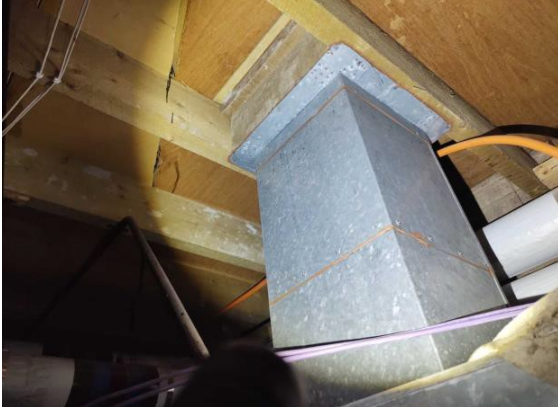
Item 19 Ref: 21-40548-15

- (Item 19) Ref: 21-40548-15 – Sealant to duct joints (Area 67/Foyer 2 and Cupboard) – Very Low Risk
- (Item 20) Ref: 21-40548-16 – Infill panels (Area 73/Stairwell) – No Risk

The sealant to duct joints (Area 67/Foyer 2 and Cupboard) contains asbestos.

Any change in its appearance should be recorded and passed to Property Services.

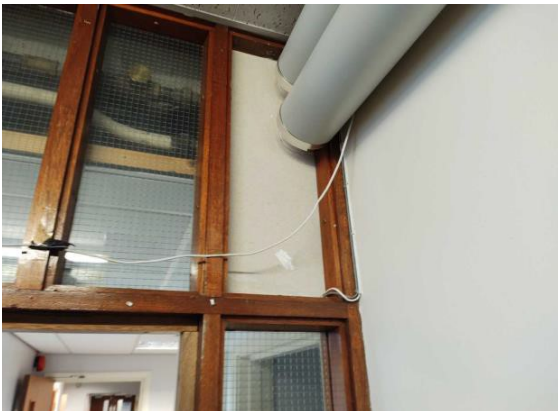
Item 20 Ref: 21-40548-16

The infill panels (Area 73/Stairwell) do not contain asbestos.

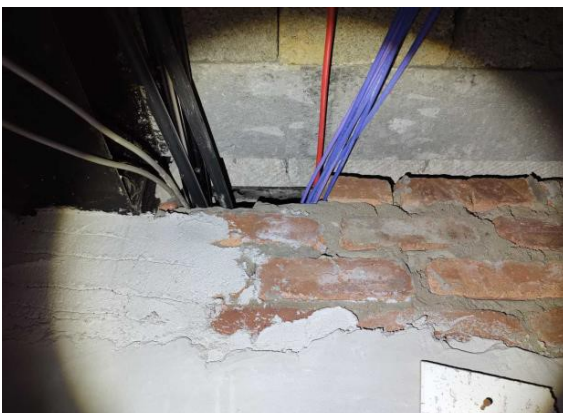
Item 21 Ref: Presumed

The shuttering within ceiling void (Area 75/Corridor 3) is presumed to contain asbestos.

Any change in its appearance should be recorded and passed to Property Services.

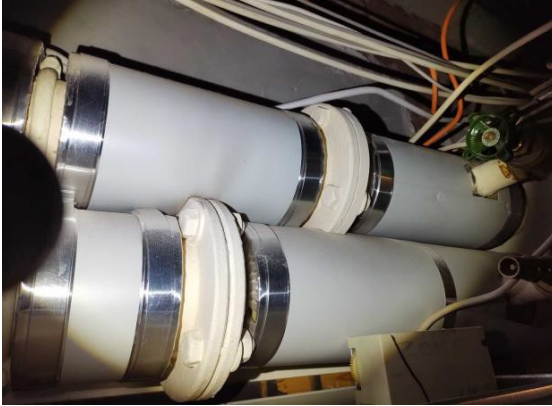
Item 22 Ref: Presumed

The gasket to close coupled pipe flanges (Area 75/Corridor 3) is presumed to contain asbestos.

Any change in its appearance should be recorded and passed to Property Services.

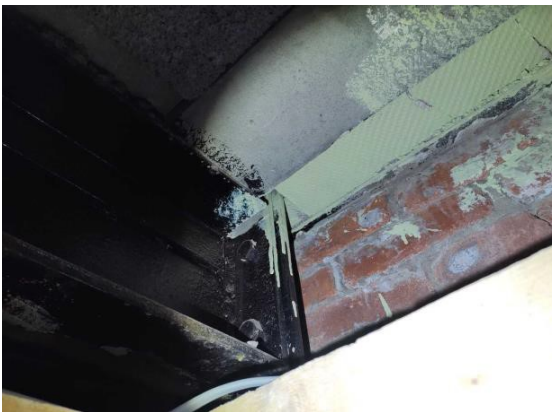
Item 23 Ref: Presumed

The cement shuttering within ceiling void (Area 79/Office 10) is presumed to contain asbestos.

Any change in its appearance should be recorded and passed to Property Services.

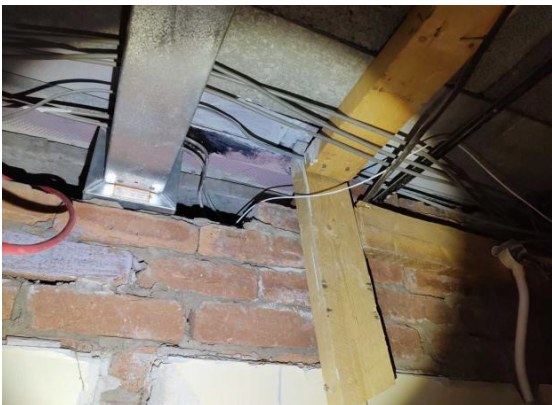
Item 24 Ref: Presumed

The cement shuttering within ceiling void (Area 80/WC accessible) is presumed to contain asbestos.

Any change in its appearance should be recorded and passed to Property Services.

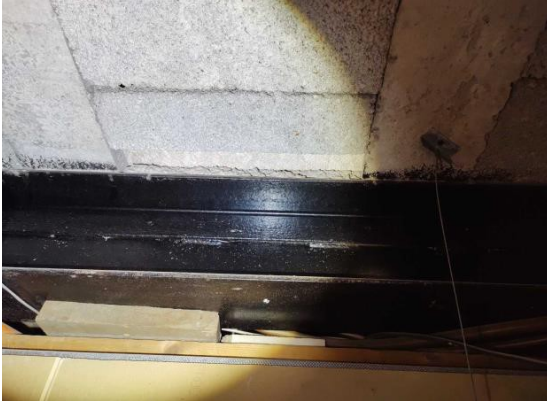
Item 25 Ref: Presumed

The cement shuttering within ceiling void (Area 85/Kitchen 2) is presumed to contain asbestos.

Any change in its appearance should be recorded and passed to Property Services.

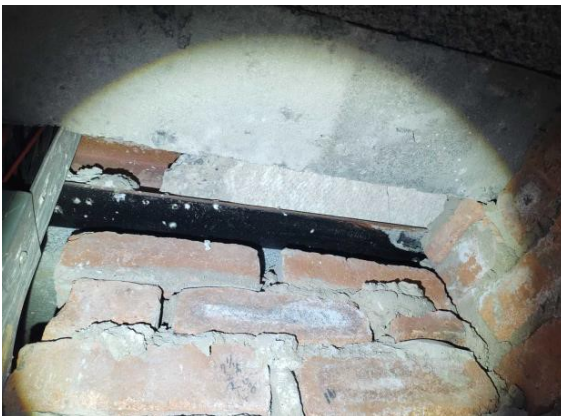
Item 26 Ref: Presumed

The ceiling (Area 88/Office and Cupboard) is presumed to contain asbestos.

Any change in its appearance should be recorded and passed to Property Services.

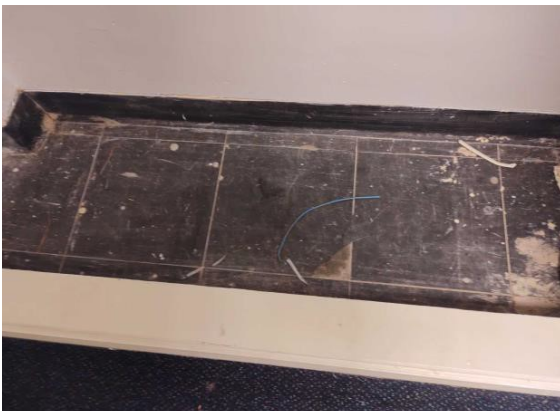
Item 27 Ref: 21-40548-14

The floor tiles and adhesive (Area 88/Office and Cupboard) do not contain asbestos.

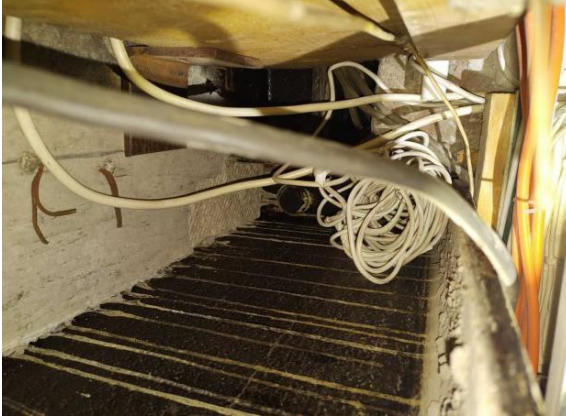
Item 28 Ref: Presumed

The cement shuttering within ceiling void (Area 89/Office 14) is presumed to contain asbestos.

Any change in its appearance should be recorded and passed to Property Services.

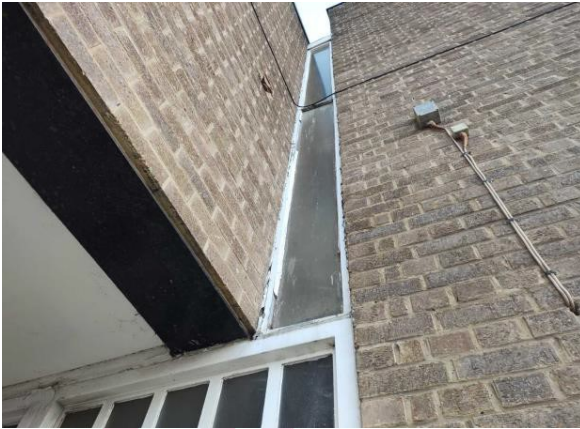
Item 29 Ref: 21-40548-18

The sealant to metal window frames (Area 95/External) contains asbestos.

Any change in its appearance should be recorded and passed to Property Services.

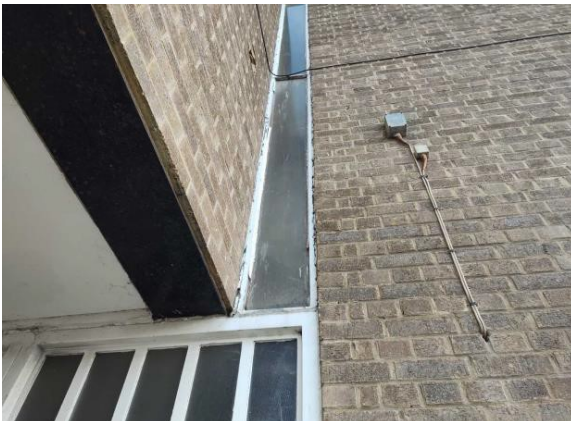
Item 30 Ref: 21-40548-19

The sealant to glazing on metal frames (Area 95/External) contains asbestos.

Any change in its appearance should be recorded and passed to Property Services.

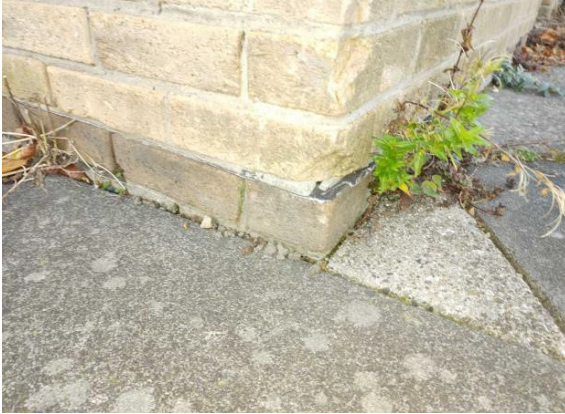
Item 31 Ref: 21-40548-20

The damp proof course (Area 95/External) contains asbestos.

Any change in its appearance should be recorded and passed to Property Services.

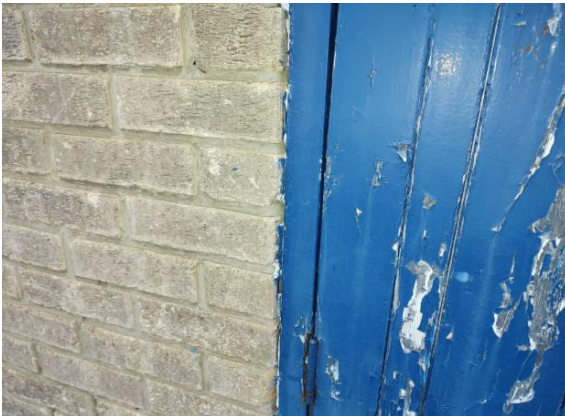
Item 32 Ref: 21-40548-21

The sealant to timber external door frame (Area 95/External) contains asbestos.

Any change in its appearance should be recorded and passed to Property Services.
