ASBESTOS SURVEY REPORT FOR JACKY WHITES MARKET, MARKET HALL, SOUTH STREET, SUNDERLAND, SR1 3DG.

Asbestos Register for

Jacky Whites Market, Market Hall, Sunderland, SR1 3DG

Date: 01 August 2025

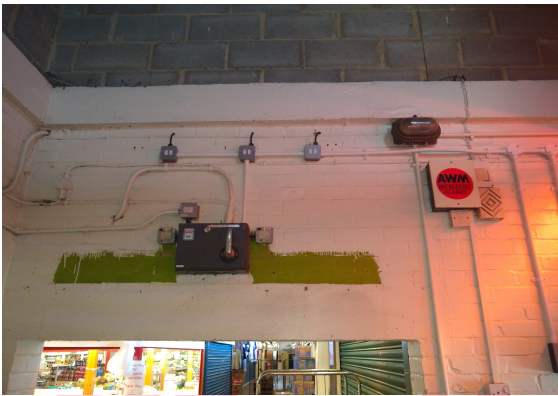
Item 8 Ref: Presumed

The electrics M.E.M in the Lobby (Rm 0/08) are presumed to contain asbestos.

Item removed but no WCN received yet

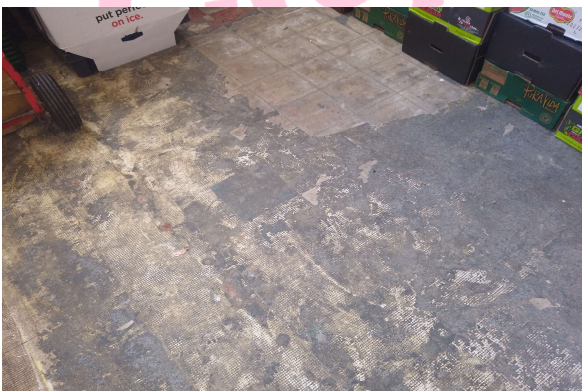
Item 12 Ref: 412163-14

The floor covering to vacant store unit 28 in the Market Hall (Rm 0/13) does not contain asbestos.

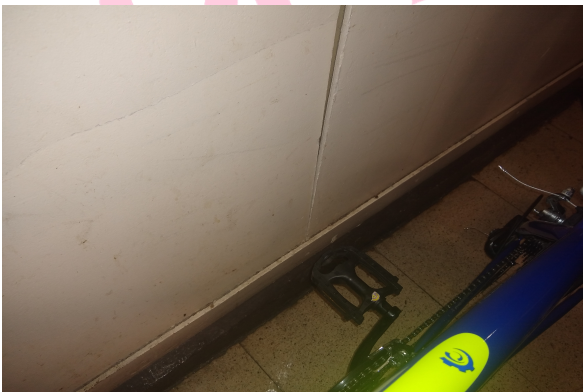
Item 15 Ref: As 412163-9

The skirting to partition wall in the Corridor (Rm 1/02) does not contain asbestos.

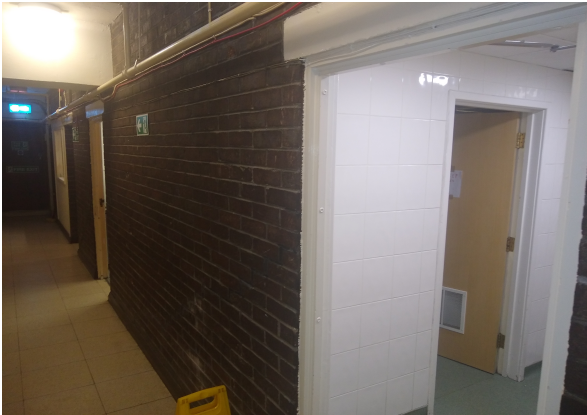
Item 17 Ref: 412163-10

The sealant to door frames in the Corridor (Rm 1/02) contains asbestos.

Any change in its appearance should be reported to Property Services.

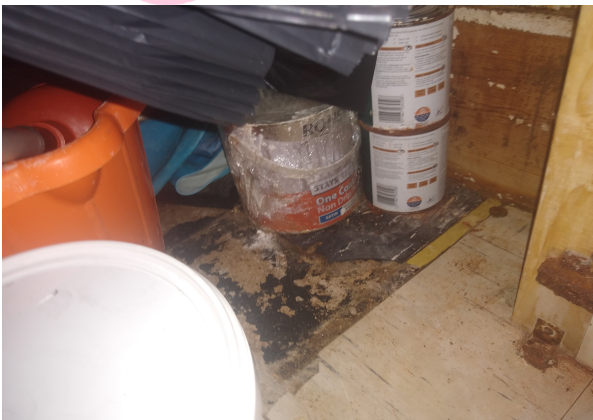
Item 18 Ref: 412163-6

The yellow and black floor covering below sink in the Tea Room (Rm 1/03) contains asbestos.

Any change in its appearance should be reported to Property Services.

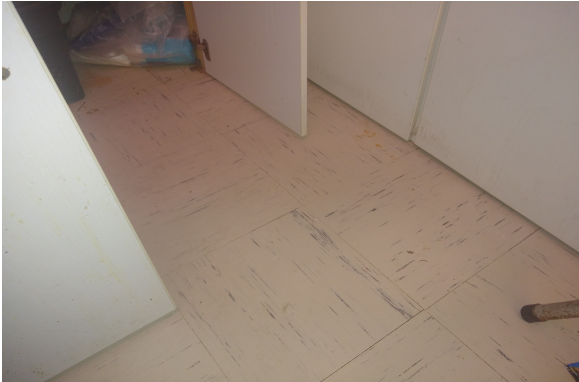
Item 19 Ref: 412163-7

The white floor covering in the Tea Room (Rm 1/03) contains asbestos.

Any change in its appearance should be reported to Property Services.

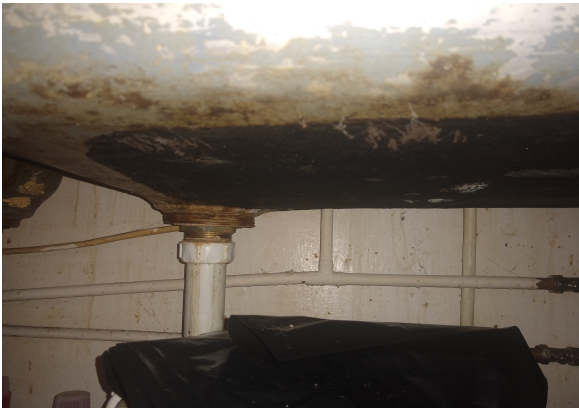
Item 20 Ref: 412163-8

The acoustic dampening finish to sink in the Tea Room (Rm 1/03) does not contain asbestos.

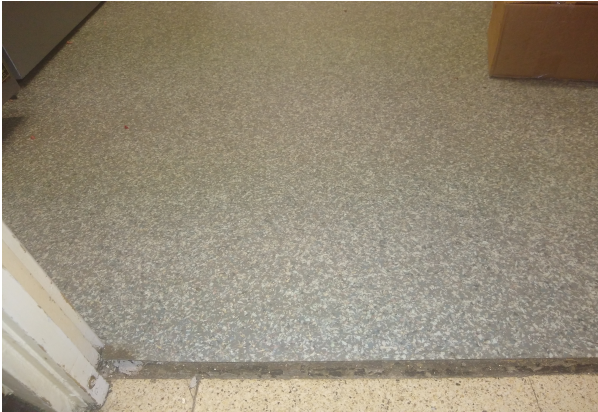
Item 22 Ref: 412163-4

The remnant tile adhesive below lino in the Prep Room (Rm 1/10) contains asbestos.

Any change in its appearance should be reported to Property Services.

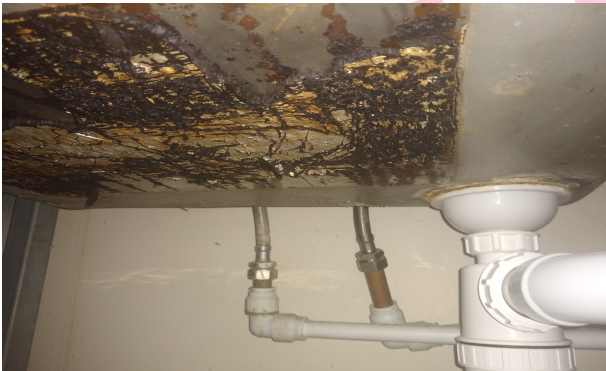
Item 23 Ref: 412163-5

The sink pad in the Prep Room (Rm 1/10) contains asbestos.

Any change in its appearance should be reported to Property Services.

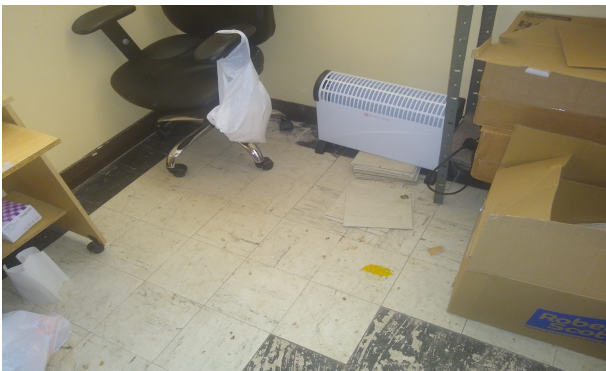
Item 24 Ref: 412163-3

The black and white floor covering in the Store (Rm 1/11) contains asbestos. Removed May 2021. However Bitumen remains and any change in its appearance should be reported to Property Services.

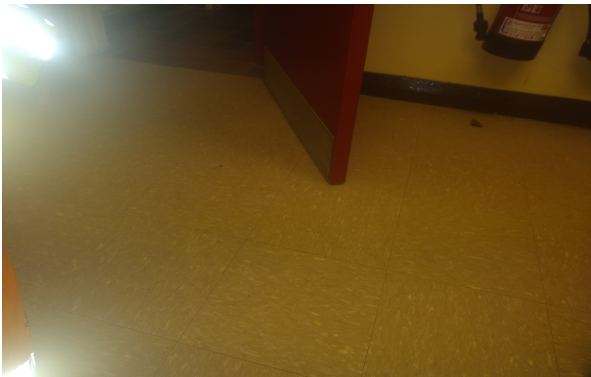
Item 26 Ref: 412163-2

The floor covering in the Office (Rm 1/14) contains asbestos.

Any change in its appearance should be reported to Property Services.

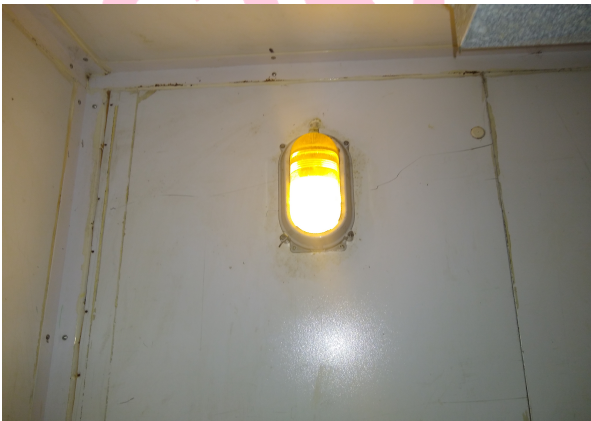
Item 27 Ref: 412163-19

The mastic to light fittings in the Chiller above greengrocers (Rm 1/21) contains asbestos.

Any change in its appearance should be reported to Property Services.

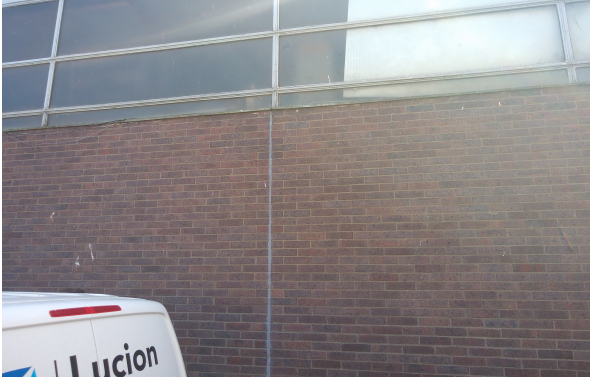
Item 28 Ref: 412163-20

The seal to expansion joints
(External) does not contain
asbestos.

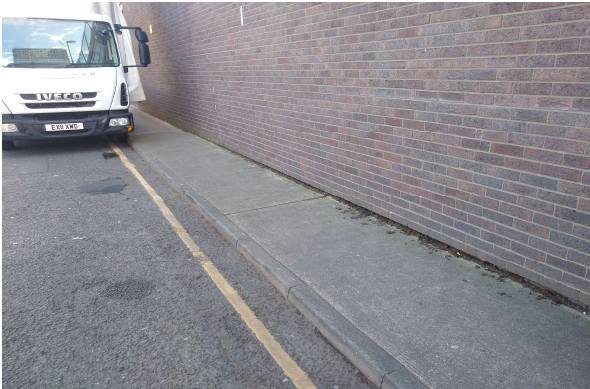
Item 29 Ref: 412163-21

The damp proof course
(External) does not contain
asbestos.

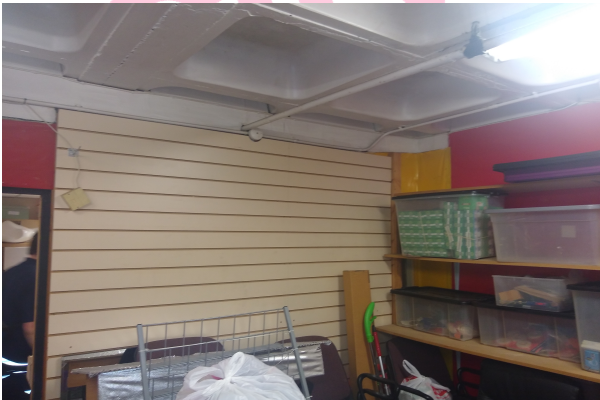
Item 30 Ref: 412163-13

The partition wall in the Store
– Former Jewellery Box
Outlet (Rm 1/16) does not
contain asbestos.

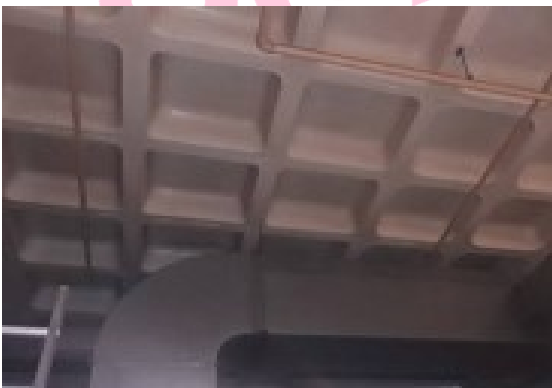
Item 33 Ref: NZ000693

The mastic to joints (G/001 Large Room above market café) does not contain asbestos.

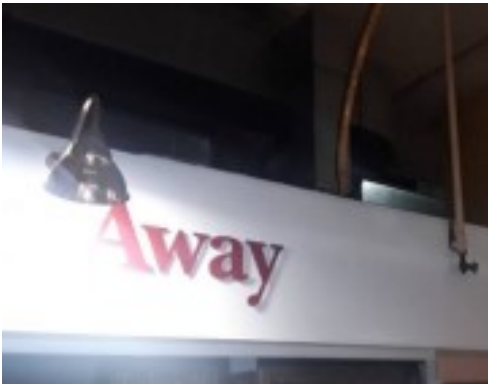
Item 34 Ref: NZ000694

The debris/residue to top of tiles and ductwork (G/001 Large Room above market café) does not contain asbestos.

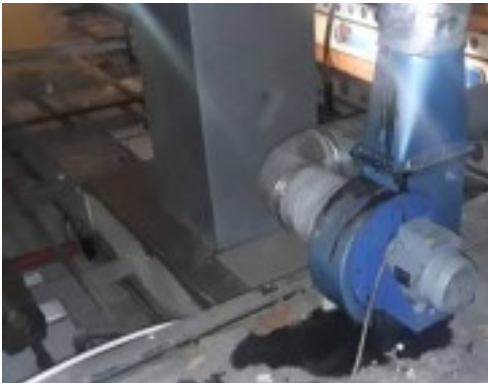
Item 35 Ref: NZ000697

The ductwork gaskets to pump (G/001 Large Room above market café) does not contain asbestos.

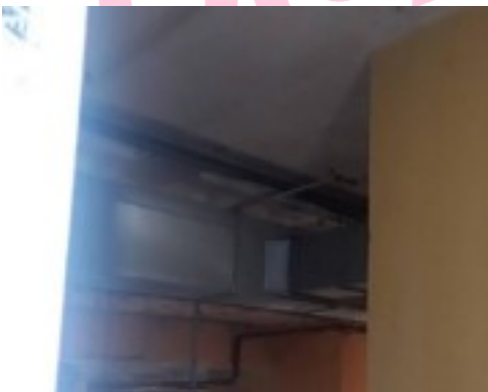
Item 36 Ref: NZ000695

The mastic to joints (G/002 Large room above Butchers and Seafood stall) does not contain asbestos.

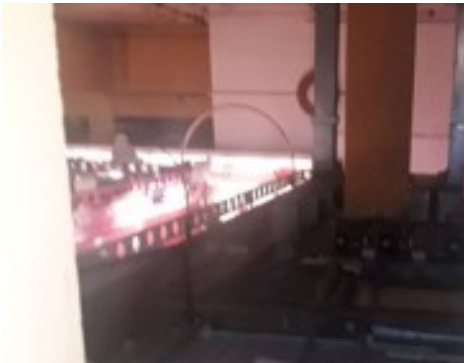
Item 37 Ref: NZ000696

The debris/residue to top of tiles and ductwork (G/002 Large room above Butchers and Seafood stall) does not contain asbestos.

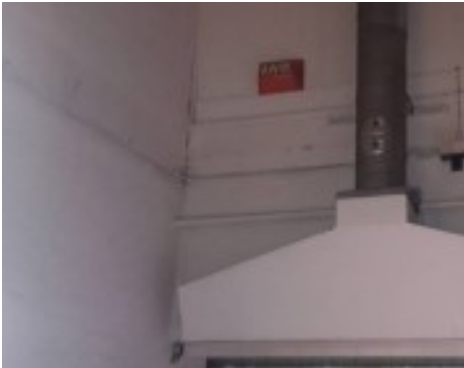
Item 38 Ref: NZ000698

The debris/residue within ductwork (G/002 Large room above Butchers and Seafood stall) does not contain asbestos.

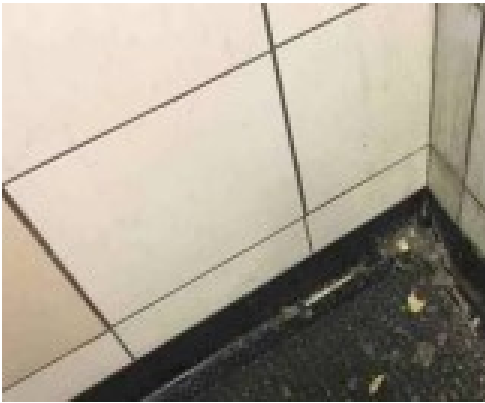
Item 40 Ref: AW005595

The floor debris in the Room Lift Lobby (G/001) does not contain asbestos.

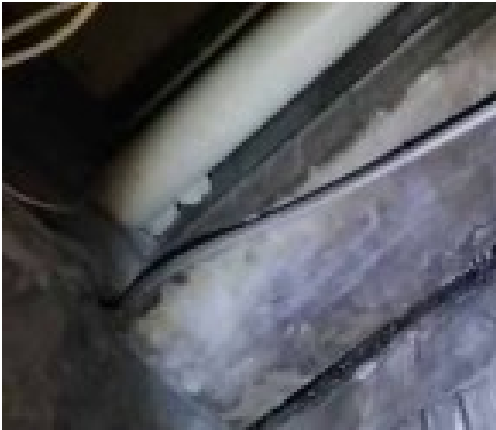
Item 41 Ref: AW005596

The ceiling void panel to expansion joint in the Room Lift Lobby (G/001) does not contain asbestos.
