ASBESTOS SURVEY REPORT FOR JACKY WHITES MARKET, MARKET HALL, SOUTH STREET, SUNDERLAND, SR1 3DG.

**Jacky Whites Market, Market Hall, Sunderland, SR1 3DG**

**Date: 20 November 2025**

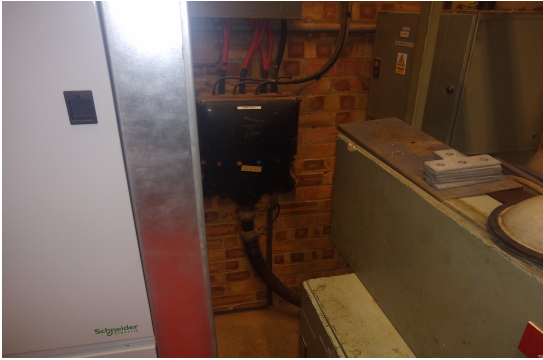
### **Item 1 Ref: Presumed**

- (Item 1) Ref: Presumed – Cable wrap to income supply (0/002 electrics distribution store) – Low Risk
- (Item 2) Ref: Presumed – Electrics MEM (0/002 electrics distribution store) – Very Low Risk

The cable wrap to income supply in the Electrics Distribution Store (Rm 0/02) is presumed to contain asbestos.

Any change in its appearance should be reported to Property Services.

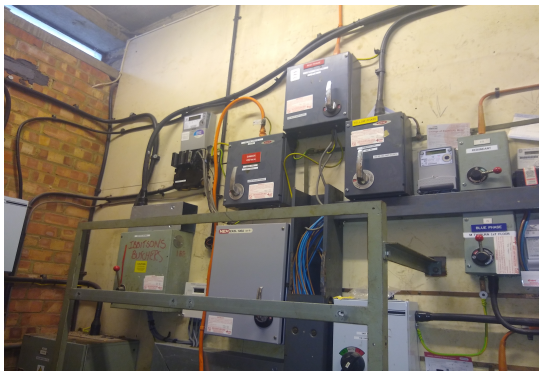
### **Item 2 Ref: Presumed**

The electrics M.E.M in the Electrics Distribution Store (Rm 0/02) is presumed to contain asbestos.

*Some items changed but no WCN received yet*

Any change in its appearance should be reported to Property Services.

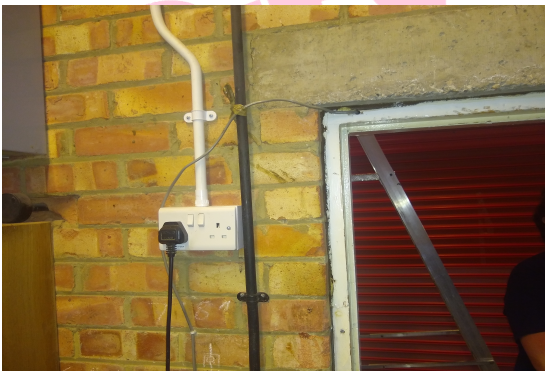
### **Item 3 Ref: 412163-12**

The sealant to door frame in the Electrics Distribution Store (Rm 0/02) contains asbestos.

Any change in its appearance should be reported to Property Services.

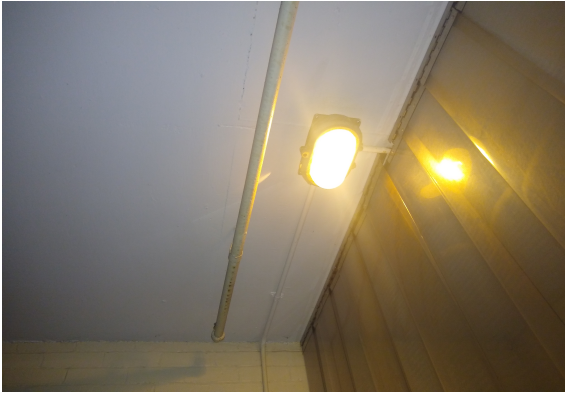
### **Item 4 Ref: 412163-11**

The sealant to light in the Loading Bay (Rm 0/03) contains asbestos.

Any change in its appearance should be reported to Property Services.

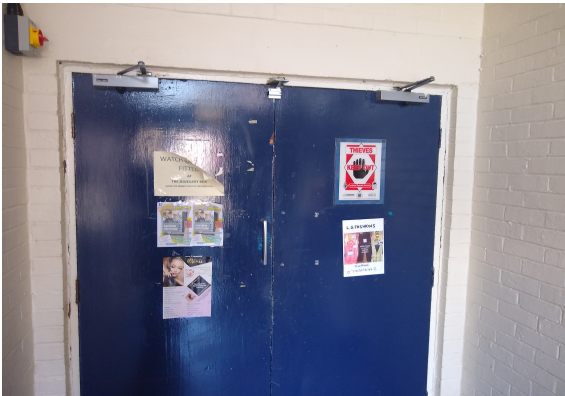
### **Item 5 Ref: 412163-15**

The sealant to door frame in the Lobby (Rm 0/05) contains asbestos.

Any change in its appearance should be reported to Property Services.

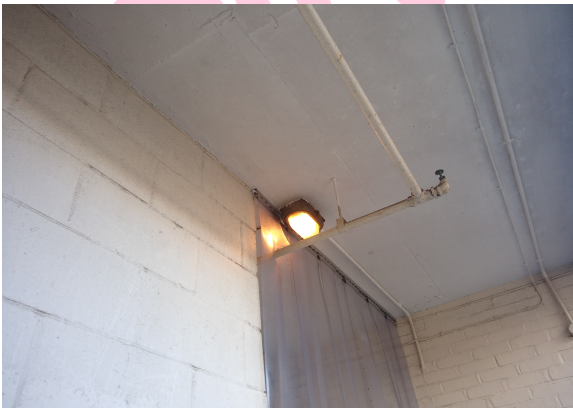
### **Item 6 Ref: As 412163-11**

The sealant to light in the Loading Bay (Rm 0/07) contains asbestos.

Any change in its appearance should be reported to Property Services.

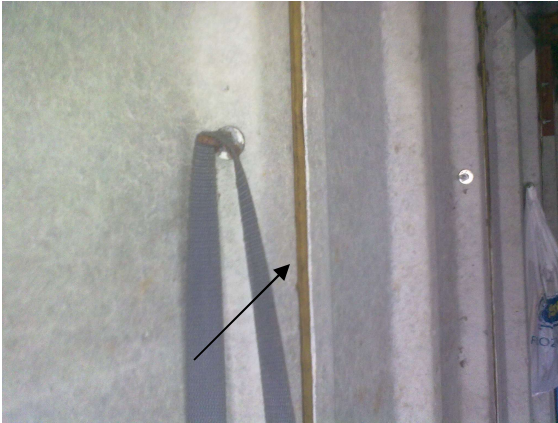
### **Item 7 Ref: 412163-16**

The soffit and fascia above fire exit in the Lobby (Rm 0/08) does not contain asbestos.

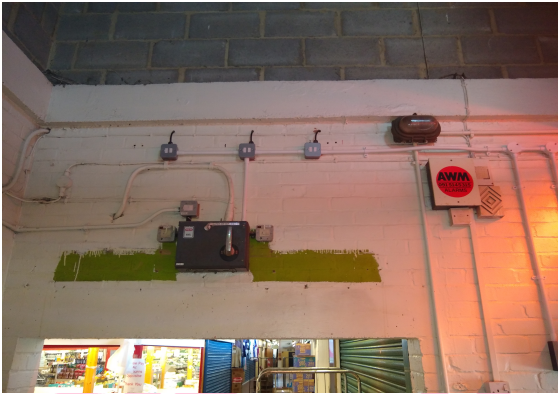
### **Item 8 Ref: Presumed**

The electrics M.E.M in the Lobby (Rm 0/08) are presumed to contain asbestos.

*Item removed but no WCN received yet*

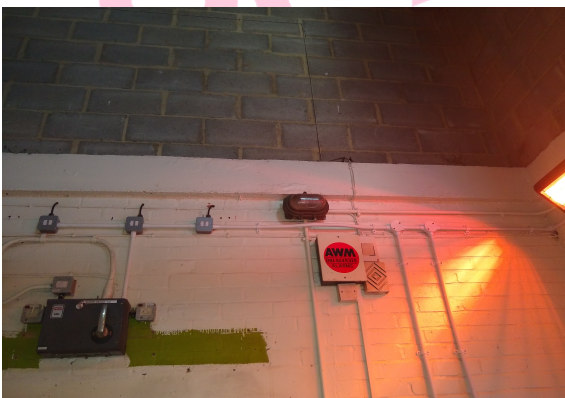
### **Item 9 Ref: As 412163-11**

The sealant to light fittings in the Lobby (Rm 0/08) contains asbestos.

Any change in its appearance should be reported to Property Services.

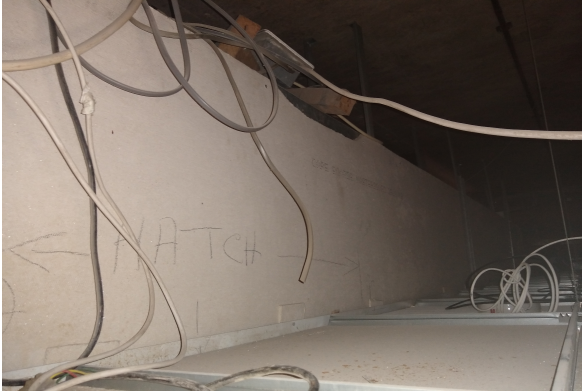
### **Item 10 Ref: 412163-17**

The firebreak to shopping centre in the Main Entrance Lobby – void above suspended ceiling (Rm 0/09) does not contain asbestos.

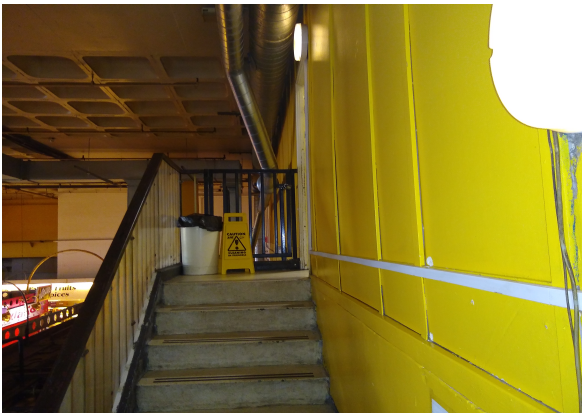
### **Item 11 Ref: As 412163-9**

The partition wall to corridor in the Stairwell (Rm 0/12) does not contain asbestos.

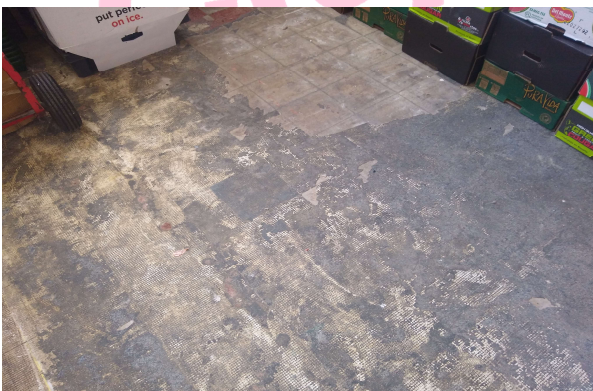
### **Item 12 Ref: 412163-14**

The floor covering to vacant store unit 28 in the Market Hall (Rm 0/13) does not contain asbestos.

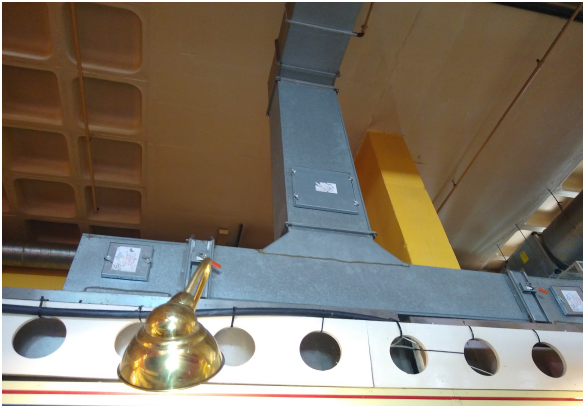
#### **Item 14 Ref: 412163-18**

The seal to ductwork in the Market Hall (Rm 0/13) does not contain asbestos.

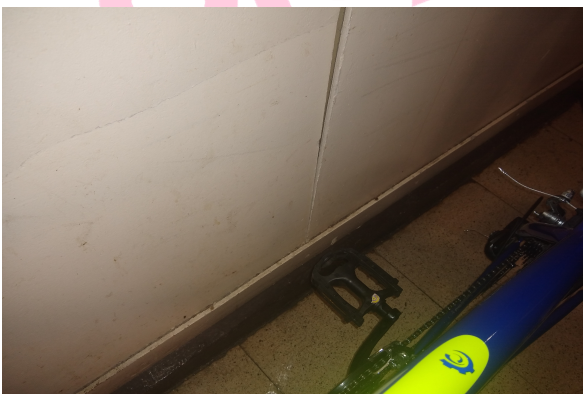
#### **Item 15 Ref: As 412163-9**

The skirting to partition wall in the Corridor (Rm 1/02) does not contain asbestos.

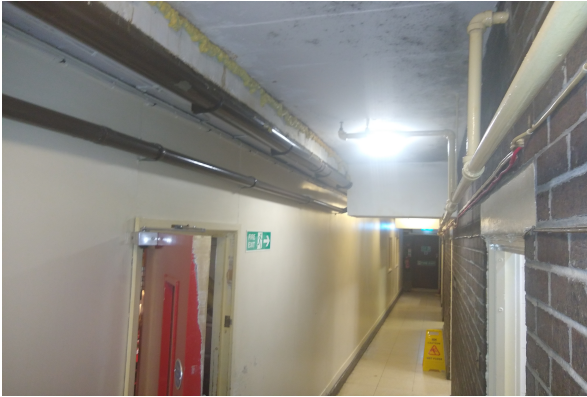
### **Item 16 Ref: 412163-9**

The partition wall in the Corridor (Rm 1/02) does not contain asbestos.

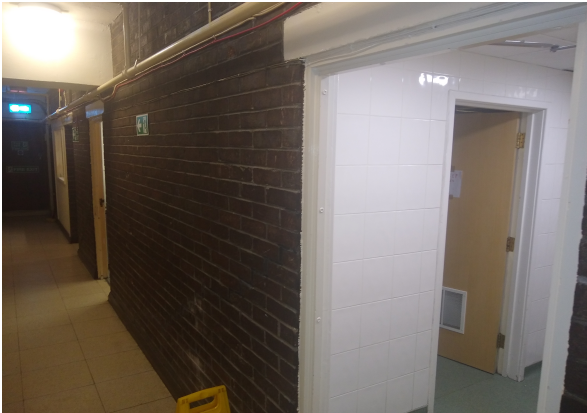
### **Item 17 Ref: 412163-10**

The sealant to door frames in the Corridor (Rm 1/02) contains asbestos.

Any change in its appearance should be reported to Property Services.

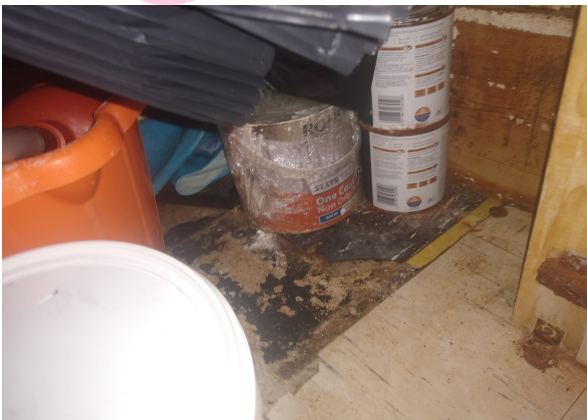
### **Item 18 Ref: 412163-6**

The yellow and black floor covering below sink in the Tea Room (Rm 1/03) contains asbestos.

Any change in its appearance should be reported to Property Services.

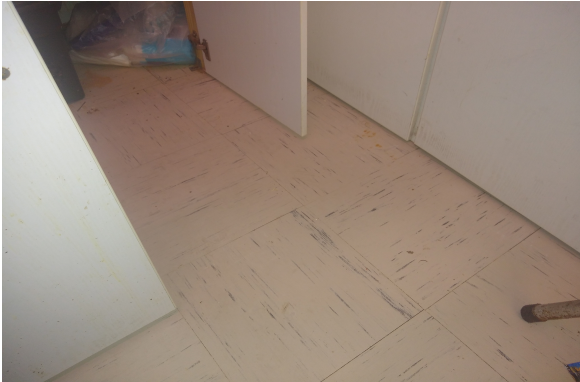
### **Item 19 Ref: 412163-7**

The white floor covering in the Tea Room (Rm 1/03) contains asbestos.

Any change in its appearance should be reported to Property Services.

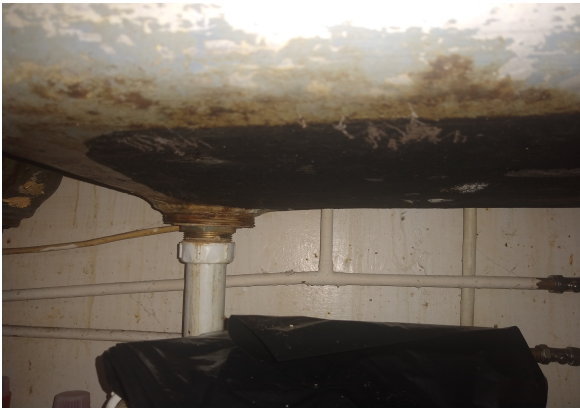
### **Item 20 Ref: 412163-8**

The acoustic dampening finish to sink in the Tea Room (Rm 1/03) does not contain asbestos.

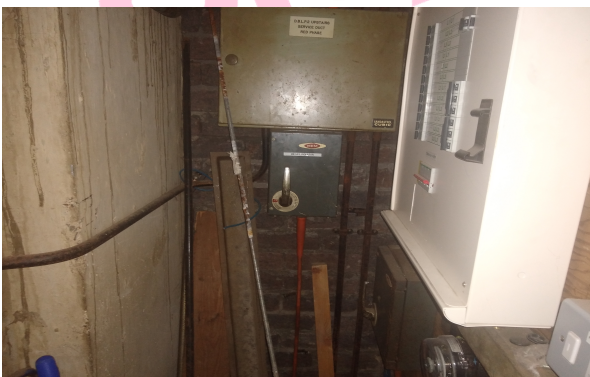
### **Item 21 Ref: Presumed**

The electrics M.E.M in the Toilet Cistern Service Void (Rm 1/07) are presumed to contain asbestos.

Any change in its appearance should be reported to Property Services.

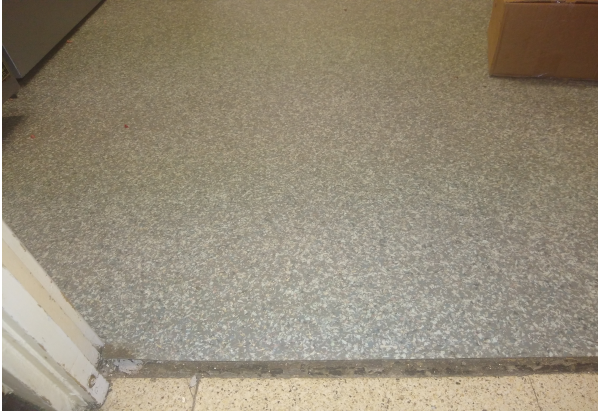
### **Item 22 Ref: 412163-4**

The remnant tile adhesive below lino in the Prep Room (Rm 1/10) contains asbestos.

Any change in its appearance should be reported to Property Services.

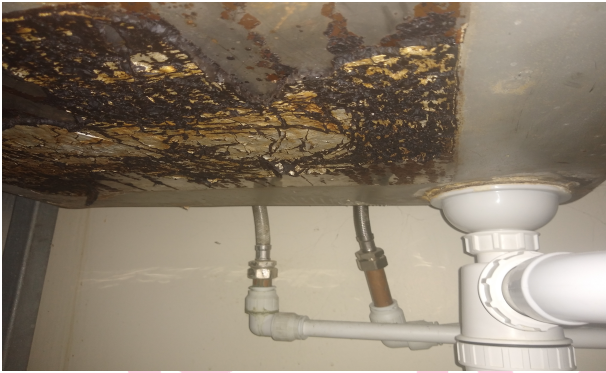
### **Item 23 Ref: 412163-5**

The sink pad in the Prep Room (Rm 1/10) contains asbestos.

Any change in its appearance should be reported to Property Services.

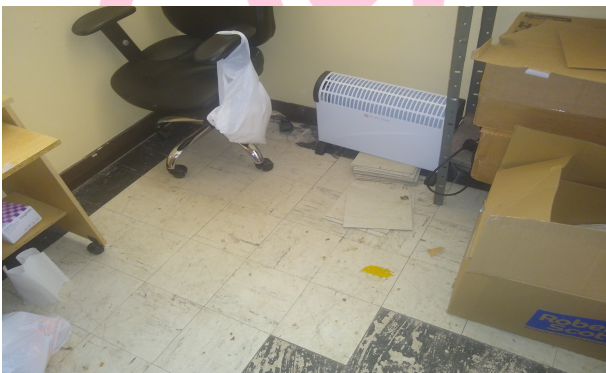
### **Item 24 Ref: 412163-3**

The black and white floor covering in the Store (Rm 1/11) contains asbestos. Removed May 2021. However Bitumen remains and any change in its appearance should be reported to Property Services.

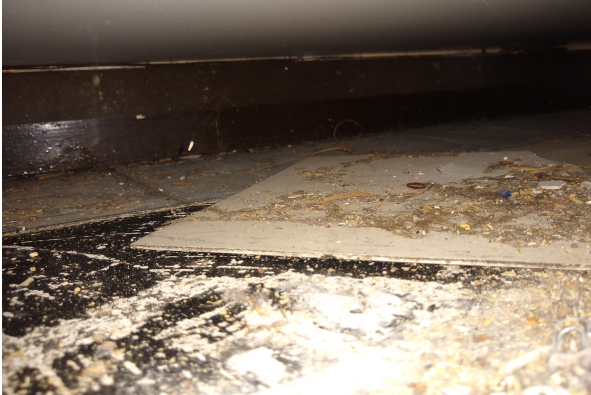
### **Item 25 Ref: 412163-1**

The remnant floor covering below cupboards in the Office (Rm 1/14) contains asbestos.

Any change in its appearance should be reported to Property Services.

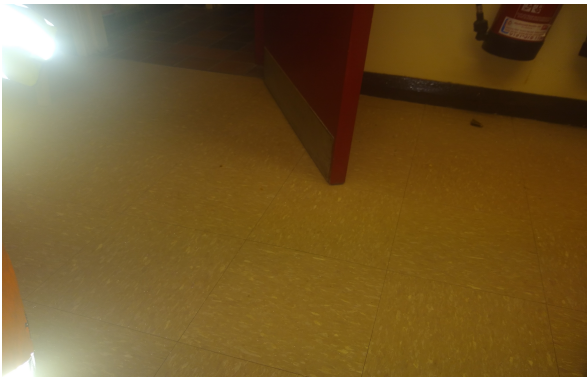
### **Item 26 Ref: 412163-2**

The floor covering in the Office (Rm 1/14) contains asbestos.

Any change in its appearance should be reported to Property Services.

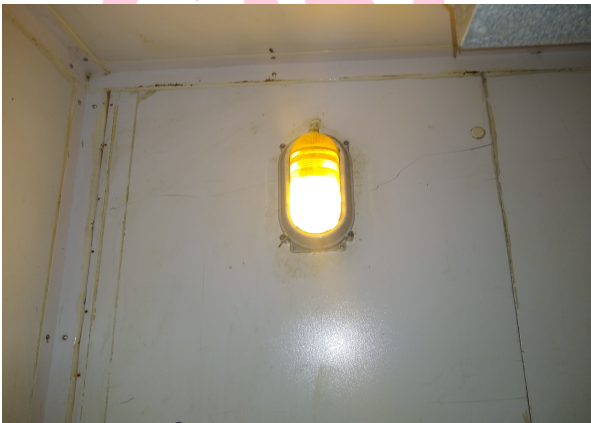
### **Item 27 Ref: 412163-19**

The mastic to light fittings in the Chiller above greengrocers (Rm 1/21) contains asbestos.

Any change in its appearance should be reported to Property Services.

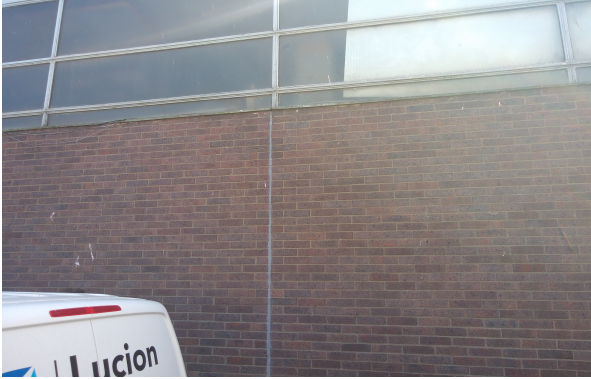
### **Item 28 Ref: 412163-20**

The seal to expansion joints (External) does not contain asbestos.

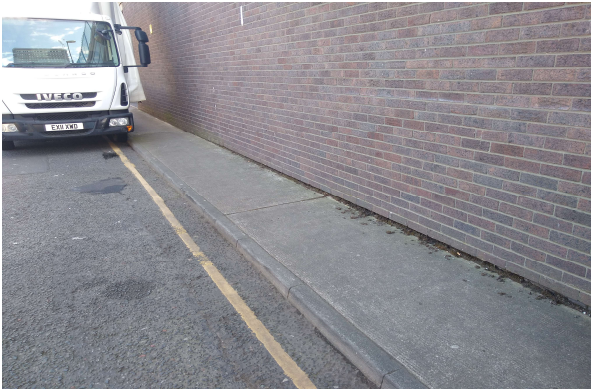
### **Item 29 Ref: 412163-21**

The damp proof course (External) does not contain asbestos.

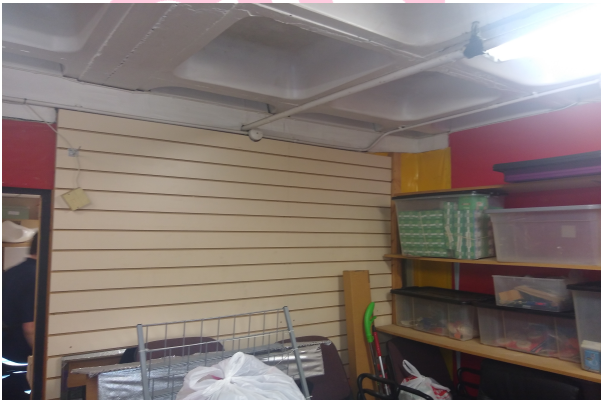
### **Item 30 Ref: 412163-13**

The partition wall in the Store – Former Jewellery Box Outlet (Rm 1/16) does not contain asbestos.

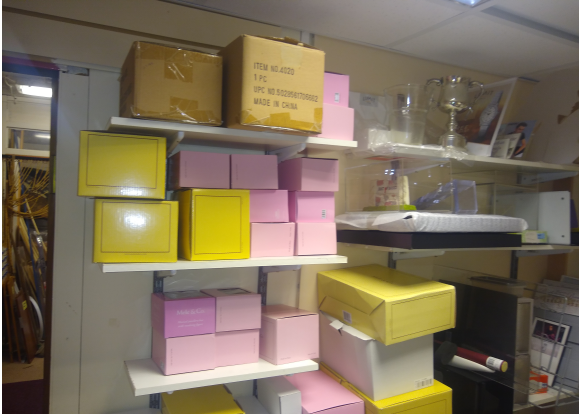
### **Item 31 Ref:As412163-13**

The partition wall in the Store – Former Jewellery Box Outlet (Rm 1/17) does not contain asbestos.

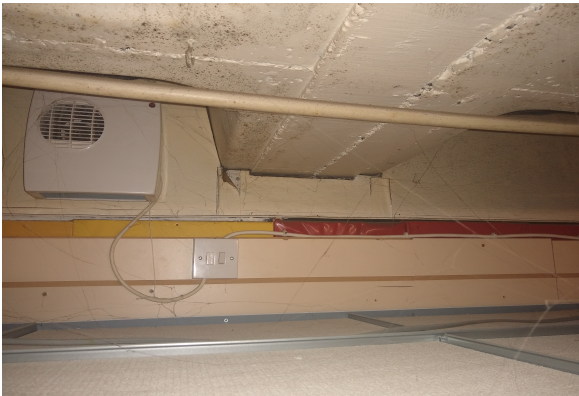
### **Item 32 Ref:As412163-13**

The partition wall in the void above Store – Former Jewellery Box Outlet (Rm 1/17) does not contain asbestos.

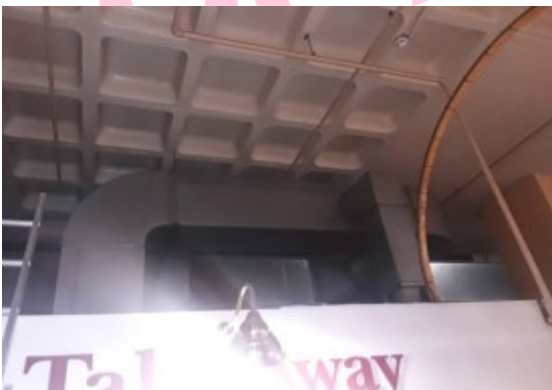
### **Item 33 Ref: NZ000693**

The mastic to joints (G/001 Large Room above market café) does not contain asbestos.

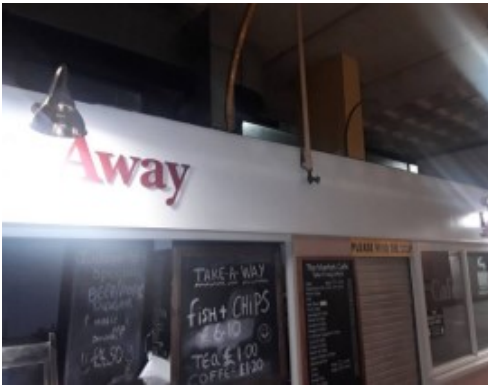
### Item 34 Ref: NZ000694

The debris/residue to top of tiles and ductwork (G/001 Large Room above market café) does not contain asbestos.

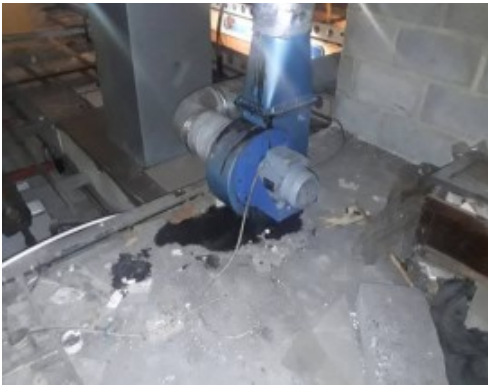
### Item 35 Ref: NZ000697

The ductwork gaskets to pump (G/001 Large Room above market café) does not contain asbestos.

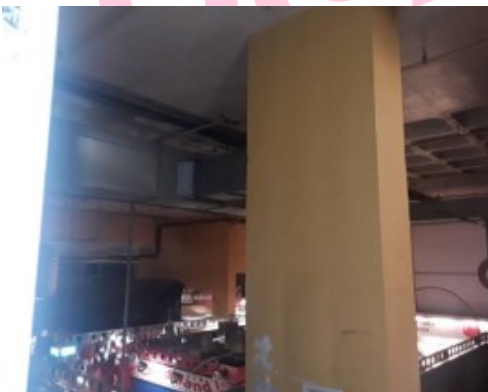
### Item 36 Ref: NZ000695

The mastic to joints (G/002 Large room above Butchers and Seafood stall) does not contain asbestos.

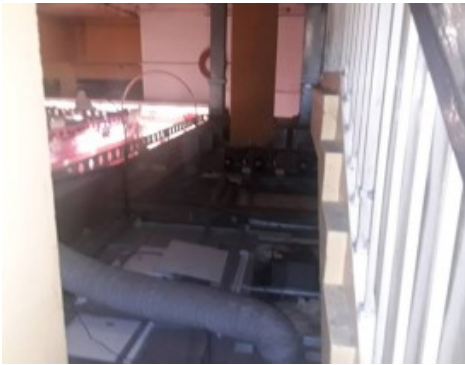
### **Item 37 Ref: NZ000696**

The debris/residue to top of tiles and ductwork (G/002 Large room above Butchers and Seafood stall) does not contain asbestos.

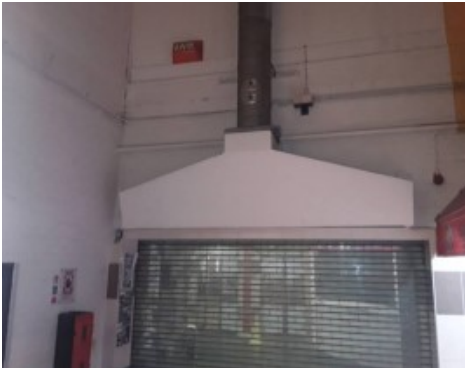
### **Item 38 Ref: NZ000698**

The debris/residue within ductwork (G/002 Large room above Butchers and Seafood stall) does not contain asbestos.

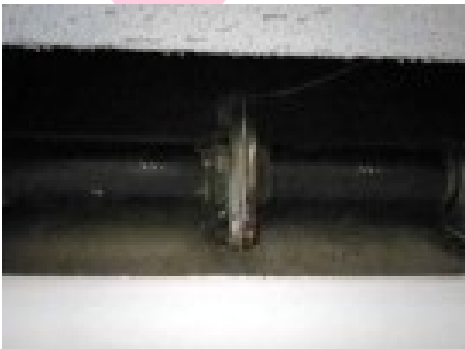
### **Item 39 Ref: AW005594**

The ceiling void pipework gasket in the Room Lift Lobby (G/001) does contain asbestos.

Any change in appearance should be reported to Property Services.

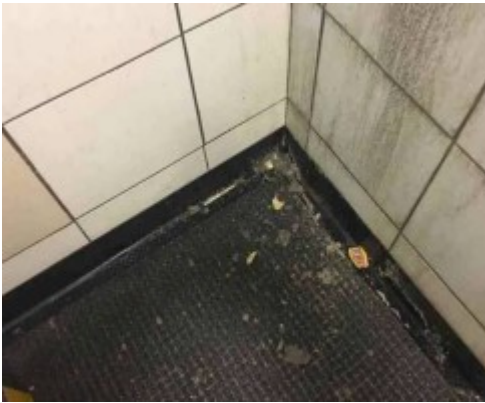
**Item 40 Ref: AW005595**

The floor debris in the Room Lift Lobby (G/001) does not contain asbestos.

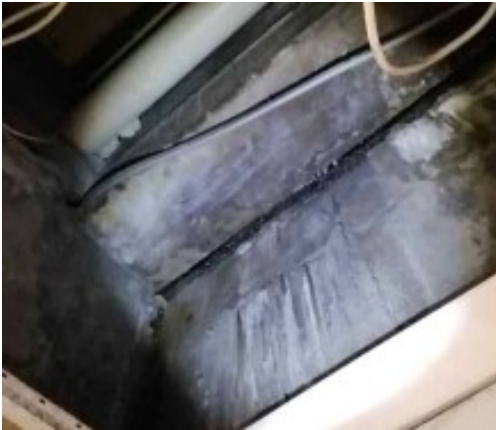
**Item 41 Ref: AW005596**

The ceiling void panel to expansion joint in the Room Lift Lobby (G/001) does not contain asbestos.

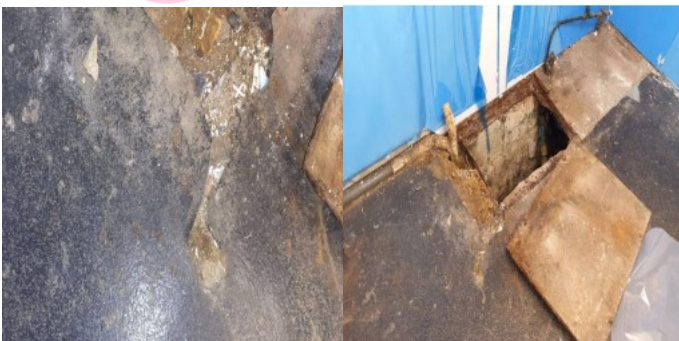
**Item 42 Ref: OU001493**

The vinyl floor to Unit 71-72 (G/01) does not contain asbestos.

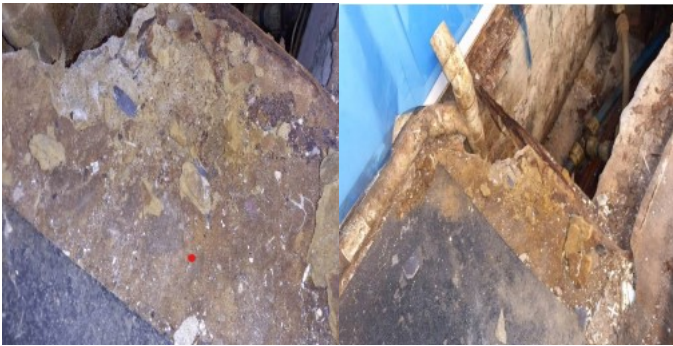
### Item 43 Ref: OU001494

The residual adhesive beneath vinyl screed to unit 71-72 (G/01) does not contain asbestos.

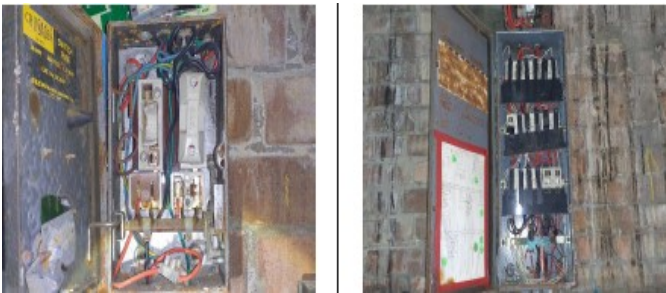
### Item 44 Ref: PK002166

The flash guards – electrical switch gear in the Store Room (G/01) does contain asbestos.

Any change in appearance should be reported to Property Services.

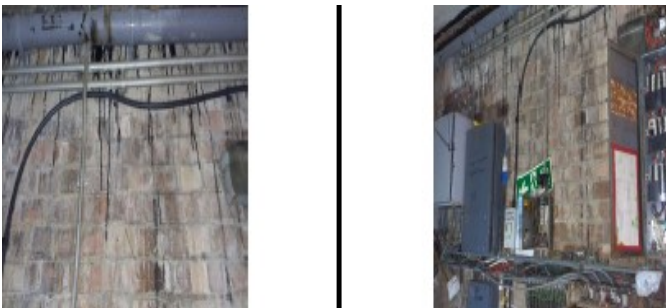
### Item 45 Ref: PK002167

The bitumen drip – wall and ceiling in the store room (G/01) does not contain asbestos.
