ASBESTOS SURVEY REPORT FOR SPRINGWELL VILLAGE HALL, FELL ROAD, SPRINGWELL, GATESHEAD, NE9 7RP.

### **Asbestos Register for Springwell Village Hall, Fell Road, Springwell**

**Date: 03 April 2025**

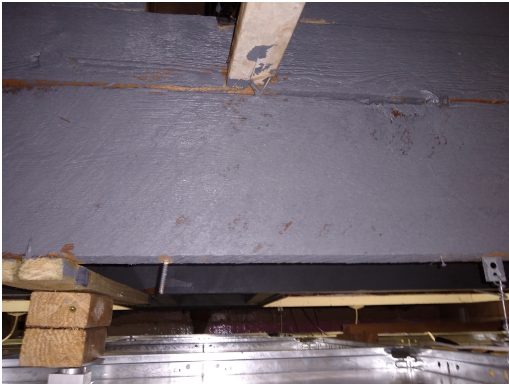
### **Item 1 Ref: Presumed**

The residue to beams (encapsulated) in 0/001/Female wc Void above is presumed to contain asbestos.

Any change in the appearance should be recorded and passed to Property Services.

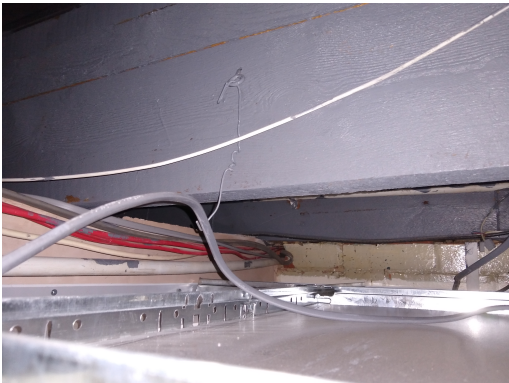
### **Item 2 Ref: Presumed**

The residue to beams (encapsulated) in 0/002/Male wc Void above is presumed to contain asbestos.

Any change in the appearance should be recorded and passed to Property Services.

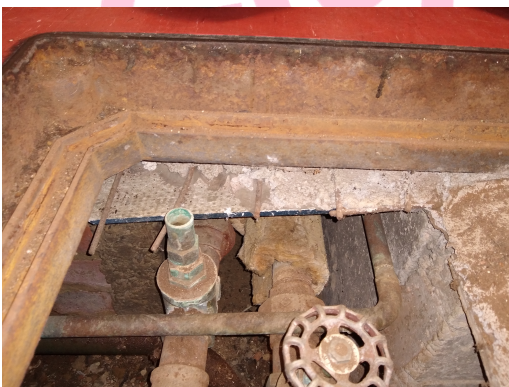
### **Item 3 Ref: 406216-4**

The shuttering below concrete floor in 0/003/Corridor pipe trench contains asbestos.

Any change in the appearance should be recorded and passed to Property Services.

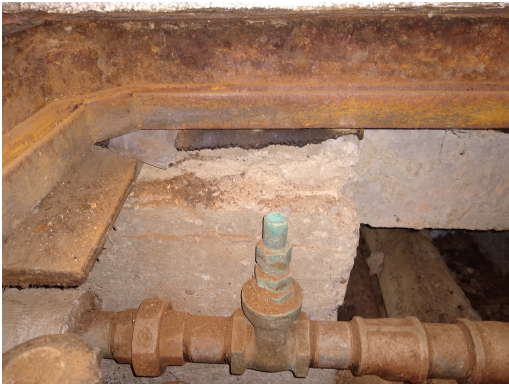
### **Item 4 Ref: 406216-5**

The damp proof membrane in 0/003/Corridor pipe trench does not contain asbestos.

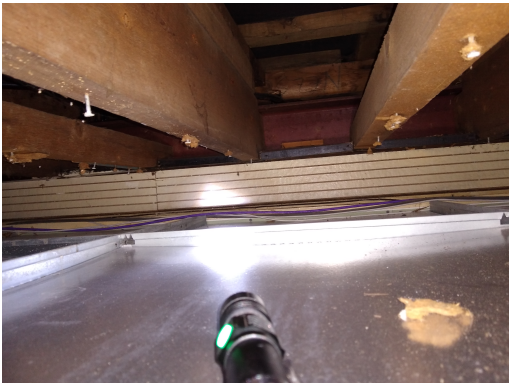
### **Item 5 Ref: As 406216-1**

The coated fibreboard wall in 0/003/Corridor void above does not contain asbestos.

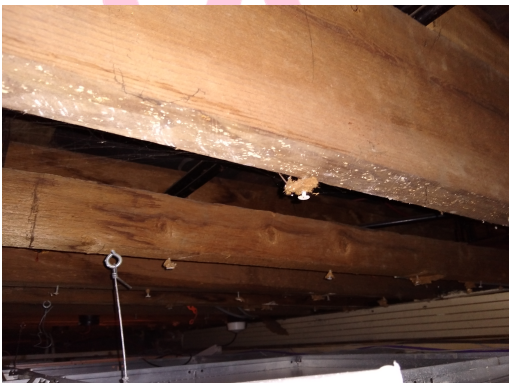
### **Item 6 Ref: As 406216-2**

The fibreboard remnant to beams in 0/003/Corridor void above does not contain asbestos.

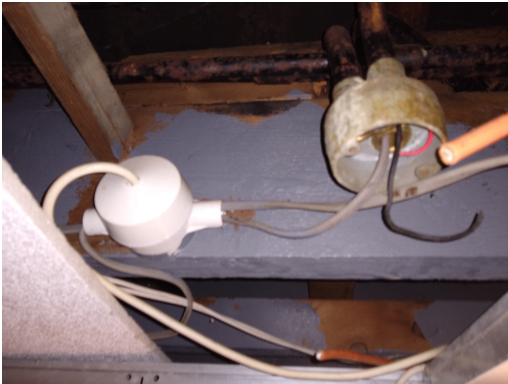
### **Item 7 Ref: Presumed**

The residue to beams (encapsulated) in 0/004/Store Void above is presumed to contain asbestos.

Any change in the appearance should be recorded and passed to Property Services.

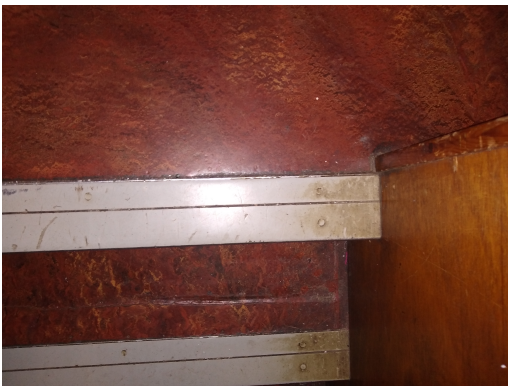
### **Item 8 Ref: 406216-6**

The stair nosing in 0/005/ Stage lobby contains asbestos.

Any change in the appearance should be recorded and passed to Property Services.

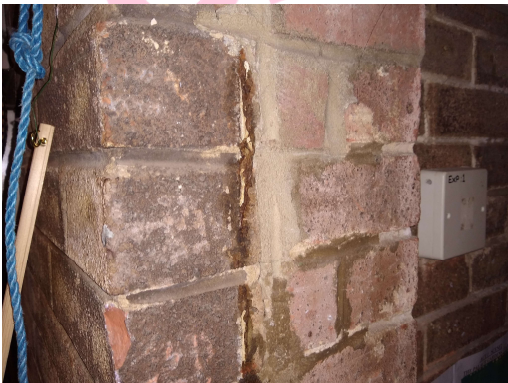
### **Item 9 Ref: 406216-7**

The remnant door frame seal in 0/005/Stage lobby contains asbestos.

Any change in the appearance should be recorded and passed to Property Services.

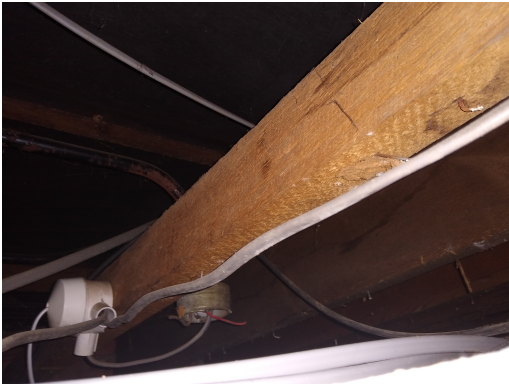
### **Item 10 Ref: As 406216-2**

The fibreboard remnant to beams in 0/005/Stage lobby void above does not contain asbestos.

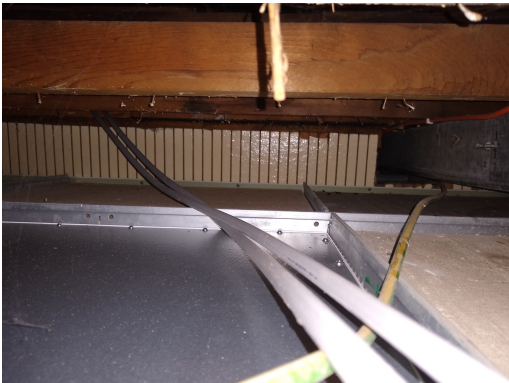
### **Item 11 Ref: As 406216-1**

The coated fibreboard wall in 0/005/Stage lobby void above does not contain asbestos.

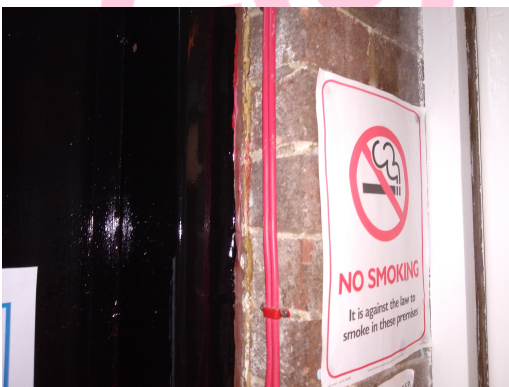
### **Item 12 Ref: 406216-3**

The sealant to door frame in 0/007/Entrance lobby does not contain asbestos.

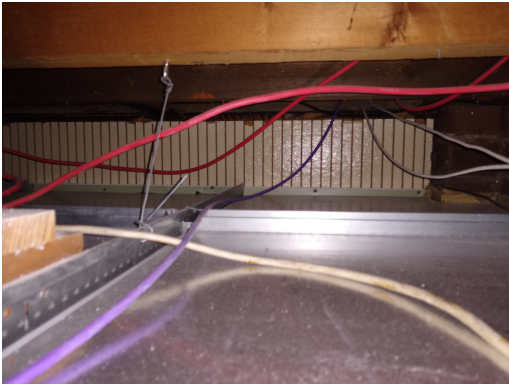
### **Item 13 Ref: 406216-1**

The panels above door in 0/007/Entrance lobby void above does not contain asbestos.

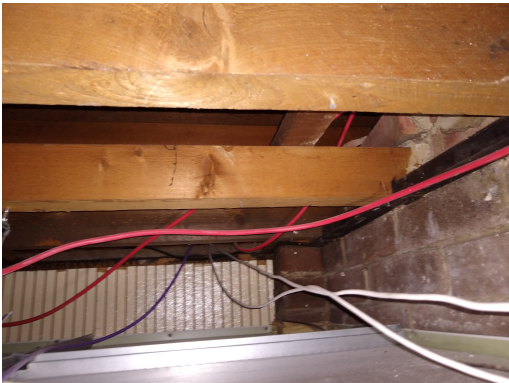
### **Item 14 Ref: 406216-2**

The debris to beams in 0/007/Entrance lobby void above does not contain asbestos.

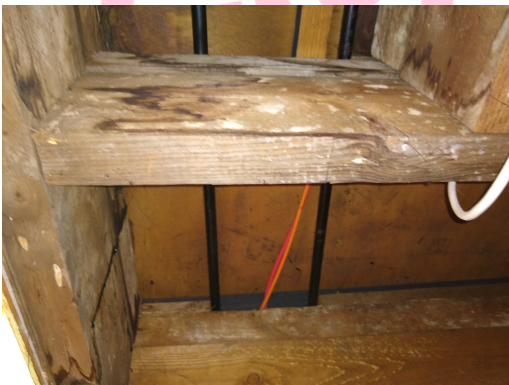
### **Item 15 Ref: 406216-8**

The residue to beams and former nail holes in 0/010/ Kitchen void above contains asbestos.

Any change in the appearance should be recorded and passed to Property Services.

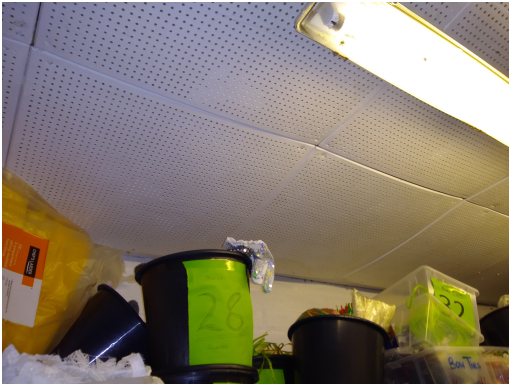
### **Item 16 Ref: 406216-9**

The fixed ceiling tiles in 0/014/Store does not contain asbestos.

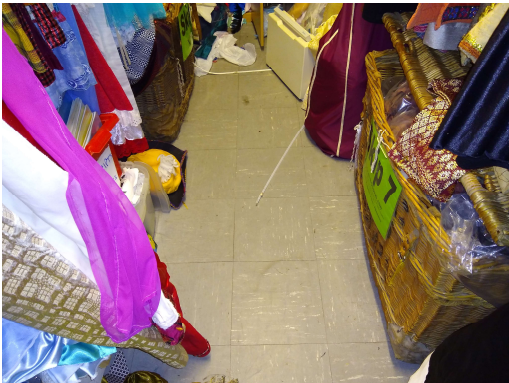
### **Item 17 Ref: 406216-10**

The floor covering in 0/014/Store contains asbestos.

Any change in the appearance should be recorded and passed to Property Services.

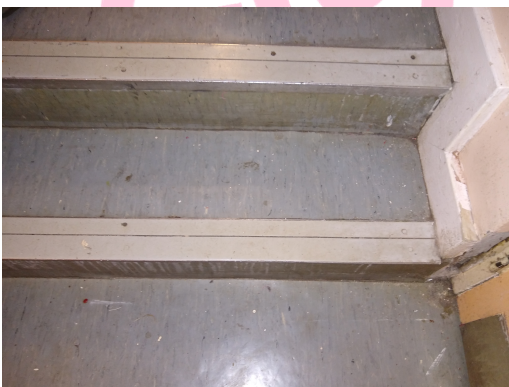
### **Item 18 Ref: 406216-11**

The step nosing in 0/015/Corridor & Lobby contains asbestos.

Any change in the appearance should be recorded and passed to Property Services.

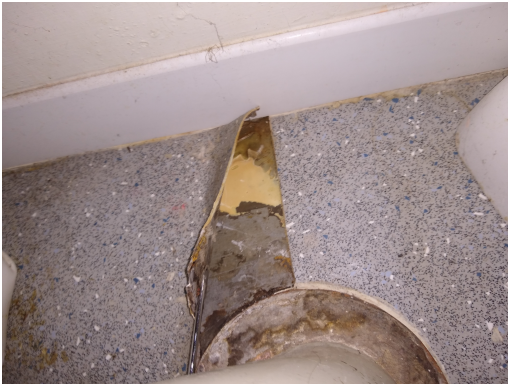
### **Item 19 Ref: 406216-12**

The floor covering below linoleum in 0/016/Toilet contains asbestos.

Any change in the appearance should be recorded and passed to Property Services.

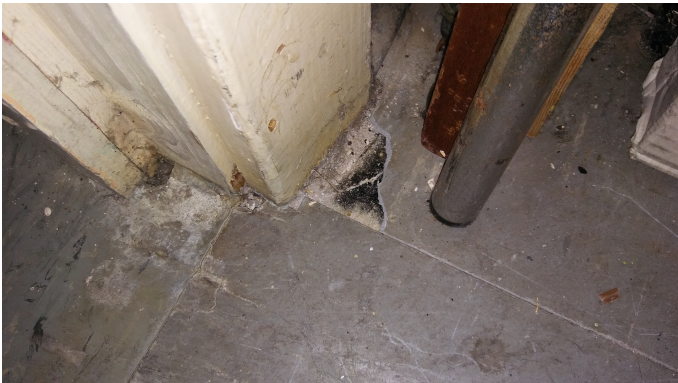
### **Item 20 Ref: 406216-27**

The floor covering in 0/017/Store contains asbestos.

Any change in the appearance should be recorded and passed to Property Services.

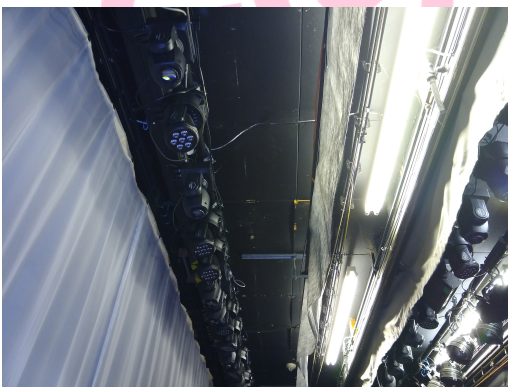
### **Item 21 Ref: 406216-13**

The fixed ceiling tiles in 0/018/Stage does not contain asbestos.

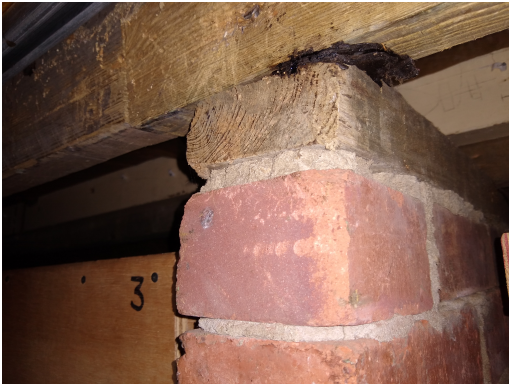
### **Item 22 Ref: 406216-14**

The packers to wall tops in 0/018/Stage void above does not contain asbestos.

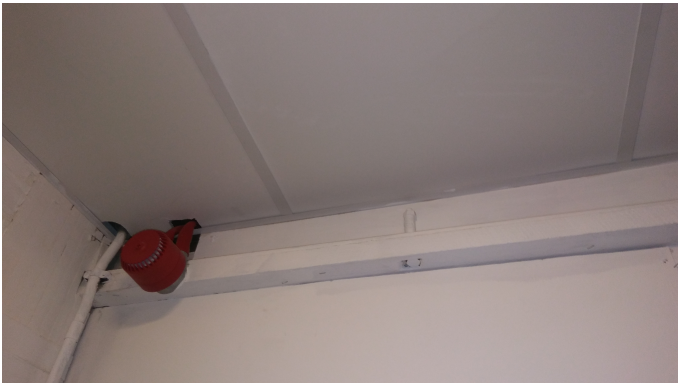
### **Item 23 Ref: 406216-15**

The fillet piece above entrance door in 0/021/Store lobby does not contain asbestos.

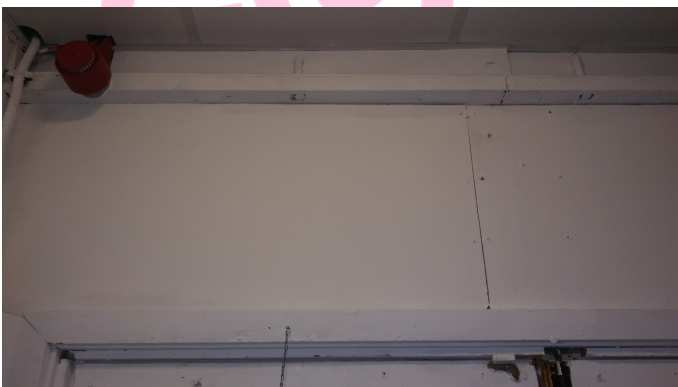
### **Item 24 Ref: 406216-16**

The panel above entrance door in 0/021/Store lobby does not contain asbestos.

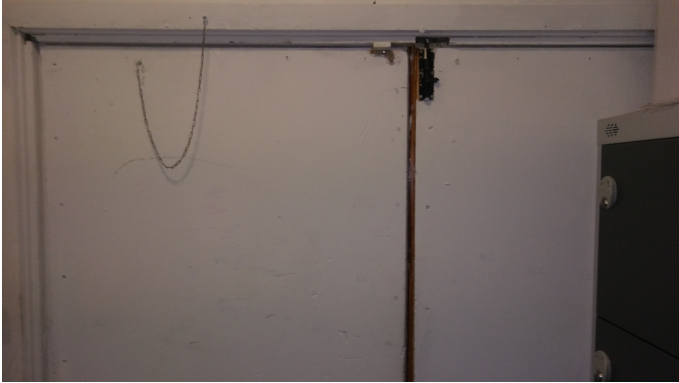
### **Item 25 Ref: 406216-17**

The panels to entrance doors in 0/021/Store lobby do not contain asbestos.

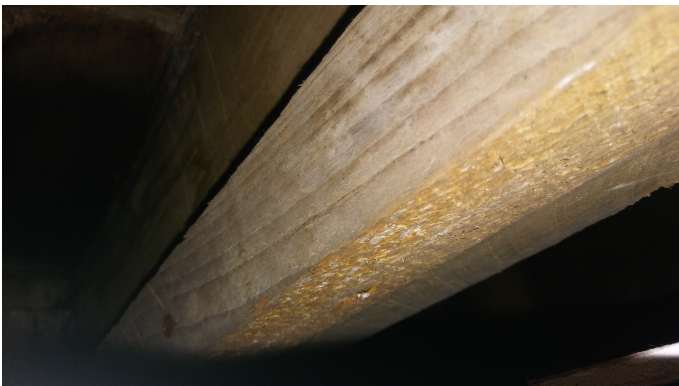
### **Item 26 Ref: As 406216-18**

The residue to beams and former nail holes in 0/021/Store lobby void above contains asbestos.

Any change in the appearance should be recorded and passed to Property Services.

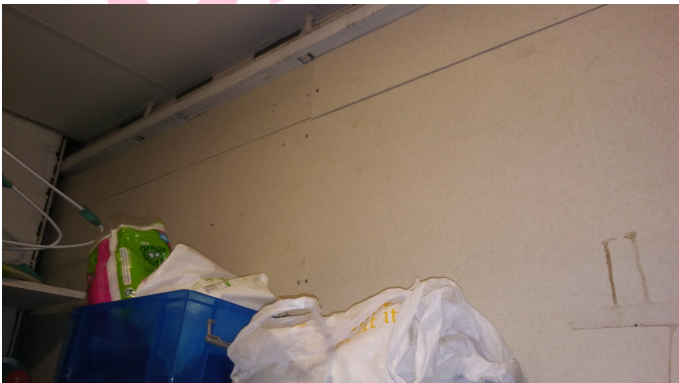
### **Item 27 Ref: 406216-19**

The panel to wall in 0/022/Store does not contain asbestos.

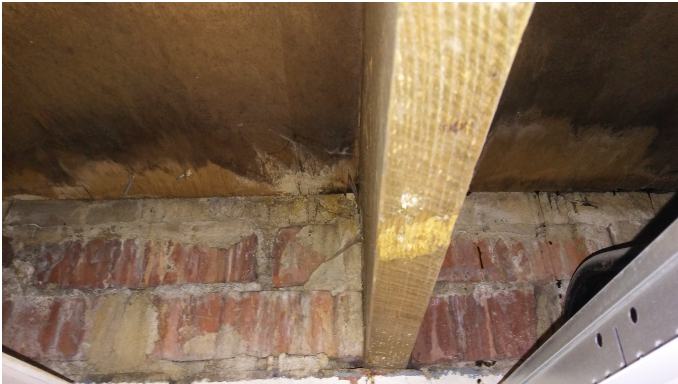
### **Item 28 Ref: 406216-18**

The residue to beams and former nail holes in 0/022/Store void above contains asbestos.

Any change in the appearance should be recorded and passed to Property Services.

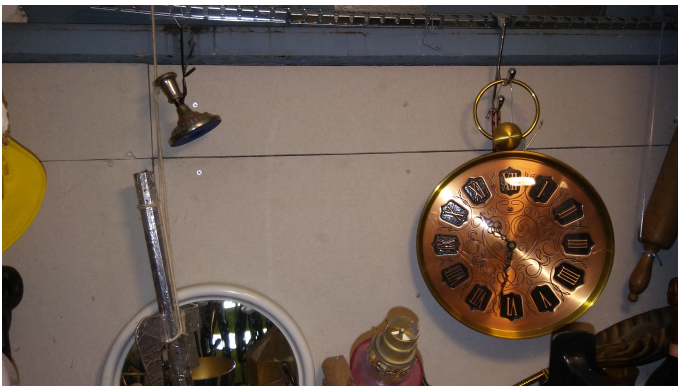
### **Item 29 Ref: As 406216-19**

The panel to wall in 0/023/Store does not contain asbestos.

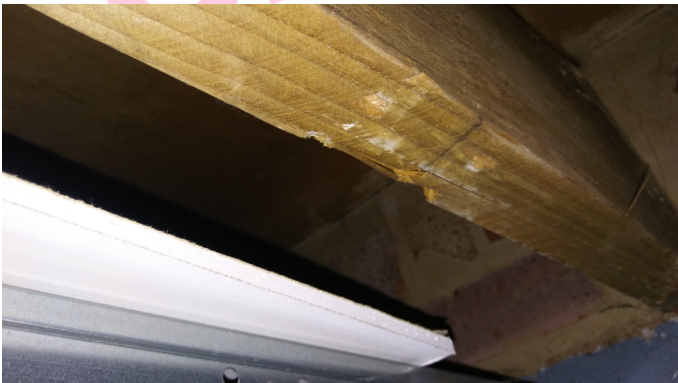
### **Item 30 Ref: 406216-18**

The residue to beams and former nail holes in 0/023/Store void above contains asbestos.

Any change in the appearance should be recorded and passed to Property Services.

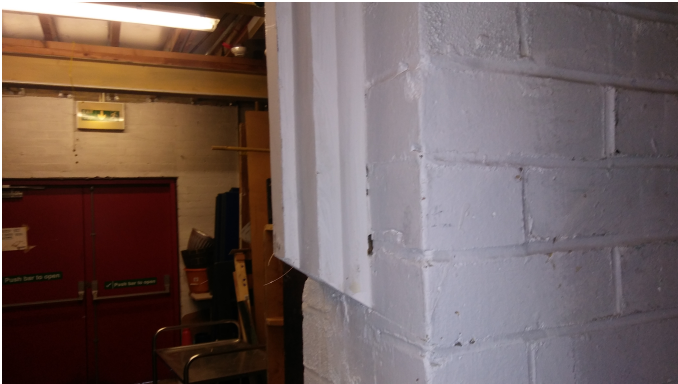
### **Item 31 Ref: 406216-20**

The sealant to door frame in 0/024/Store does not contain asbestos.

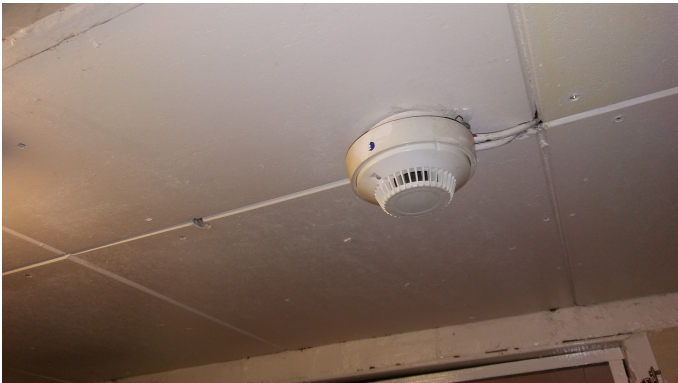
### **Item 32 Ref: 406216-24**

The ceiling in 0/026/Rear exit does not contain asbestos.

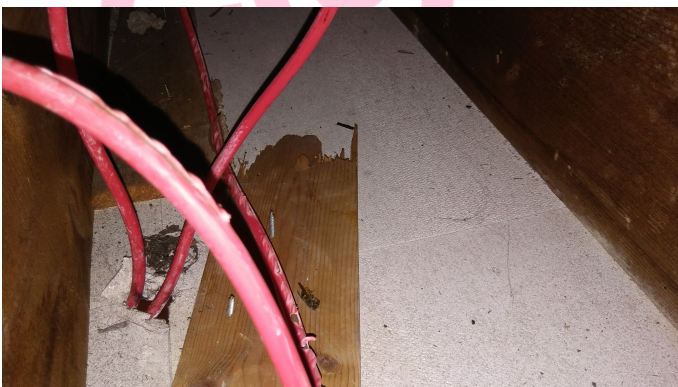
### **Item 33 Ref: As 406216-23**

The topside of ceiling in 0/026/rear exit loft space does not contain asbestos.

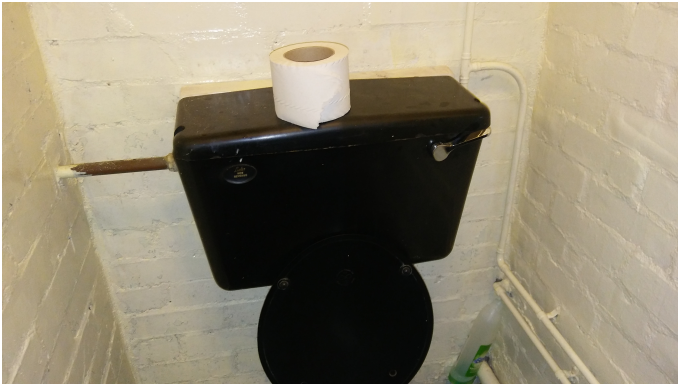
#### **Item 34 Ref: 406216-21**

The toilet cistern in 0/027/WC contains asbestos.

Any change in the appearance should be recorded and passed to Property Services.

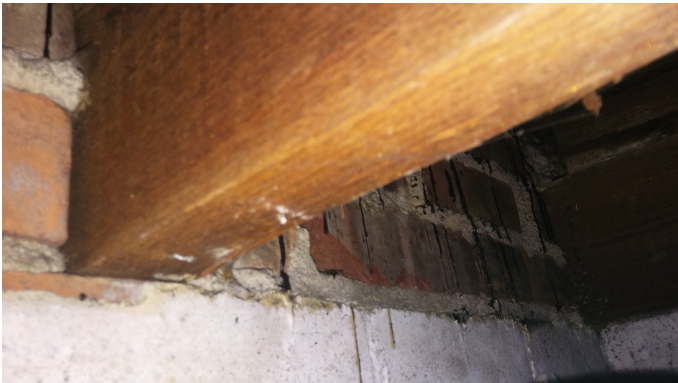
#### **Item 35 Ref: As 406216-22**

The residue to beams and former nail holes in 0/027/WC void above does not contain asbestos.

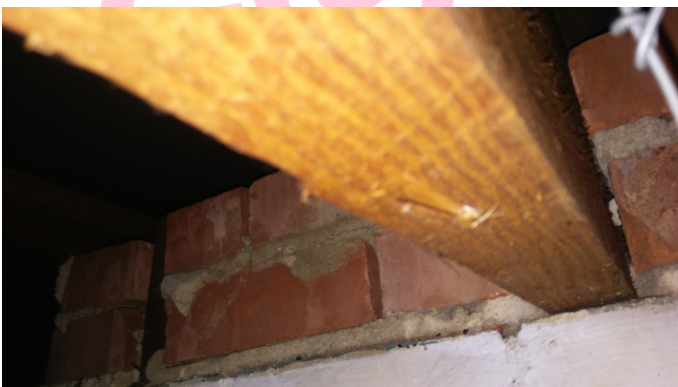
#### **Item 36 Ref: 406216-22**

The residue to beams and former nail holes in 0/028/Store void above does not contain asbestos.

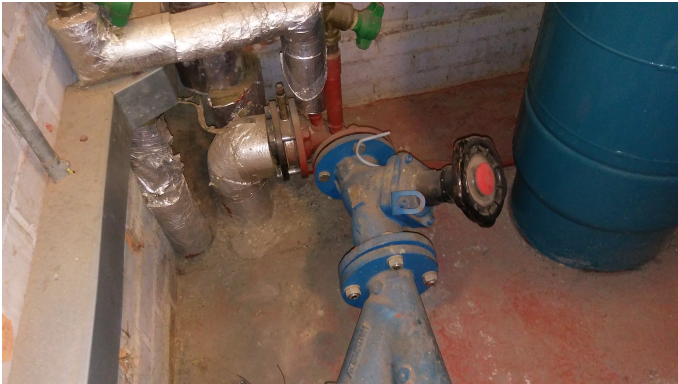
**Item 37 Ref: 406216-25**

The pipework flange gasket in 0/029/Boiler room loft space does not contain asbestos.

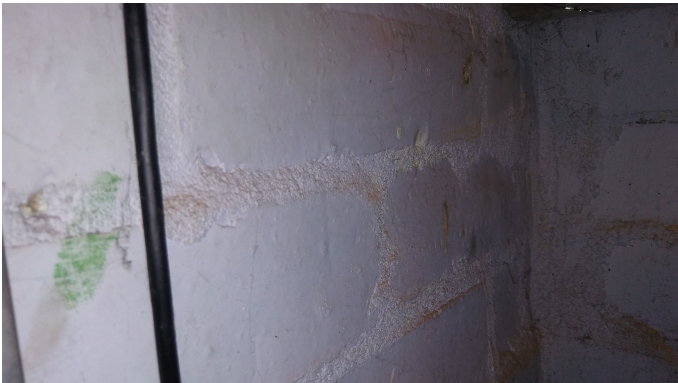
**Item 38 Ref: 406216-26**

The residue to wall adjacent control panel and door in 0/029/Boiler room loft space does not contain asbestos.

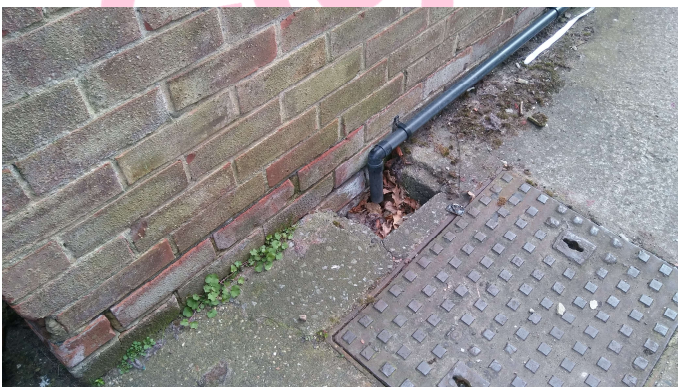
**Item 39 Ref: 406216-23**

The damp proof course (External) does not contain asbestos.

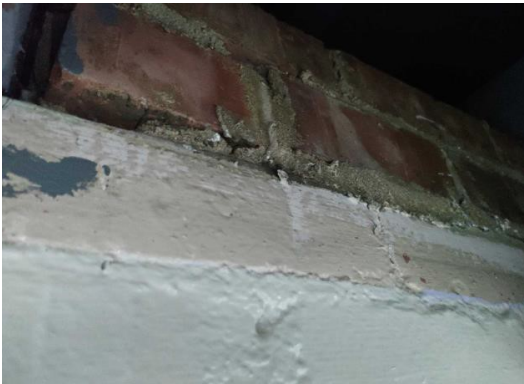
### **Item 40 Ref: 21-40959-8**

The residues to wall  
(Insulating board - ceiling  
void) (Room/Area: 1 Female  
Toilets - ceiling void) contains  
asbestos.

Any change in the appearance  
should be recorded and  
passed to Property Services.

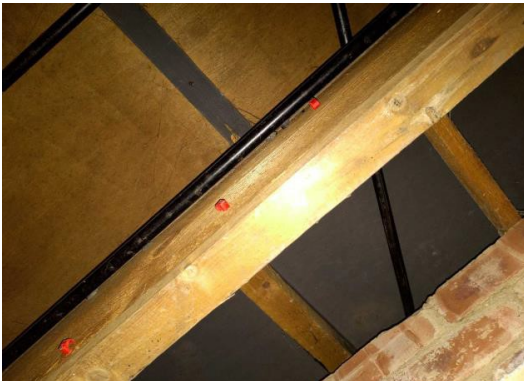
### **Item 41 Ref: 21-40959-2**

The residues to beams  
(Insulating board)  
(Room/Area: 9 Cafe Serving  
Area - ceiling void) contain  
asbestos.

Any change in the appearance  
should be recorded and  
passed to Property Services.

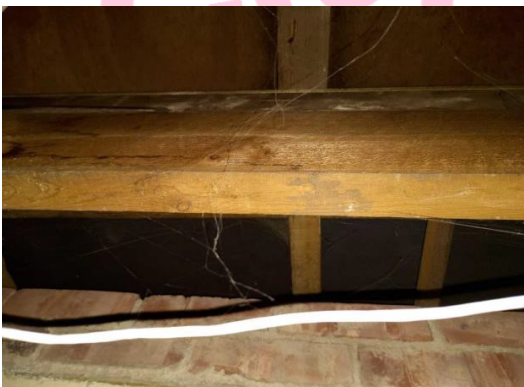
### **Item 42 Ref: 21-40959-7**

The residues to beams  
(Insulating board)  
(Room/Area: 30 Kitchen Store  
- ceiling void) contain  
asbestos.

Any change in the appearance  
should be recorded and  
passed to Property Services.

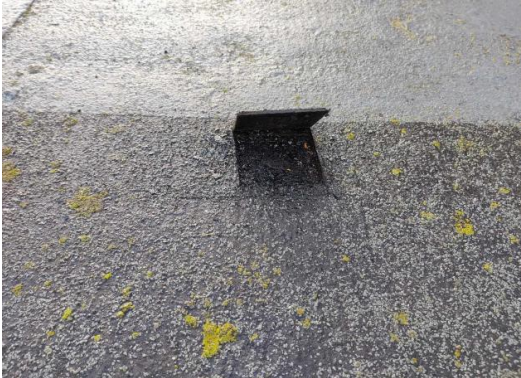
### **Item 43 Ref: 21-40959-10**

The roof felt (Bitumen - ceiling void) (Room/Area: 31 Roof - Right Elevation) does not contain asbestos.

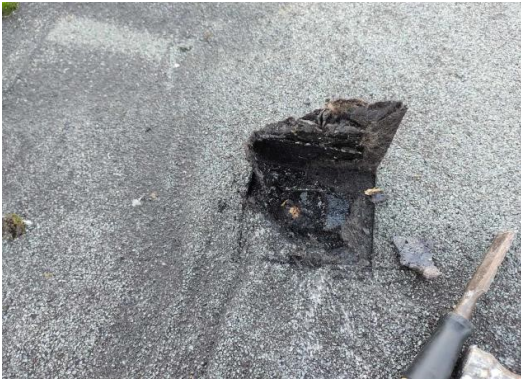
### **Item 44 Ref: 21-40959-11**

The roof felt (Bitumen - ceiling void) (Room/Area: 31 Roof - Right Elevation) does not contain asbestos.

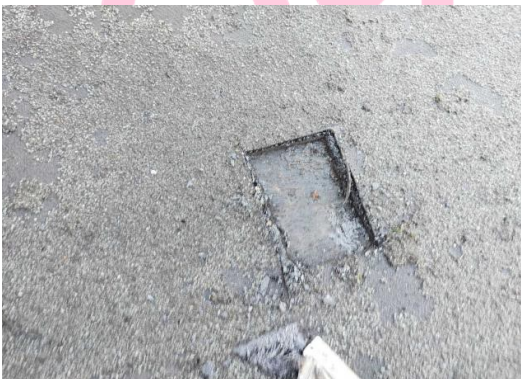
### **Item 45 Ref: 21-40959-12**

The floor - roof felt (Bitumen - ceiling void) (Room/Area: 31 Roof - Right Elevation) does not contain asbestos.

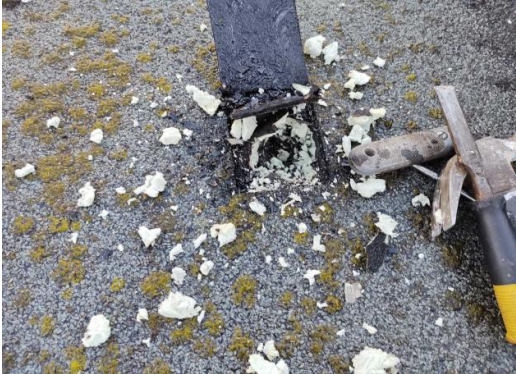
### **Item 46 Ref: 21-40959-13**

The roof felt (Bitumen - ceiling void) (Room/Area: 31 Roof - Right Elevation) does not contain asbestos.

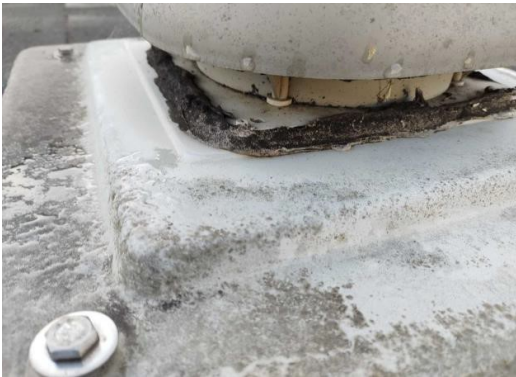
### **Item 47 Ref: 21-40959-14**

The window - sealant to fibreglass vent cover (Mastic - ceiling void) (Room/Area: 31 Roof - Right Elevation) does not contain asbestos.

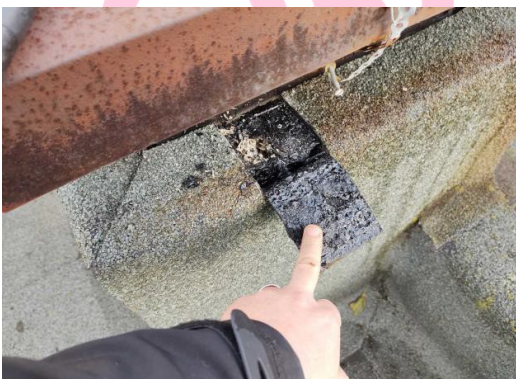
### **Item 48 Ref: 21-40959-15**

The roof - felt to stramit upstand of former vent (Bitumen - ceiling void) (Room/Area: 31 Roof - Right Elevation) does not contain asbestos.

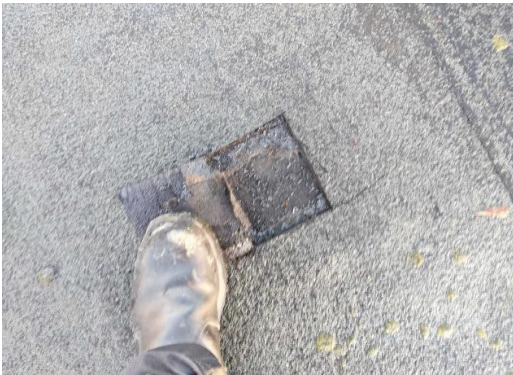
### **Item 49 Ref: 21-40959-9**

The roof (Bitumen - ceiling void) (Room/Area: 31 Roof - Right Elevation) does not contain asbestos.

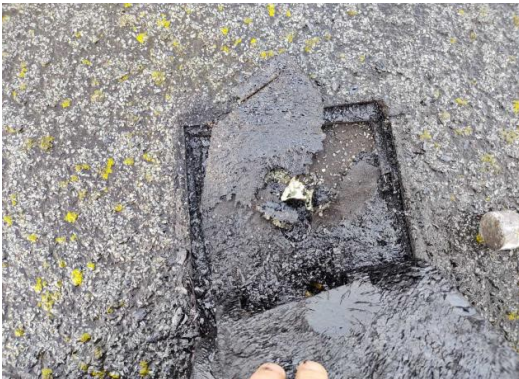
### **Item 50 Ref: 21-40959-16**

The roof felt (Bitumen - ceiling void) (Room/Area: 32 Roof - Central Elevation) does not contain asbestos.

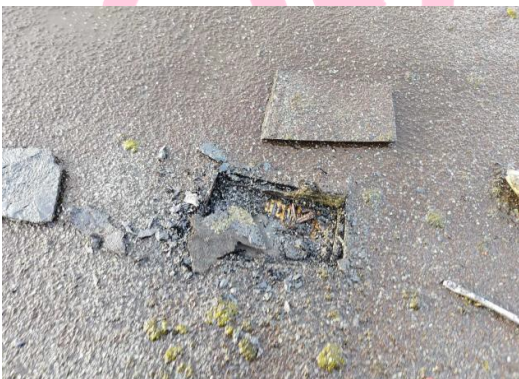
### **Item 51 Ref: 21-40959-17**

The roof felt (Bitumen - ceiling void) (Room/Area: 32 Roof - Central Elevation) does not contain asbestos.

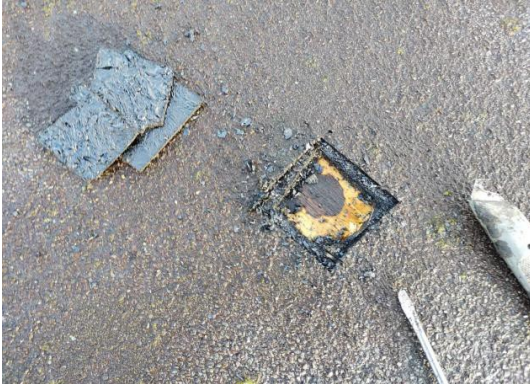
### **Item 52 Ref: 21-40959-18**

The roof felt (Bitumen - ceiling void) (Room/Area: 32 Roof - Central Elevation) does not contain asbestos.

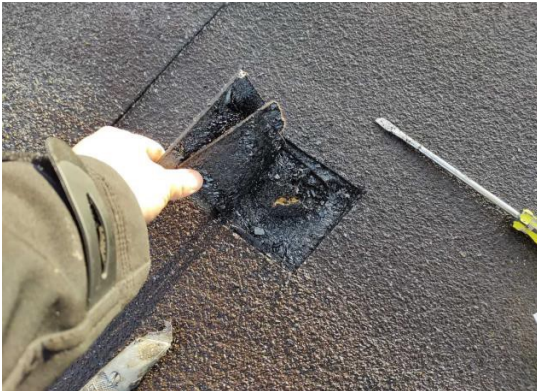
### **Item 53 Ref: 21-40959-19**

The roof felt (Bitumen - ceiling void) (Room/Area: 32 Roof - Central Elevation) does not contain asbestos.

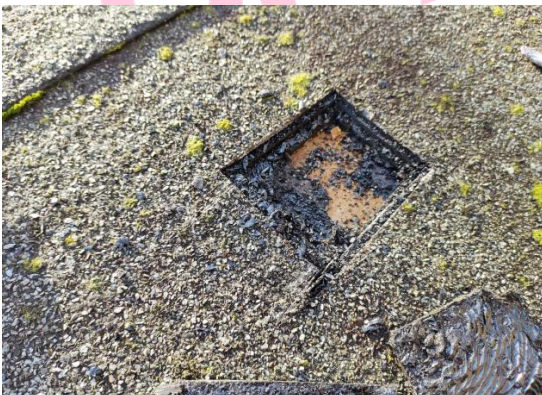
### **Item 54 Ref: 21-40959-20**

The roof (Bitumen - ceiling void) (Room/Area: 33 Roof - Left Elevation) does not contain asbestos.

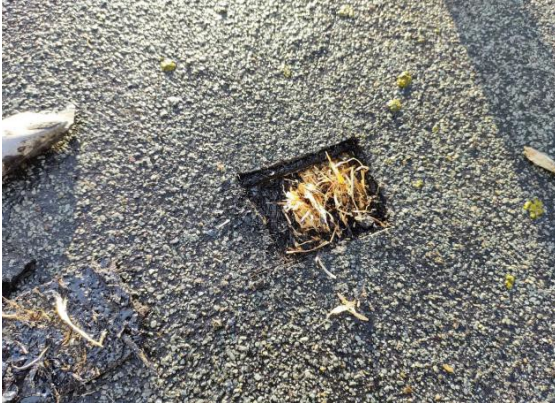
### **Item 55 Ref: 21-40959-21**

The roof (Bitumen - ceiling void) (Room/Area: 33 Roof - Left Elevation) does not contain asbestos.

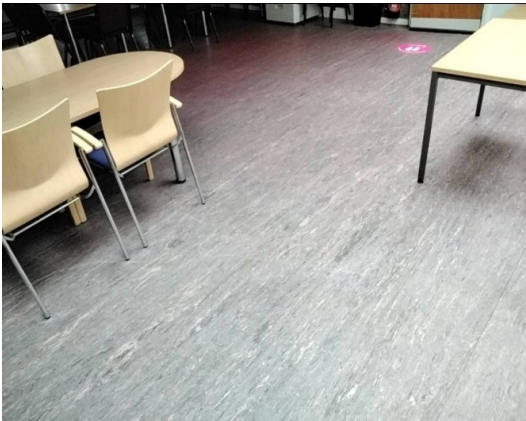
### **Item 56 Ref: SC004269**

The composite vinyl tile with adhesive in the Training Room (Rm 013) does contain asbestos.

Any change in appearance should be reported to Property Services.

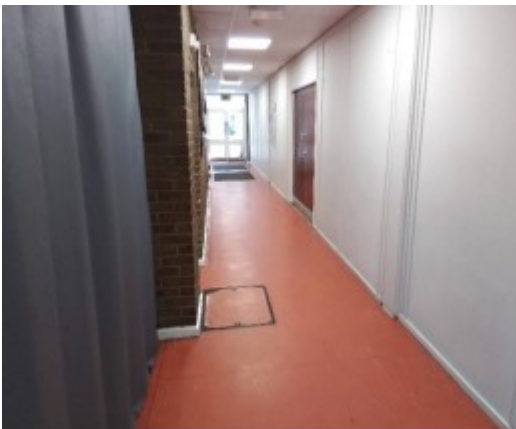
### **Item 57 Ref: KN001429**

The floor covering in the hallway/passageway (Room G001) does not contain asbestos.

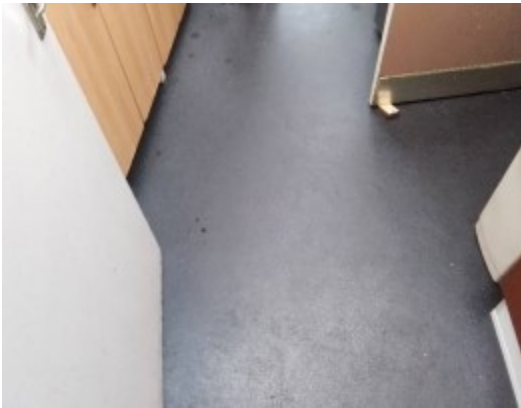
**Item 58 Ref: KN001430**

The floor covering in the Kitchen (Room G/002) does not contain asbestos.
