ASBESTOS SURVEY REPORT FOR SPRINGWELL VILLAGE HALL, FELL ROAD, SPRINGWELL, GATESHEAD, NE9 7RP.

Asbestos Register for Springwell Village Hall, Fell Road, Springwell

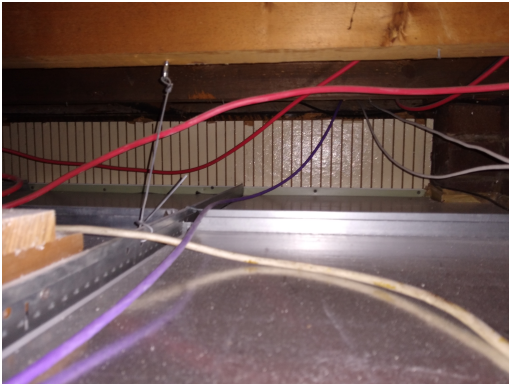
Item 13 Ref: 406216-1

The panels above door in 0/007/Entrance lobby void above does not contain asbestos.

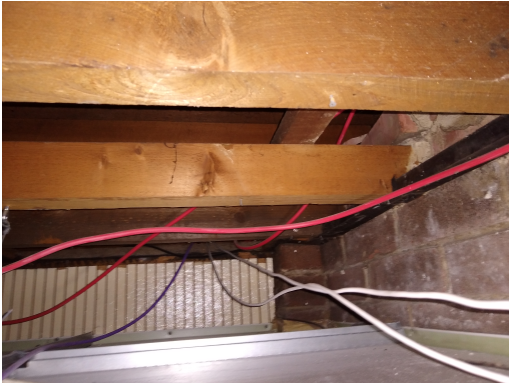
Item 14 Ref: 406216-2

The debris to beams in 0/007/Entrance lobby void above does not contain asbestos.

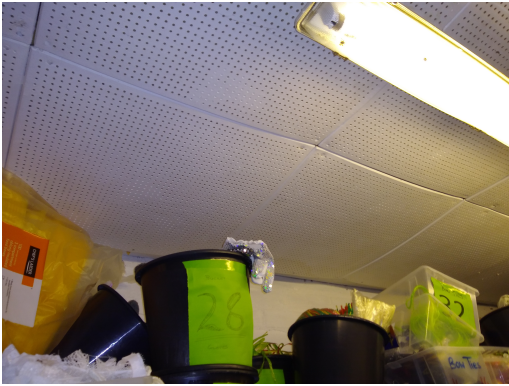
Item 16 Ref: 406216-9

The fixed ceiling tiles in 0/014/Store does not contain asbestos.

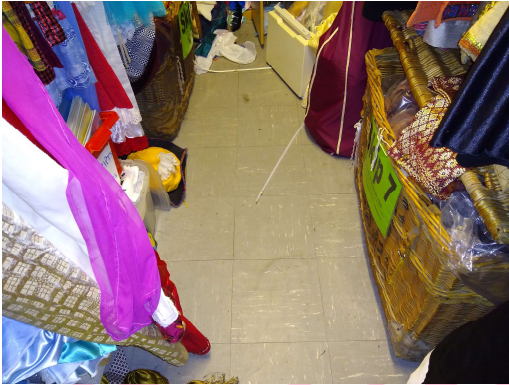
Item 17 Ref: 406216-10

The floor covering in 0/014/Store contains asbestos.

Any change in the appearance should be recorded and passed to Property Services.

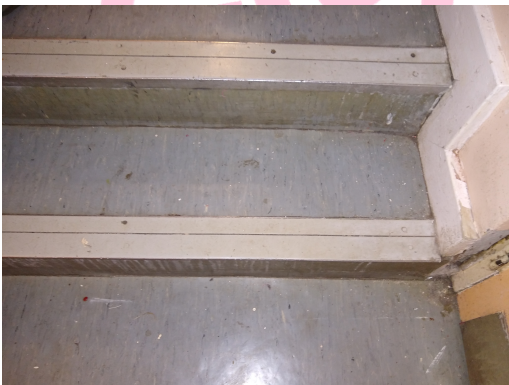
Item 18 Ref: 406216-11

The step nosing in 0/015/Corridor & Lobby contains asbestos.

Any change in the appearance should be recorded and passed to Property Services.

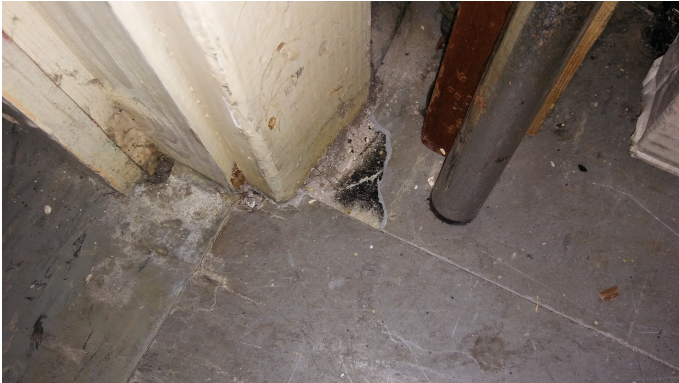
Item 20 Ref: 406216-27

The floor covering in 0/017/Store contains asbestos.

Any change in the appearance should be recorded and passed to Property Services.

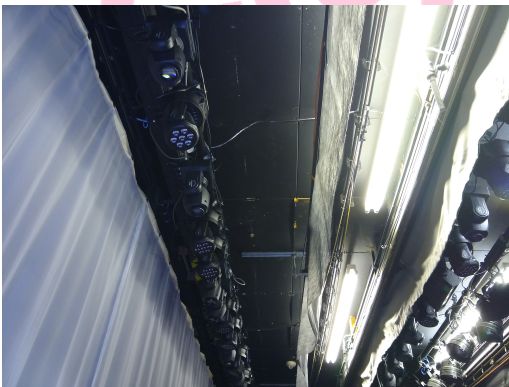
Item 21 Ref: 406216-13

The fixed ceiling tiles in 0/018/Stage does not contain asbestos.

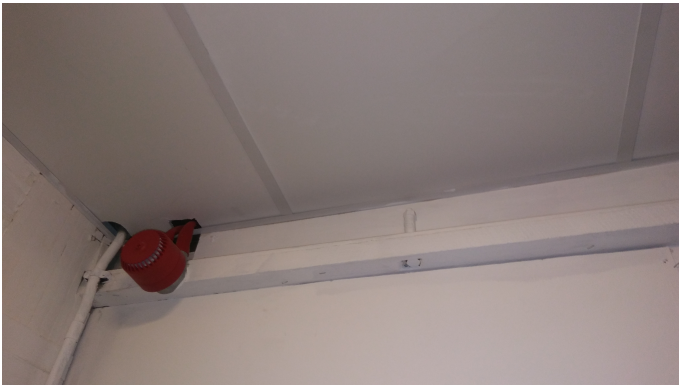
Item 23 Ref: 406216-15

The fillet piece above entrance door in 0/021/Store lobby does not contain asbestos.

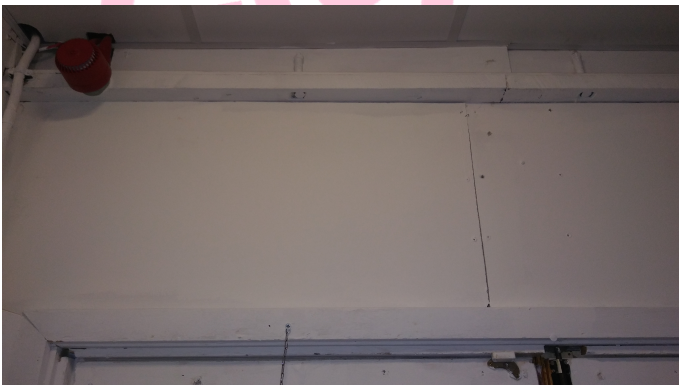
Item 24 Ref: 406216-16

The panel above entrance door in 0/021/Store lobby does not contain asbestos.

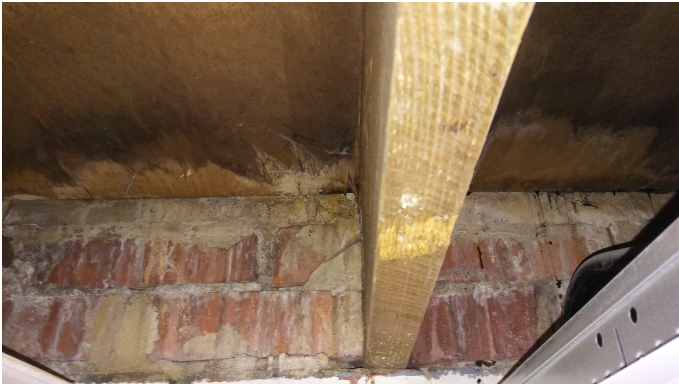
Item 28 Ref: 406216-18

The residue to beams and former nail holes in 0/022/Store void above contains asbestos.

Any change in the appearance should be recorded and passed to Property Services.

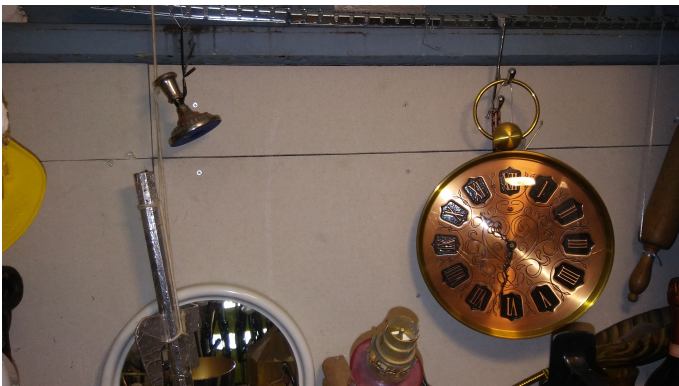
Item 29 Ref: As 406216-19

The panel to wall in 0/023/Store does not contain asbestos.

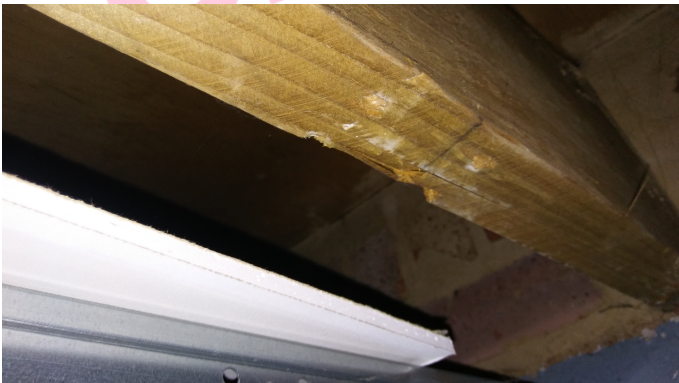
Item 30 Ref: 406216-18

The residue to beams and former nail holes in 0/023/Store void above contains asbestos.

Any change in the appearance should be recorded and passed to Property Services.

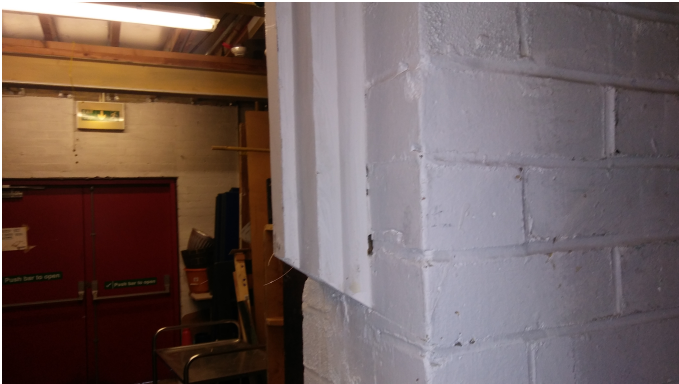
Item 31 Ref: 406216-20

The sealant to door frame in 0/024/Store does not contain asbestos.

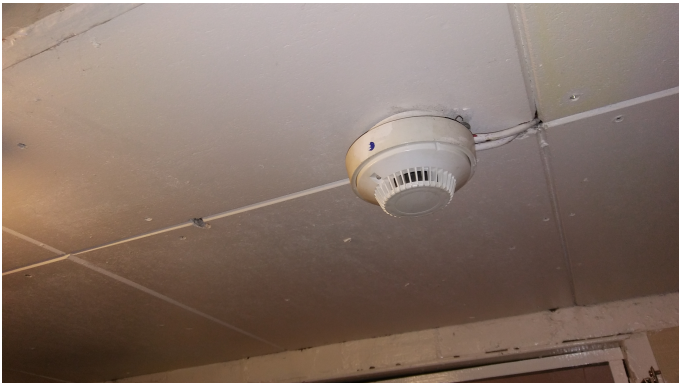
Item 32 Ref: 406216-24

The ceiling in 0/026/Rear exit does not contain asbestos.

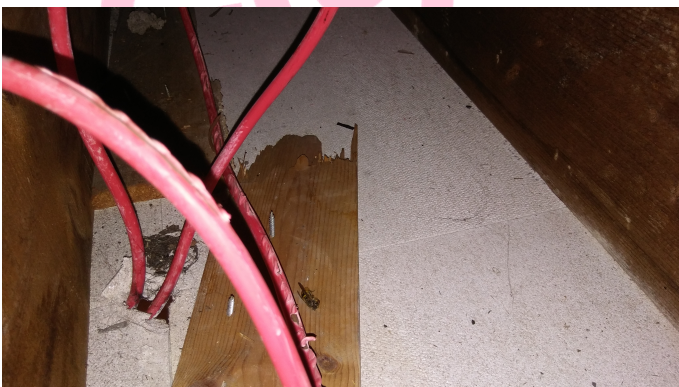
Item 33 Ref: As 406216-23

The topside of ceiling in 0/026/rear exit loft space does not contain asbestos.

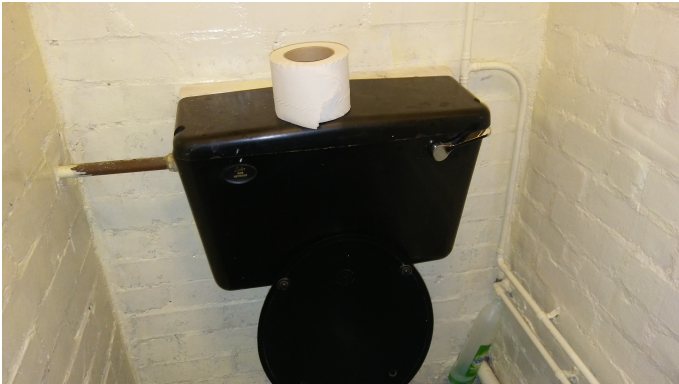
Item 34 Ref: 406216-21

The toilet cistern in 0/027/WC contains asbestos.

Any change in the appearance should be recorded and passed to Property Services.

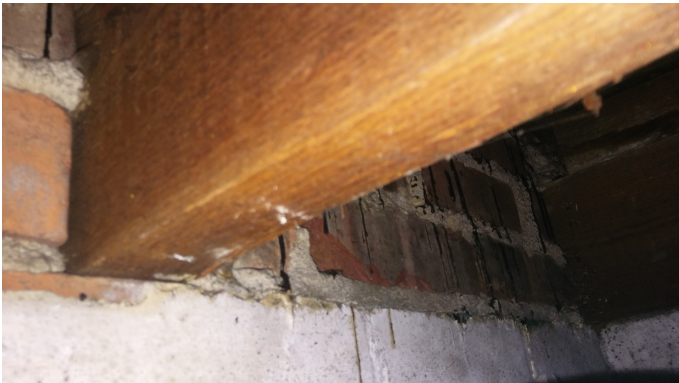
Item 35 Ref: As 406216-22

The residue to beams and former nail holes in 0/027/WC void above does not contain asbestos.

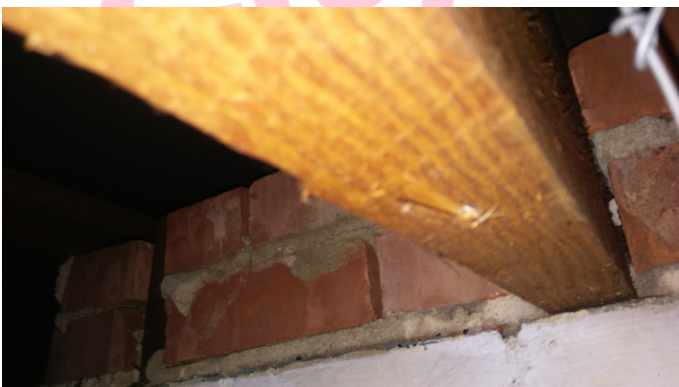
Item 36 Ref: 406216-22

The residue to beams and former nail holes in 0/028/Store void above does not contain asbestos.

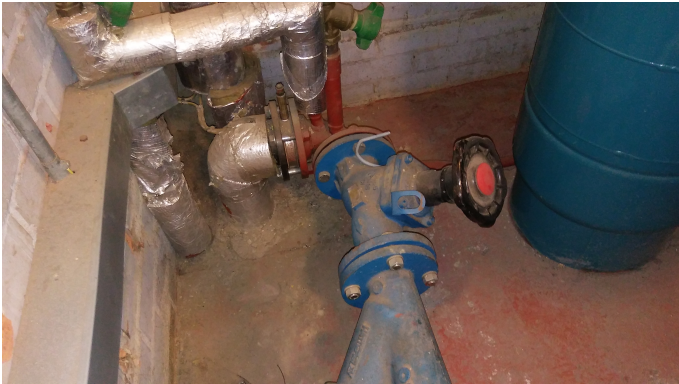
Item 37 Ref: 406216-25

The pipework flange gasket in 0/029/Boiler room loft space does not contain asbestos.

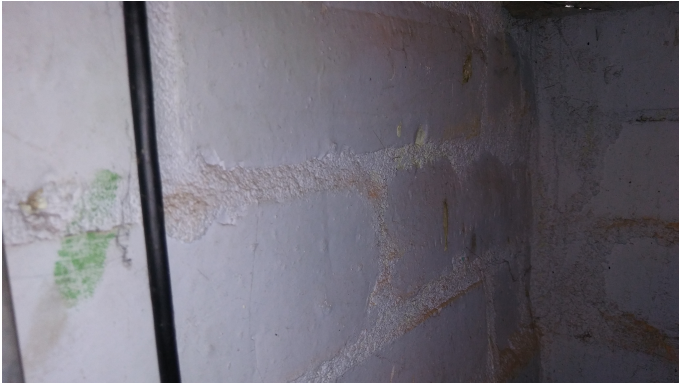
Item 38 Ref: 406216-26

The residue to wall adjacent control panel and door in 0/029/Boiler room loft space does not contain asbestos.

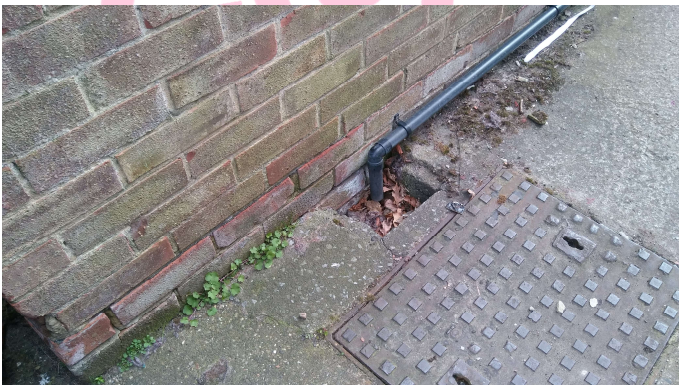
Item 39 Ref: 406216-23

The damp proof course (External) does not contain asbestos.

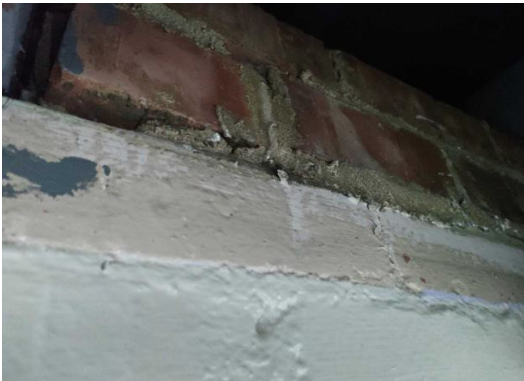
Item 40 Ref: 21-40959-8

The residues to wall (Insulating board - ceiling void) (Room/Area: 1 Female Toilets - ceiling void) contains asbestos.

Any change in the appearance should be recorded and passed to Property Services.

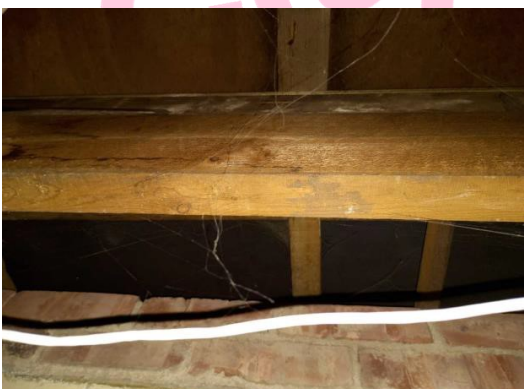
Item 42 Ref: 21-40959-7

The residues to beams (Insulating board) (Room/Area: 30 Kitchen Store - ceiling void) contain asbestos.

Any change in the appearance should be recorded and passed to Property Services.

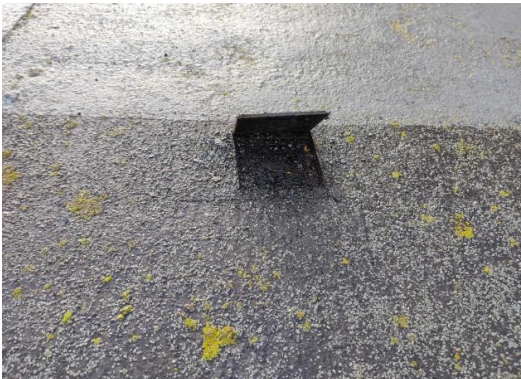
Item 43 Ref: 21-40959-10

The roof felt (Bitumen - ceiling void) (Room/Area: 31 Roof - Right Elevation) does not contain asbestos.

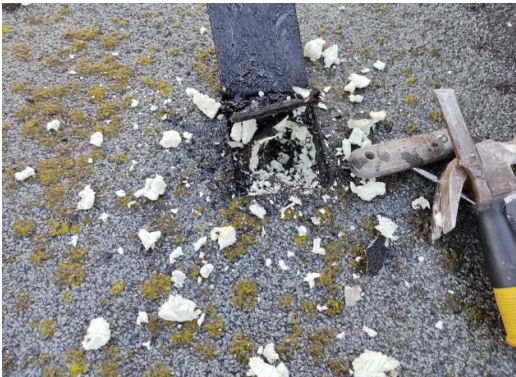
Item 46 Ref: 21-40959-13

The roof felt (Bitumen - ceiling void) (Room/Area: 31 Roof - Right Elevation) does not contain asbestos.

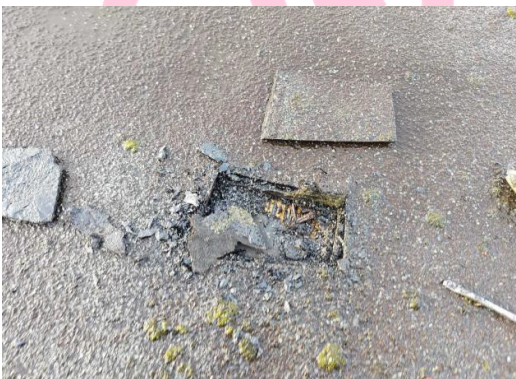
Item 51 Ref: 21-40959-17

The roof felt (Bitumen - ceiling void) (Room/Area: 32 Roof - Central Elevation) does not contain asbestos.

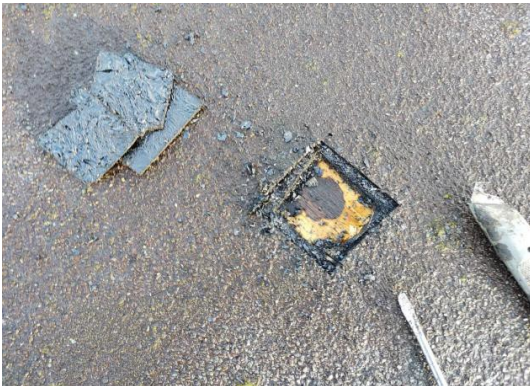
Item 52 Ref: 21-40959-18

The roof felt (Bitumen - ceiling void) (Room/Area: 32 Roof - Central Elevation) does not contain asbestos.

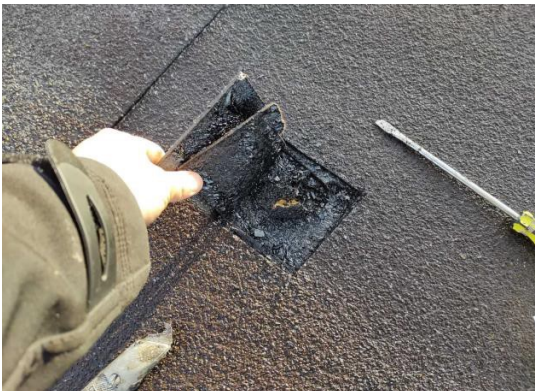
Item 53 Ref: 21-40959-19

The roof felt (Bitumen - ceiling void) (Room/Area: 32 Roof - Central Elevation) does not contain asbestos.

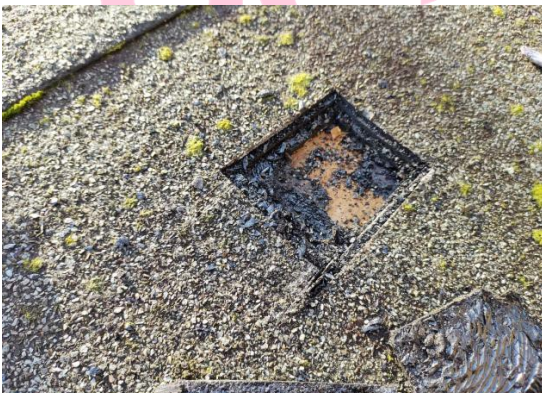
Item 54 Ref: 21-40959-20

The roof (Bitumen - ceiling void) (Room/Area: 33 Roof - Left Elevation) does not contain asbestos.

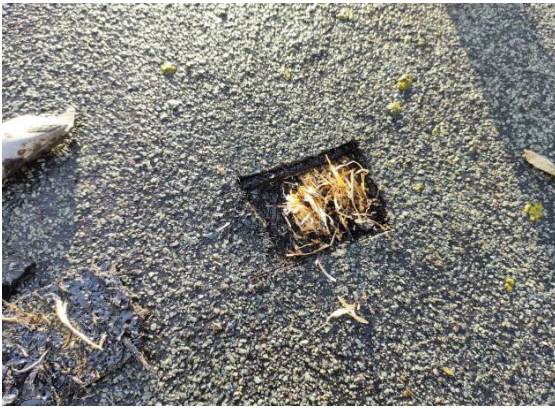
Item 55 Ref: 21-40959-21

The roof (Bitumen - ceiling void) (Room/Area: 33 Roof - Left Elevation) does not contain asbestos.

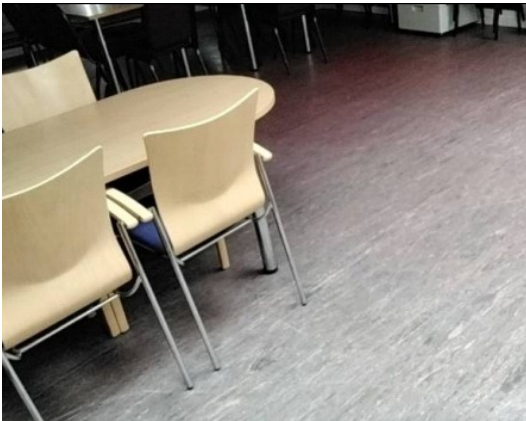
Item 56 Ref: SC004269

The composite vinyl tile with adhesive in the Training Room (Rm 013) does contain asbestos.

Any change in appearance should be reported to Property Services.

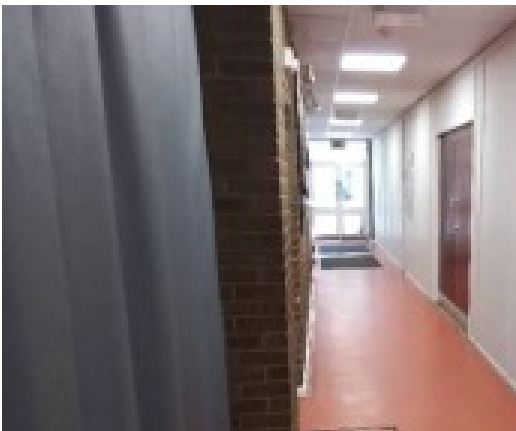
Item 57 Ref: KN001429

The floor covering in the hallway/passageway (Room G001) does not contain asbestos.

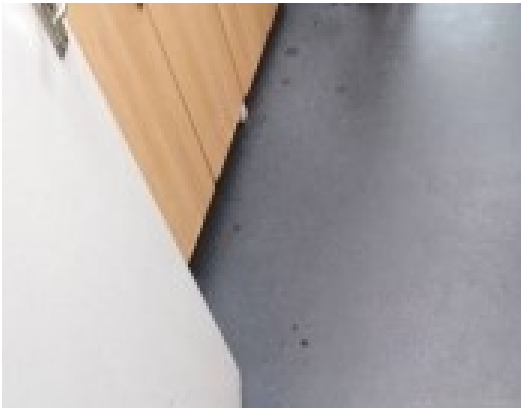
Item 58 Ref: KN001430

The floor covering in the Kitchen (Room G/002) does not contain asbestos.
