ASBESTOS SURVEY REPORT FOR DEPTFORD & MILLFIELD CA, SUNDERLAND

Asbestos Register for DEPTFORD & MILLFIELD CA, SUNDERLAND

Last updated 31/03/2026 – Depford and Millfield CA – Version 2

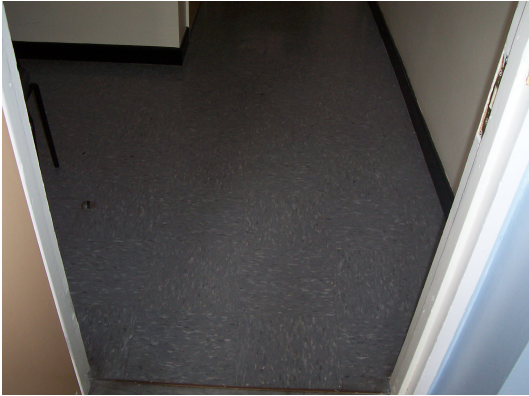
Item 1 Ref: CS06/967

The grey floor tiles to the disabled male WC do not contain asbestos.

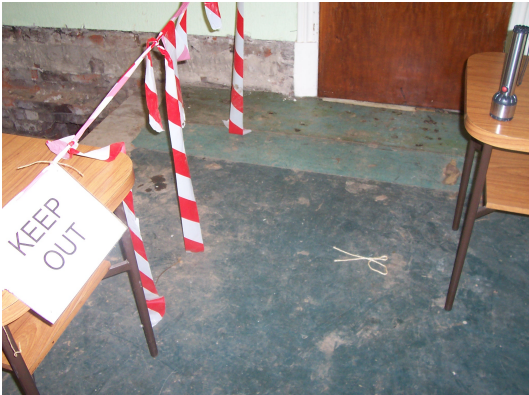
Item 2 - Ref: CS06/969

The blue and grey vinyl flooring over wood in communal room 1 does not contain asbestos.

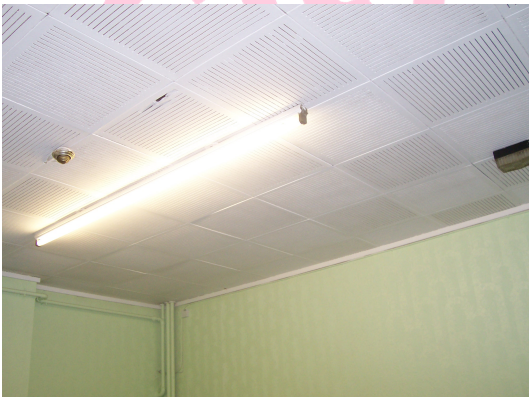
Item 3 - Ref: CS06/970

The coating to the fibreboard ceiling tiles in communal room 1 does not contain asbestos.

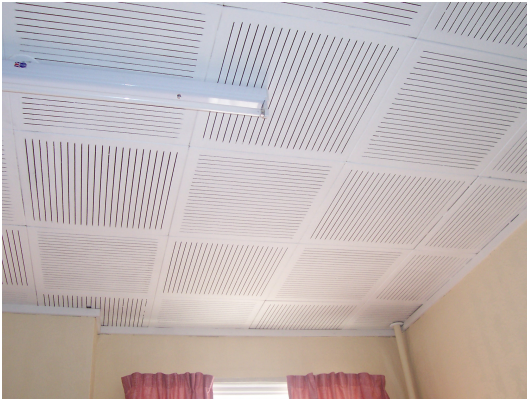
Item 4 - As CS06/970

The coating to the fibreboard ceiling in the office does not contain asbestos.

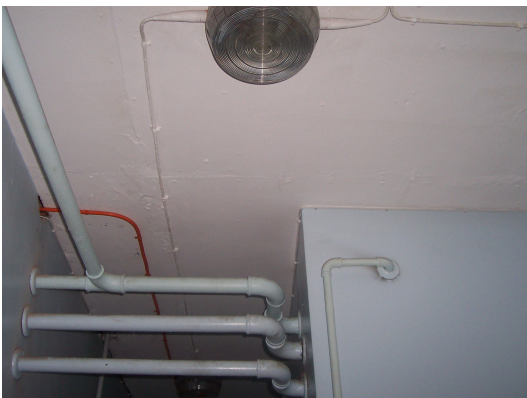
Item 5 - As CS06/972

The cement ceiling panels to area above kitchen door contain asbestos. Any change in its appearance should be recorded, and passed to Property Services.

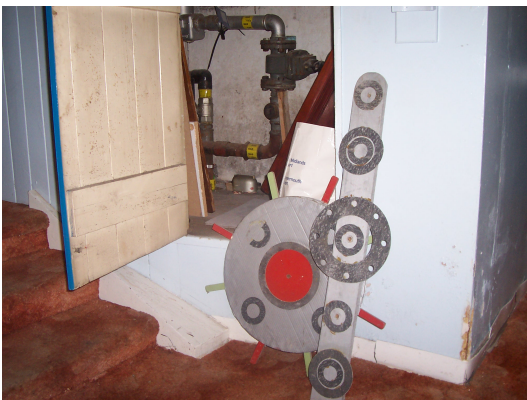
Item 6 - Ref: CS06/971

The redundant gaskets in the under stairs cupboard contain asbestos. Any change in its appearance should be recorded, and passed to Property Services.

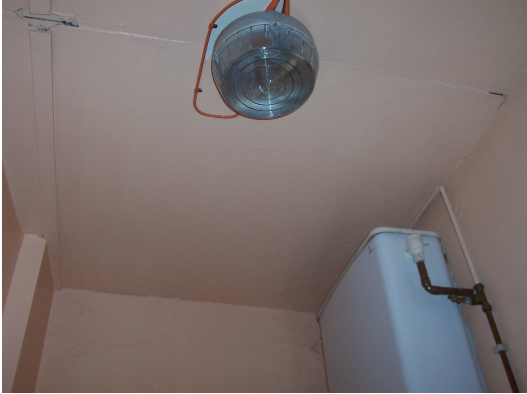
Item 7 - Ref: CS06/972

The cement ceiling panels to the kitchen contain asbestos. Any change in its appearance should be recorded, and passed to Property Services.

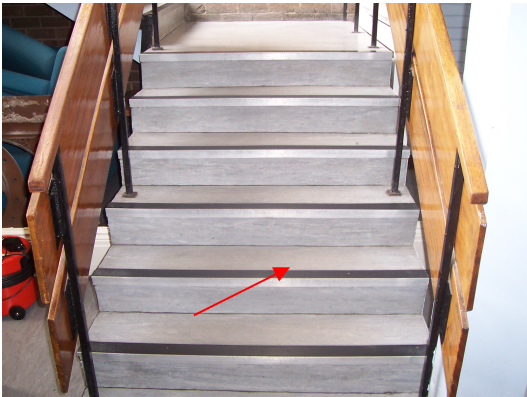
Item 8 - Ref: CS06/973

The stair nosing to the foyer, stairs and lobby does not contain asbestos.

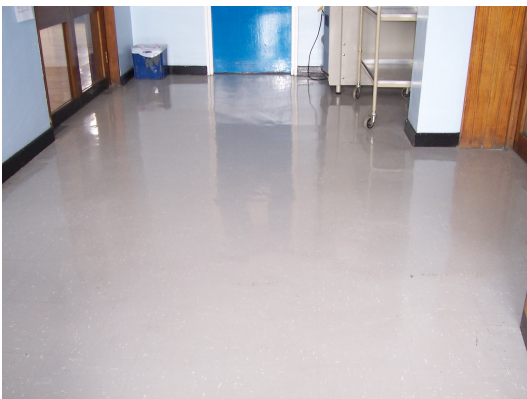
Item 9 - Ref: CS06/974

The grey floor tiles to the foyer, stairs and landing do not contain asbestos.

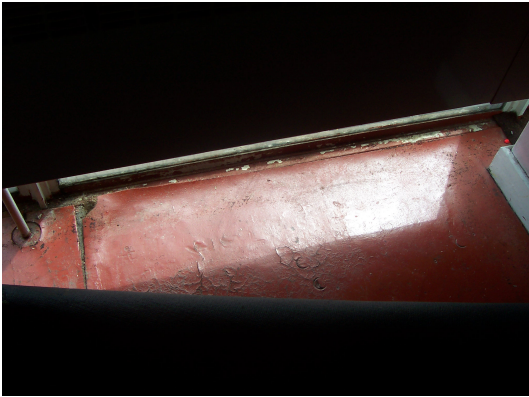
Item 10 - CS06/975

The red vinyl flooring under carpet & adhesive in dressing room 1 does not contain asbestos.

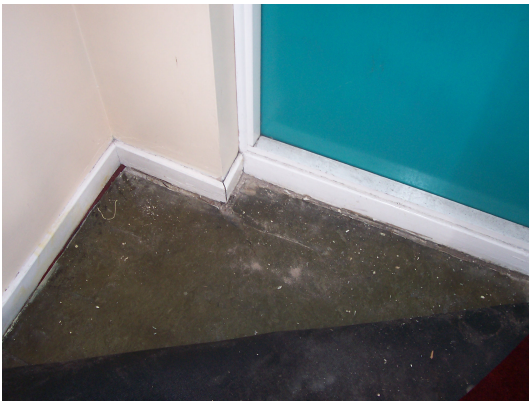
Item 11 - CS06/976

The green vinyl flooring under carpet & adhesive in dressing room 2 does not contain asbestos.

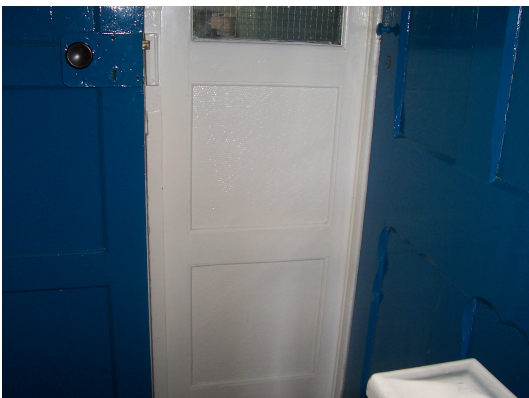
Item 12 - CS06/977

The cement panels to side of door on stairs 2 to second floor and landing does contain asbestos. Any change in its appearance should be recorded, and passed to Property Services.

Item 12	Cement panels to side of door in the stairs 2 to 2nd floor & Landing	Low	6 monthly	20.09.26
<i>Item 13</i>	<i>No asbestos</i>	<i>Is present</i>		
<i>Item 14</i>	<i>No asbestos</i>	<i>Is present</i>		
<i>Item 15</i>	<i>No asbestos</i>	<i>Is present</i>

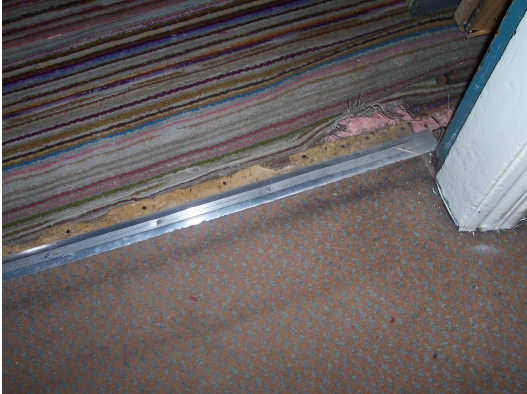
Item 13 - CS06/978

The beige flooring under carpet on corridor 3 does not contain asbestos.

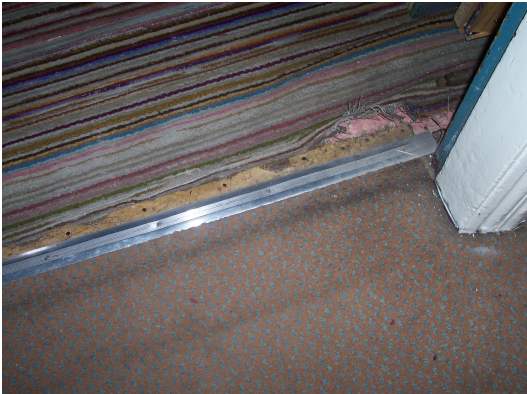
Item 14 - CS06/979

The red vinyl covering under carpet in store 8 does not contain asbestos.

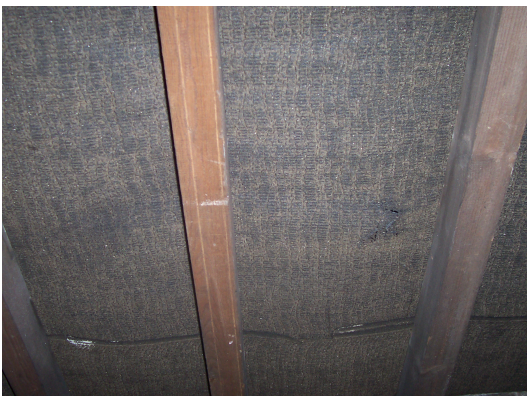
Item 15 - CS06/980

The sarking felt to roof in the loft does not contain asbestos.

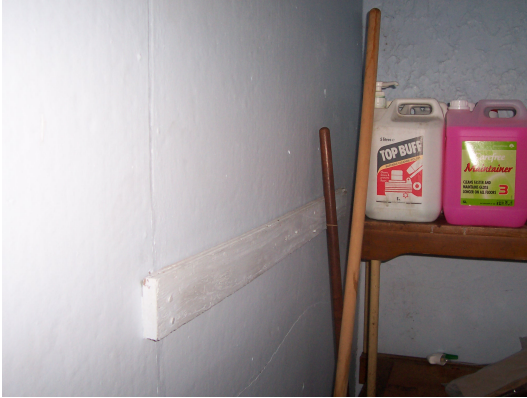
Item 16 - CS06/981

The cement panels to the walls in the cleaners store contain asbestos. Any change in its appearance should be recorded, and passed to Property Services.

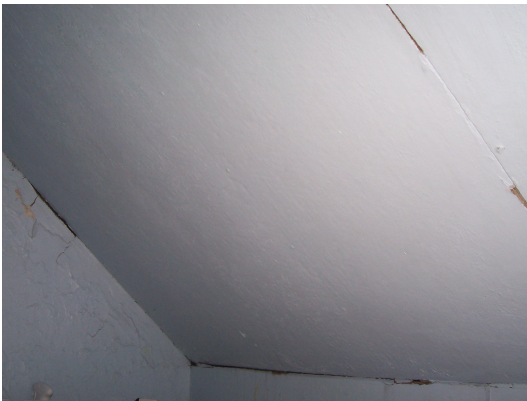
Item 17 - CS06/982

The cement panels to the ceiling angle in the cleaners store contain asbestos. Any change in its appearance should be recorded, and passed to Property Services.

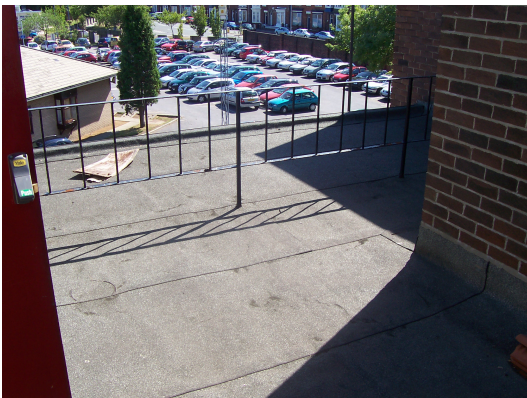
Item 18 - CS06/983

The external flat roof felt does not contain asbestos.

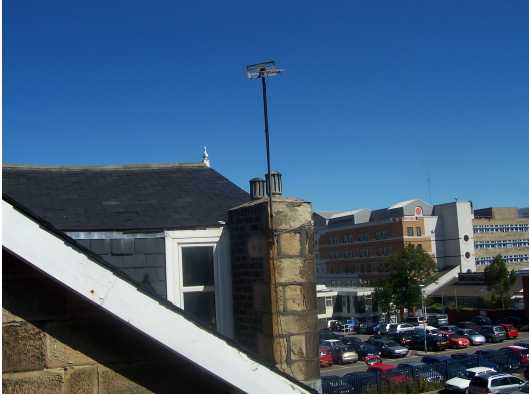
Item 19 – presumed

The four external cement flues are presumed to contain asbestos. Any change in its appearance should be recorded, and passed to Property Services.

Item 19	External cement panels x 4	Very Low	12 monthly	20.09.26

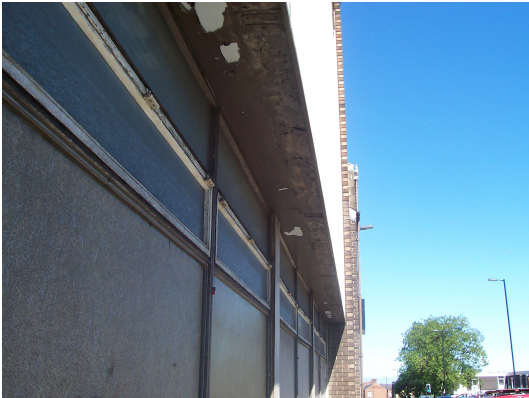
Item 20 - CS06/984

The cement soffits to the ground level contain asbestos. Any change in its appearance should be recorded, and passed to Property Services.

Encapsulated October 2020

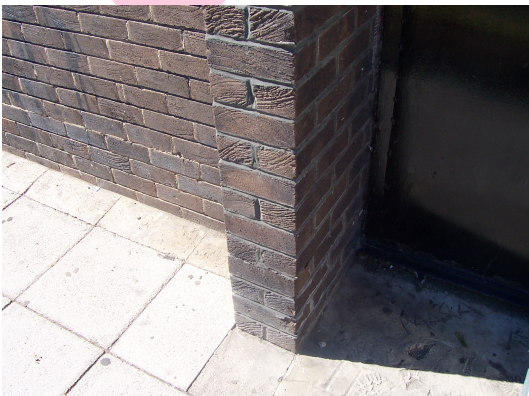
Item 21 - CS06/985

The external damp proof course does not contain asbestos.

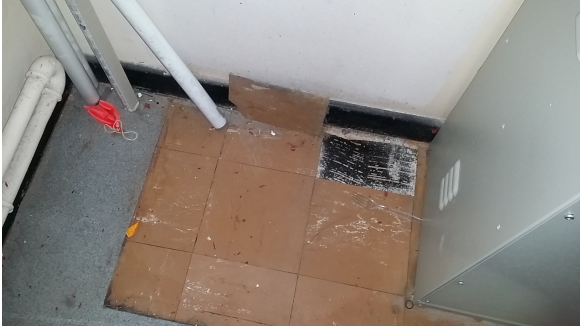
Item 22 – 250834-2

Floor tile with bitumen adhesive in 0/02/female toilets contain asbestos.

Any change in its appearance should be recorded, and passed to Property Services.

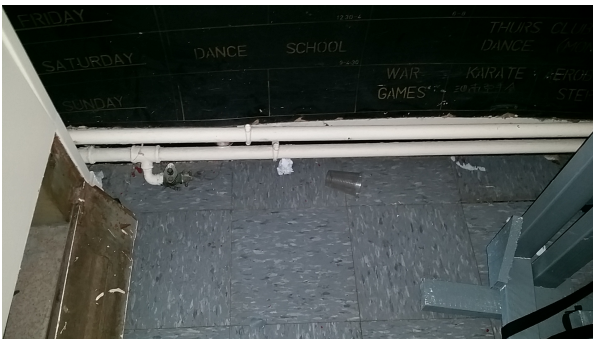
Item 23 – 250834-3

Floor tile with bitumen adhesive in 0/03/male toilets contain asbestos.

Any change in its appearance should be recorded, and passed to Property Services.

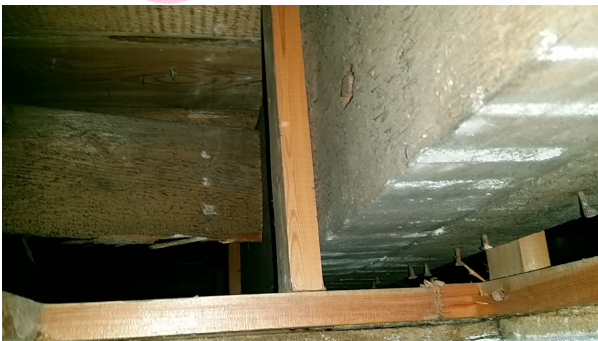
Item 24 – 250834-4

Debris to beams nails & nail holes within beams in 0/04/communal room 1 (void above) do not contain asbestos.

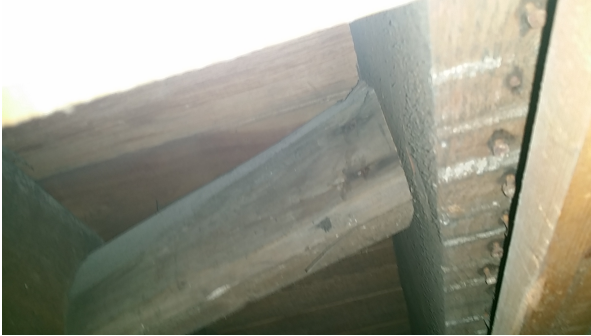
Item 25 – As 250834-4

Debris to beams nails & nail holes within beams in 0/05/office (void above) do not contain asbestos.

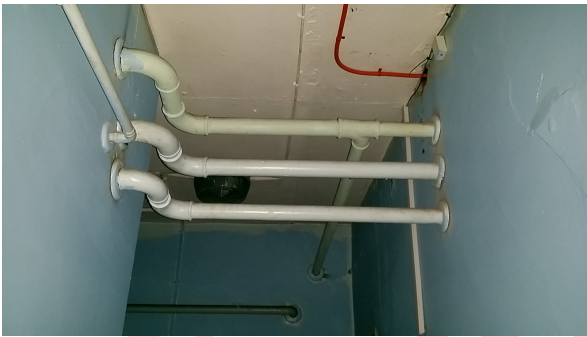
Item 26 – 250834-6

Ceiling in 0/08/corridor contains asbestos.

Any change in its appearance should be recorded, and passed to Property Services.

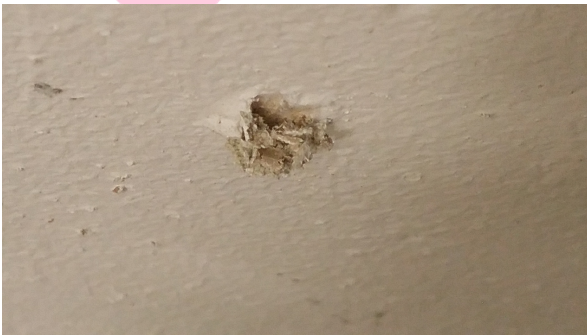
Item 27 – 250834-10

Debris to wall in ground floor boiler room contains asbestos.

Environmental clean completed June 2018 – asbestos debris removed

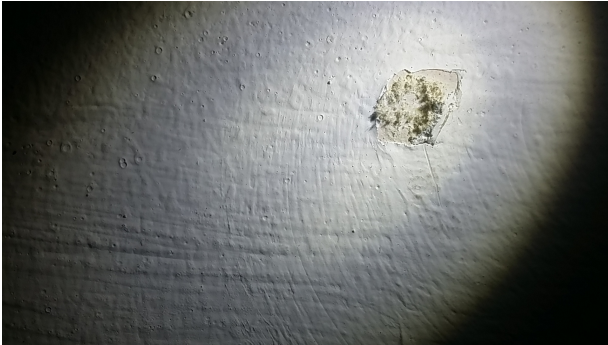
Item 28 – 250834-11

Debris to wall in ground floor boiler room contains asbestos.

Environmental clean completed June 2018 – asbestos debris removed

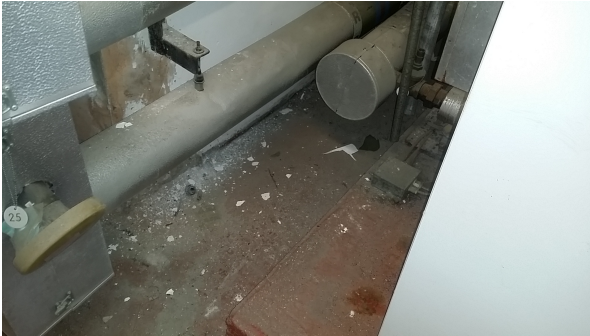
Item 29 – 250834-12

General debris to floor in ground floor boiler room contains asbestos.

Environmental clean completed June 2018 – asbestos debris removed

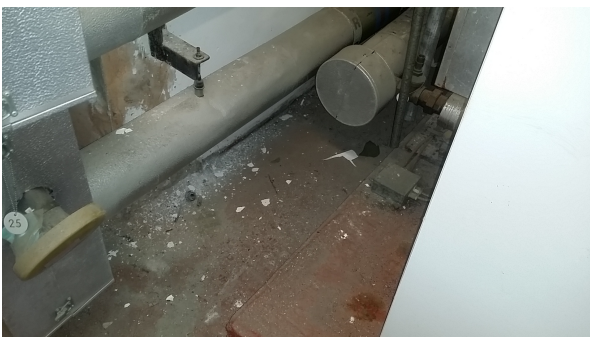
Item 30 – 250834-13

General debris to pipe penetration in floor in ground floor boiler room contains asbestos.

Environmental clean completed June 2018 – asbestos debris removed

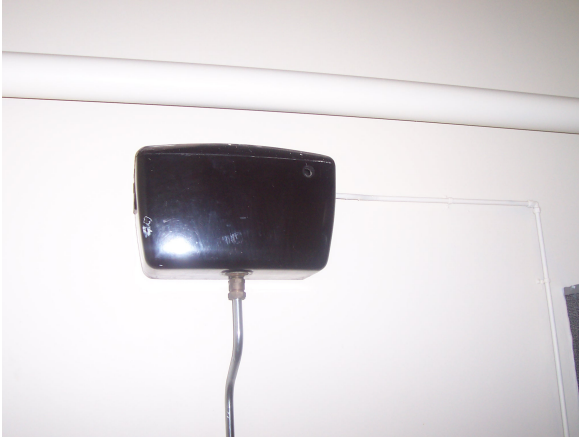
Item 31 – CS06-968

The 2xToilet Cisterns and 1xSeat in the Male WC contains asbestos.

Removed from property but no WCN paperwork.

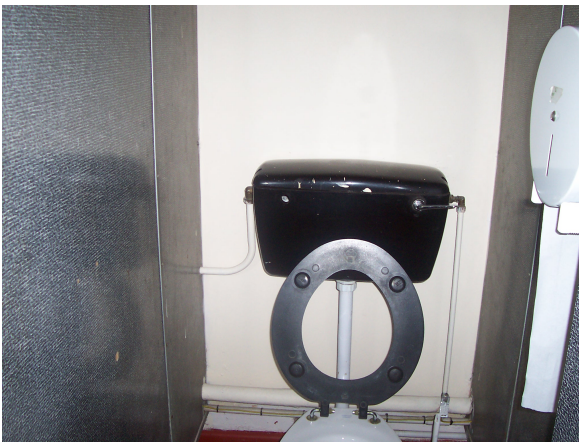
Item 32 – As CS06-968

The 2xToilet Cisterns and 2xSeat in the Female WC contains asbestos.

Removed from property but no WCN paperwork.

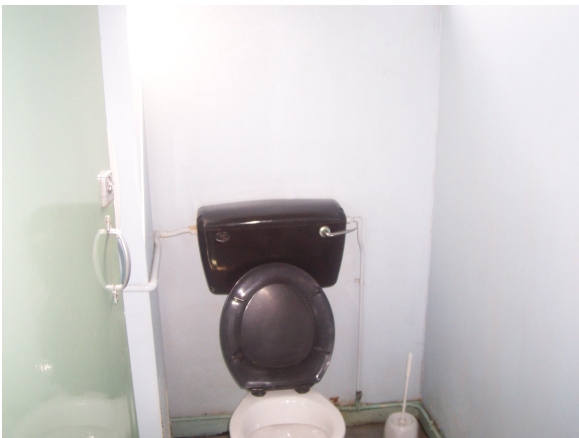
Item 33 – As CS06-968

The Toilet Cistern and Seat in the Male WC contains asbestos.

Removed from property but no WCN paperwork.

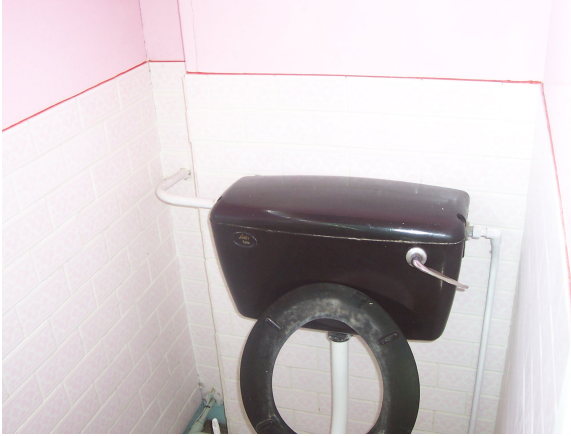
Item 34 – As CS06-968

The Toilet Cistern and Seat in the Ladies WC contains asbestos.

Removed from property but no WCN paperwork.
