ASBESTOS SURVEY REPORT FOR SUNDERLAND CREMATORIUM,  
CHESTER ROAD, SUNDERLAND, SR4 7RS.

## *Control of Asbestos Regulations 2012*

**Sunderland Crematorium, Chester Road, Sunderland,  
SR4 7RS**

**Date: 30 January 2026**

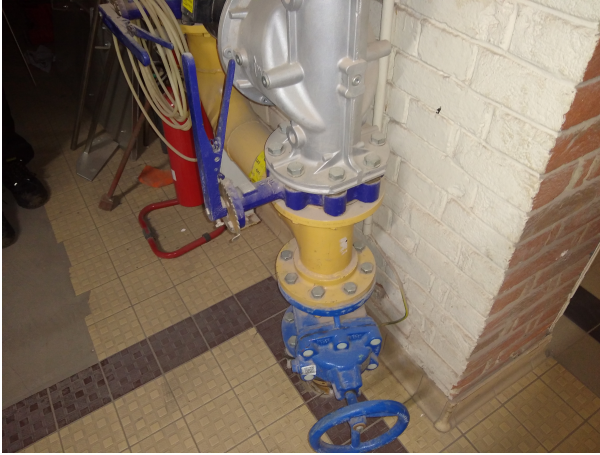
### **Item 1 Ref: As 411588-6**

The pipework flange gasket (0/001/Cremator room 1) does not contain asbestos.

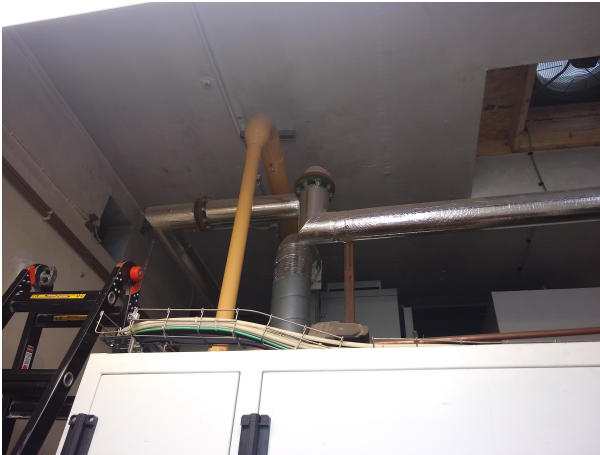
### **Item 2 Ref: 411588-12**

The pipework flange gasket (0/002/Cremator room 2) does not contain asbestos.

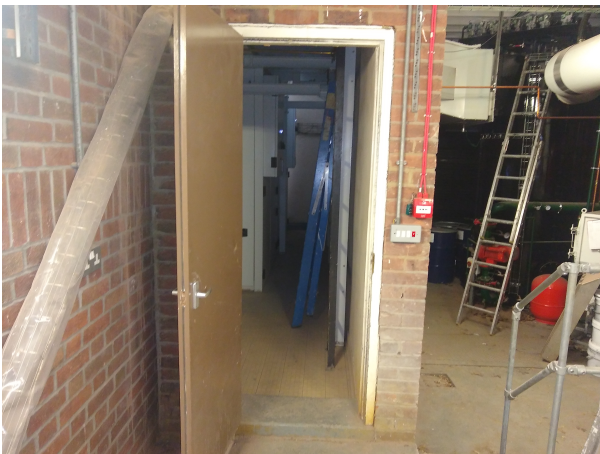
### **Item 3 Ref: 411588-15**

The sealant to door frame (0/003/Plant room containing mercury abatement system) does not contain asbestos.

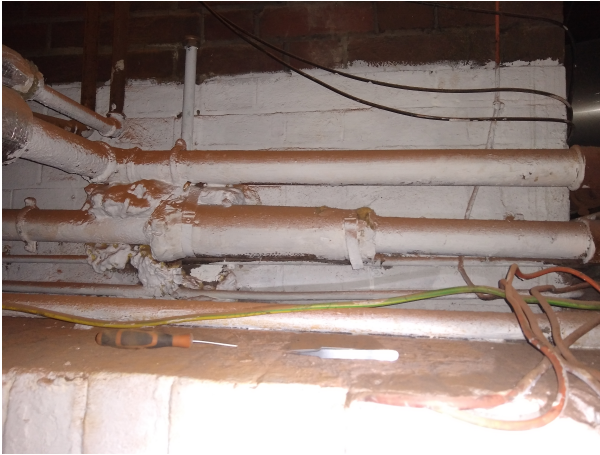
### **Item 4 Ref: 411588-10**

The loose debris behind high level pipework/cable conduits above ledge, partially encapsulated (0/004/Boiler room) contains asbestos.

Removed May 2020.

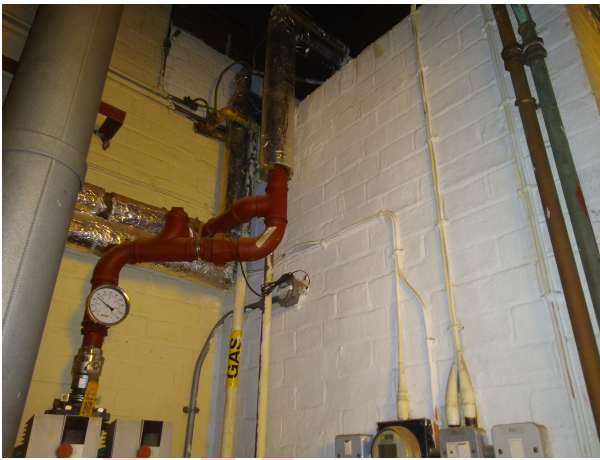
### **Item 5 Ref: 411588-11**

The debris to walls encapsulated (0/004/Boiler room) contain asbestos.

Any change in its appearance should be recorded and passed to Property Services.

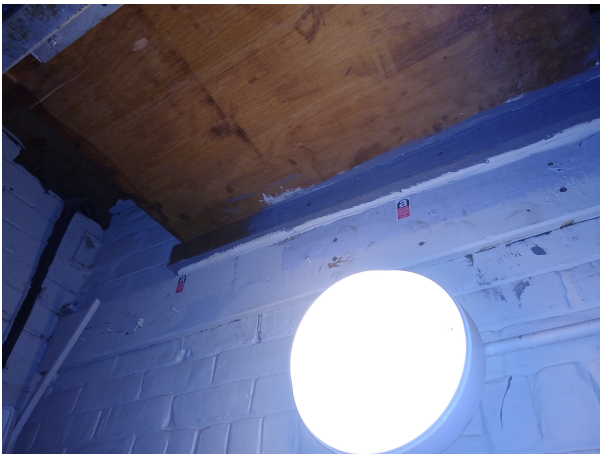
### **Item 6 Ref: Presumed**

The thin fillet above door above wooden fascia (0/004/Boiler Room) is presumed to contain asbestos.

Any change in its appearance should be recorded and passed to Property Services.

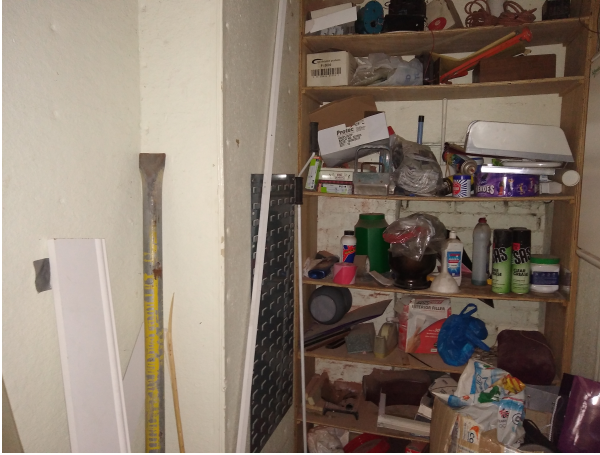
### **Item 7 Ref: 411588-13**

The panels to walls  
(0/007/Store room) do not  
contain asbestos.

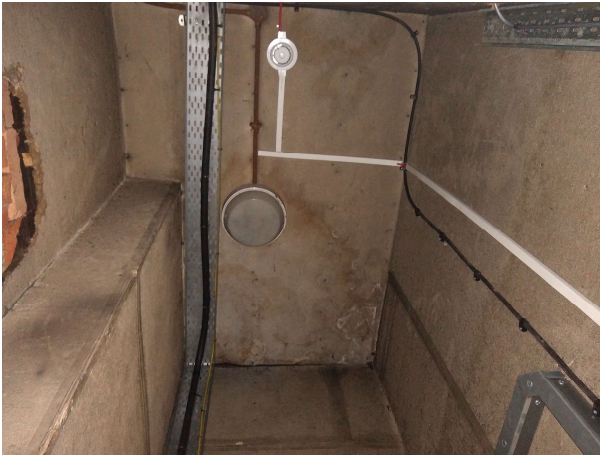
### **Item 8 Ref: As 411588-13**

The panels to ceiling  
(0/007/Store room) does not  
contain asbestos.

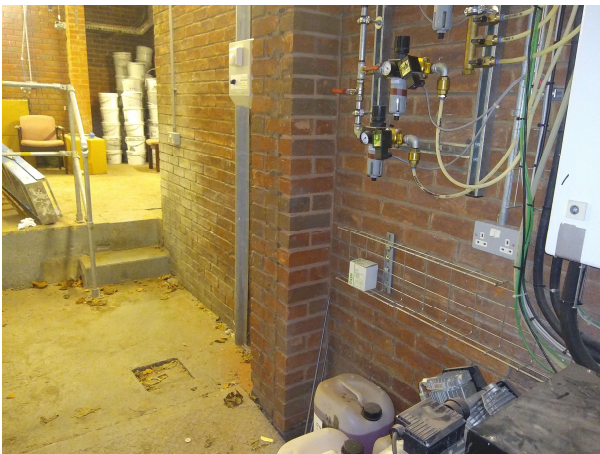
### **Item 9 Ref: 411588-14**

The remnant sealant to brick  
pillars (0/008/Plant Room) do  
not contain asbestos.

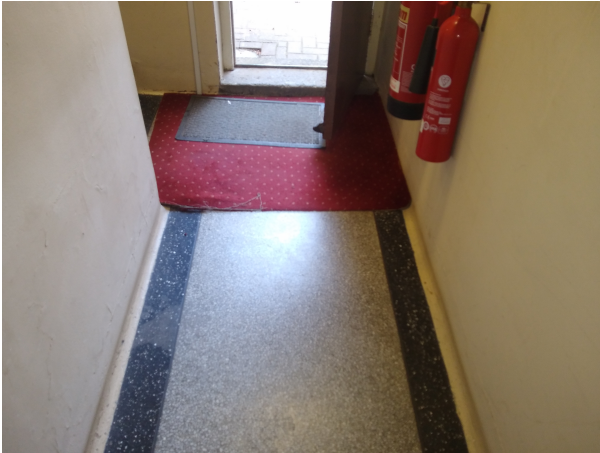
### **Item 10 Ref: 411588-5**

The floor covering (0/009/Corridor) does not contain asbestos.

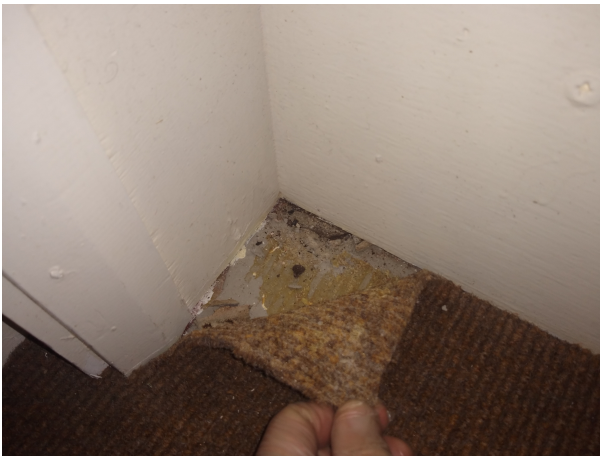
### **Item 11 Ref: 411588-3**

The remnant floor tiles beneath skirting (0/010/Office) contain asbestos.

Any change in its appearance should be recorded and passed to Property Services.

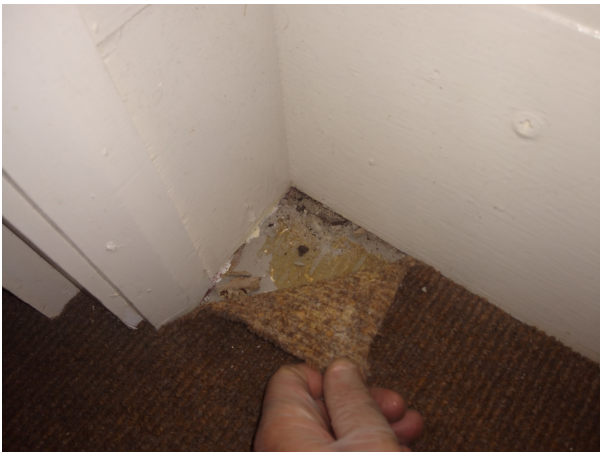
### **Item 12 Ref: 411588-4**

The remnant adhesive to floor beneath screed (0/010/Office) contains asbestos.

Any change in its appearance should be recorded and passed to Property Services.

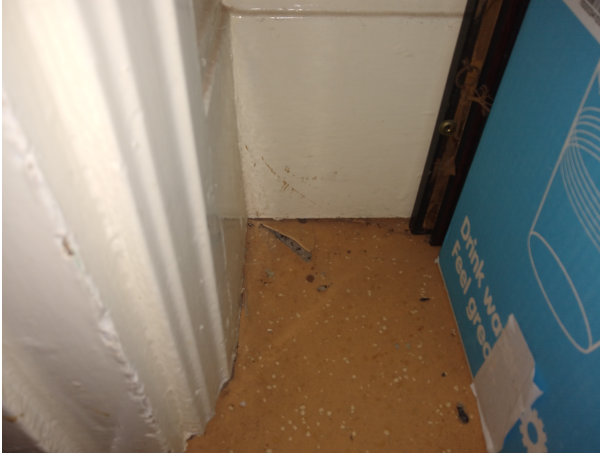
### **Item 13 Ref: 411588-4**

The remnant adhesive to floor beneath screed (0/012/Office store) contains asbestos.

Any change in its appearance should be recorded and passed to Property Services.

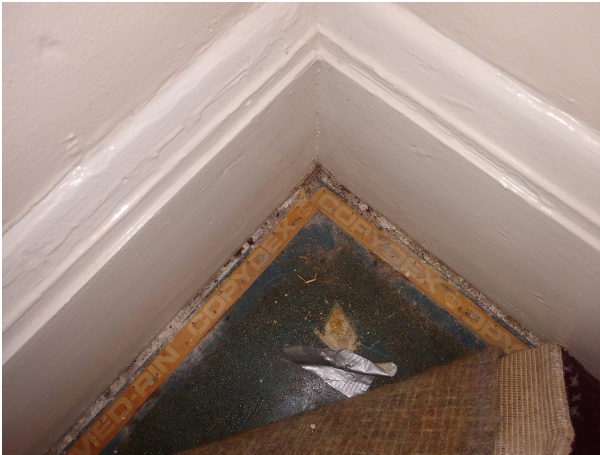
### **Item 14 Ref: 411588-16**

The subfloor (0/017/Waiting room) contains asbestos.

Any change in its appearance should be recorded and passed to Property Services.

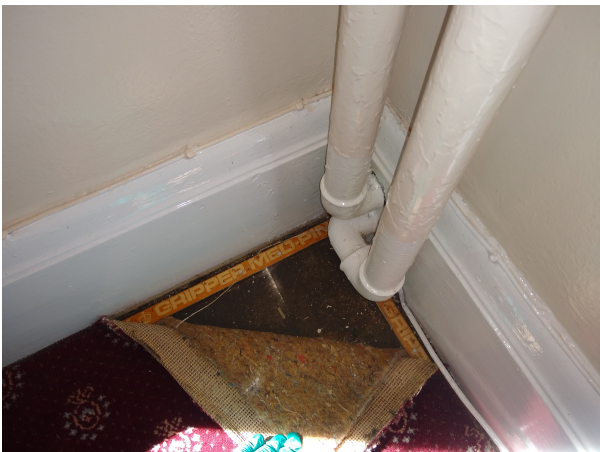
### **Item 15 Ref: As 411588-2**

The subfloor (0/019/Lobby) contains asbestos.

Any change in its appearance should be recorded and passed to Property Services.

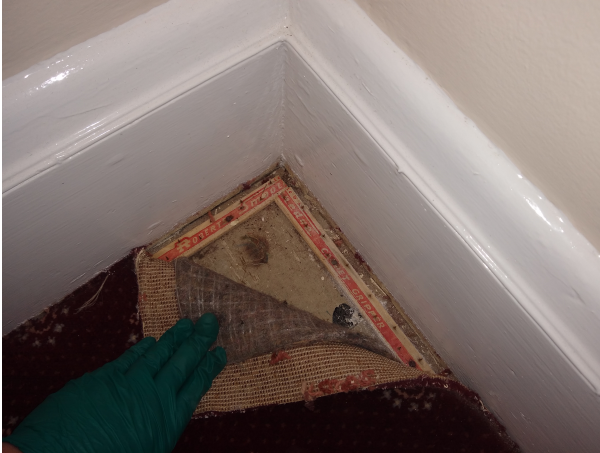
### **Item 16 Ref: 411588-17**

The subfloor (0/21/  
Remembrance corridor)  
contains asbestos.

Any change in its appearance  
should be recorded and  
passed to Property Services.

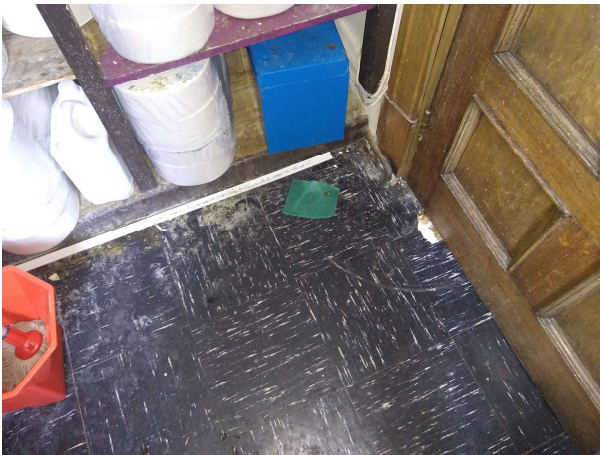
### **Item 17 Ref: 411588-18**

The floor covering  
(0/024/Cleaners store) does  
not contain asbestos.

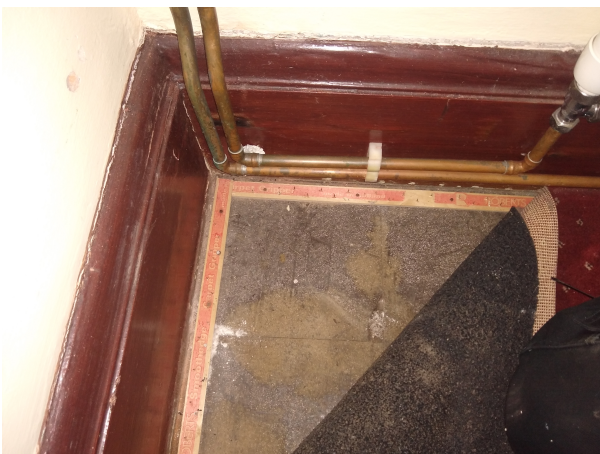
### **Item 18 Ref: 411588-2**

The subfloor (0/025/Lobby)  
contains asbestos.

Any change in its appearance  
should be recorded and  
passed to Property Services.

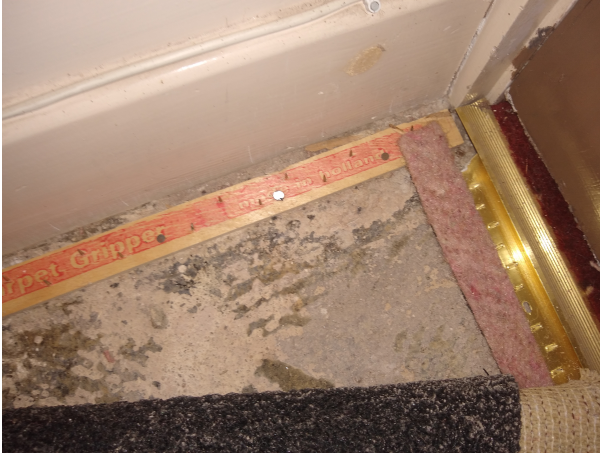
### **Item 19 Ref: As 411588-1**

The remnant adhesive to floor (0/031/Records room) contains asbestos.

Any change in its appearance should be recorded and passed to Property Services.

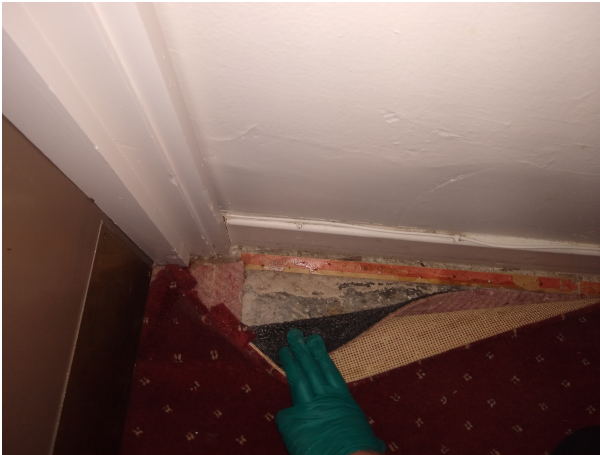
### **Item 20 Ref: As 411588-1**

The remnant adhesive to floor (0/032/Records lobby) contains asbestos.

Any change in its appearance should be recorded and passed to Property Services.

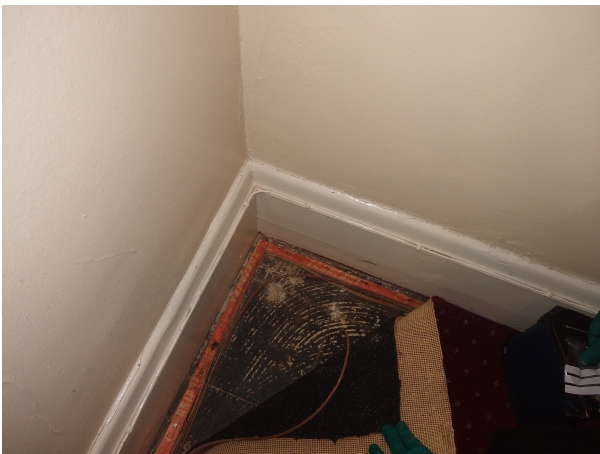
### **Item 21 Ref: 411588-1**

The remnant adhesive to floor (0/033/Lobby) contains asbestos.

Any change in its appearance should be recorded and passed to Property Services.

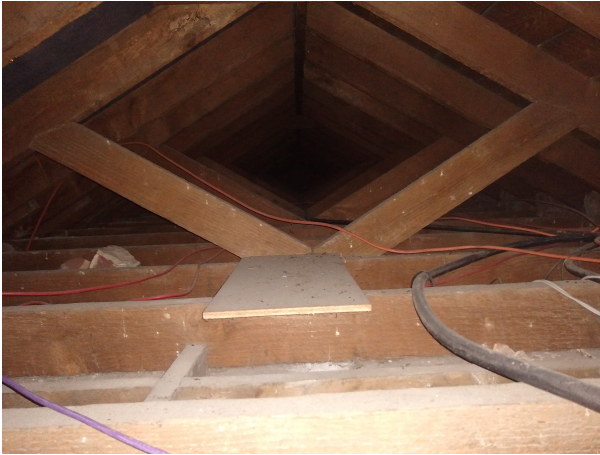
### **Item 22 Ref: 139184-2**

The general debris to top side of ceiling below (1/001/Loft void above lobby 0/033) does not contain asbestos.

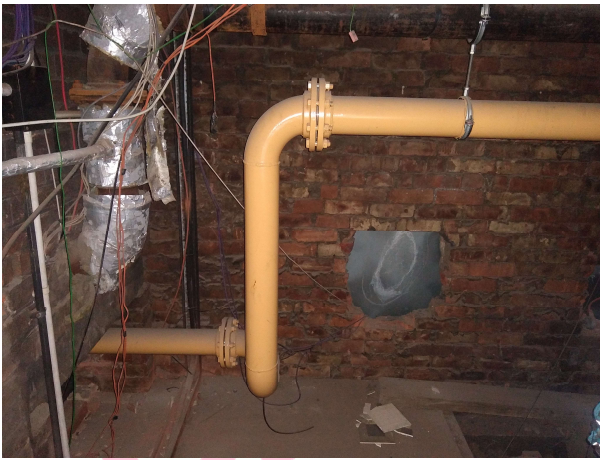
### **Item 23 Ref: 411588-6**

The gas pipework flange gaskets (1/003/loft void) does not contain asbestos.

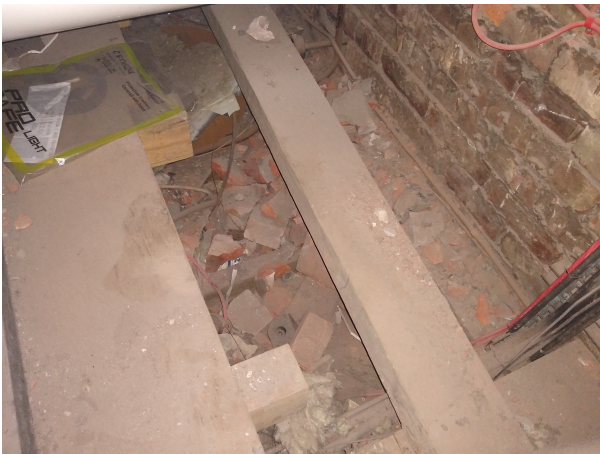
### **Item 24 Ref: 411588-7**

The remnant floor beneath timber flooring (1/003/loft void) contains asbestos.

Any change in its appearance should be recorded and passed to Property Services.

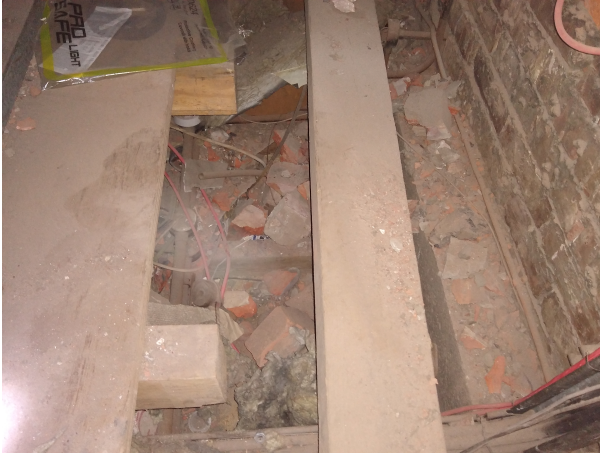
### **Item 25 Ref: 411588-8**

The debris beneath timber floor (1/003/loft void) contains asbestos.

Any change in its appearance should be recorded and passed to Property Services.

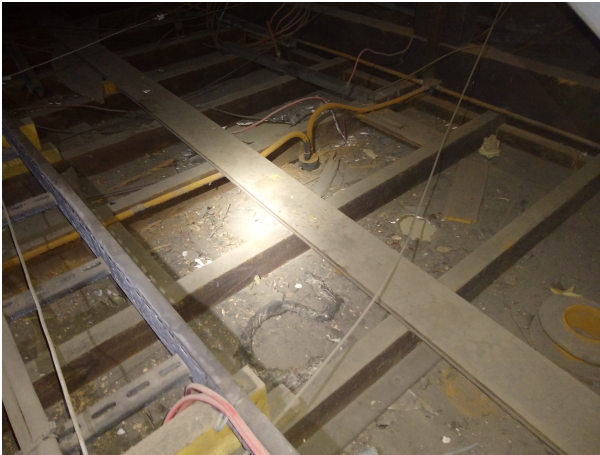
### **Item 26 Ref: 411588-9**

The debris to top side of ceiling below 0/005 (1/003/loft void) contains asbestos.

Removed June 2025

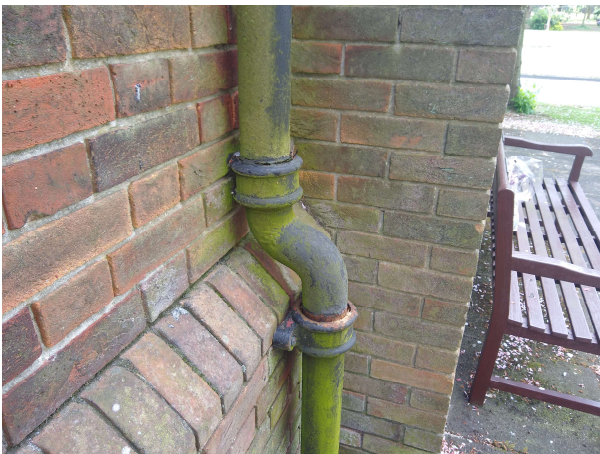
### **Item 27 Ref: 411588-19**

The sealant to downpipe collars (External) does not contain asbestos.

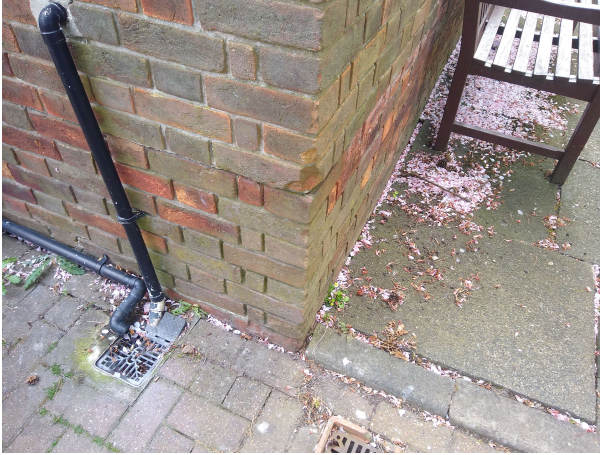
### **Item 28 Ref: 411588-20**

The damp proof course  
(External) contains asbestos.

Any change in its appearance  
should be recorded and  
passed to Property Services.

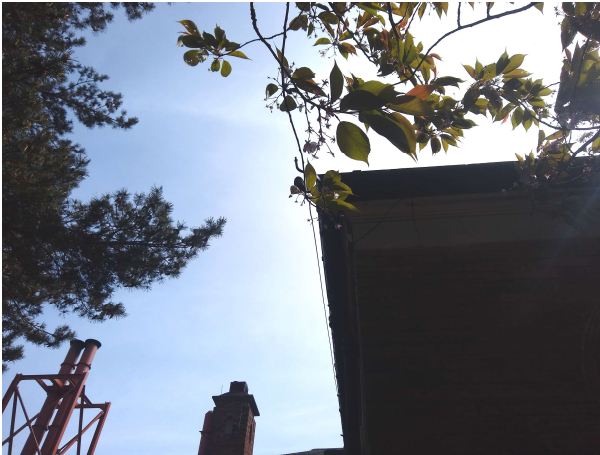
### **Item 29 Ref: 411588-21**

The telephone insulator  
(External) contains asbestos.

Any change in its appearance  
should be recorded and  
passed to Property Services.

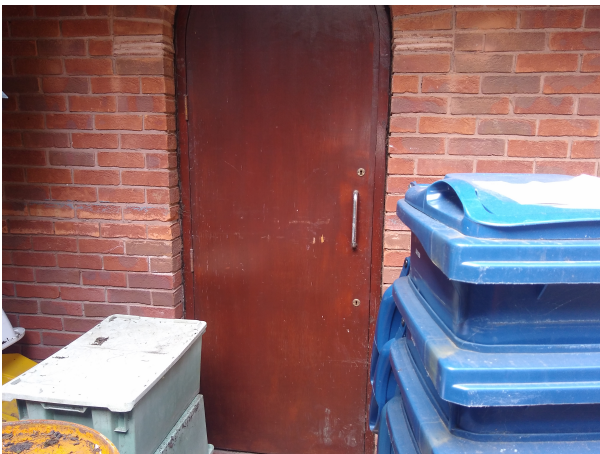
### **Item 30 Ref: 411588-22**

The sealant to door frame  
0/011 (External) does not  
contain asbestos.

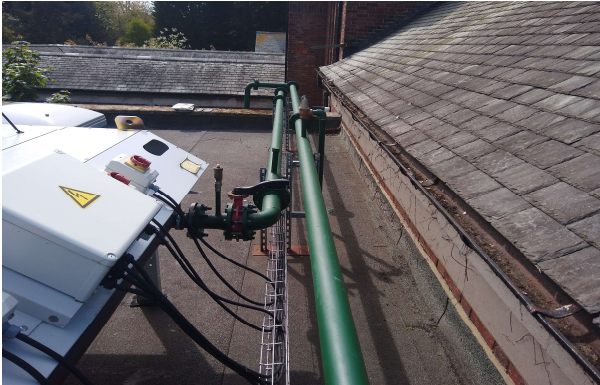
### **Item 31 Ref: 411588-22**

The pipework flange gaskets to flat roof top (External) does not contain asbestos.

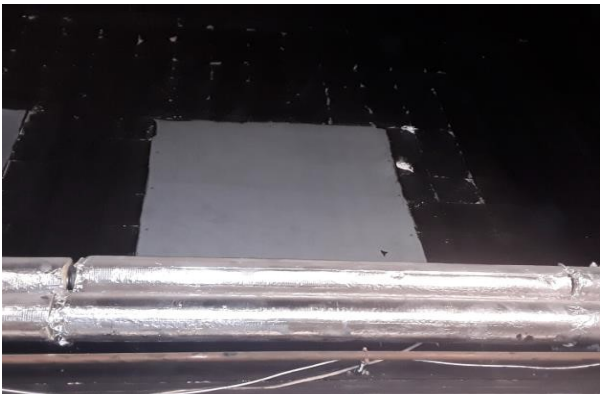
### **Item 32 Ref: 20-28162-1**

The walls (tiles & adhesive) in the Cremator Room do not contain asbestos.

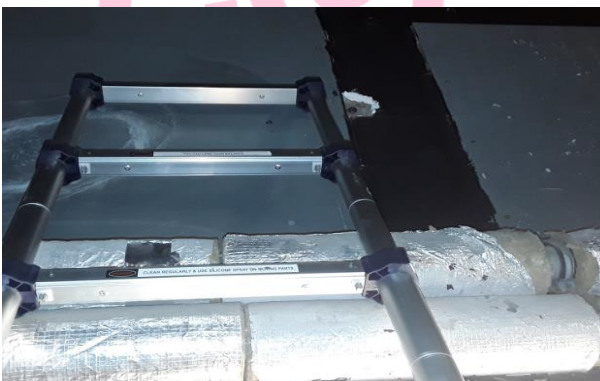
### **Item 33 Ref: 20-28162-2**

The walls (tiles & adhesive) in the Cremator Room do not contain asbestos.

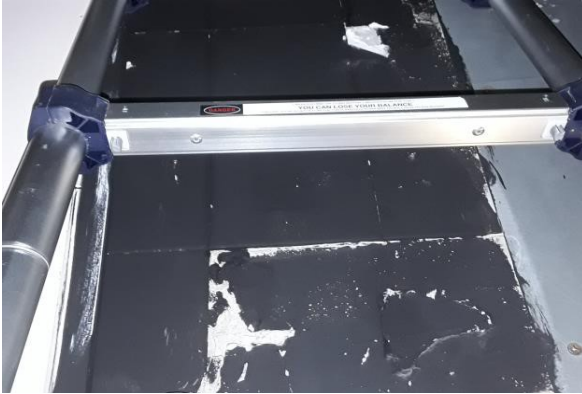
**Item 34 Ref: 20-28162-3**

The walls (tiles & adhesive) in the Cremator Room do not contain asbestos.

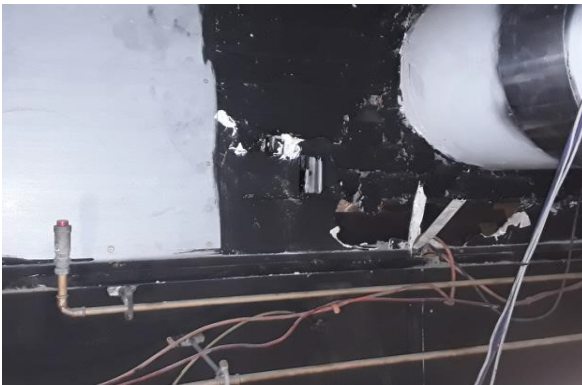
**Item 35 Ref: 20-28162-4**

The walls (plaster) in the Cremator Room do not contain asbestos.

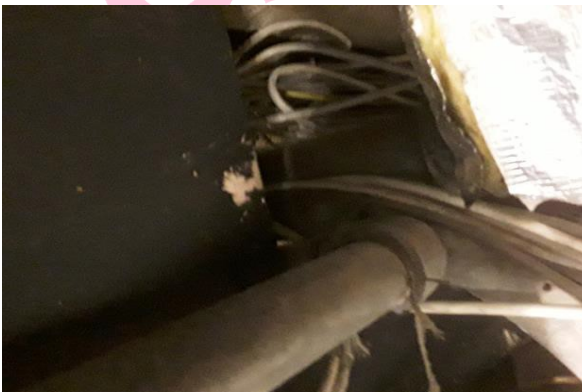
**Item 36 Ref: 20-28162-5**

The walls – cable tray intrusion (debris) in the Cremator Room does not contain asbestos.
