ASBESTOS SURVEY REPORT FOR WASHINGTON F PIT MUSEUM, WASHINGTON

Asbestos Register for

WASHINGTON F PIT MUSEUM, WASHINGTON

Date: 04 February 2026

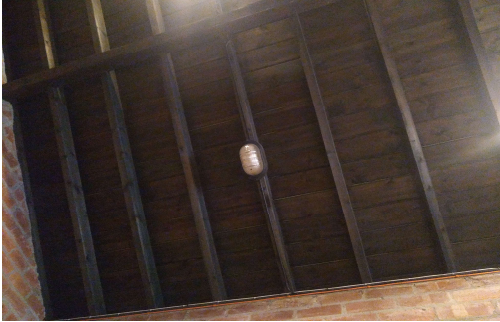
Item 1 Ref: As 423190-1

- (Item 1) Ref: As 423190-1 Sealant to diffuser (Exhibition Space 0/001) – Very Low Risk
- (Item 2) Ref: 423190-2 – Sealant to door frame (Exhibition Space 0/001) – Very Low Risk

The sealant to diffuser of bulkhead light fittings in Exhibition Space 0/001 does contain asbestos.

Any change in its appearance should be recorded and reported to Property Services.

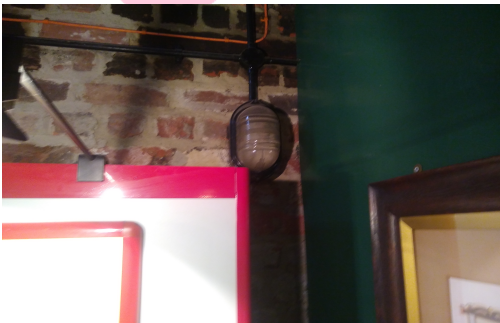
Item 3 Ref: 423190-1

The sealant to diffuser of bulkhead light fittings in Exhibition Space 0/004 does contain asbestos.

Any change in its appearance should be recorded and reported to Property Services.

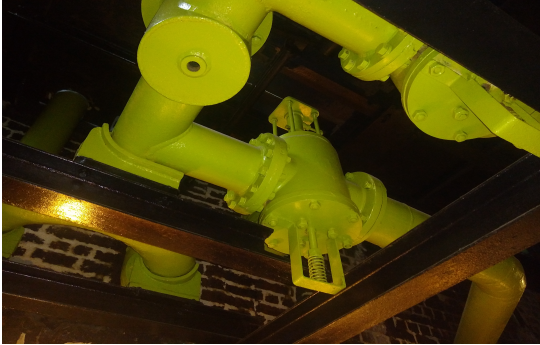
Item 4 Ref: 423190-3

The pipework flange gaskets in Exhibition Space 0/004 contain asbestos.

Any change in its appearance should be recorded and reported to Property Services.

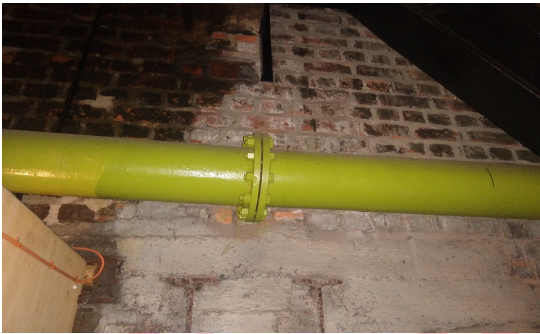
Item 5 Ref: As 423190-3

The pipework flange gaskets Below Main Wheel 0/005 contain asbestos.

Any change in its appearance should be recorded and reported to Property Services.

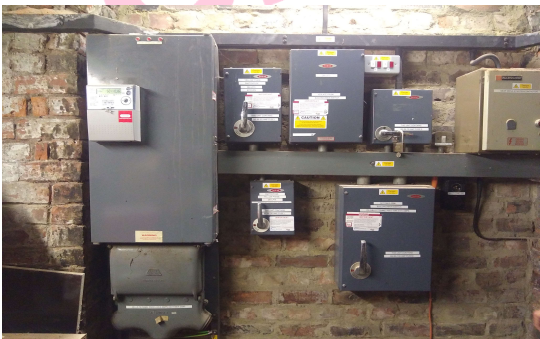
Item 6 Ref: Presumed

The Mem/ Allenwest/ Lucy Oxford electrics Below Main Wheel 0/005 are presumed to contain asbestos.

Any change in its appearance should be recorded and reported to Property Services.

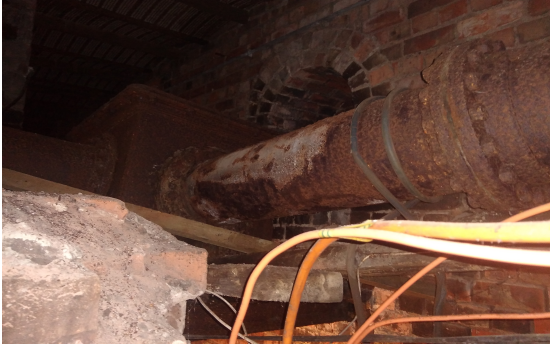
Item 7 Ref: 423190-4

The pipework/ tank flange gasket in the Void 0/007 do not contain asbestos.

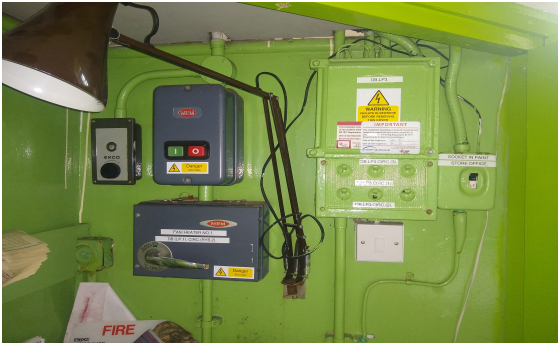
Item 8 Ref: Presumed

The electrics in Engine Room 1/001 are presumed to contain asbestos.

Any change in its appearance should be recorded and reported to Property Services.

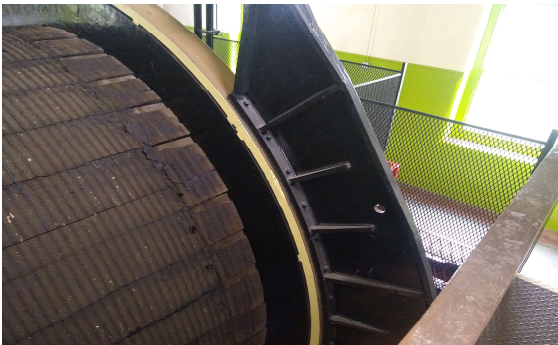
Item 9 Ref: 423190-5

The brake pads to the main wheel in Engine Room 1/001 do contain asbestos.

Any change in its appearance should be recorded and reported to Property Services.

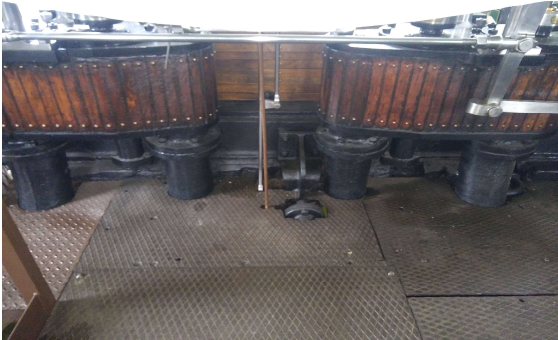
Item 10 Ref: As 423190-3

The pipework flange gaskets in Engine Room 1/001 do contain asbestos.

Any change in its appearance should be recorded and reported to Property Services.

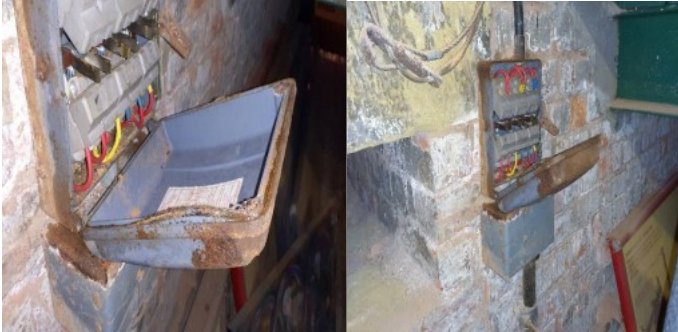
Item 23 Ref: OB001306

The rope seal to MEMLOK isolate box in the mains electrical room (G/01) does not contain asbestos.

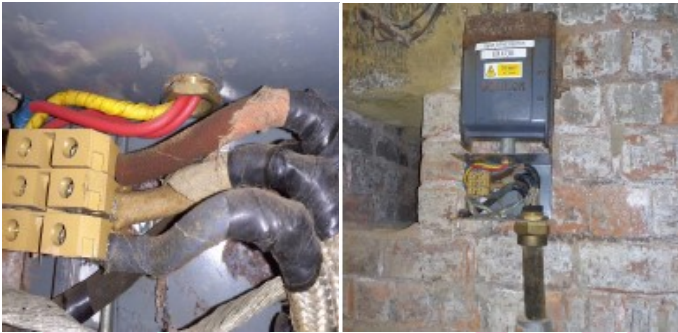
Item 24 Ref: RT000002

The red, white and blue cable wrap in the Wheelhouse (G/01) does not contain asbestos.
