ASBESTOS SURVEY REPORT FOR 64 FAWCETT STREET, SUNDERLAND, SR1 1BB.

Asbestos Register for

64 Fawcett Street, Sunderland, SR1 1BB

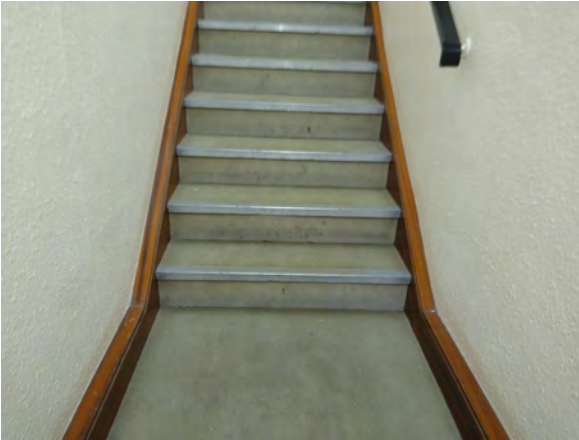
Item 1 Ref: 347395-1

The stair nosing in the lobby/stairwell (Rm -1/001) does not contain asbestos.

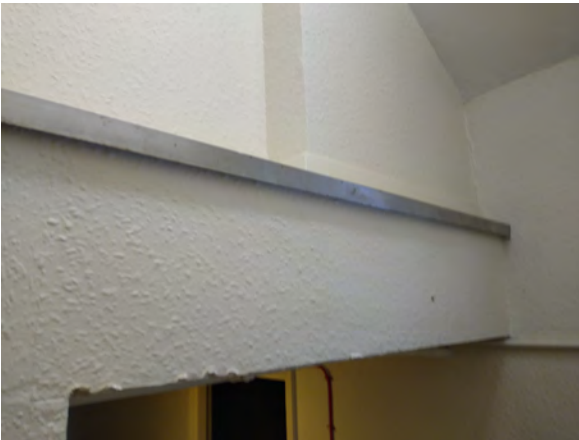
Item 2 Ref: As 347395-1

The high level edging in the lobby/stairwell (Rm -1/001) does not contain asbestos.

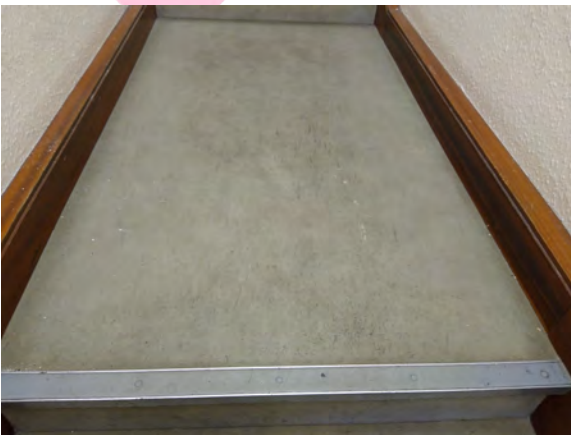
Item 3 Ref: 347395-2

The floor covering in the lobby/stairwell (Rm -1/001) does not contain asbestos.

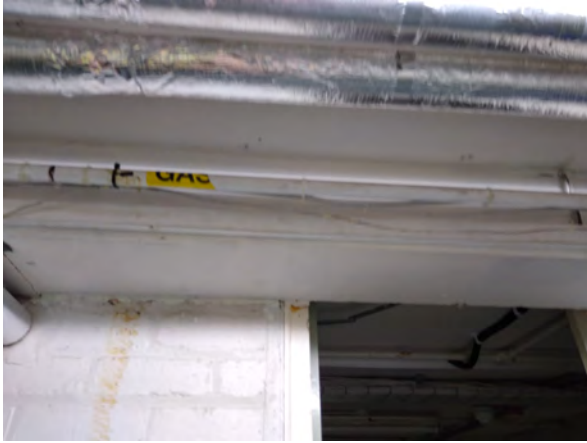
Item 4 Ref: 347395-3

The boxing above the door to boiler house in the Store (Room -1/002) does not contain asbestos.

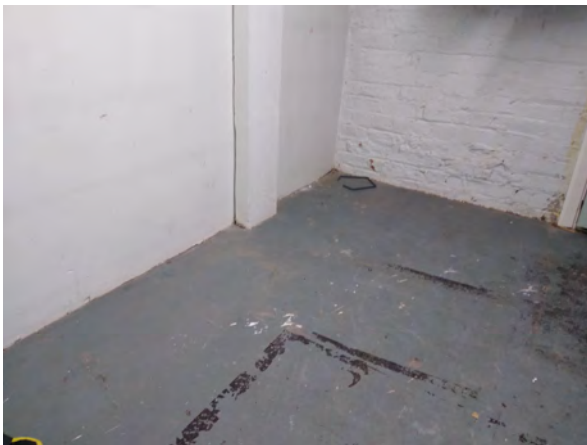
Item 5 Ref: 347395-4

The coating to the floor in the store (Rm -1/002) does not contain asbestos.

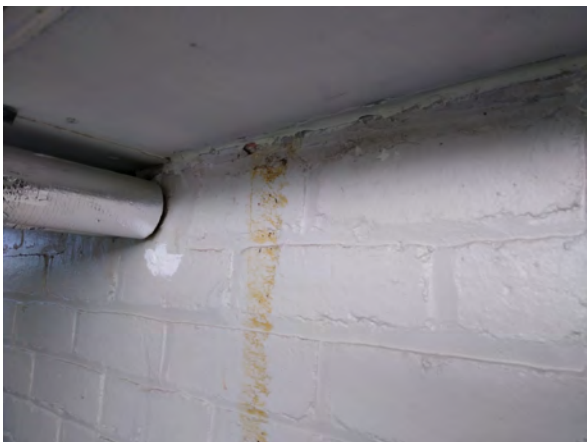
Item 6 Ref: 347395-5

The debris to walls below pipe penetration in the Store (Room -1/002) does not contain asbestos.

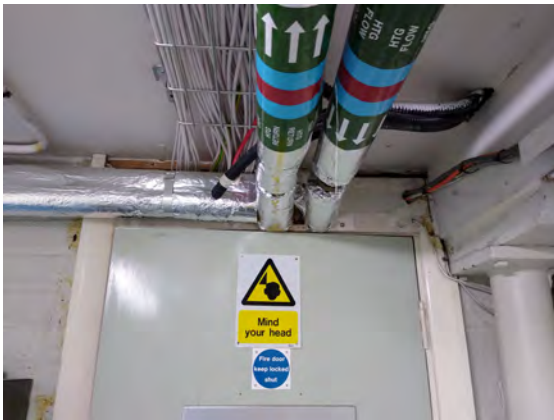
Item 7 Ref: As 347395-3

The panel above the door in the Store (Room -1/002) does not contain asbestos.

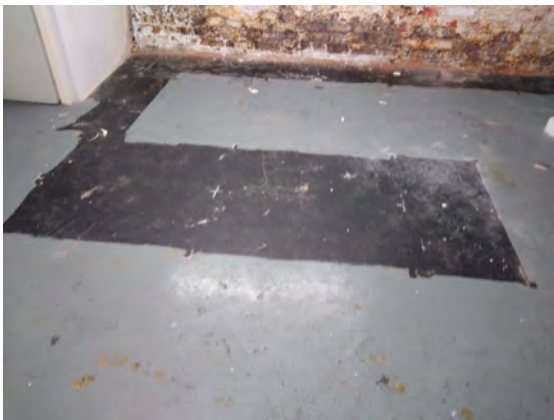
Item 8 Ref: 347395-6

The coating to the floor in the Store (Room -1/003) does not contain asbestos.

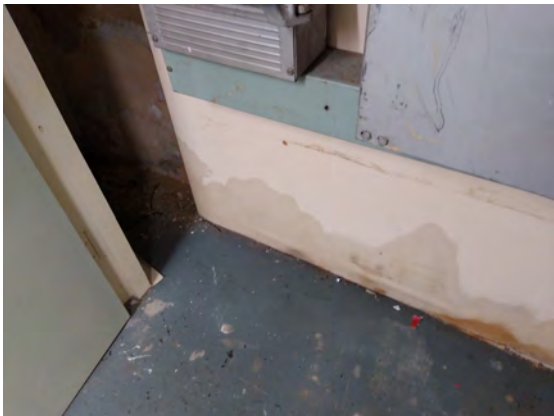
Item 9 Ref: As 347395-6

The coating to the floor in the Store electrics cupboard (Room -1/003a) does not contain asbestos.

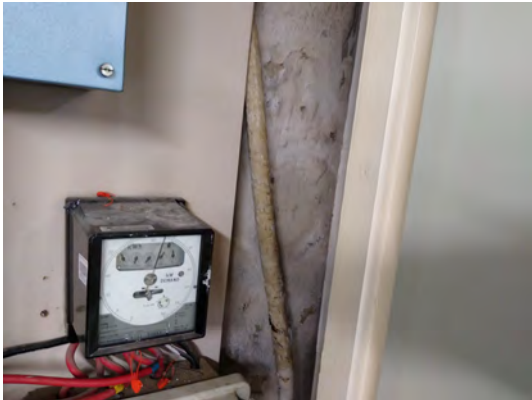
Item 11 Ref: 347395-7

The cable wrap in the electrics cupboard in the Store (Room -1/003a) does not contain asbestos.

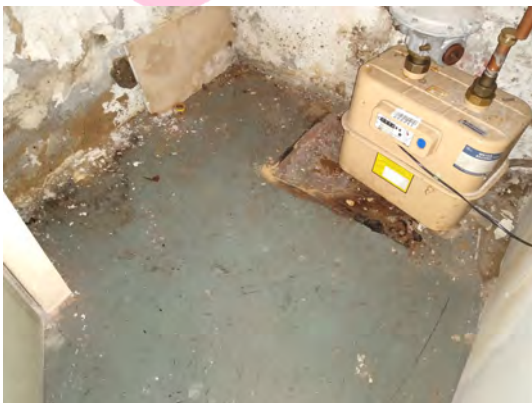
Item 12 Ref: As 347395-6

The floor covering in the Store gas cupboard (Room -1/003b) does not contain asbestos.

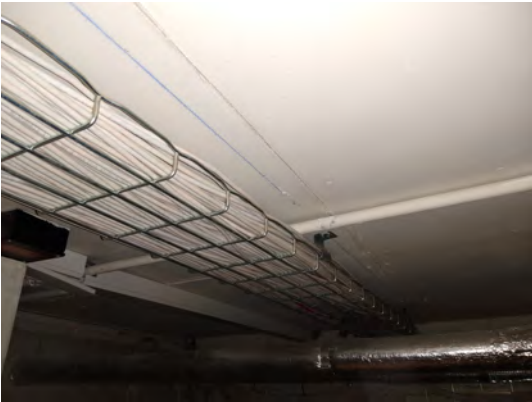
Item 14 Ref: 347395-8

The ceiling in the boiler room (Room -1/005) does not contain asbestos.

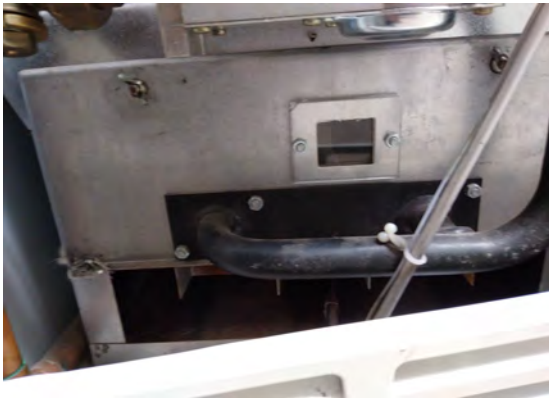
Item 16 Ref: 347395-10

The mastic to pilot light window in the boiler room (Room -1/005) does not contain asbestos.

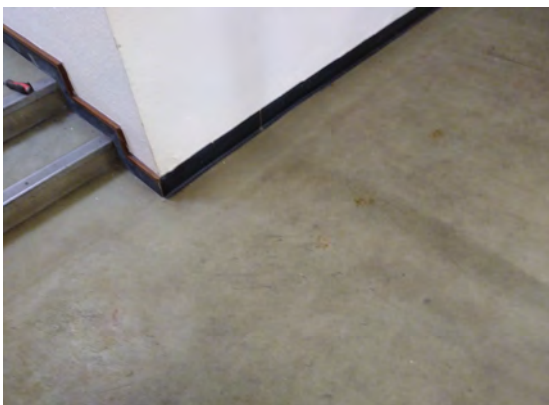
Item 18 Ref: As 347395-2

The floor covering in the corridor (Room -1/006) does not contain asbestos.

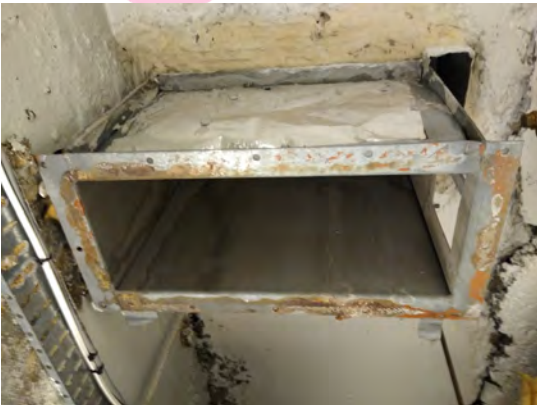
Item 27 Ref: 347395-14

The remnant mastic to redundant ductwork in the lobby and circulation area (Room -1/008) does not contain asbestos.

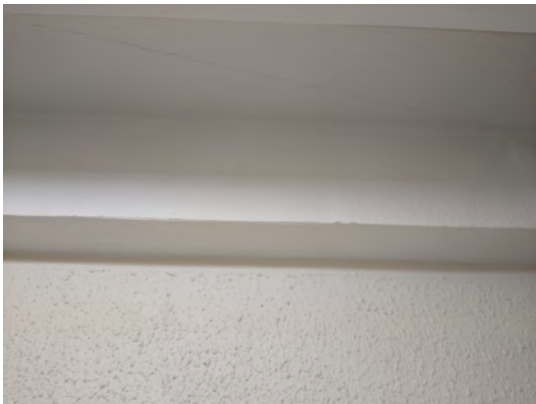
Item 29 Ref: As 347395-13

The high level boxing above sinks in the Female WC (Room -1/010) does not contain asbestos.

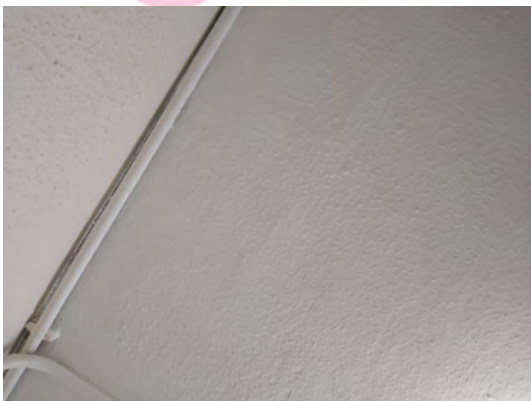
Item 30 Ref: As 347395-12

- (Item 30) **Ref: As 347395-12 – Ceiling coating (Female WC Rm -1/10) – Very Low Risk**
- (Item 31) Ref: 347395-15 – Wall coating (Female WC Rm -1/10) – No Risk

The ceiling coating in the female WC (Room -1/010) does contain asbestos.

Any change in appearance should be reported to Property Services.

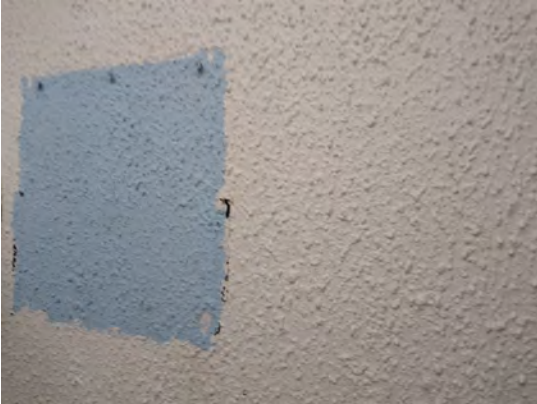
Item 31 Ref: 347395-15

The wall coating in the female Wc (Room -1/010) does not contain asbestos.

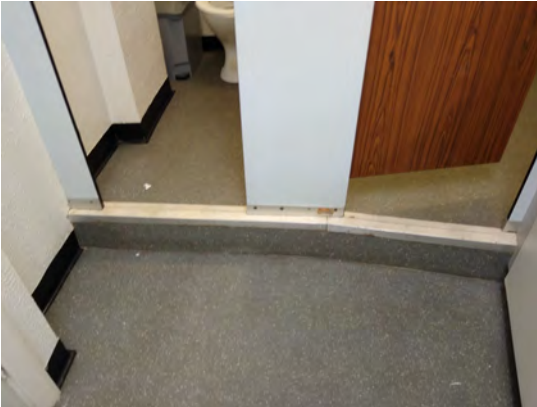
Item 32 Ref: 347395-16

The stair nosing in the Female WC (Room -1/010) does not contain asbestos.

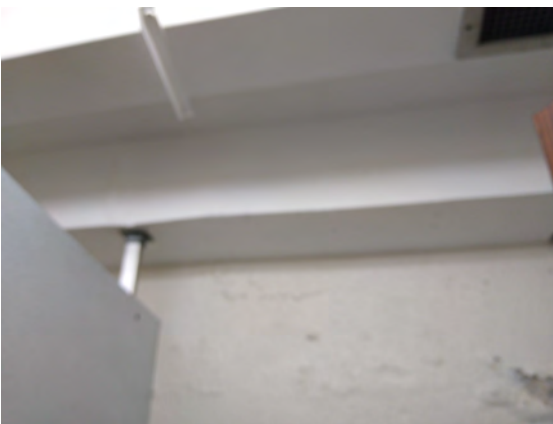
Item 33 Ref: As 347395-13

The high level boxing above wc in the male wc (Room -1/011) does not contain asbestos.

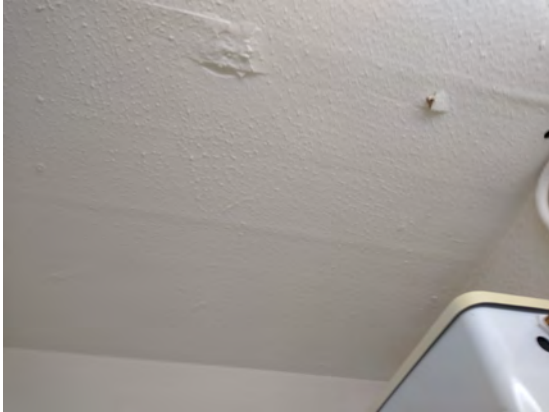
Item 34 Ref: As 347395-12

- (Item 32) Ref: 347395-16 – Stair nosing (Female WC Rm -1/10) – No Risk
- (Item 33) Ref: As 347395-13 – High level boxing (Male WC Rm -1/11) – No Risk
- (Item 34) **Ref: As 347395-12 – Ceiling coating (Male WC Rm -1/11) – Very Low Risk**

The ceiling coating in the male WC (Room -1/011) does contain asbestos.

Any change in appearance should be reported to Property Services.

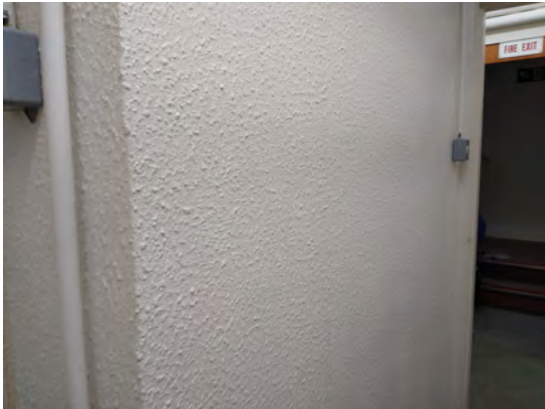
Item 35 Ref: As 347395-15

The wall coating in the male WC (Room -1/011) does not contain asbestos.

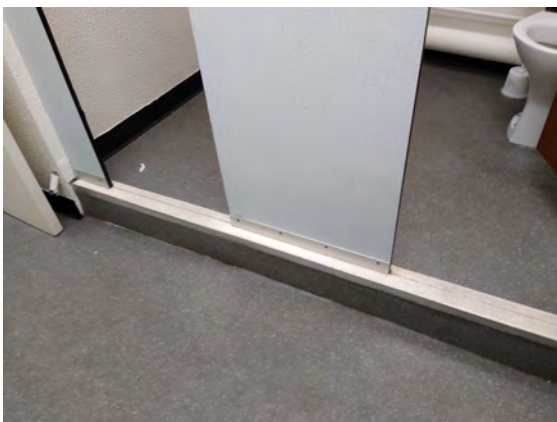
Item 36 Ref: As 347395-16

The stair nosing in the male wc (Room -1/011) does not contain asbestos.

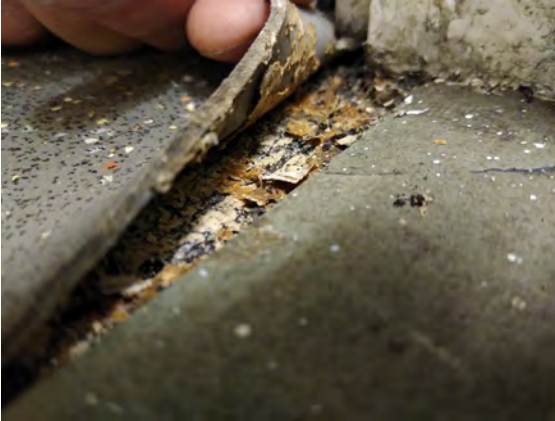
Item 37 Ref: As 347395-6

The adhesive below linoleum in the male wc (Room -1/011) does not contain asbestos.

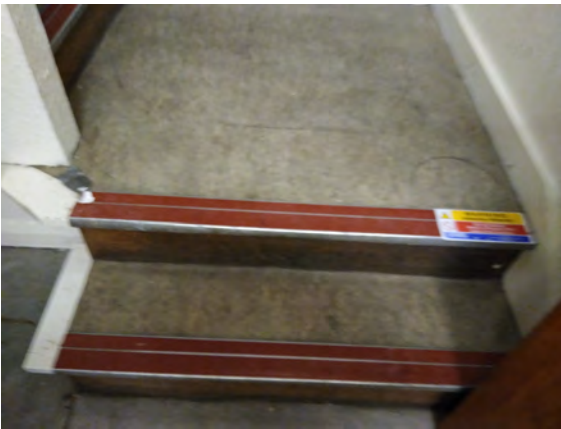
Item 38 Ref: 347395-17

- (Item 38) Ref: 347395-17 – Stair nosing (Stairwell Rm -1/12) – Very Low Risk
- (Item 39) Ref: As 347395-3 – Panel to door reveal (Store Rm -1/14) – No Risk

The stair nosing in the stairwell (Room -1/012) does contain asbestos.

Any change in appearance should be reported to Property Services.

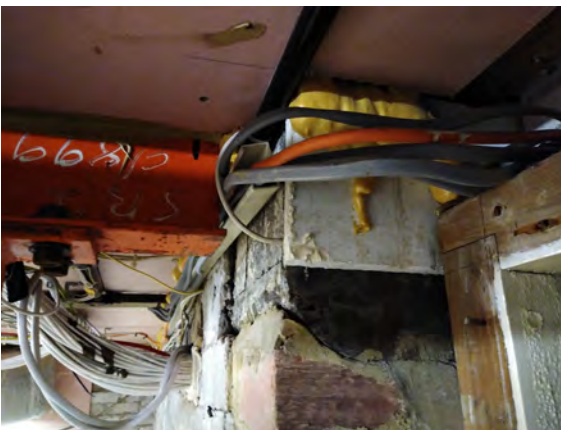
Item 39 Ref: As 347395-3

The panel to the door reveal in the Store (Room -1/014) does not contain asbestos.

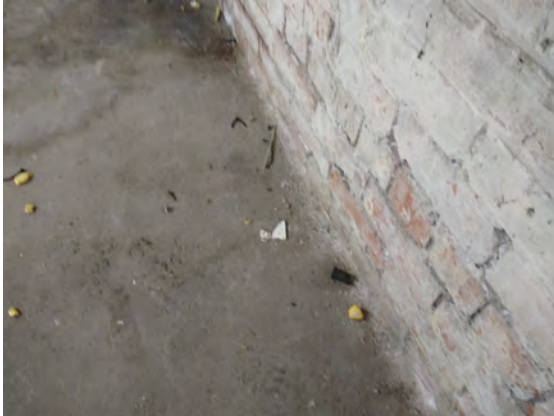
Item 40 Ref: 347395-18

The debris to the floor in the Store (Room -1/014) does not contain asbestos.

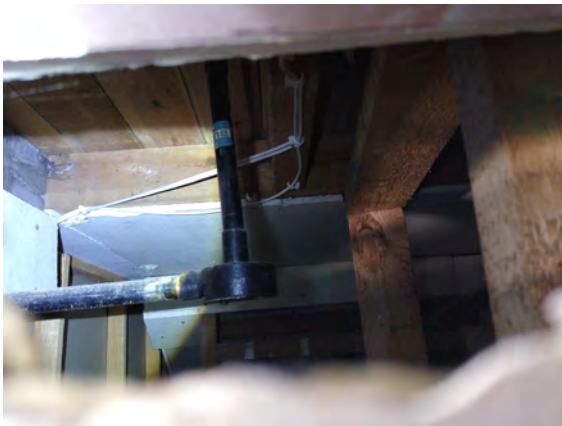
Item 41 Ref: 347395-19

The panels to ceilings and wall and associated debris to the floor in the Store (Void below stairs) (Room -1/014) does not contain asbestos.

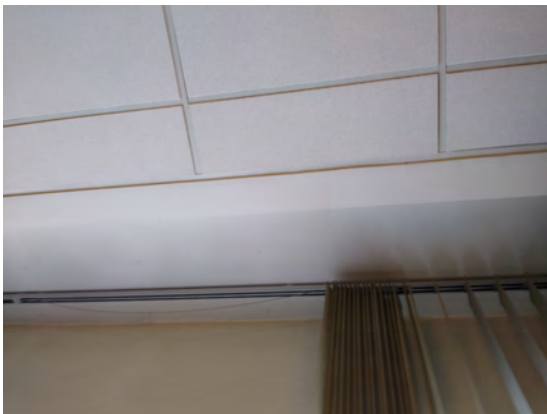
Item 42 Ref: 347395-20

The ceiling above window in the office (Room 0/001) does not contain asbestos.

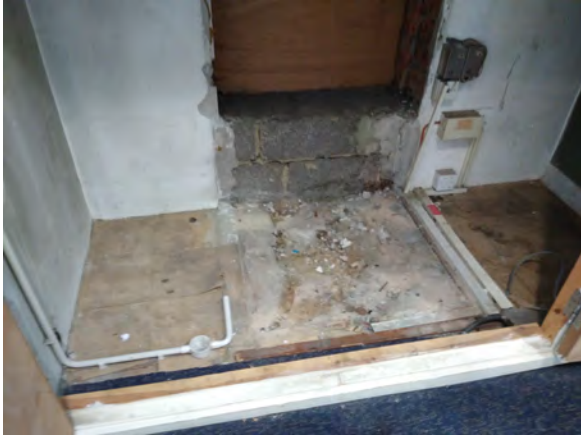
Item 43 Ref: 347395-22

The subfloor covering in the ATM Cupboard (Room 0/002) does not contain asbestos.

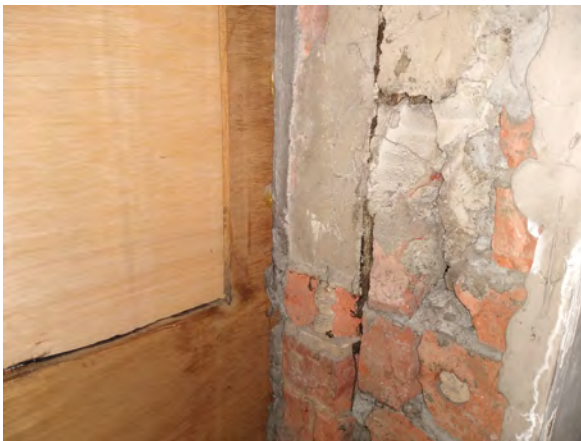
Item 44 Ref: 347395-21

The damp proof membrane in the ATM Cupboards (Room 0/002) does not contain asbestos.

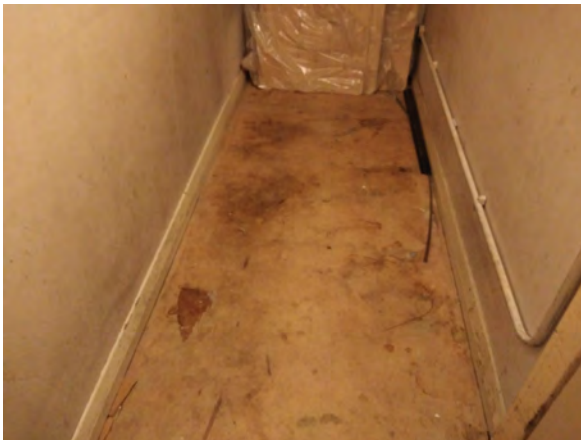
Item 45 Ref: As 347395-22

The floor covering in the store (Room 0/06) does not contain asbestos.

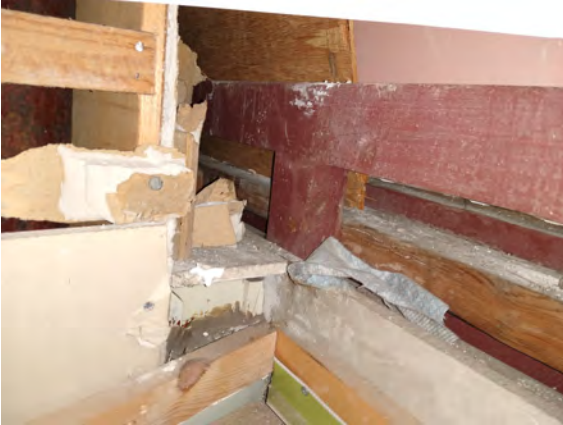
Item 46 Ref: 347395-23

The horizontal panel in from of column near window of the void above cashiers (Room 0/007) does not contain asbestos.

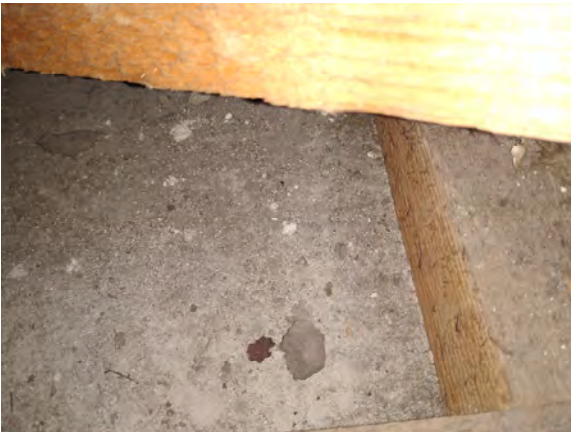
Item 47 Ref: 347395-24

The horizontal panel behind plasterboard fascia near window of the void above cashiers (Room 0/007) does not contain asbestos.

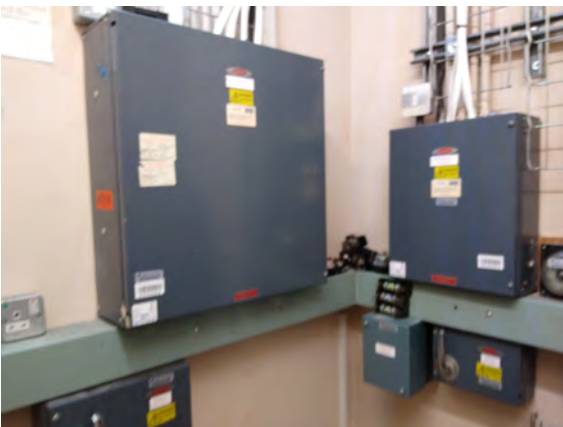
Item 48 Ref: Presumed

The MEM electrics in the electrical switchroom (Room 0/009) are presumed to contain asbestos.

Removed November 2019

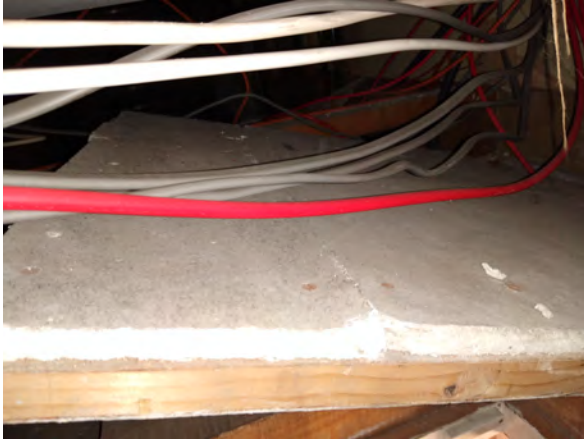
Item 49 Ref: 347395-25

The top side of the loft hatch in the void above the electrical switch room (Room 009) does not contain asbestos.

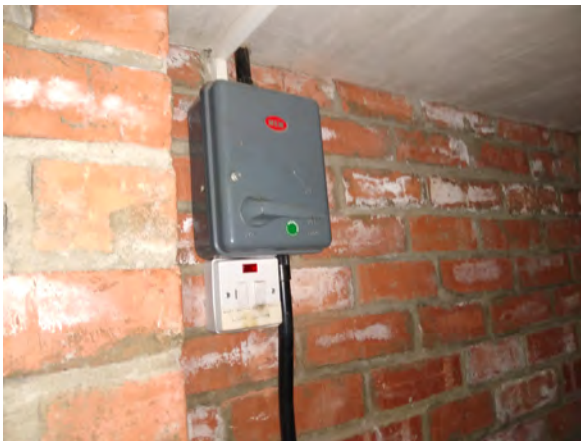
Item 50 Ref: Presumed

The MEM electrics in the lift motor room (Room 0/011) are presumed to contain asbestos.

Removed November 2019

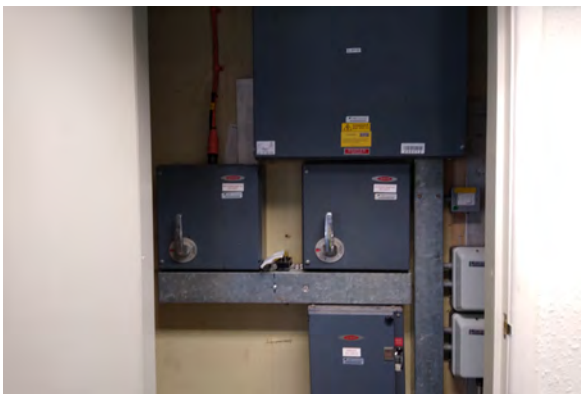
Item 51 Ref: Presumed

The MEM electrics in the office electrics cupboard (Room 1/001) are presumed to contain asbestos.

Removed November 2019

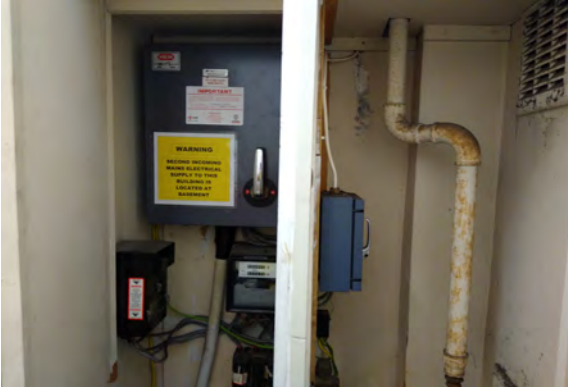
Item 52 Ref: Presumed

The electrics in the landing/stairwell electrics cupboard (Room 1/007) are presumed to contain asbestos.

Removed November 2019

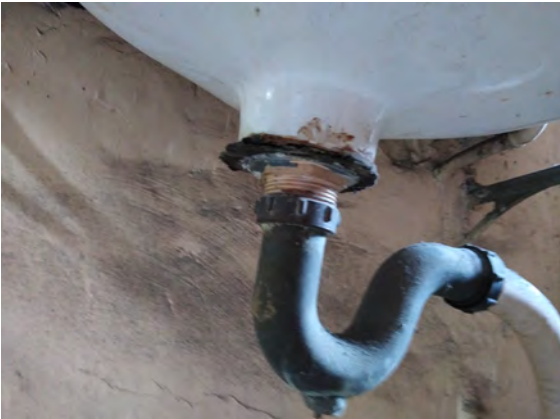
Item 53 Ref: 347395-26

The gasket to the sink in the disused toilet (Room 1/010) contains asbestos.

Removed November 2019

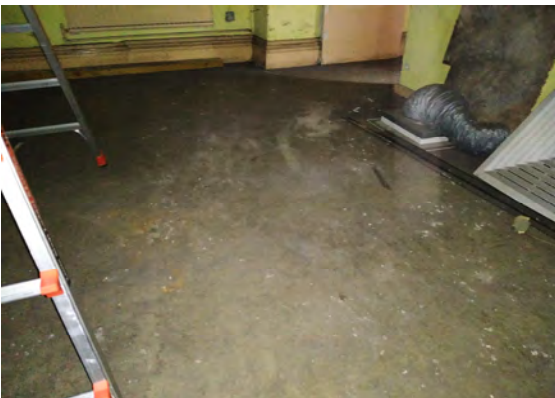
Item 54 Ref: 347395-27

The floor covering in the store (Room 2/002) does not contain asbestos.

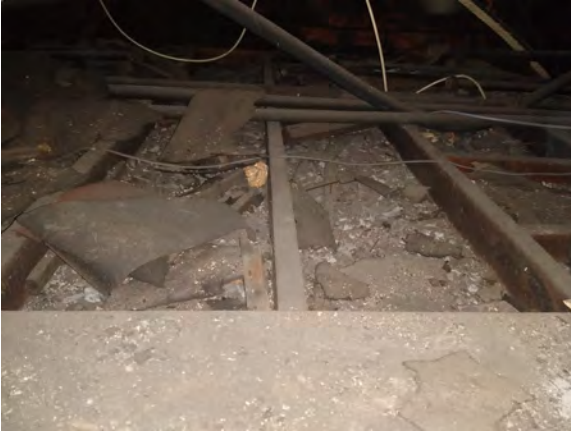
Item 55 Ref: 347395-28

The loose lying felt in the void above the store (Room 2/002) does not contain asbestos.

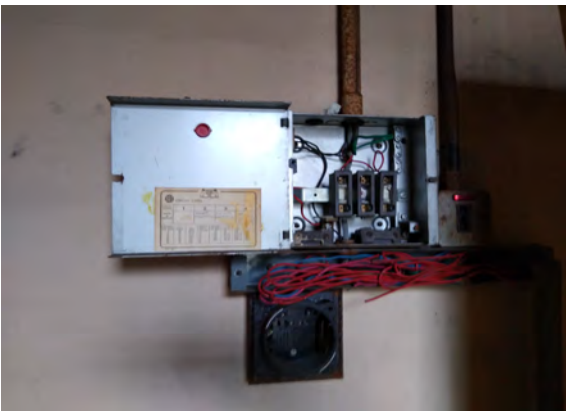
Item 56 Ref: 347395-29

The flashguards to Bill electrics (Room 2/004) contains asbestos.

Removed November 2019

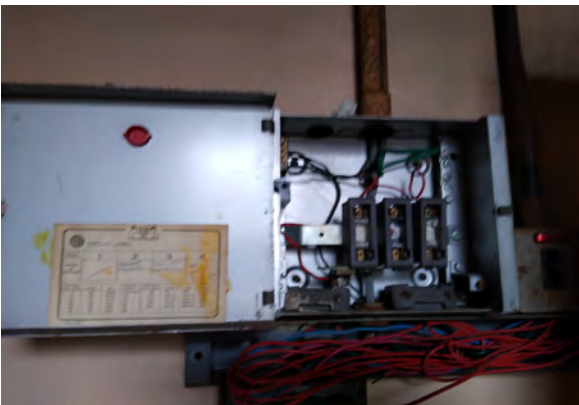
Item 57 Ref: 347395-30

The screw cap putty to Bill electrics (Room 2/004) contains asbestos.

Removed November 2019

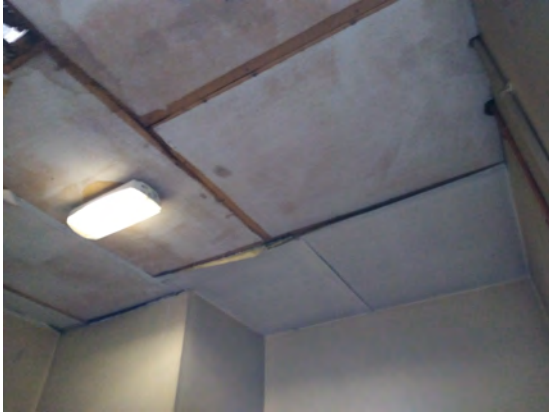
Item 58 Ref: 347395-31

The ceiling panels in the lobby and stairwell (Room 2/005) does not contain asbestos.

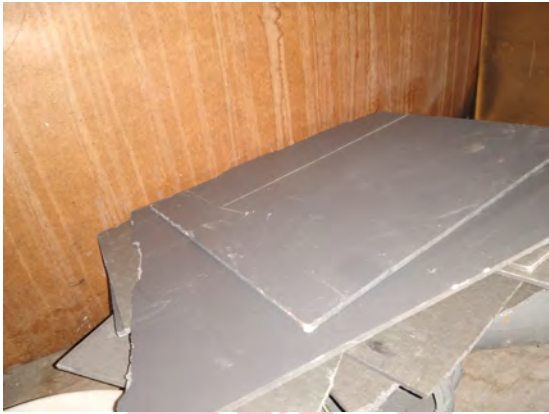
Item 59 Ref: 347395-32

The loose lying simulated slate tiles in the cupboards in the lobby and stairwell (Room 2/005) does not contain asbestos.

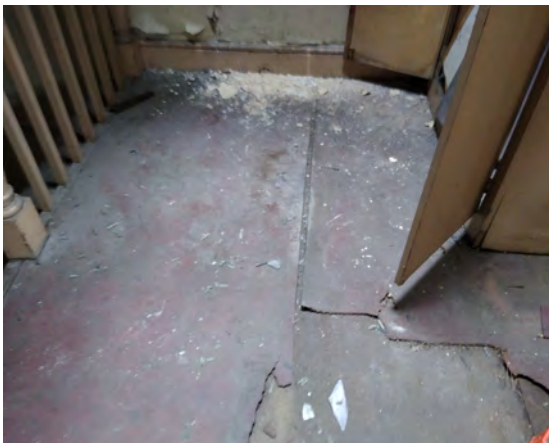
Item 60 Ref: 347395-33

The floor covering in the cupboards in the lobby and stairwell (Room 2/005) does not contain asbestos.

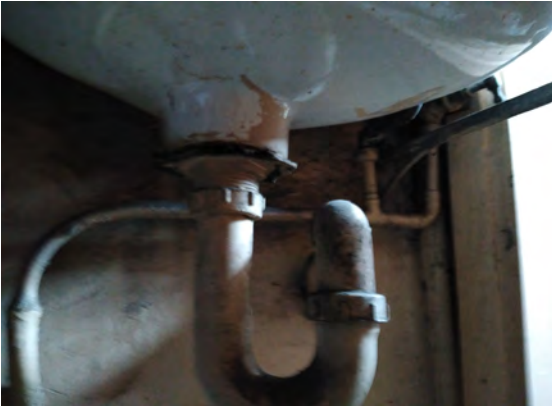
Item 62 Ref: As 347395-26

The gasket to sink in the disused toilet (Room 2/007) does contain asbestos.

Any change in appearance should be reported to Property Services.

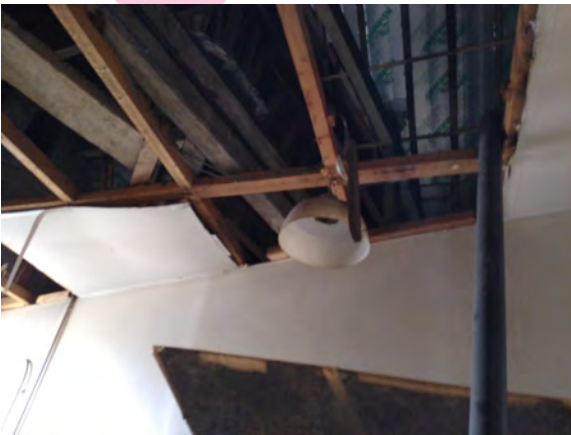
Item 63 Ref: As 347395-31

The ceiling and associated debris in the store (Room 2/008) does not contain asbestos.

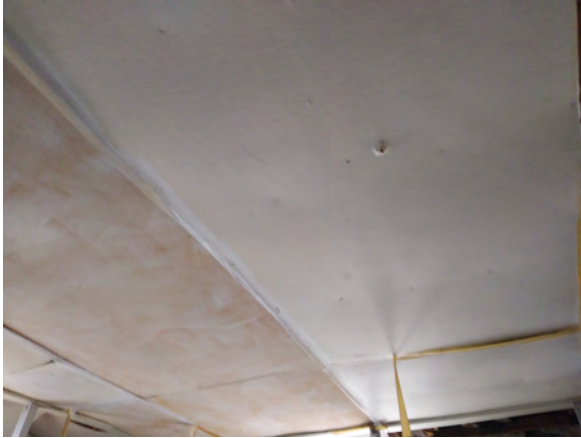
Item 64 Ref: As 347395-31

The ceiling and associated debris in the store (Room 2/009) does not contain asbestos.

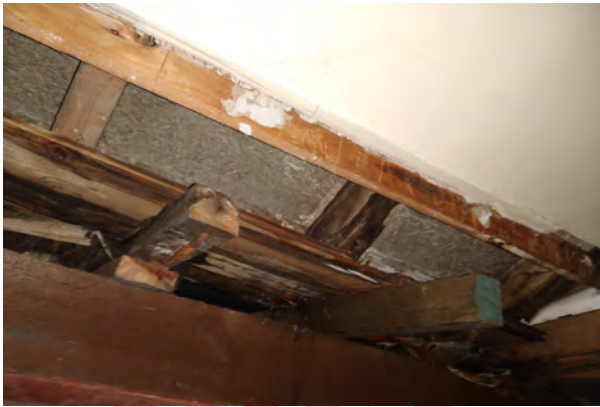
Item 65 Ref: 347395-34

The underside of roof in the store (Room 2/010) does not contain asbestos.

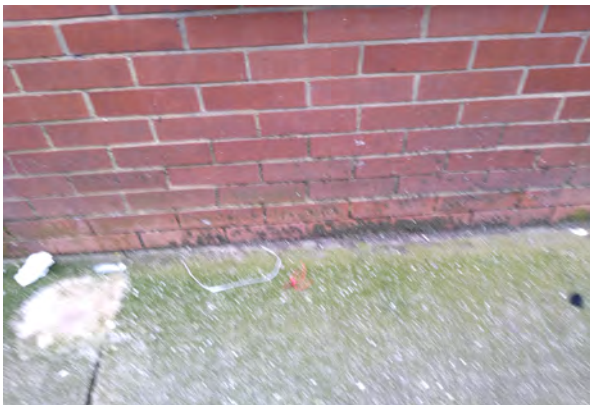
Item 66 Ref: 347395-35

The damp proof course to the rear (External) does not contain asbestos.

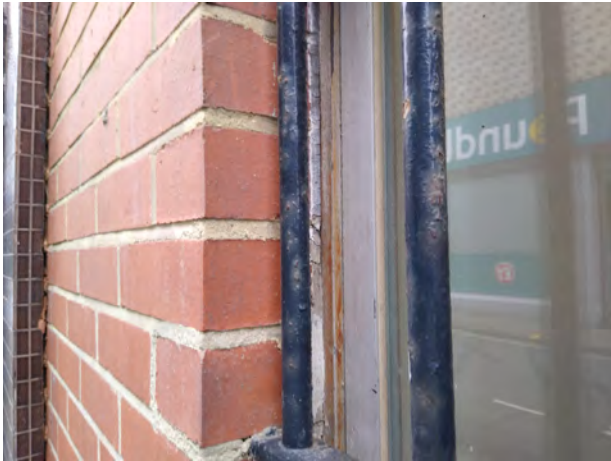
Item 67 Ref: 347395-36

The mastic to low level windows (External) contains asbestos.

Removed November 2019

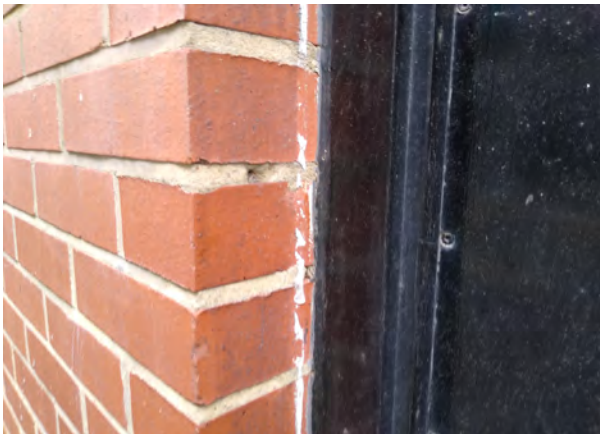
Item 68 Ref: 347395-37

The remnant mastic to rear door (External) does not contain asbestos.

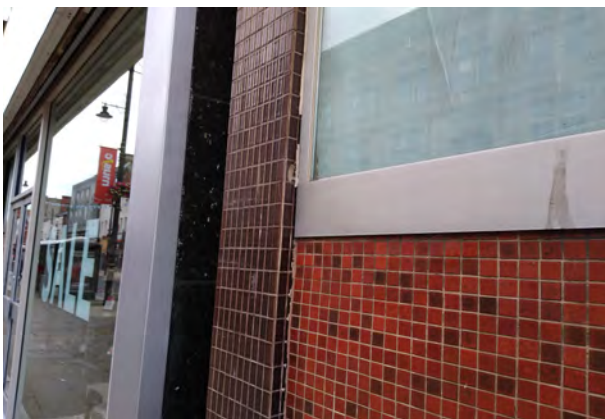
Item 69 Ref: As 347395-37

The remnant mastic to LHS edge of building and ceramic area low level (External) does not contain asbestos.

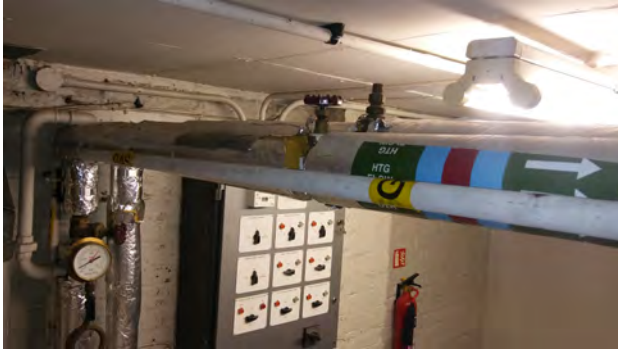
Item 70 Ref: 349273-1

The debris to pipework below pipe lagging (Boiler room Rm 1/05) does not contain asbestos.

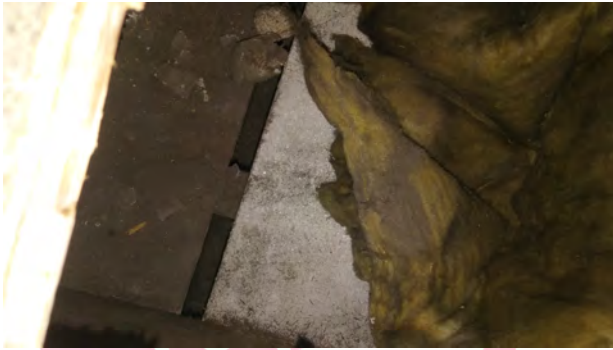
Item 71 Ref: As 349273-2

The topside of ceiling below (Public area-floor void Rm 0/03) does not contain asbestos.

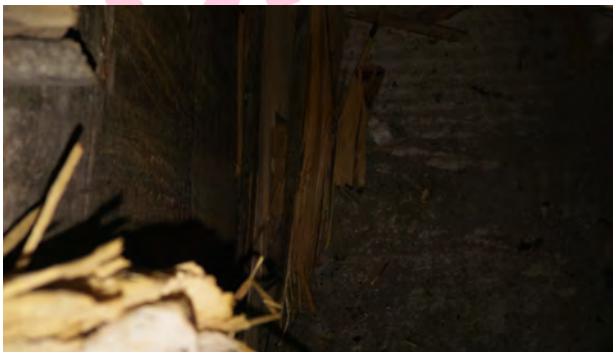
Item 72 Ref: As 349273-2

The topside of ceiling below entrance (Back office-floor void Rm 0/05) does not contain asbestos.

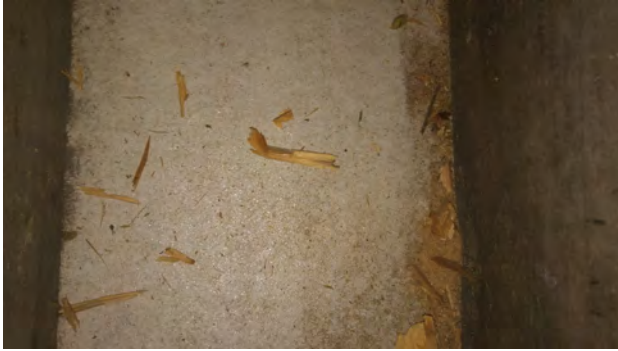
Item 73 Ref: 349273-2

The topside of ceiling below (Cashiers-floor void Rm 0/07) does not contain asbestos.

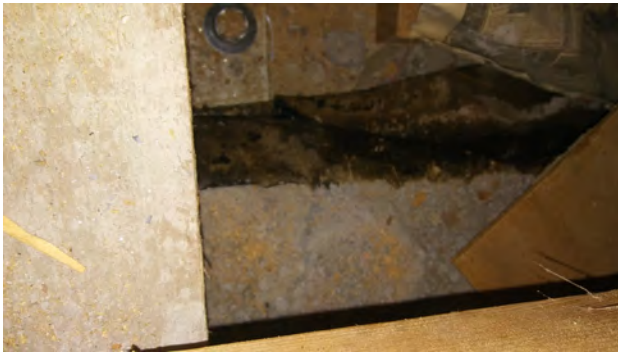
Item 74 Ref: 349273-3

The membrane to concentrate wall (Cashiers-floor void Rm 0/07) does not contain asbestos.

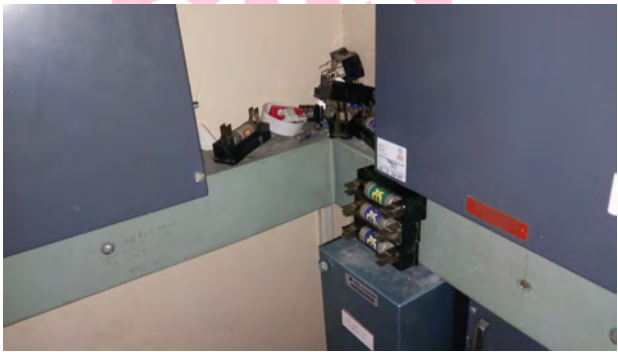
Item 75 Ref: Presumed

The fuse end caps (Electrical switchroom Rm 0/09) are presumed to contain asbestos.

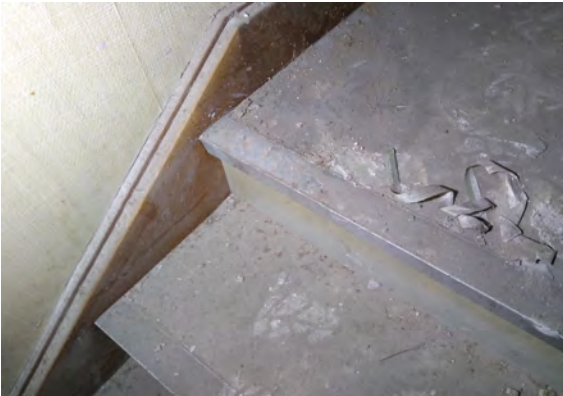
Item 77 Ref: 349273-5

The stair nosing (Redundant Stairwell Rm 0/09a) does not contain asbestos.

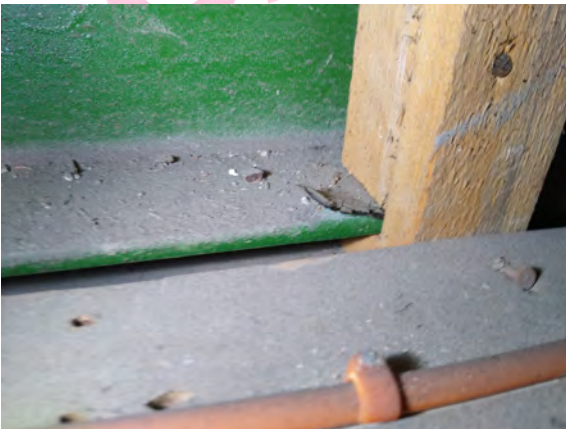
Item 78 Ref: 349273-6

The packer (Redundant Stairwell Rm 0/09a) contains asbestos.

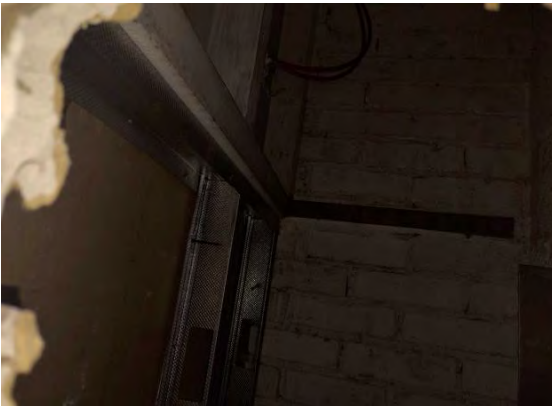
Item 82 Ref: 21-39587-4

The internal wall – plasterboard (Area 2/ Cupboard) does not contain asbestos.

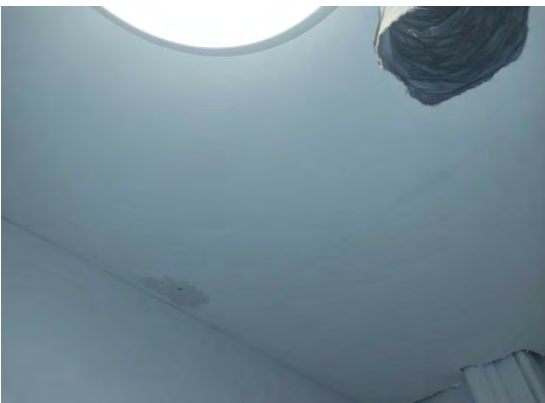
Item 83 Ref: 21-39587-5

The ceiling - plasterboard (Area 3/First Floor WC) does not contain asbestos.

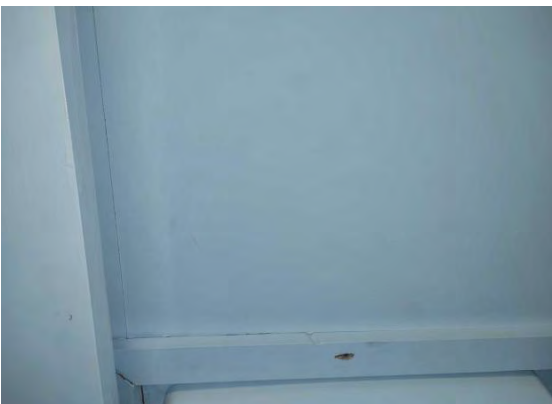
Item 84 Ref: 21-39587-6

The walls - wood (Area 3/First Floor WC) do not contain asbestos.

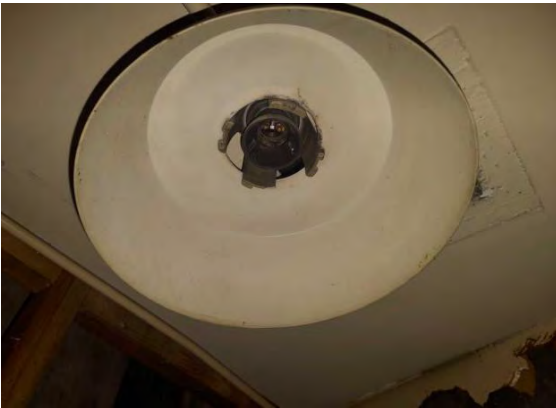
Item 85 Ref: 21-39587-7

The ceiling – plasterboard (Area 4/Second Floor WC) does not contain asbestos.

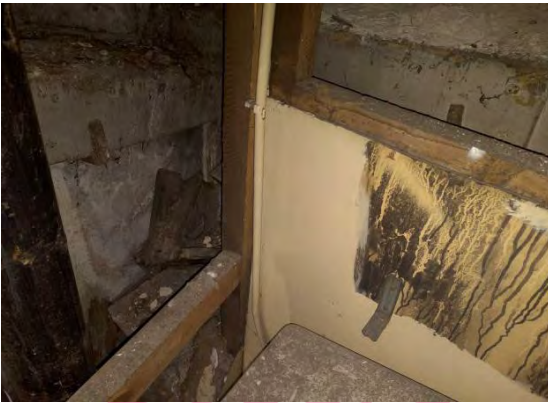
Item 86 Ref: 21-39587-8

The walls – wood (Area 4/Second Floor WC) do not contain asbestos.

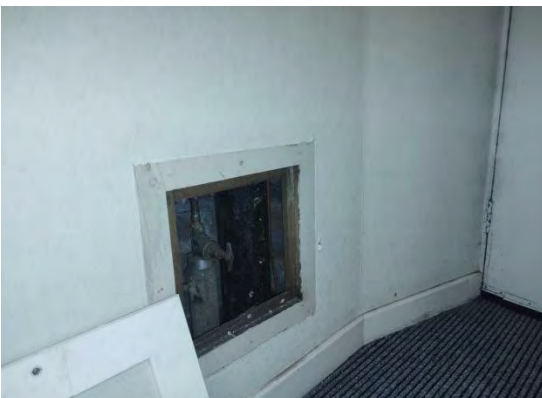
Item 87 Ref: 21-39587-10

The walls – wood adjacent to soil pipe (Area 5/Lobby Adjacent to Emergency Exit) do not contain asbestos.
