ASBESTOS SURVEY REPORT FOR 7 COLOMBO ROAD, HYLTON CASTLE, SUNDERLAND

Asbestos Register for

7 COLOMBO ROAD, HYLTON CASTLE, SUNDERLAND

Date: 06 March 2025

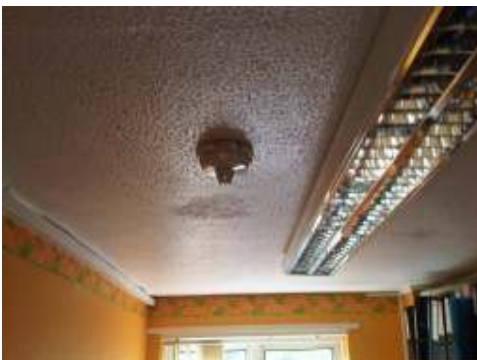
Item 3 - Ref: NO10/8047

The textured coating to the office (Room 7) contains asbestos.

Removed June 2024

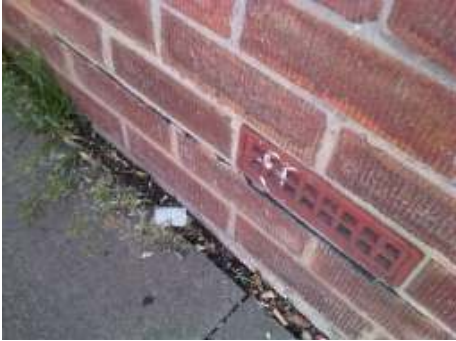
Item 8 - Ref: NO10/8048

The damp proof course to the external of the building does not contain asbestos.

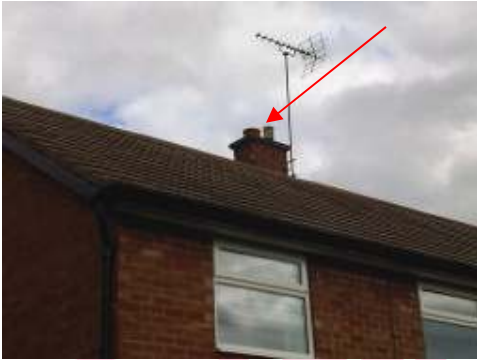
Item 9- Ref: Presumed

Presumed – Cowl to roof (External) (Item 9) Very Low Risk

The cement cowl to the chimney on the roof is strongly presumed to contain asbestos.

Any change in its appearance should be recorded and passed to Property Services.

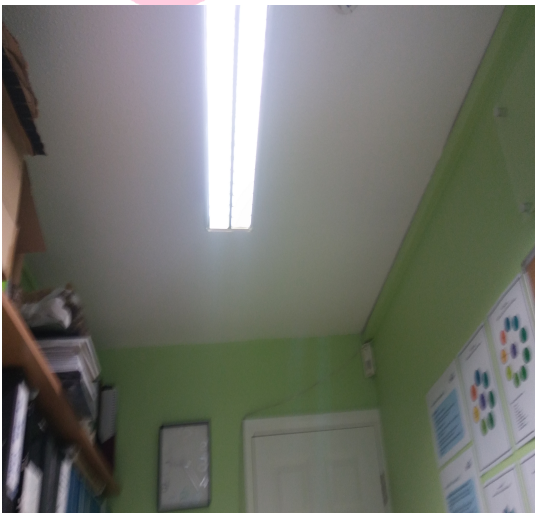
Item 10 - Ref: Presumed

Presumed – Textured coating to Walls (Back Office) (Item 10) Very low Risk

The textured coating to the walls in the back Store area is strongly presumed to contain asbestos.

Any change in its appearance should be recorded and passed to Property Services.

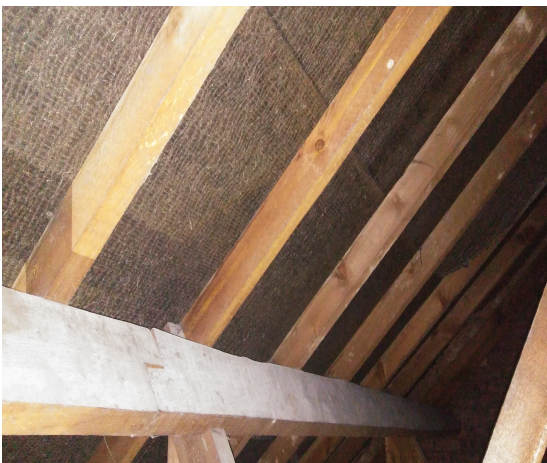
Item 13 - Ref: 275133-1

The sarking in the loft does not contain asbestos.

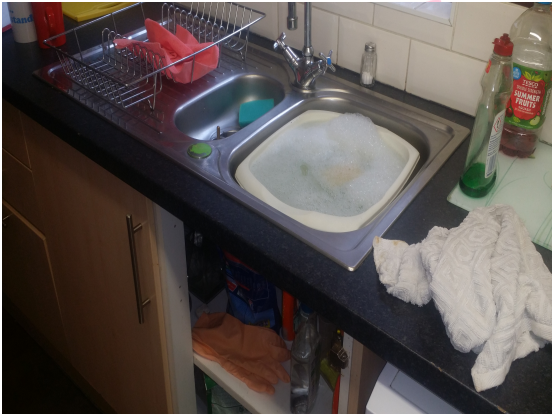
Item 15 - Ref: 315571-2

The sink pad in the kitchen does not contain asbestos.

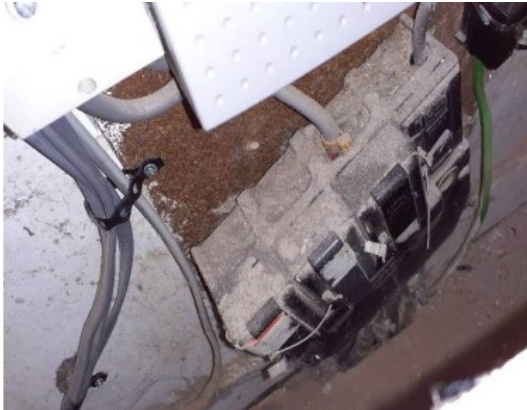
Item 20 - Presumed

Presumed – Flashguards within electrics (Electric cupboard G/003) (Item 20) – Low Risk

The flashguards within electrics in the electric cupboard (Room G/03) are presumed to contain asbestos.

Any change in appearance should be recorded and passed to Property Services.

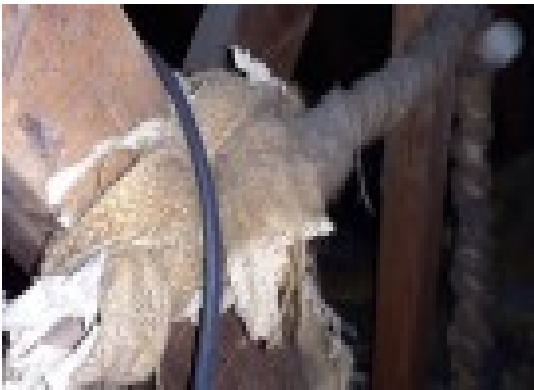
Item 21 - Ref: OB001299

The paper lining to hessian insulated pipework in the Loft (room R/001) does not contain asbestos.
