ASBESTOS SURVEY REPORT FOR 7 COLOMBO ROAD, HYLTON CASTLE, SUNDERLAND

Asbestos Register for

7 COLOMBO ROAD, HYLTON CASTLE, SUNDERLAND

Date: 03 March 2026

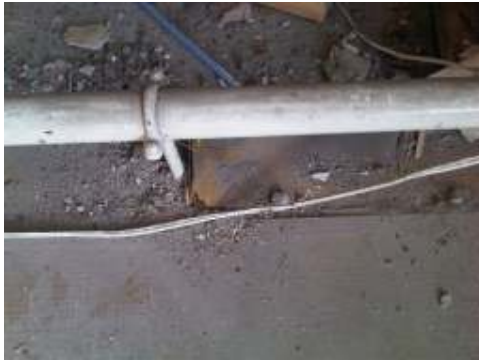
Item 1 Ref: NO10/

The flooring to the lounge (Room 1) does not contain asbestos.

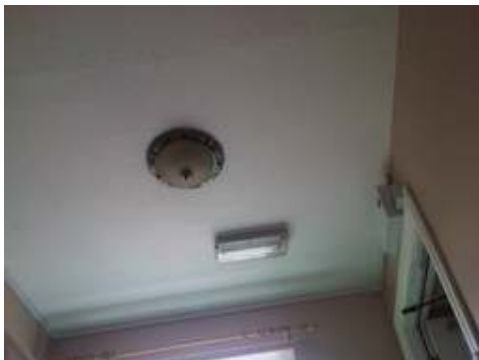
Various - Ref: NO10/8046

As NO10/8046 – Textured coating to ceiling (Room 12 WC) (Item 4) Very Low Risk

As NO10/8046 – Textured coating to ceiling (Room 15 Shower) (Item 7) Very Low Risk

The textured coating to the ceiling of the stairs /landing/cupboards (Area 5) contains asbestos.

Rooms 5, 13 & 14 removed June 2024

Similar textured coating is located on the ceilings to rooms 12, 13, 14 and 15.

Any change in its appearance should be recorded and passed to Property Services.

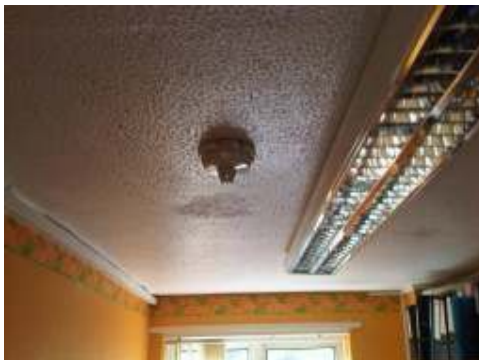
Item 3 - Ref: NO10/8047

The textured coating to the office (Room 7) contains asbestos.

Removed June 2024

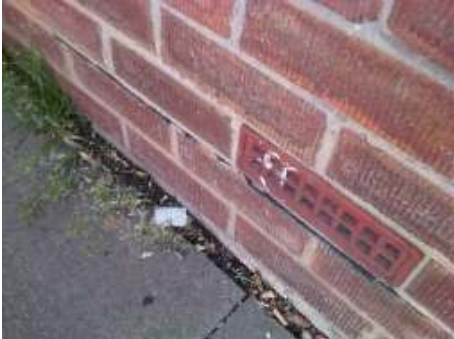
Item 8 - Ref: NO10/8048

The damp proof course to the external of the building does not contain asbestos.

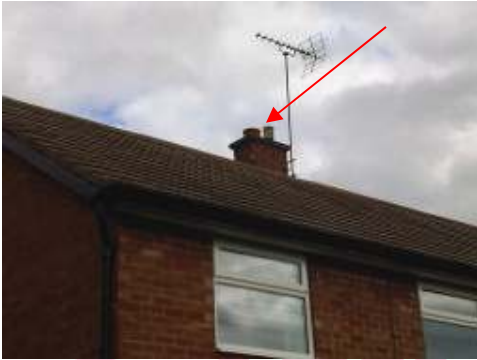
Item 9- Ref: Presumed

Presumed – Cowl to roof (External) (Item 9) Very Low Risk

The cement cowl to the chimney on the roof is strongly presumed to contain asbestos.

Any change in its appearance should be recorded and passed to Property Services.

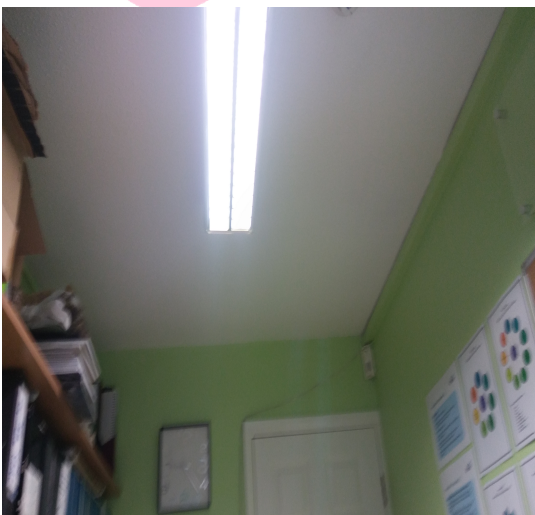
Item 10 - Ref: Presumed

Presumed – Textured coating to Walls (Back Office) (Item 10) Very low Risk

The textured coating to the walls in the back Store area is strongly presumed to contain asbestos.

Any change in its appearance should be recorded and passed to Property Services.

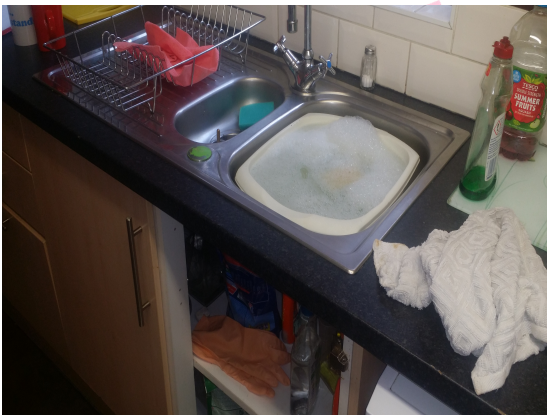
Item 15 - Ref: 315571-2

The sink pad in the kitchen does not contain asbestos.

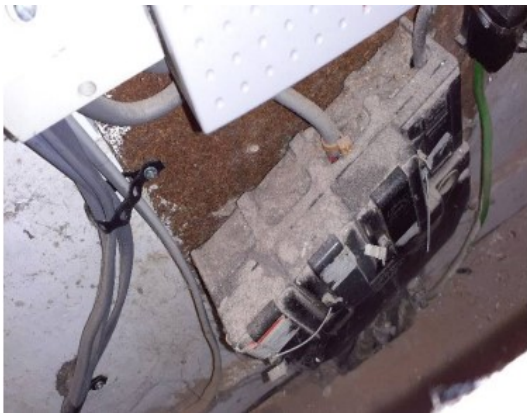
Item 20 - Presumed

Presumed – Flashguards within electrics (Electric cupboard G/003) (Item 20) – Low Risk

The flashguards within electrics in the electric cupboard (Room G/03) are presumed to contain asbestos.

Any change in appearance should be recorded and passed to Property Services.
