ASBESTOS SURVEY REPORT FOR FORMER AWARDS CENTRE
HAVELOCK TOWERS, 270A HYLTON ROAD, SUNDERLAND, SR4 7XJ

**Asbestos Register for
Havelock Towers, 27a Hylton Road,
Sunderland, SR4 7XJ**

Date: 16 November 2022

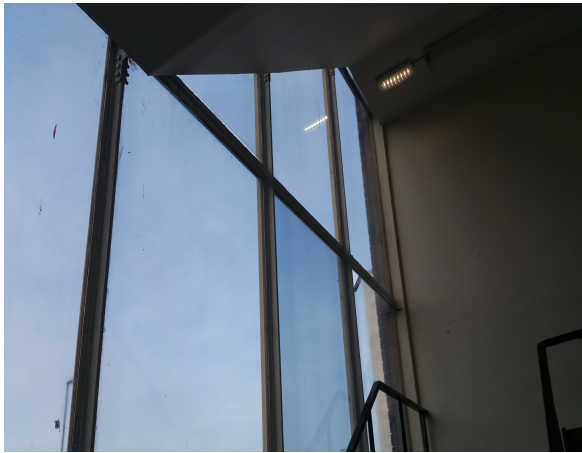
Item 1 Ref: 149012-1

The sealant to windows in the stairwell lobby (Rm 0/02) does not contain asbestos.

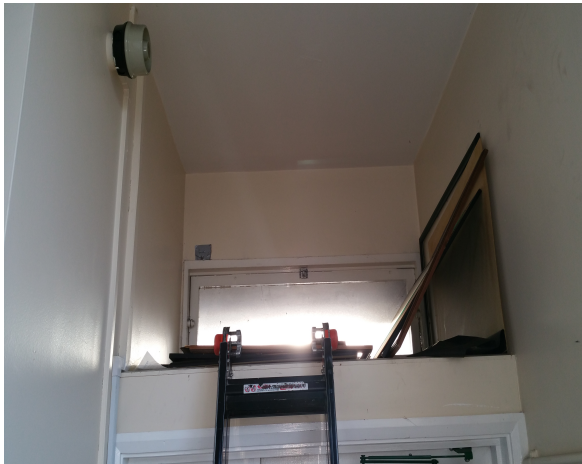
Item 2 Ref: 149012-2

The panel above the door in the stairwell lobby (Rm 0/02) does not contain asbestos.

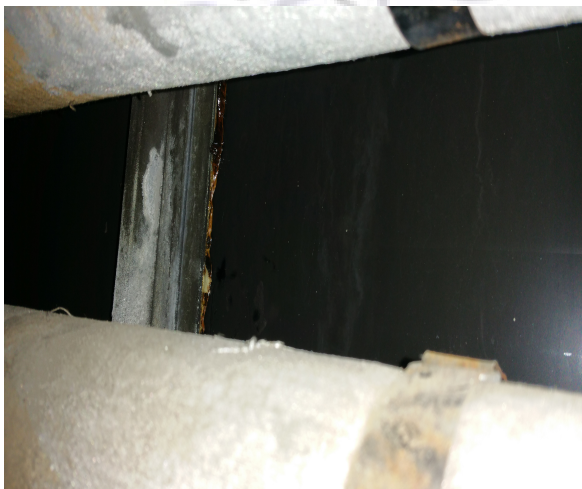
Item 3 Ref: 149012-3

The sealant to the windows behind pipework in the staff room ceiling void (Rm 0/04) does not contain asbestos.

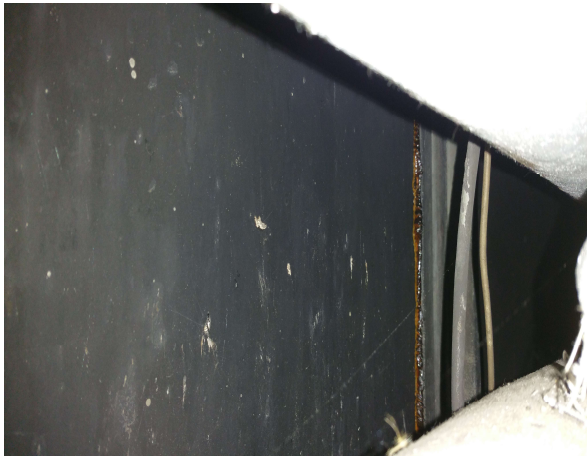
Item 4 Ref: As 149012-3

The sealant to the windows behind pipework in the classroom ceiling void (Rm 0/05) does not contain asbestos.

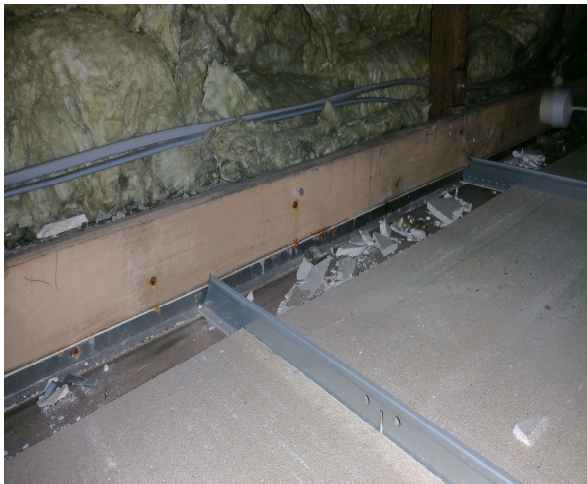
Item 5 Ref: 149012-4

The debris to top of ceiling tiles adjacent to windows in the classroom ceiling void (Rm 0/05) does not contain asbestos.

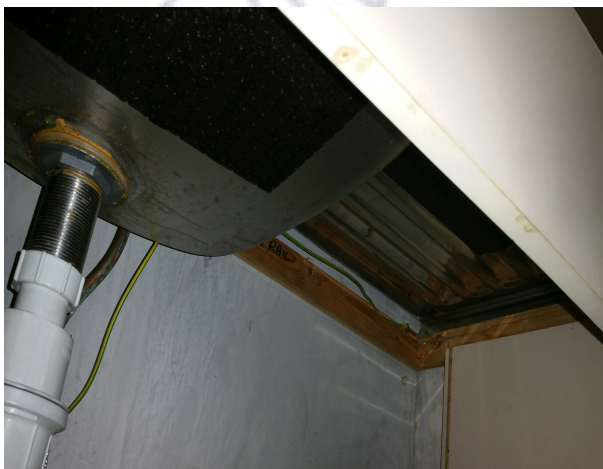
Item 6 Ref: 149012-5

The sink pad in the staff room kitchen (Rm 0/06) does not contain asbestos.

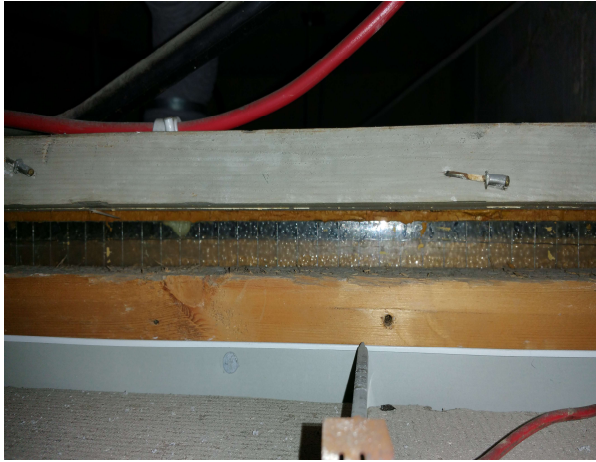
Item 7 Ref: 149012-6

The sealant to windows in the corridor ceiling void (Rm 0/07) does not contain asbestos.

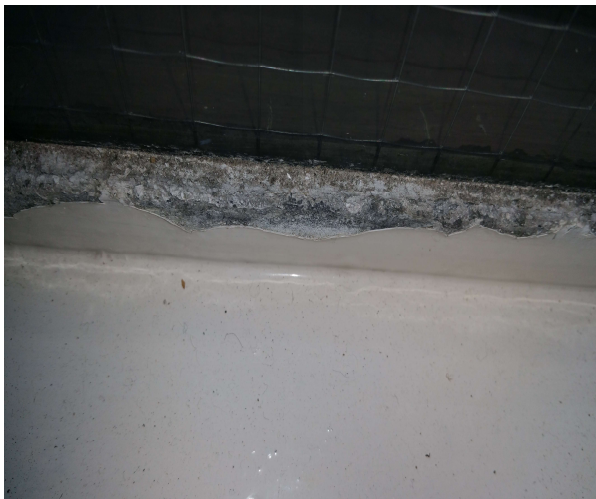
Item 8 Ref: As 149012-1

The sealant to windows in the female WC (Rm 0/10) does not contain asbestos.

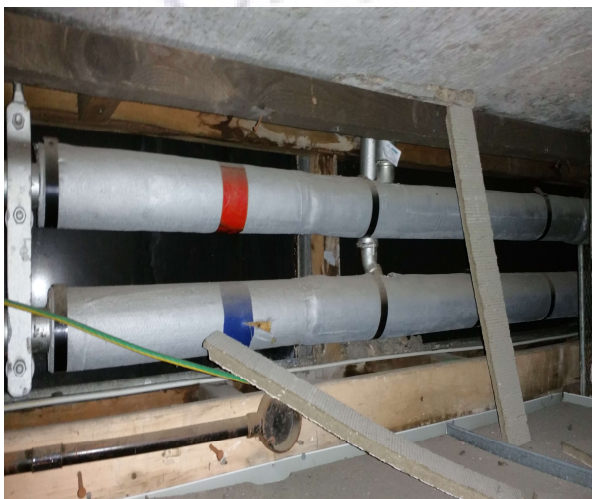
Item 9 Ref: As 149012-3

The sealant to windows behind the pipework in the female WC ceiling void (Rm 0/10) does not contain asbestos.

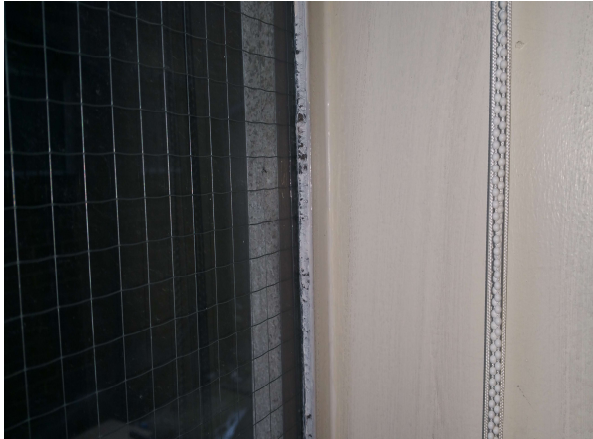
Item 10 Ref: As 149012-1

The sealant to windows in the office (Rm 0/11) does not contain asbestos.

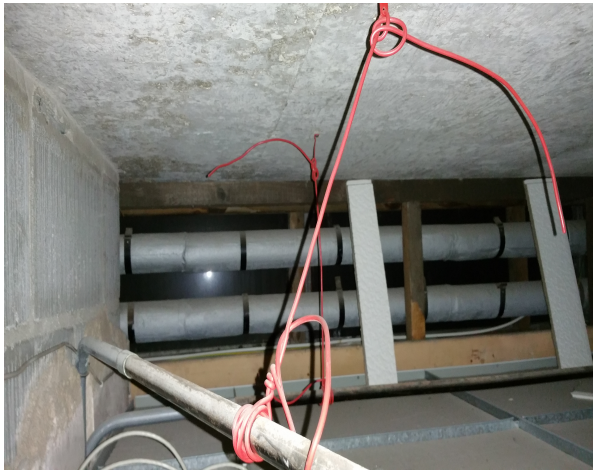
Item 11 Ref: As 149012-3

The sealant to windows behind the pipework in the office ceiling void (Rm 0/11) does not contain asbestos.

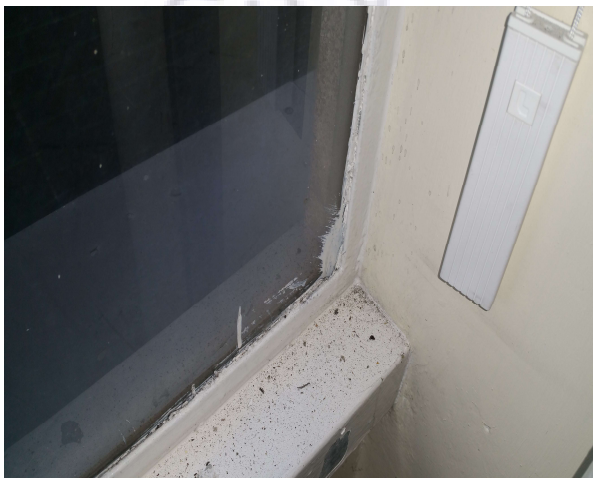
Item 12 Ref: As 149012-1

The sealant to windows in the office (Rm 0/12) does not contain asbestos.

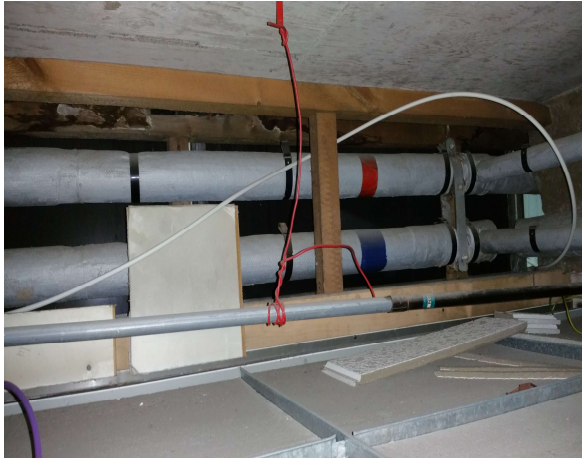
Item 13 Ref: As 149012-3

The sealant to windows behind the pipework in the office ceiling void (Rm 0/12) does not contain asbestos.

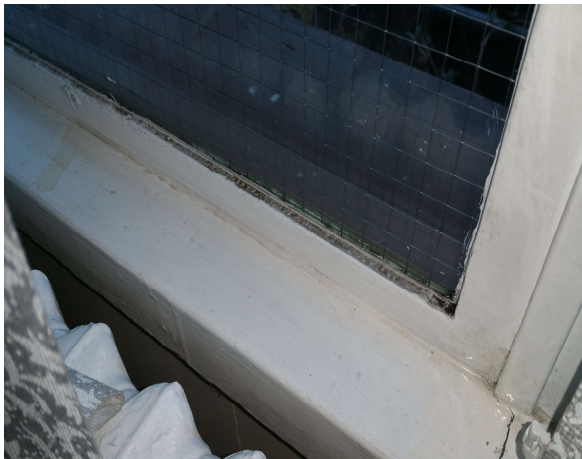
Item 14 Ref: As 149012-1

The sealant to windows in the classroom (Rm 0/13) does not contain asbestos.

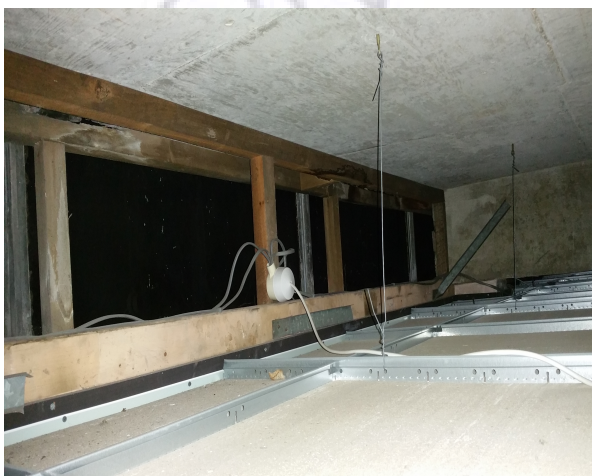
Item 15 Ref: As 149012-3

The sealant to windows in the classroom ceiling void (Rm 0/13) does not contain asbestos.

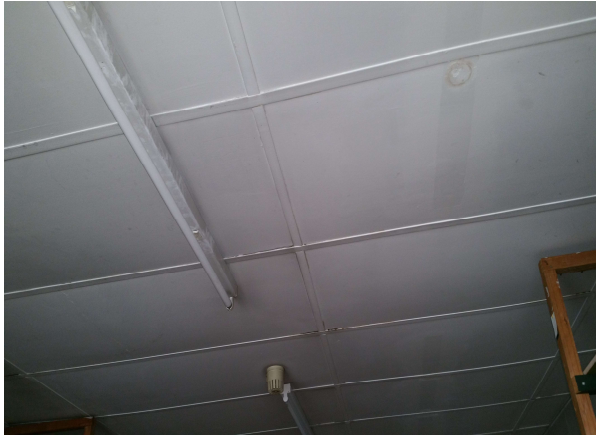
Item 16 Ref: 149012-7

The suspended ceiling in the stock room (Rm 0/15) does not contain asbestos.

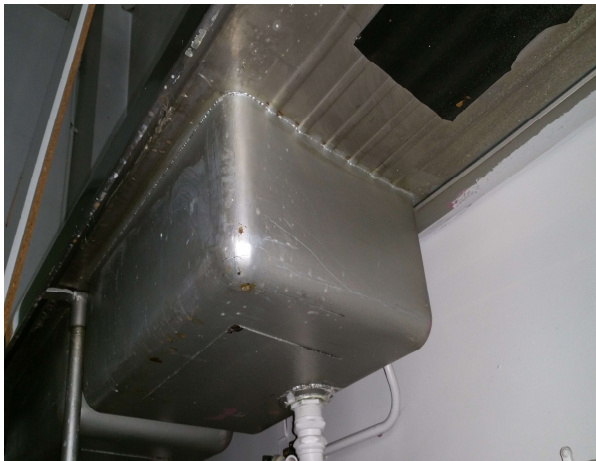
Item 17 Ref: 149012-8

- (Item 15) Ref: As 149012-3 – Sealant to windows (Room 013) – No Risk
- (Item 16) Ref: 149012-7 – Suspended ceiling (Room 015) – No Risk
- (Item 17) Ref: 149012-8 – Sink pad (Room 015) – Very Low Risk

The sink pad in the stock room (Rm 0/15) contains asbestos.

Any change in its appearance should be recorded and passed to Property Services.

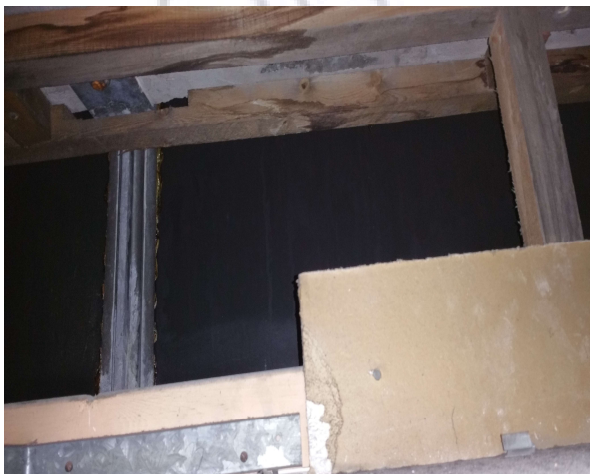
Item 18 Ref: As 149012-3

The sealant to windows in the stock room ceiling void (Rm 0/15) does not contain asbestos.

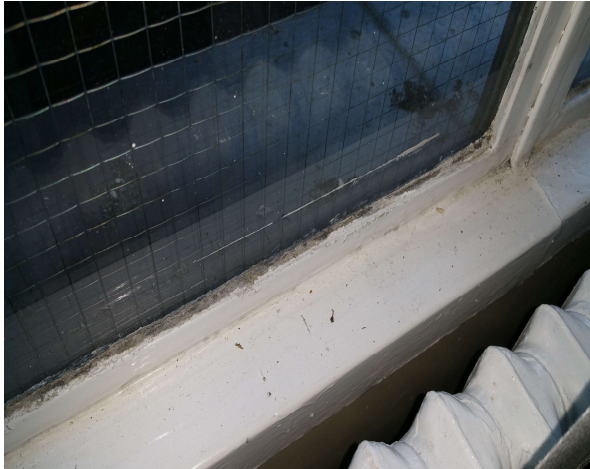
Item 19 Ref: As 149012-1

The sealant to windows in the office (Rm 0/16) does not contain asbestos.

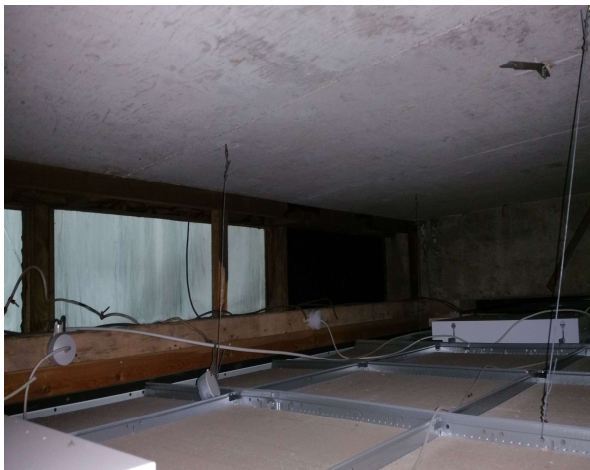
Item 20 Ref: As 149012-3

The sealant to windows in the office ceiling void (Rm 0/16) does not contain asbestos.

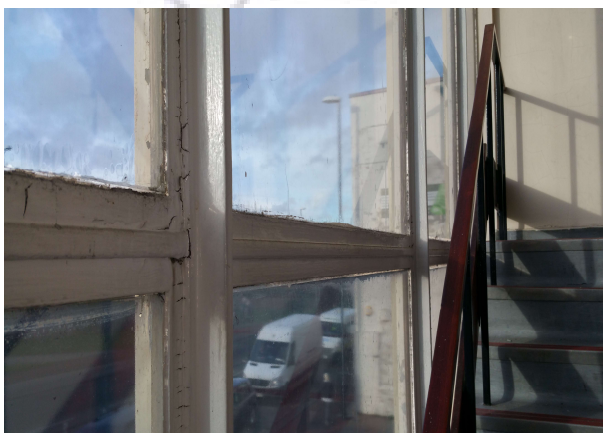
Item 21 Ref: As 149012-1

The sealant to windows in the stairwell & landing (Rm 1/01) does not contain asbestos.

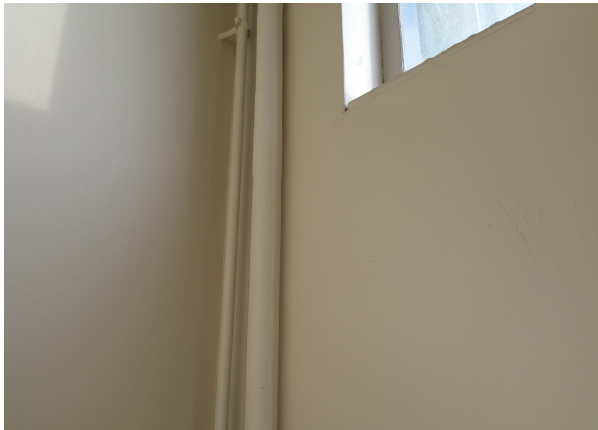
Item 23 Ref: As 149012-9

The pipework insulation in the female WC (Rm 1/02) does not contain asbestos.

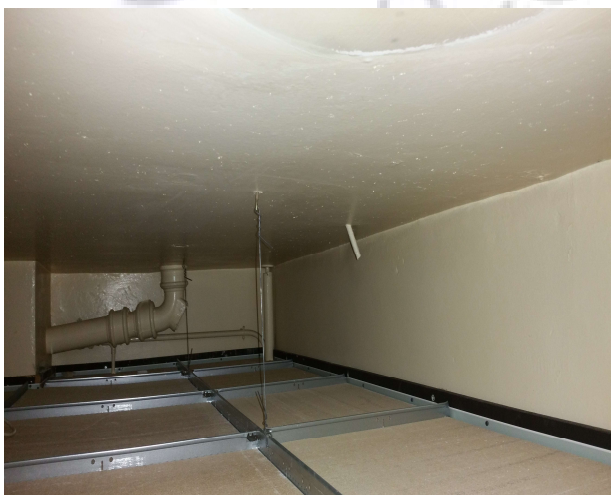
Item 24 Ref: 149012-9

The pipework insulation in the female WC ceiling void (Rm 1/02) does not contain asbestos.

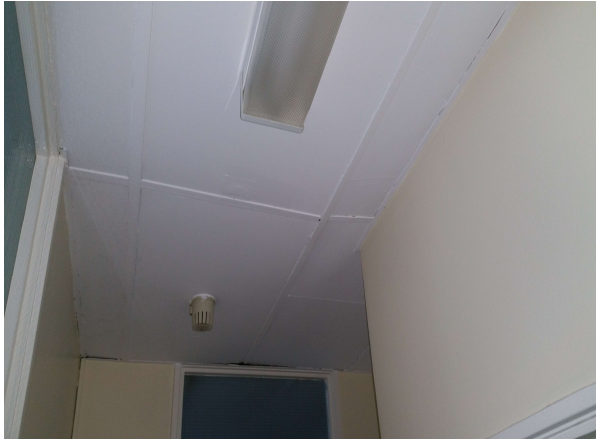
Item 25 Ref: As 149012-7

The suspended ceiling in the corridor (Rm 1/03) does not contain asbestos.

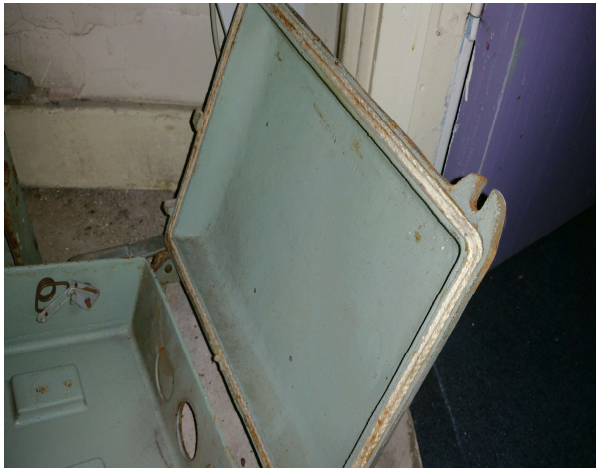
Item 26 Ref: 149012-11

The gasket to loose lying junction box in the switchroom (Rm 1/04) does not contain asbestos.

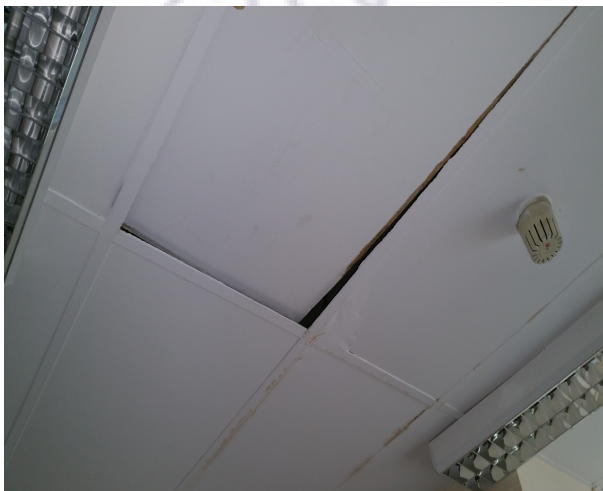
Item 27 Ref: As 149012-7

The suspended ceiling in the office (Rm 1/05) does not contain asbestos.

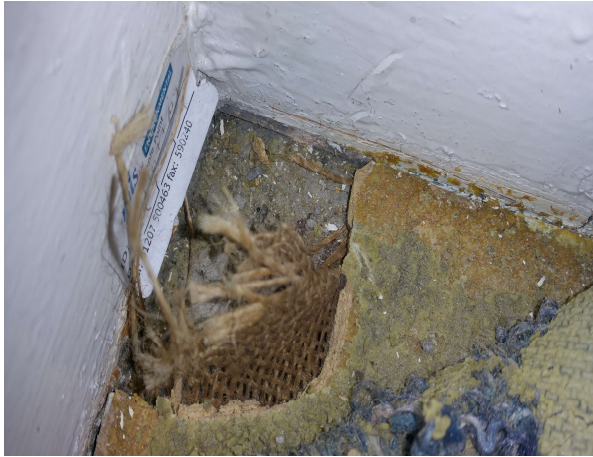
Item 28 Ref: 149012-13

The subfloor covering in the office (Rm 1/05) does not contain asbestos.

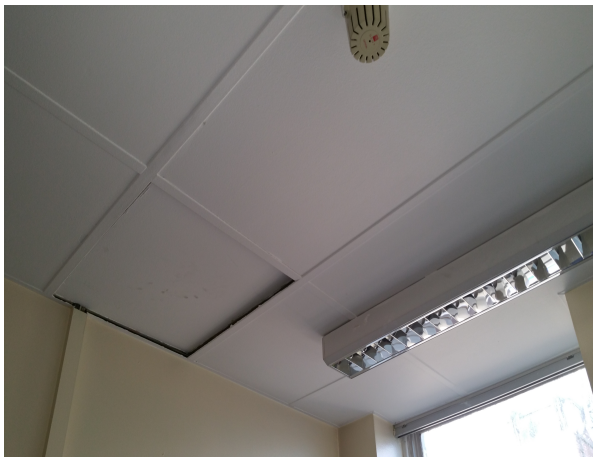
Item 29 Ref: As 149012-7

The suspended ceiling in the office (Rm 1/06) does not contain asbestos.

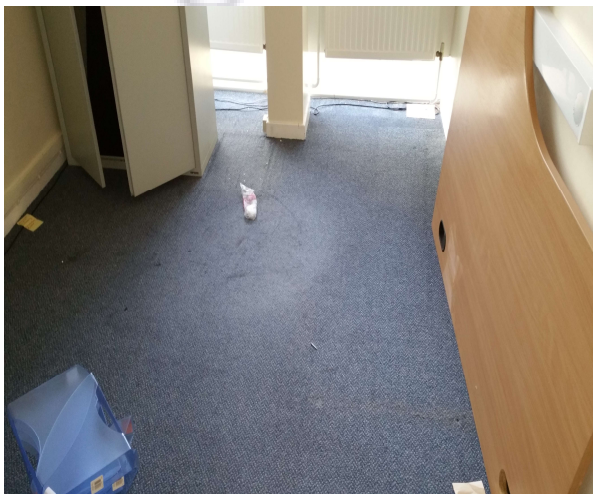
Item 30 Ref: As 149012-13

The subfloor covering in the office (Rm 1/06) does not contain asbestos.

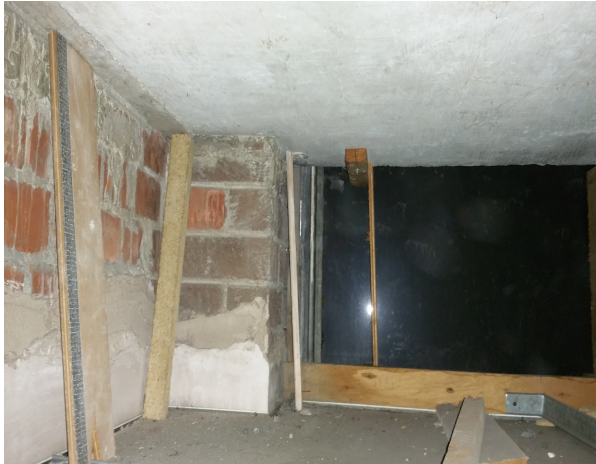
Item 31 Ref: As 149012-3

The sealant to windows in the office ceiling void (Rm 1/06) does not contain asbestos.

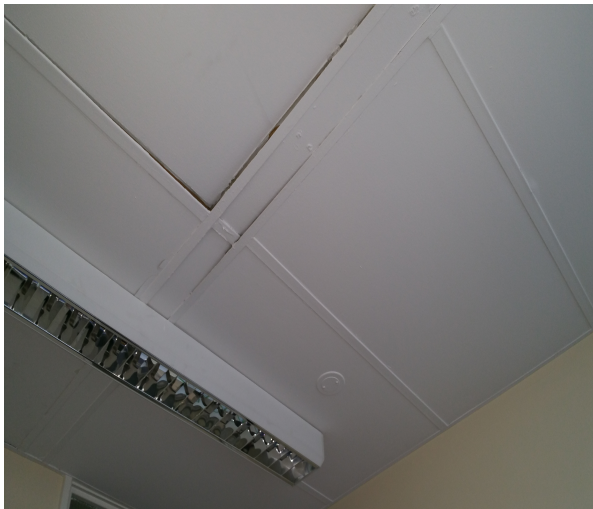
Item 32 Ref: As 149012-7

The suspended ceiling in the office (Rm 1/07) does not contain asbestos.

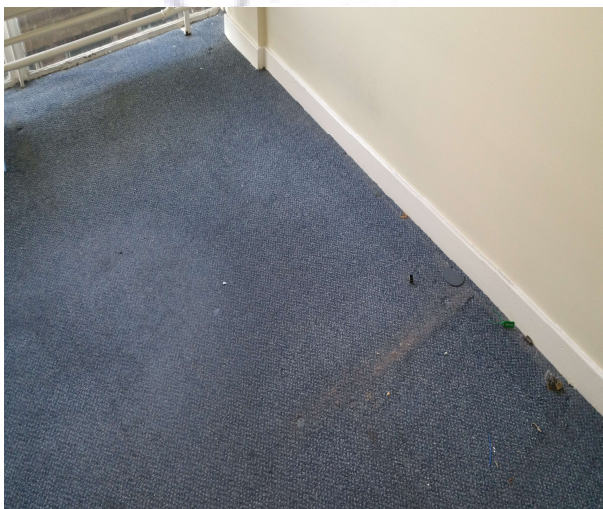
Item 33 Ref: As 149012-13

The subfloor covering in the office (Rm 1/07) does not contain asbestos.

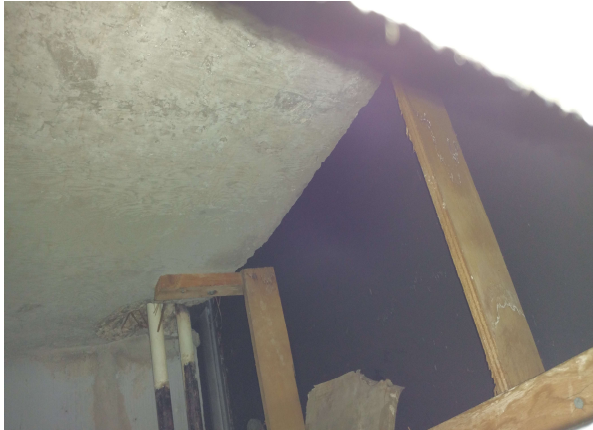
Item 34 Ref: As 149012-3

The sealant to windows in the office ceiling void (Rm 1/07) does not contain asbestos.

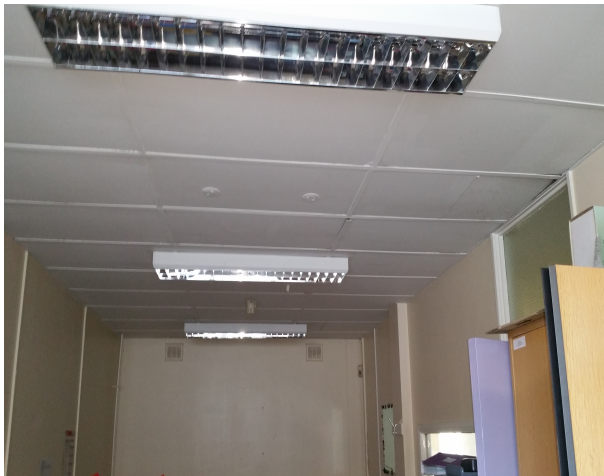
Item 35 Ref: As 149012-7

The suspended ceiling in the office (Rm 1/08) does not contain asbestos.

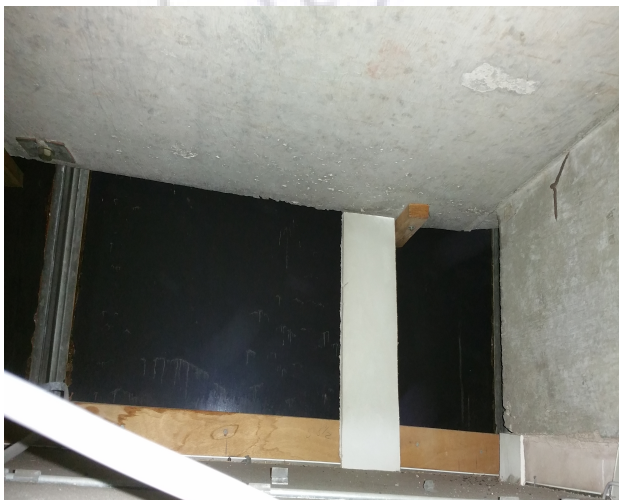
Item 36 Ref: As 149012-3

The sealant to windows in the office ceiling void (Rm 1/08) does not contain asbestos.

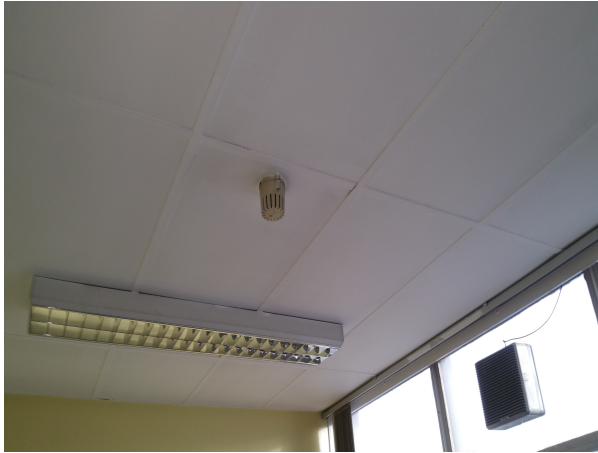
Item 37 Ref: As 149012-7

The suspended ceiling in the office (Rm 1/09) does not contain asbestos.

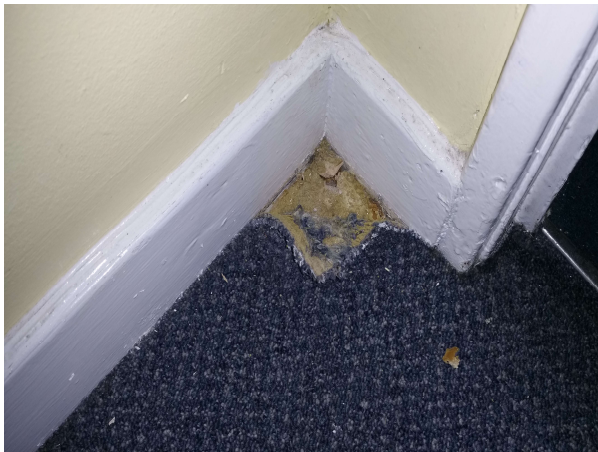
Item 38 Ref: As 149012-13

The subfloor covering in the office (Rm 1/09) does not contain asbestos.

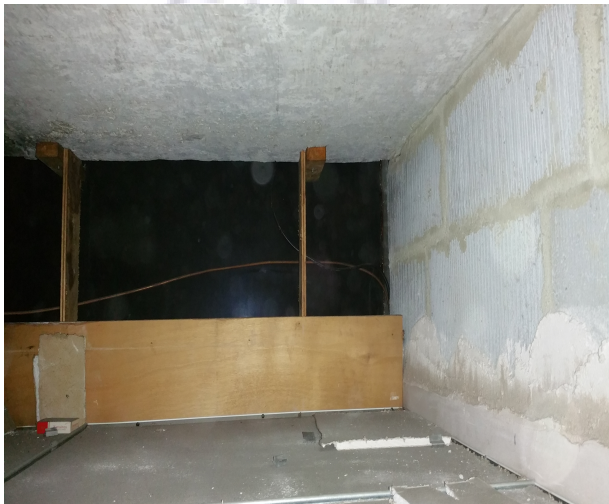
Item 39 Ref: As 149012-3

The sealant to windows in the office ceiling void (Rm 1/09) does not contain asbestos.

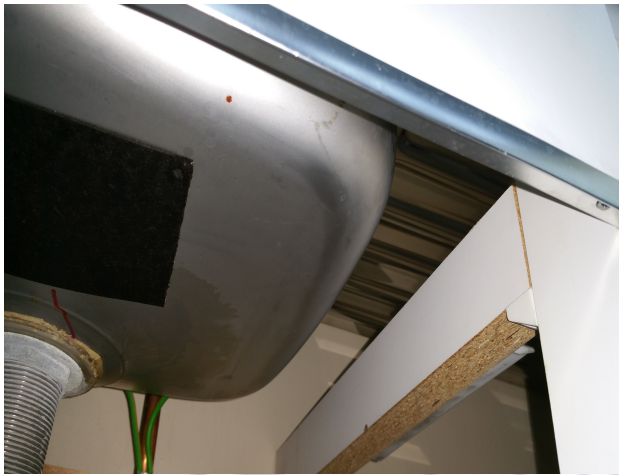
Item 41 Ref: 149012-12

The sink pad in the staff room (Rm 1/10) does not contain asbestos.

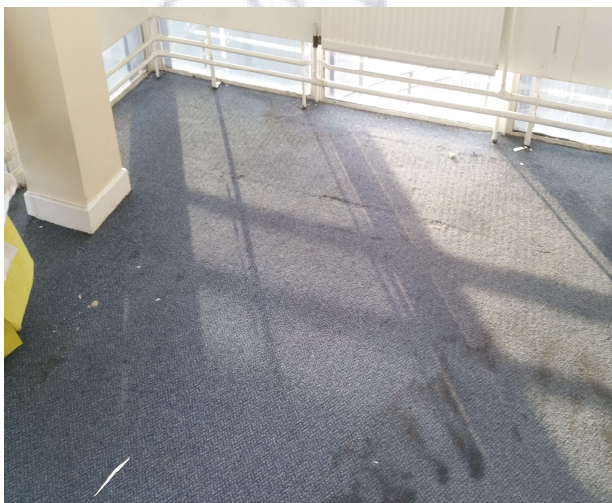
Item 42 Ref: As 149012-13

The subfloor covering in the staff room (Rm 1/10) does not contain asbestos.

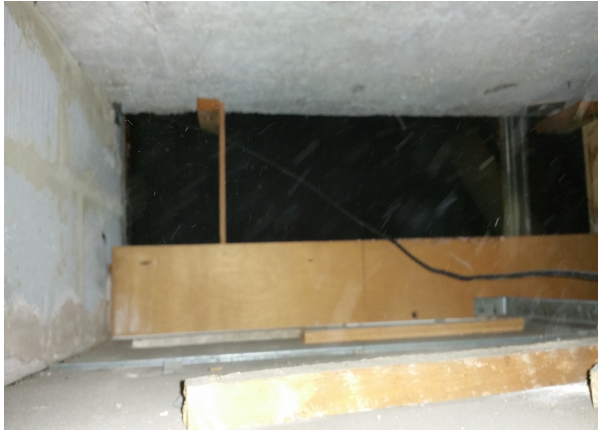
Item 43 Ref: As 149012-3

The sealant to windows in the staff room ceiling void (Rm 1/10) does not contain asbestos.

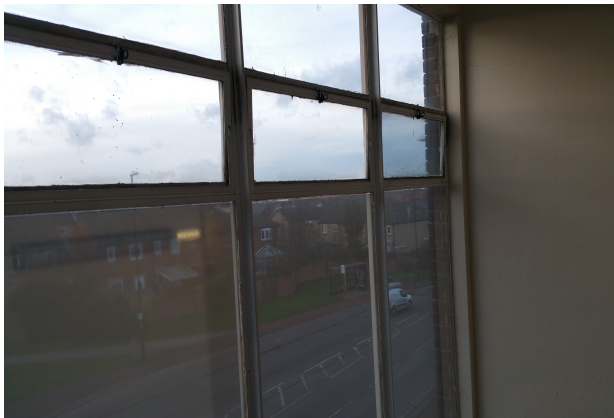
Item 44 Ref: As 149012-1

The sealant to windows in the stairwell & landing (Rm 2/01) does not contain asbestos.

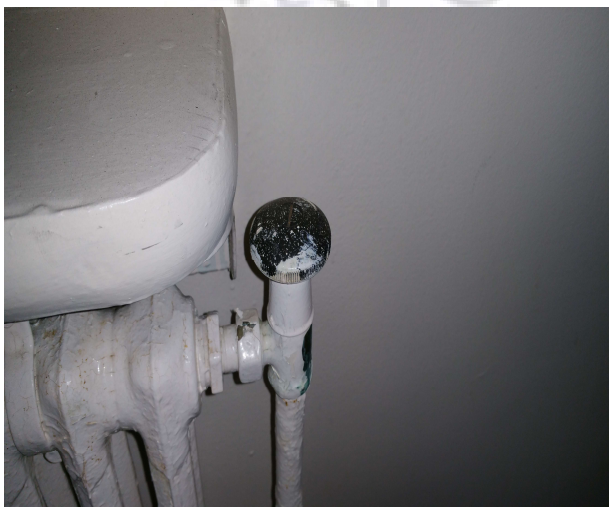
Item 45 Ref: As 149012-10

The radiator knob in the male WC (Rm 2/02) does not contain asbestos.

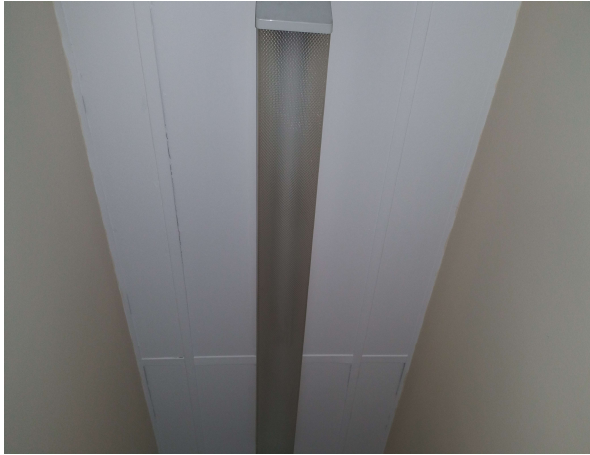
Item 46 Ref: As 149012-7

The suspended ceiling in the corridor (Rm 2/03) does not contain asbestos.

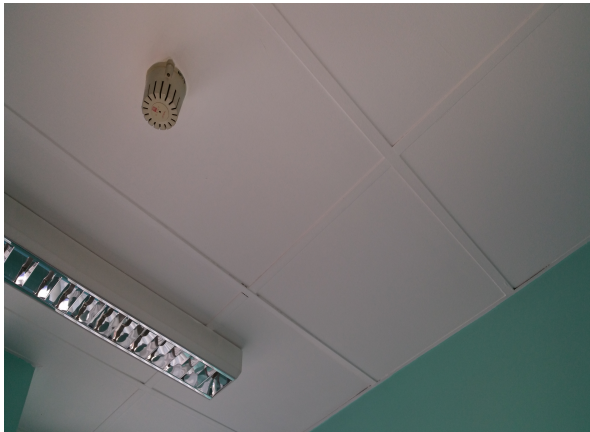
Item 47 Ref: As 149012-7

The suspended ceiling in the office (Rm 2/04) does not contain asbestos.

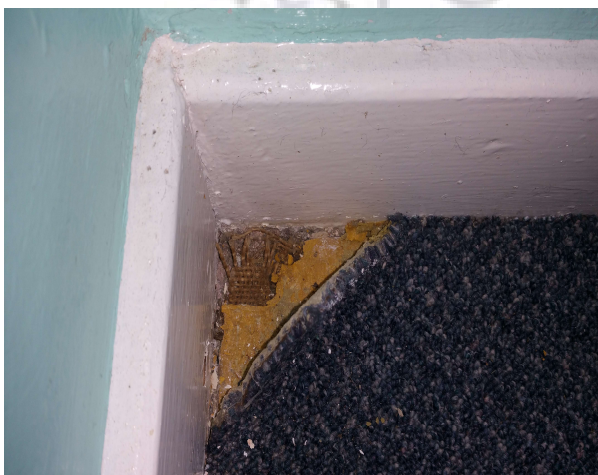
Item 48 Ref: 149012-14

The subfloor covering in the office (Rm 2/04) does not contain asbestos.

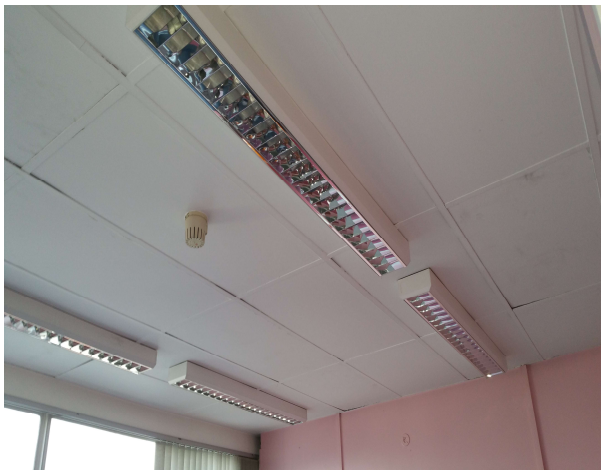
Item 50 Ref: As 149012-7

The suspended ceiling in the office (Rm 2/04) does not contain asbestos.

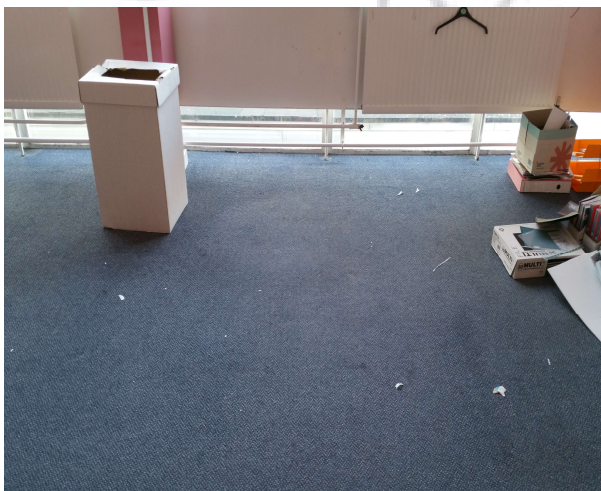
Item 51 Ref: As 149012-14

The subfloor covering in the office (Rm 2/05) does not contain asbestos.

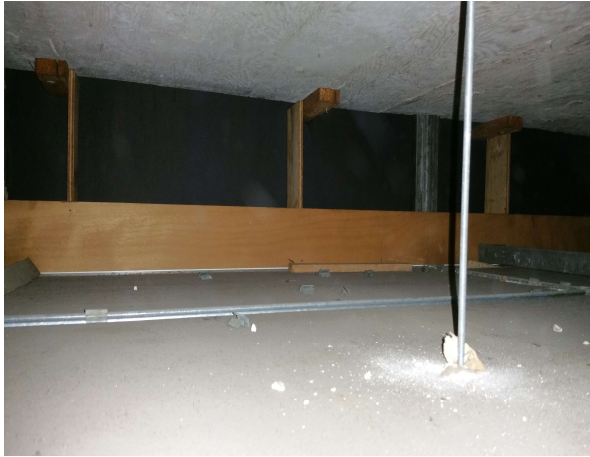
Item 52 Ref: As 149012-3

The sealant to windows in the office ceiling void (Rm 2/05) does not contain asbestos.

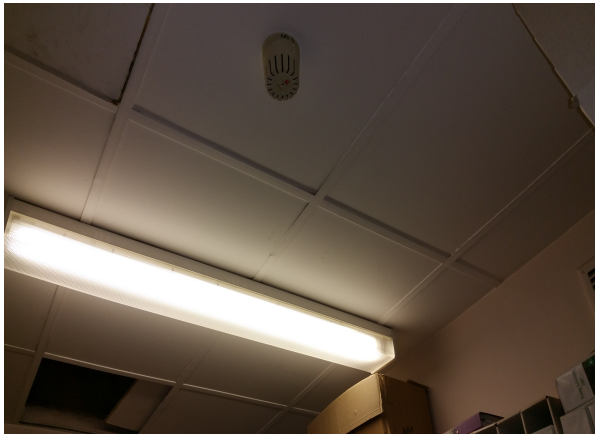
Item 53 Ref: As 149012-7

The suspended ceiling in the office (Rm 2/06) does not contain asbestos.

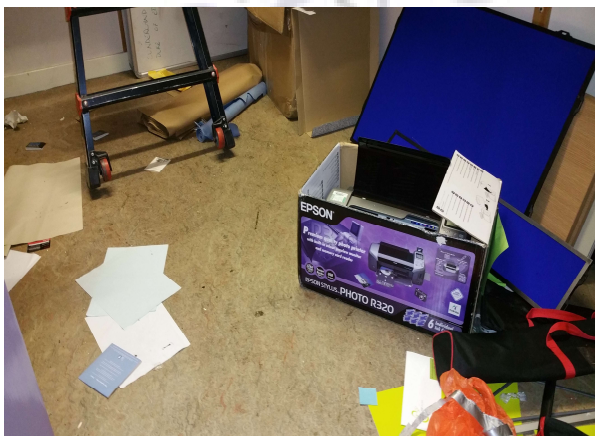
Item 54 Ref: 149012-15

The floor covering in the store room (Rm 2/06) does not contain asbestos.

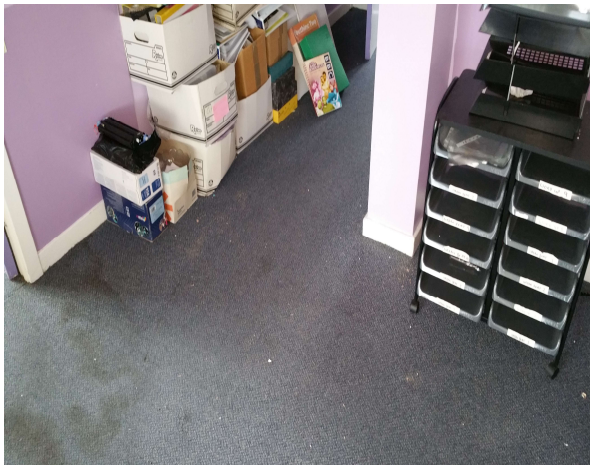
Item 56 Ref: As 149012-15

The sub floor covering in the office (Rm 2/07) does not contain asbestos.

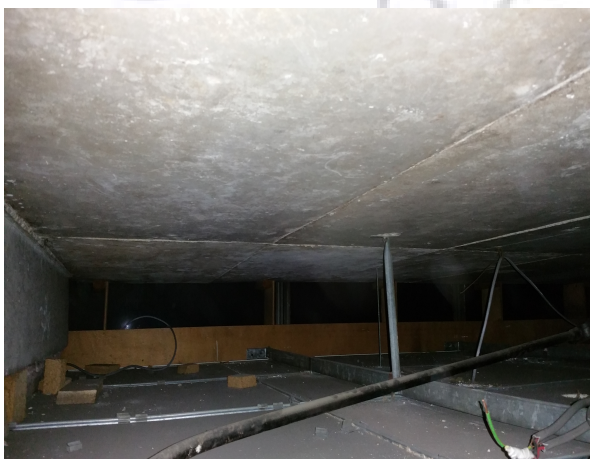
Item 57 Ref: As 149012-3

The sealant to windows in the office ceiling void (Rm 2/07) does not contain asbestos.

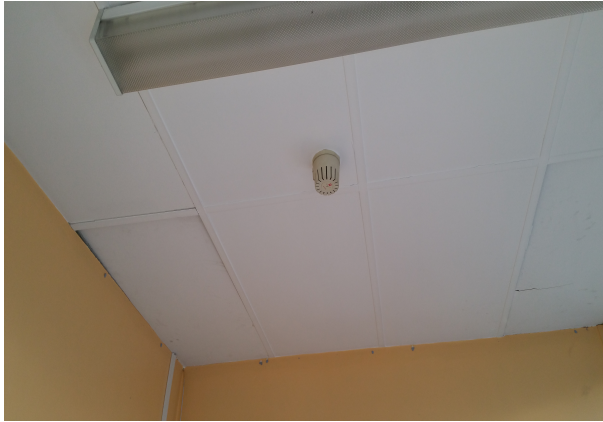
Item 58 Ref: As 149012-7

The suspended ceiling in the office (Rm 2/08) does not contain asbestos.

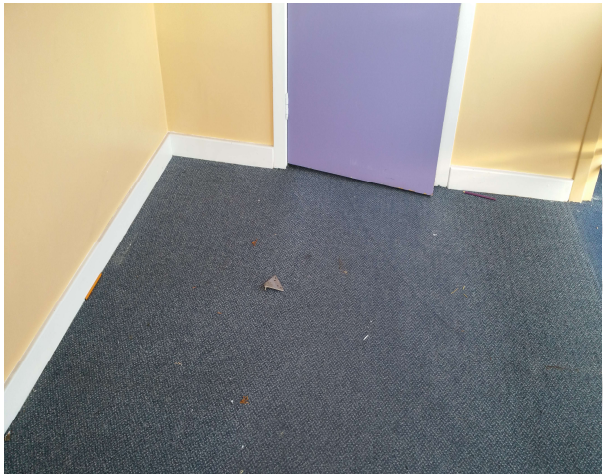
Item 59 Ref: As 149012-15

The sub floor covering in the office (Rm 2/08) does not contain asbestos.

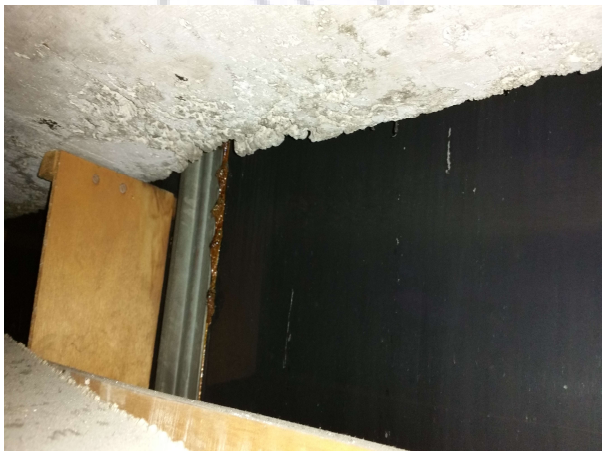
Item 60 Ref: As 149012-3

The sealant to windows in the office ceiling void (Rm 2/08) does not contain asbestos.

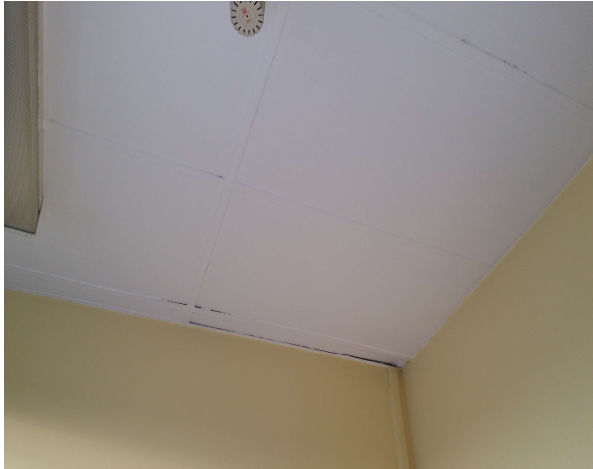
Item 61 Ref: As 149012-7

The suspended ceiling in the staff room (Rm 2/09) does not contain asbestos.

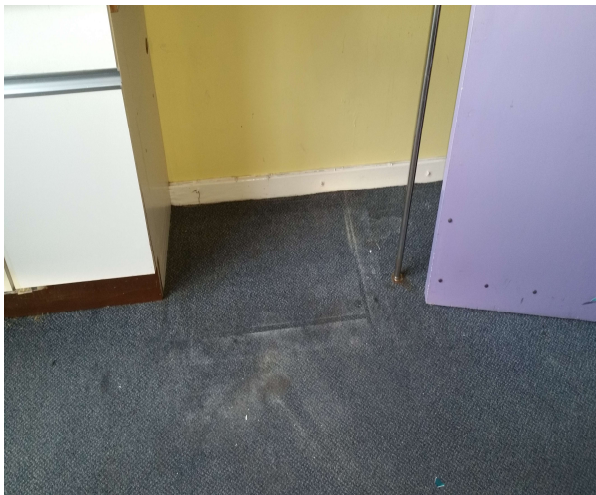
Item 62 Ref: As 149012-15

The sub floor covering in the staff room (Rm 2/09) does not contain asbestos.

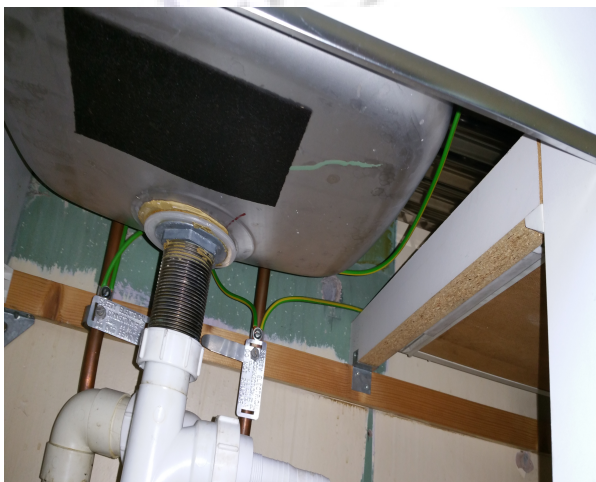
Item 63 Ref: As 149012-12

The sink pad in the staff room (Rm 2/09) does not contain asbestos.

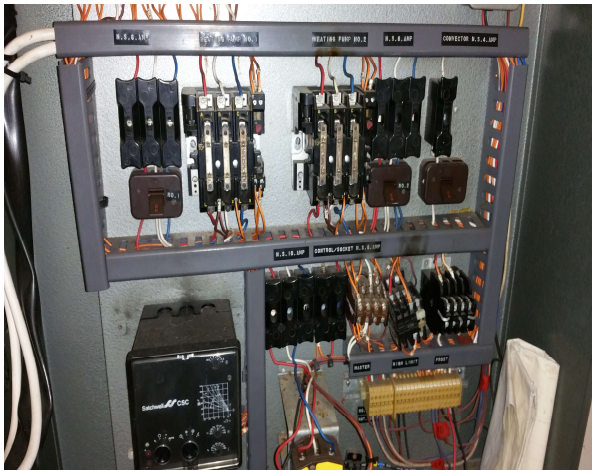
Item 65 Ref: Presumed

The electrics – cartridge fuses in the boiler room (Rm 2/10) is presumed to contain asbestos.

Any change in its appearance should be recorded and passed to Property Services.

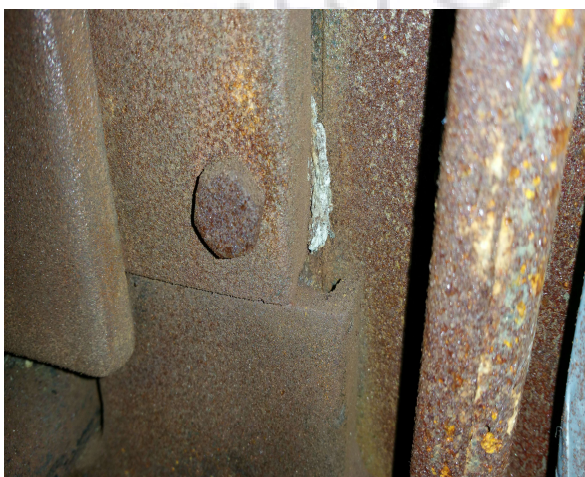
Item 66 Ref: 149012-16

The gasket to boiler in the boiler room (Rm 2/10) contains asbestos.

Any change in its appearance should be recorded and passed to Property Services.

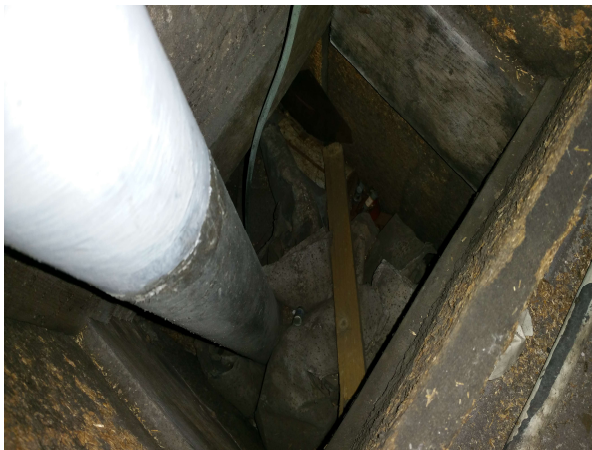
Item 68 Ref: Presumed

The loose lying cartridge fuses within the floor void in the boiler room (Rm 2/10) is presumed to contain asbestos.

Any change in its appearance should be recorded and passed to Property Services.

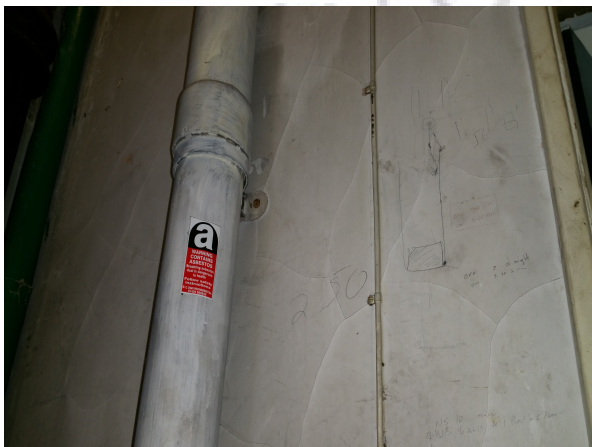
Item 69 Ref: 149012-18

The downpipe adjacent to door in the boiler room (Rm 2/10) contains asbestos.

Any change in its appearance should be recorded and passed to Property Services.

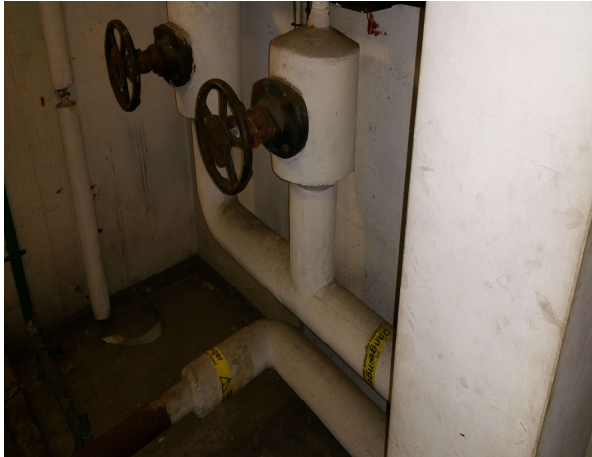
Item 70 Ref: 149012-19

The pipework lagging in the boiler room (Rm 2/10) contains asbestos.

Any change in its appearance should be recorded and passed to Property Services.

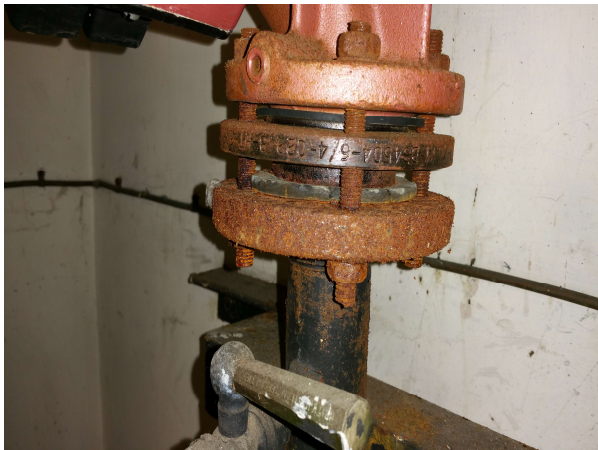
Item 71 Ref: 149012-20

The gasket to pipework flange in the boiler room (Rm 2/10) does not contain asbestos.

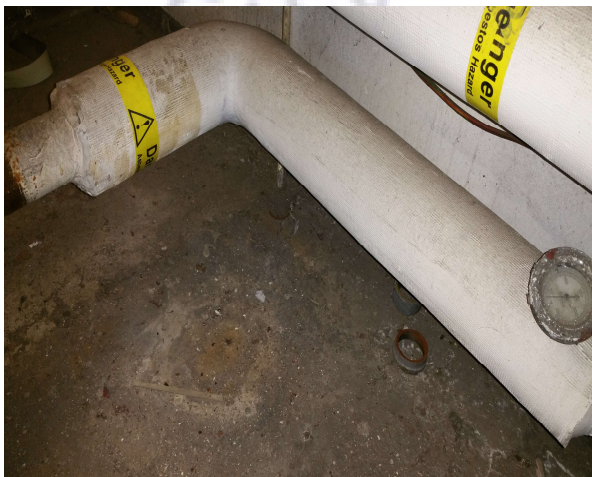
Item 72 Ref: 149012-22

The general debris to floor to pipework runs in the boiler room (Rm 2/10) does not contain asbestos.

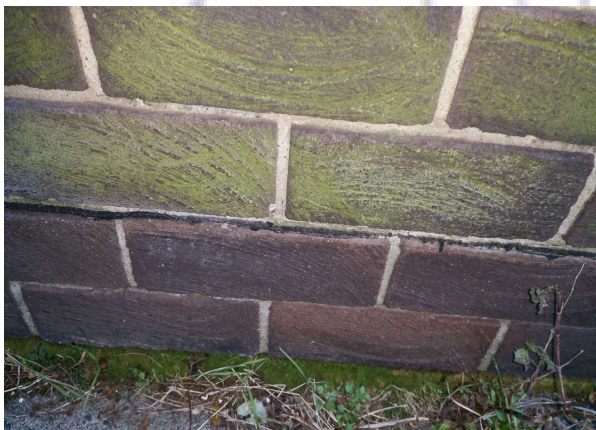
Item 75 Ref: 149012-24

The damp proof course
(External) does not contain
asbestos.

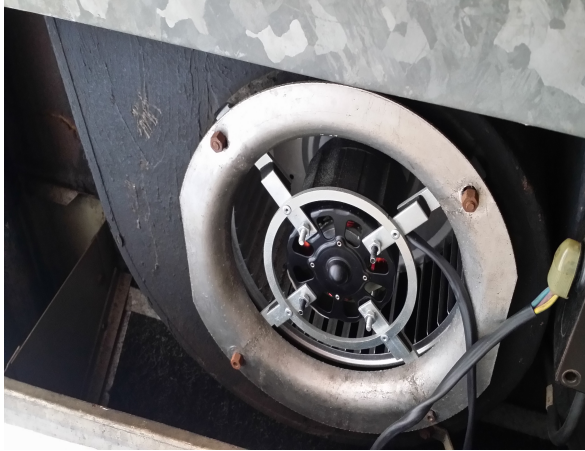
Item 76 Ref: 284014-1

The acoustic paint to fans in heater in the downstairs cupboard (Rm 0/03) contains asbestos.

Any change in its appearance should be recorded and passed to Property Services.
