ASBESTOS SURVEY REPORT FOR 20 VILLIERS STREET, SUNDERLAND,
SR1 1EJ

20 Villiers Street, Sunderland, SR1 1EJ

Date: 22 April 2026

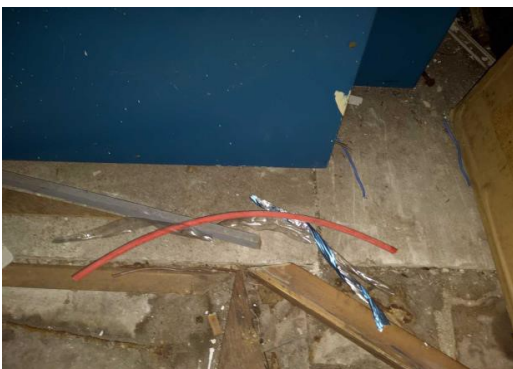
Item 3 Ref: 22-53656-3

The floor – insulating board
(Room/Area: 3 Boiler
Cupboard)
does not contain
asbestos.

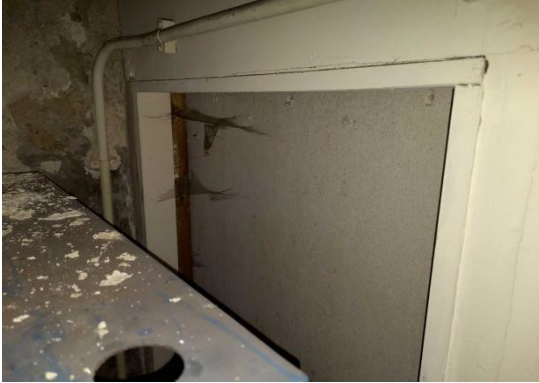
Item 4 Ref: 22-53656-3

The floor – infill panels
(Room/Area: 3 Boiler
Cupboard) does not contain
asbestos.

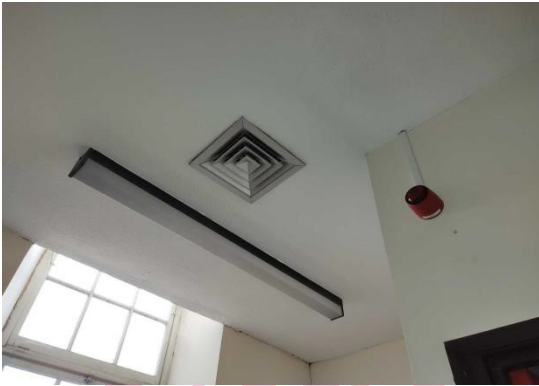
Item 5 Ref: 22-53656-2

The ceiling – textured coating
(Room/Area: 4 WC & Lobby)
does not contain asbestos.

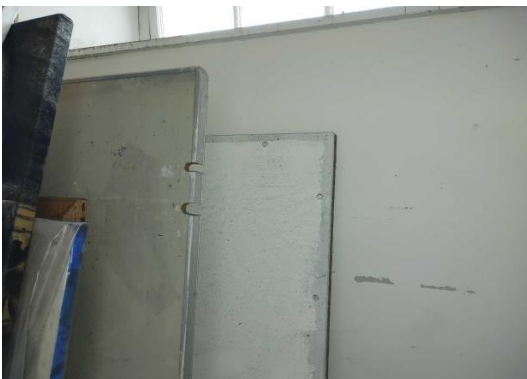
Item 6 Ref: 22-53656-3

The panel – insulating board
(Room/Area: 4 WC & Lobby)
does not contain asbestos.

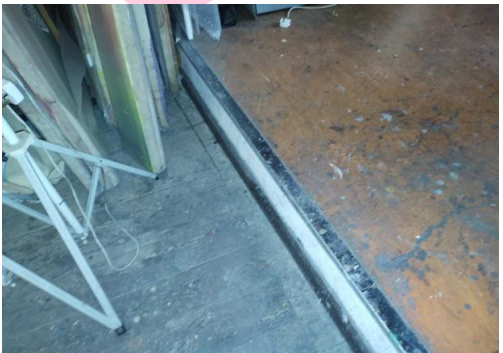
Item 9 Ref: 22-53656-5

The floor – composite
(Room/Area: 8 Main Studio)
does not contain asbestos.

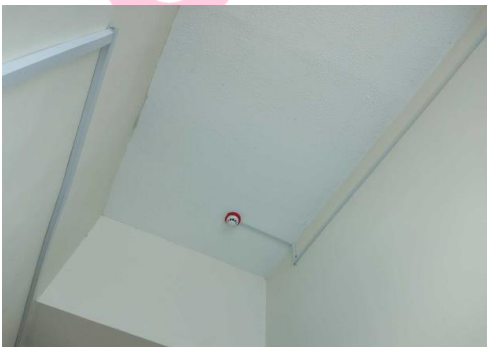
Item 12 Ref: 22-53656-7

The ceiling – textured coating (Room/Area: 11 Entrance Hall) does not contain asbestos.

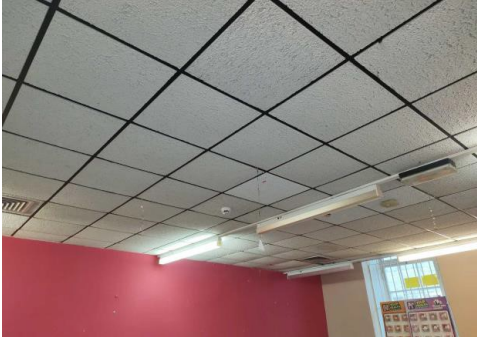
Item 13 Ref: 22-53656-8

The ceiling - suspended ceiling tiles insulating board (Room/Area: 12 Large Storeroom 1) does not contain asbestos.

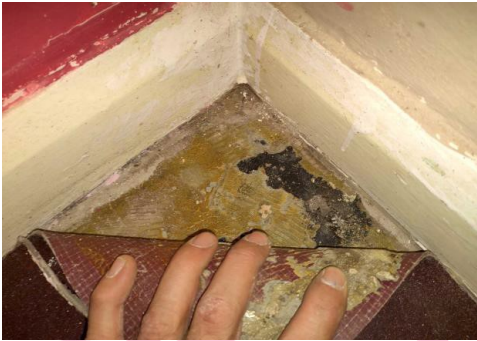
Item 14 Ref: 22-53656-9

The floor – asphalt bitumen (Room/Area: 12 Large Storeroom 1) does not contain asbestos.

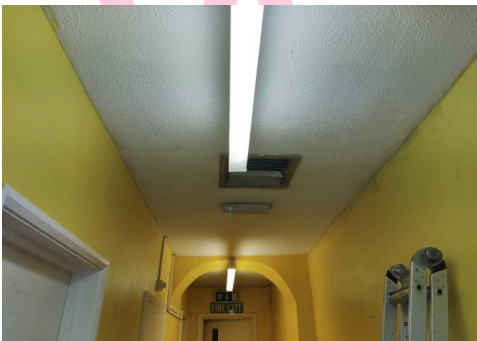
Item 15 Ref: 22-53656-7

The ceiling – textured coating (Room/Area: 15 Corridor) does not contain asbestos.

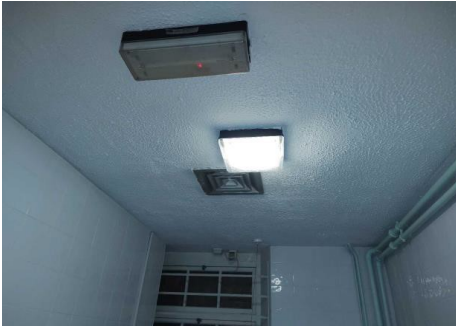
Item 20 Ref: 22-53656-7

The ceiling – textured coating (Room/Area: 18 Accessible WC) does not contain asbestos.

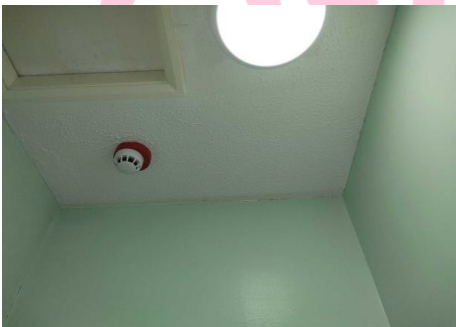
Item 21 Ref: 22-53656-7

The ceiling – textured coating (Room/Area: 19 Female WC) does not contain asbestos.

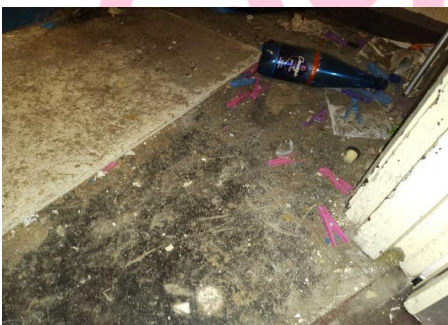
Item 24 Ref: 22-53656-9

The floor – asphalt bitumen (Room/Area: 23 Boiler Cupboard) does not contain asbestos.
