ASBESTOS SURVEY REPORT FOR RYHOPE RECREATION PARK, SUNDERLAND

Asbestos Register for Ryhope Park

UPRN: - J552465

TF Ref: PPO049-01-02-03

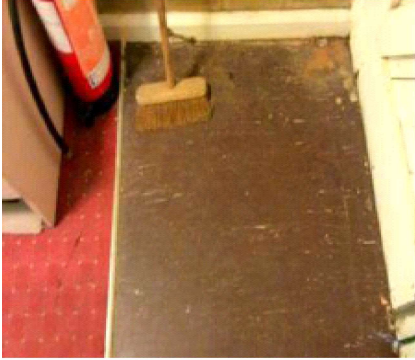
Item 1: Ref: EA003364

The brown vinyl floor covering to the locker area (Room 1) does not contain asbestos.

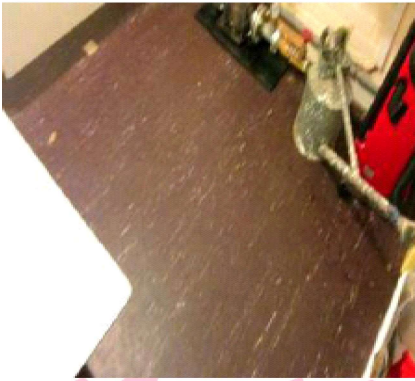
Item 5: As EA003364

The brown vinyl flooring to the female toilets (Room 4) does not contain asbestos.

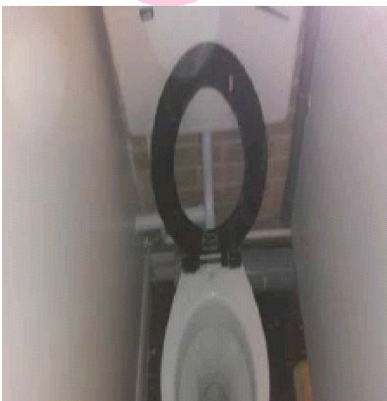
Item 6: Ref: EA003366

The toilet seats to the female toilets (Room 4) do not contain asbestos.

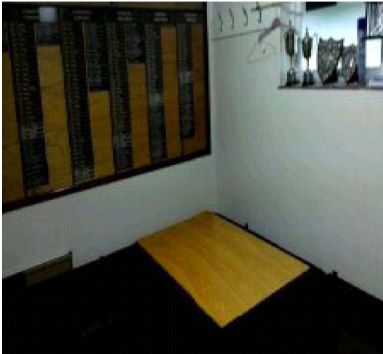
Room 5 (Male changing area) was accessed, and no suspect materials were found.

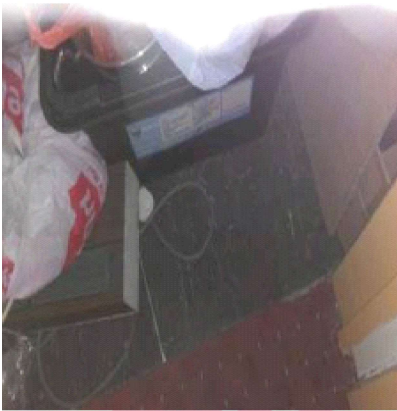
Item 7: As EA003364

The brown vinyl flooring to the cupboard (Room 6) does not contain asbestos.

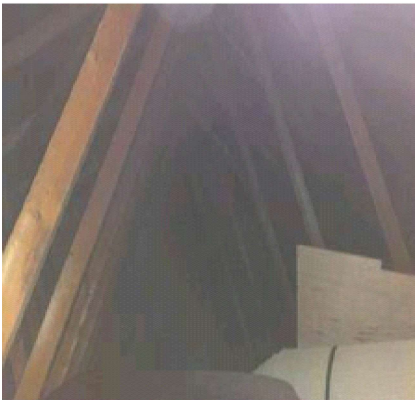
The loft (room 1) was accessed, and no suspect materials were found.

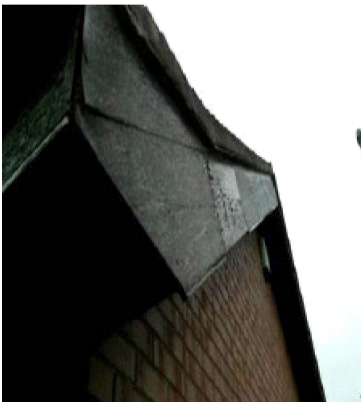
Item 10: Ref: EA003368

The under tile edging to the roof (External) contains asbestos. Any change in its appearance should be noted passed to Property Services.

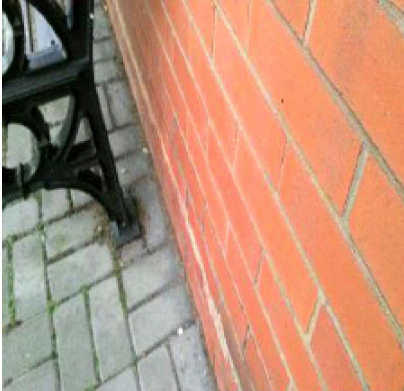
Item 11: Ref: EA003369

The damp proof course to the external does not contain asbestos.

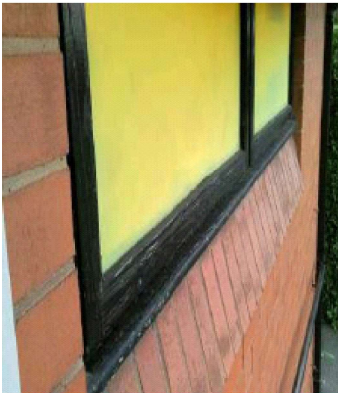
Item 12: Ref: EA003370

The window putty to the external contains asbestos. Any change in its appearance should be noted passed to Property Services.

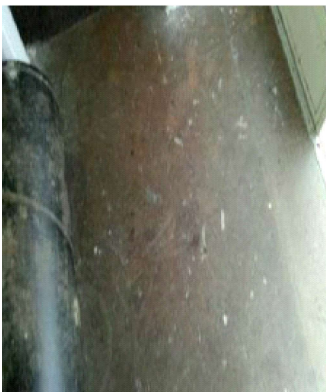
Item 13: Ref: EA003352

The brown vinyl flooring to the lobby (Room 1) does not contain asbestos.

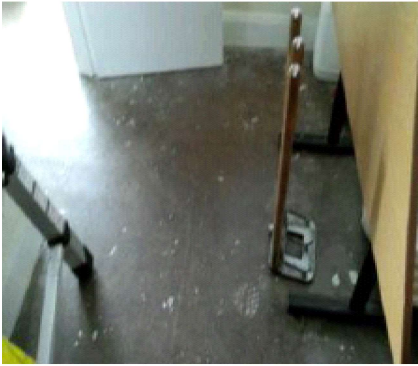
Item 14: As EA003352

The brown vinyl flooring to the store (Room 2) does not contain asbestos.

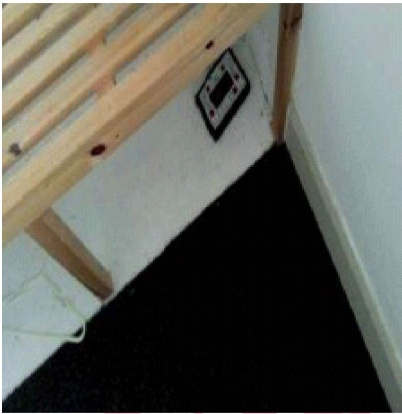
Item 15: As EA003352

The brown vinyl flooring to the umpire's room (Room 3) does not contain asbestos.

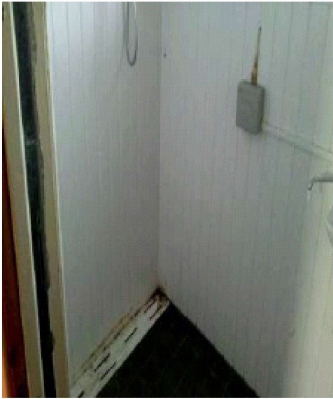
Room 5 (Showers on LHS) were accessed, and no suspect materials were found.

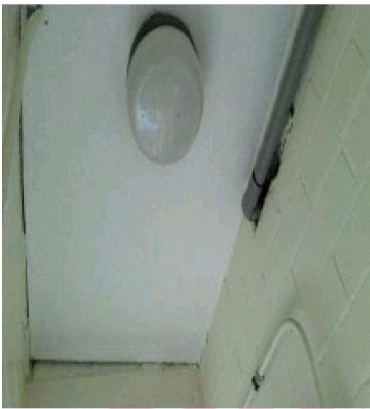
Item 17: As: EA003353

The fibreboard ceiling panels to the toilet on the left-hand side (Room 6) do not contain asbestos.

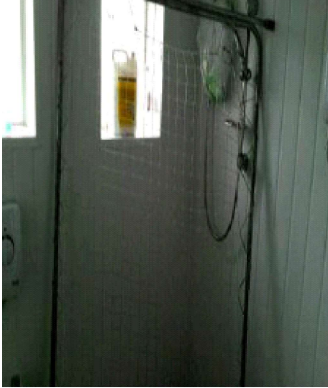
Room 8 (Shower - RHS) was accessed and no suspect materials were found.

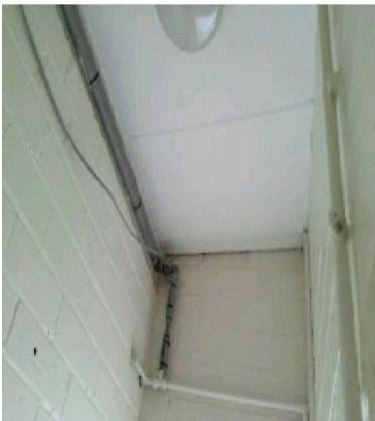
Item 19: As: EA003353

The fibreboard ceiling panels to the toilet (RHS) Room 9 do not contain asbestos.

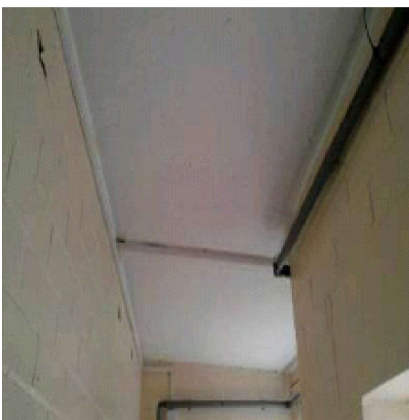
Item 22: As: EA003353

The fibreglass ceiling panels to the gent's toilet (Room 13) do not contain asbestos.

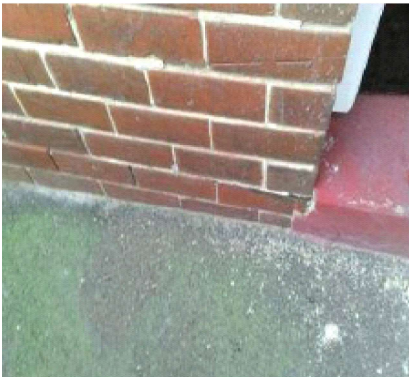
Item 23: Ref: EA003354

The damp proof course to the external does not contain asbestos.

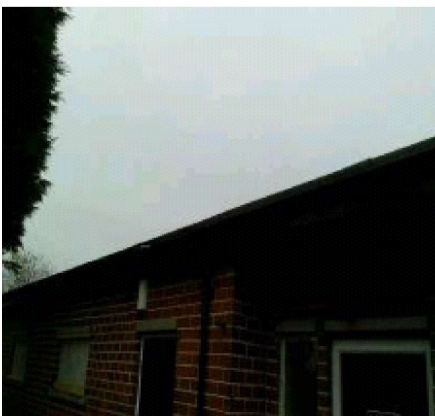
Item 24: Ref: EA003355

The bitumen to the flat roof does not contain asbestos.

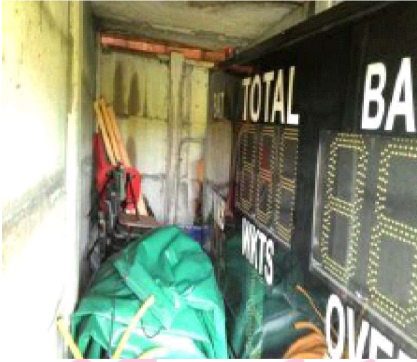
The cricket store (Room 1) was accessed, and no suspect materials were found.

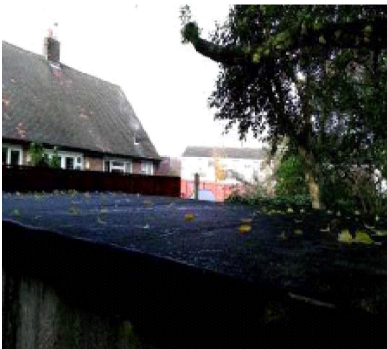
Item 26: Ref: EA003376

The bitumen to the flat roof (external) of the cricket store does not contain asbestos.

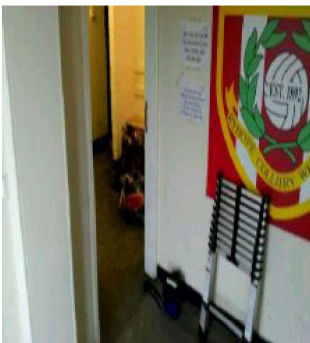
Room 1 (Lobby) was accessed, and no suspect materials were found.

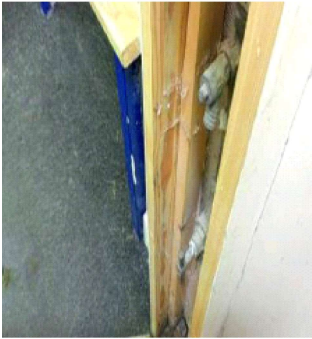
Room 2 (Home Changing Room) was accessed, and no suspect materials were found.

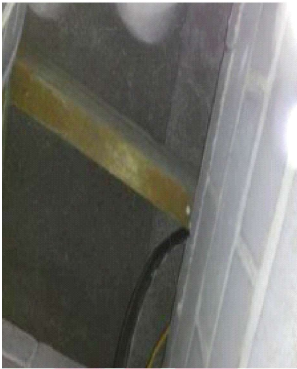
Item 29: Ref: EA003357

The residue to the batons in the electrical cupboard does not contain asbestos.

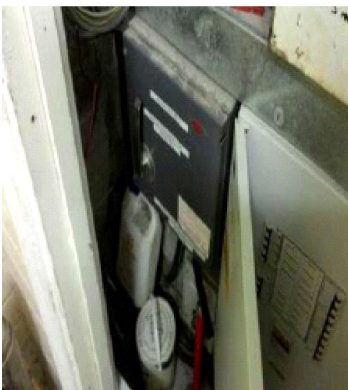
Item 30: Ref: Presumed

The flash guards within the electrics to the electrical cupboard are presumed to contain asbestos. Any change in its appearance should be noted and passed to Property Services.

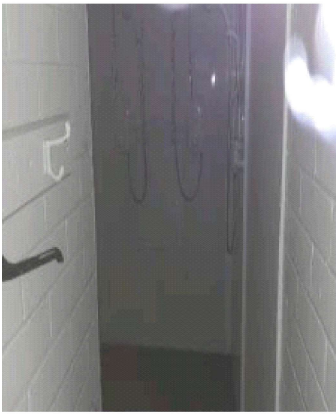
Room 4 (Home showers) was accessed, and no suspect materials were found.

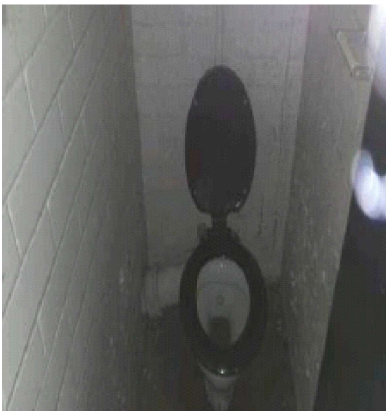
Item 31: Ref: EA003358

The wc seat to the Toilets (Room 5) does not contain asbestos.

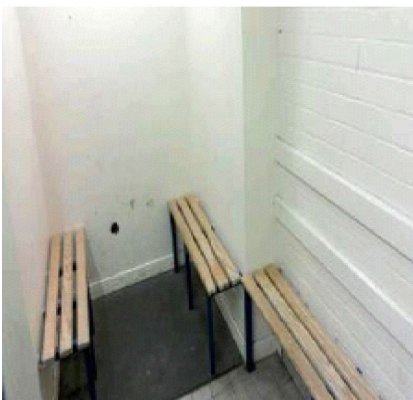
Room 6 (Away changing room) was accessed, and no suspect materials were found.

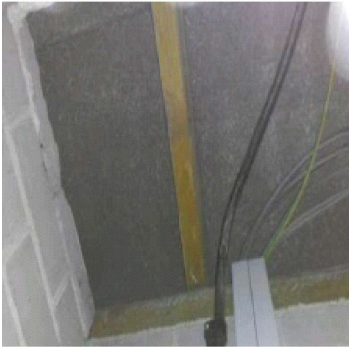
Item 32: Ref: EA003359

The residue to the timber batons to the ceiling in the electric cupboard (Room 7) does not contain asbestos.

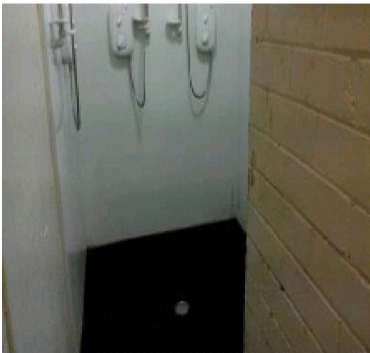
Room 8 (Away showers) was accessed, and no suspect materials were found.

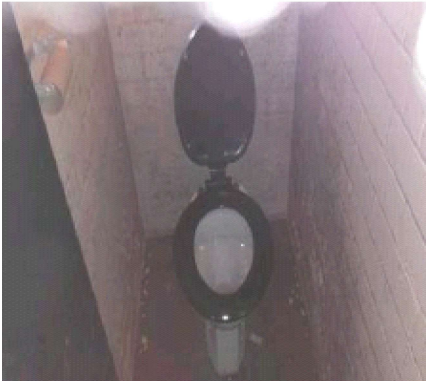
Item 34: As: EA003358

The WC seat to the toilet (Room 9) does not contain asbestos.

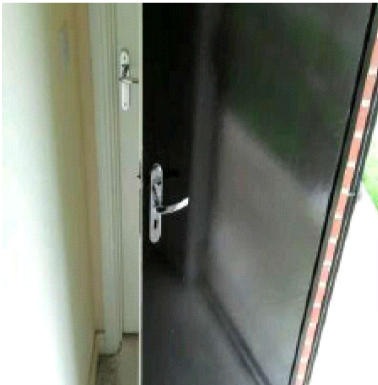
Room 10 (Vestibule) was accessed, and no suspect materials were found.

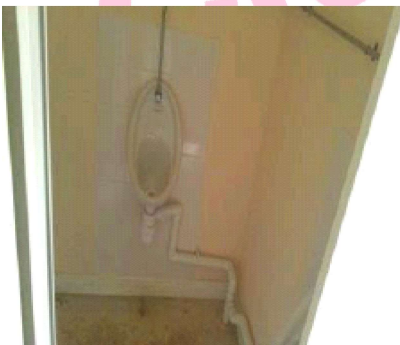
Room 11 (Male toilets) was accessed, and no suspect materials were found.

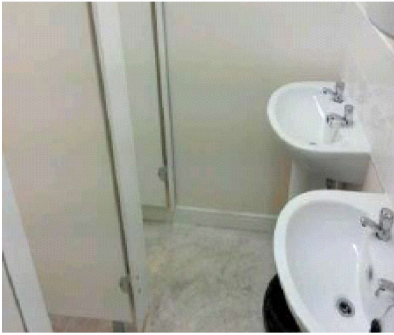
Room 12 (Female toilets) was accessed and no suspect materials were found.

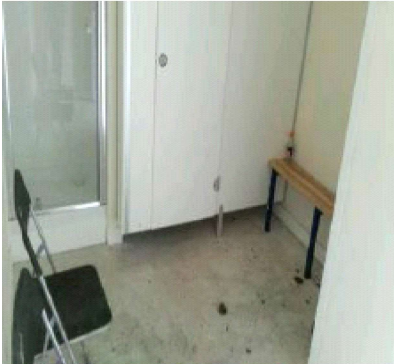
Room 13 (Officials area) was accessed and no suspect materials were found.

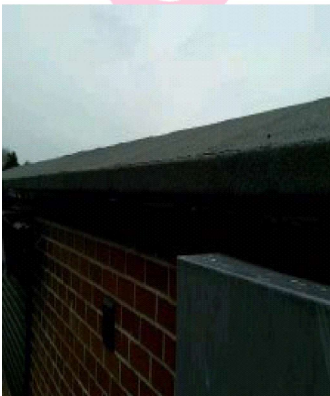
The roof felt to the external does not contain asbestos.

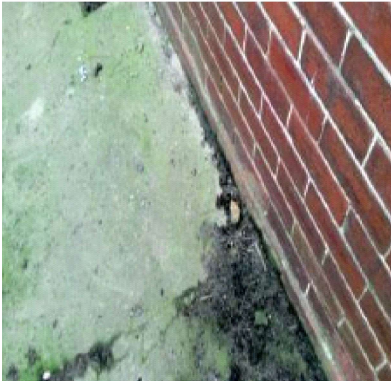
Item 35 Ref: EA003361

The damp proof course to the external contains asbestos. Any change in its appearance should be noted and passed to Property Services.

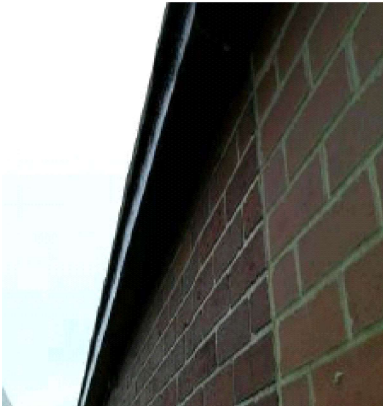
Item 36 Ref: EA003361

The external soffits to the changing rooms contain asbestos. Any change in its appearance should be noted and passed to Property Services.

Soffits encapsulated March 2026 (still required periodic inspections to be carried out)

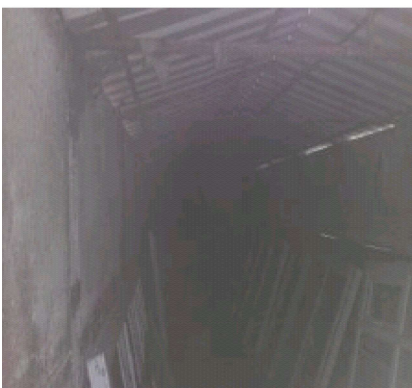
The internal area to the garage behind the staff cabin was accessed and no suspect materials were found.

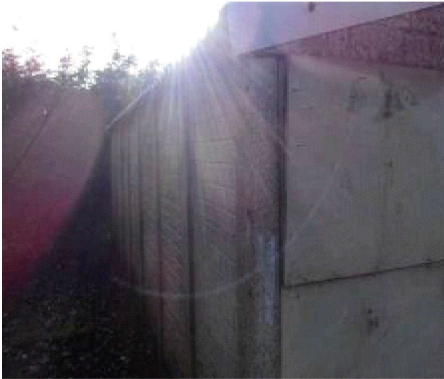
The external area to the garage behind the staff cabin was accessed and no suspect materials were found.

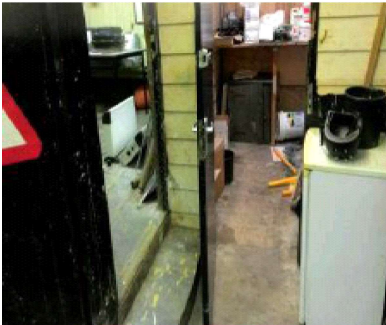
Room 1 (lobby) was accessed, and no suspect materials were found.

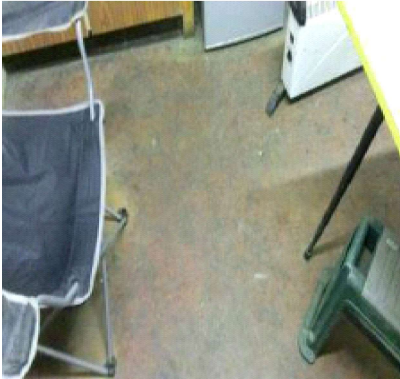
Item 39 As EA003348

The red vinyl floor covering to the staff room (Room 3) does not contain asbestos.

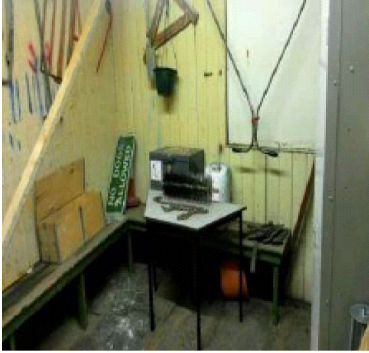
Room 4 (store) was accessed and no suspect materials were found.

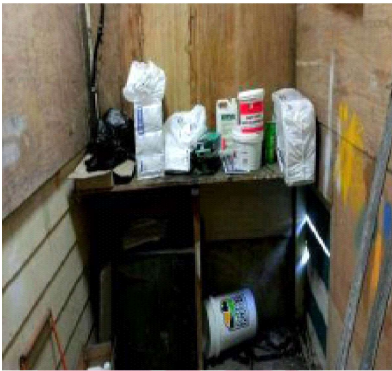
The store room (room 5) was accessed and no suspect materials were found.

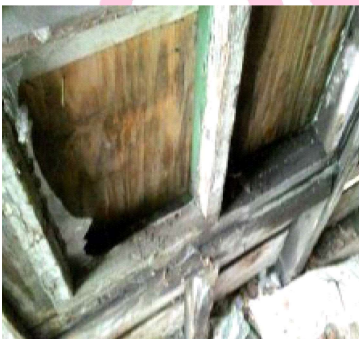
Item 41 Ref: EA003351

The window putty to the external of the mess / storage area does not contain asbestos.

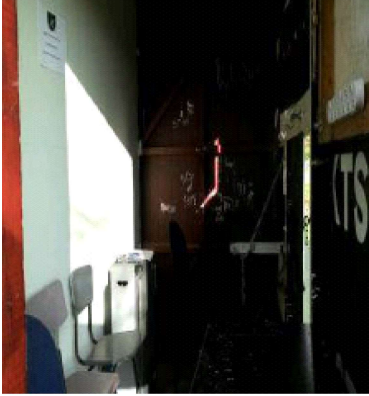
The scoreboard was accessed and no suspect materials were found.

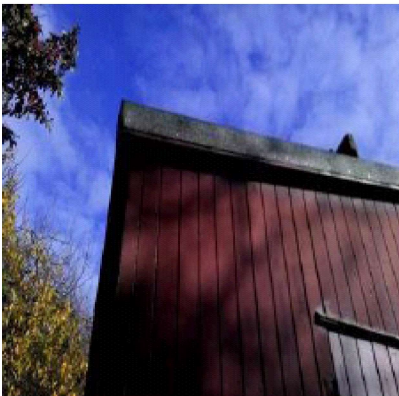
Item 42 Ref: EA003377

The bitumen felt to the flat roof of the scoreboard does not contain asbestos.

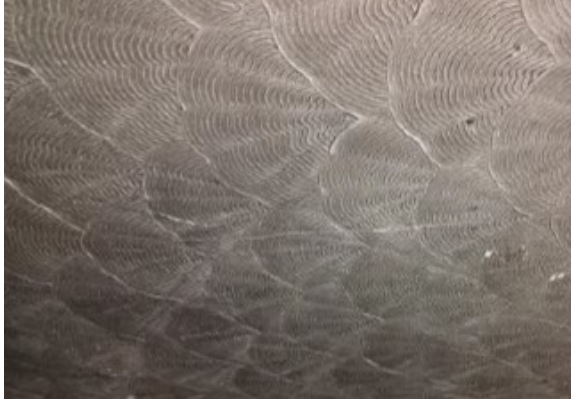
Item 43 Ref: 21-38916-1

The textured coated ceiling (Kitchen) does not contain asbestos.

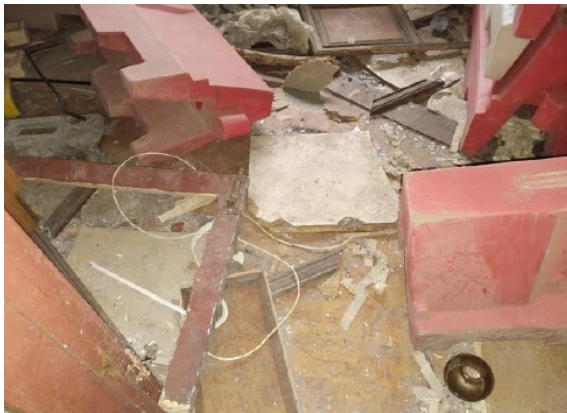
Item 44 Ref: 21-38916-1

The debris from ceiling to floor (Kitchen) does not contain asbestos.

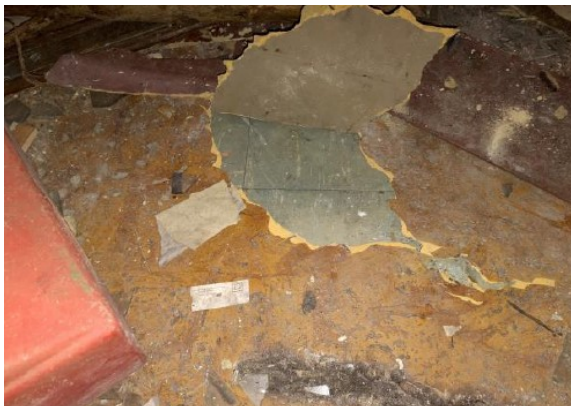
Item 45 Ref: 21-38916-2

The floor tiles and adhesive (Kitchen) contain asbestos.

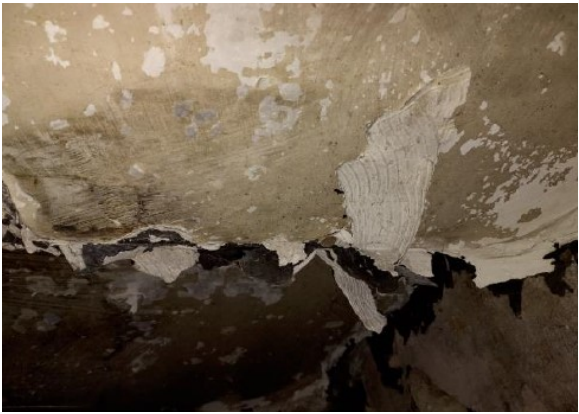
Item 46 Ref: 21-38916-1

The textured coated ceiling (Hall) does not contain asbestos.

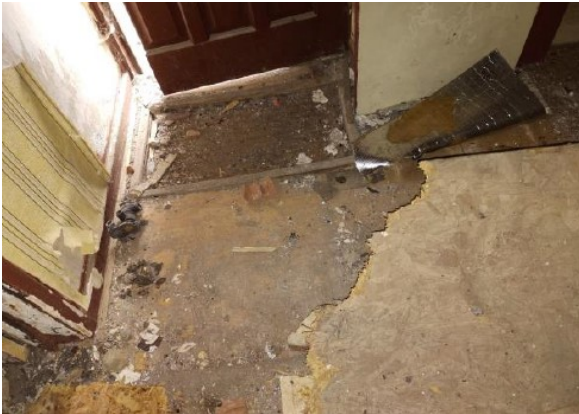
Item 47 Ref: 21-38916-1

The debris from ceiling to floor (Hall) does not contain asbestos.

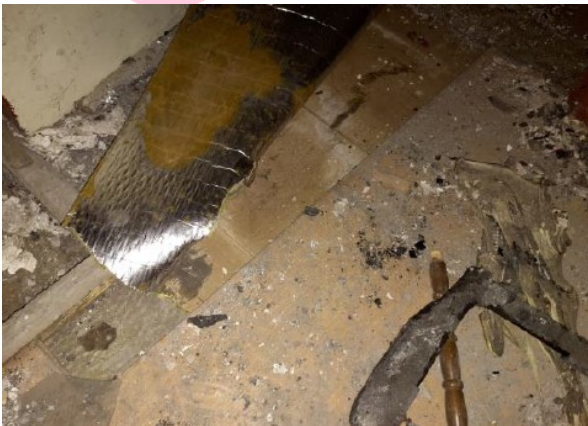
Item 48 Ref: 21-38916-3

The floor tiles and adhesive (Hall) contain asbestos.

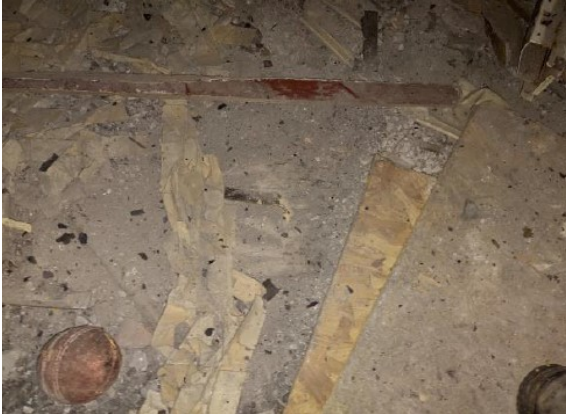
Item 49 Ref: 21-38916-4

The floor tiles and adhesive (Lounge) contain asbestos.

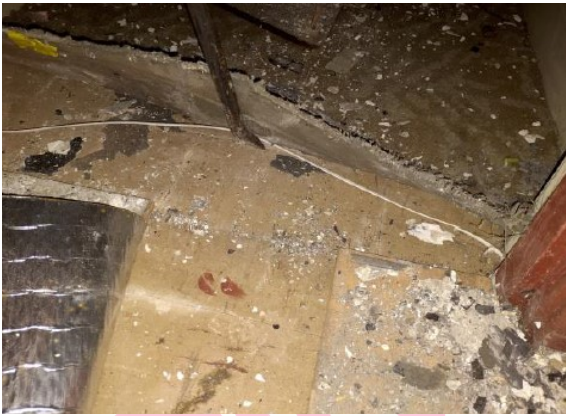
Item 50 Ref: 21-38916-3

The floor tiles and adhesive (Cupboard Understairs) contain asbestos.

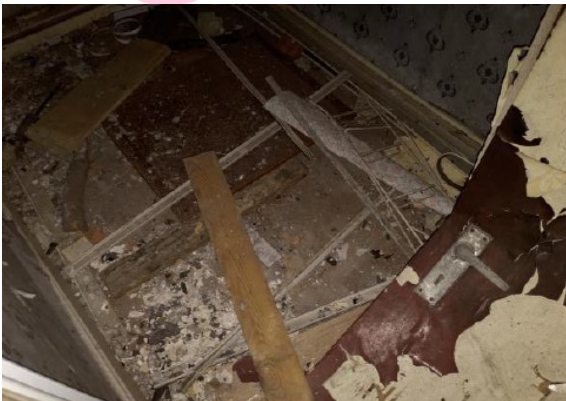
Item 51 Ref: 21-38916-3

The floor tiles and adhesive (WC) contain asbestos.

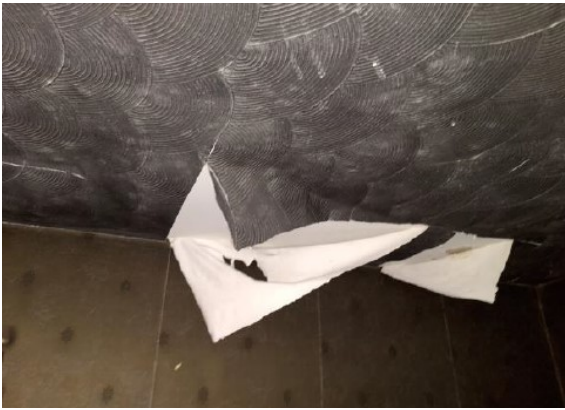
Item 52 Ref: 21-38916-1

The textured coated ceiling (Stairs and Landing) does not contain asbestos.

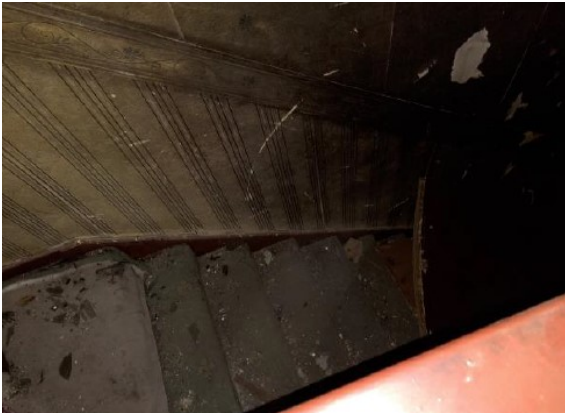
Item 53 Ref: 21-38916-1

The textured coated ceiling (Stairs and Landing) does not contain asbestos.

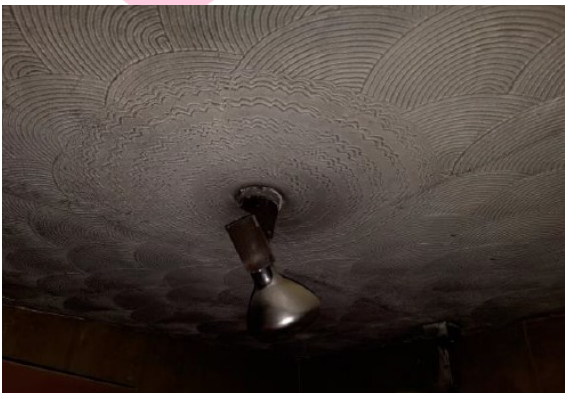
Item 54 Ref: 21-38916-1

The textured coated ceiling (Bathroom) does not contain asbestos.

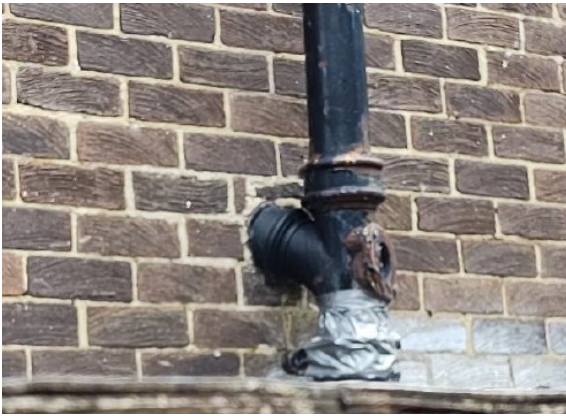
Item 55 Ref: 21-38916-10

The putty to joint capping soil pipe (External) contains asbestos.

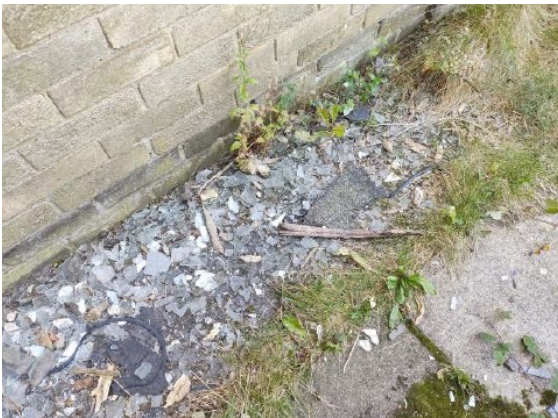
Item 56 Ref: 21-38916-11

The bitumen felt to floor (External) does not contain asbestos.

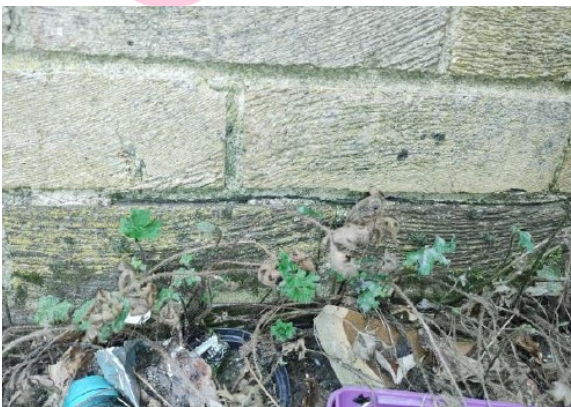
Item 57 Ref: 21-38916-5

The damp proof course (External) contains asbestos.

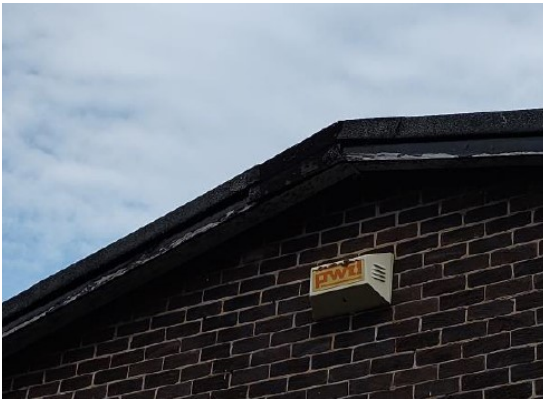
Item 58 Ref: 21-38916-6

The felt bitumen to roof (External) does not contain asbestos.

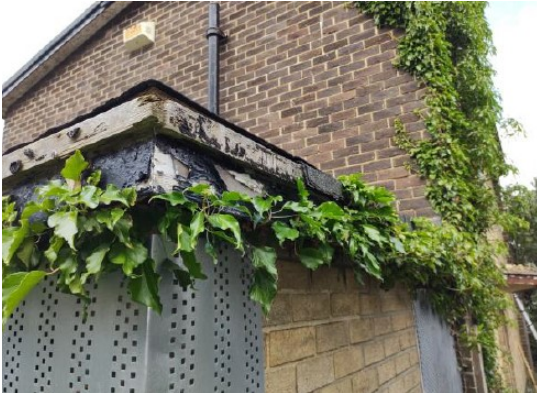
Item 59 Ref: 21-38916-6

The felt bitumen to outhouse roof (External) does not contain asbestos.

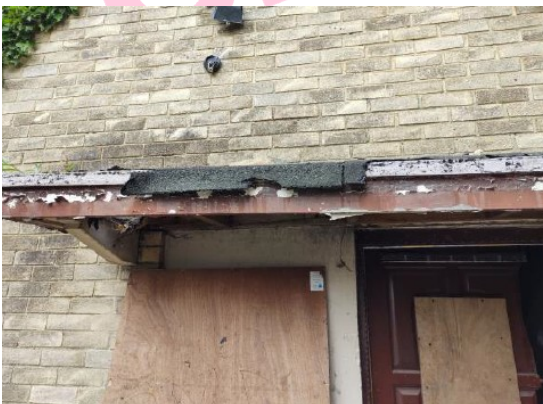
Item 60 Ref: 21-38916-6

The felt bitumen to canopy roof (External) does not contain asbestos.

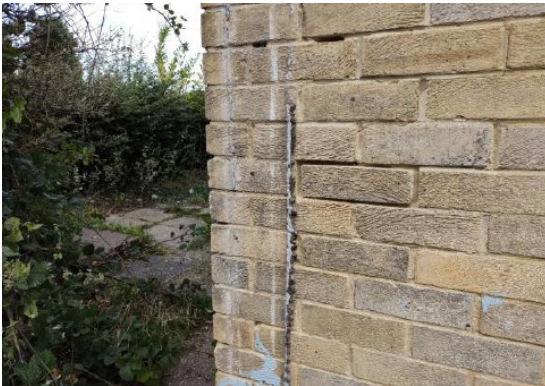
Item 61 Ref: 21-38916-7

The frame sealant to outhouse walls (External) does not contain asbestos.

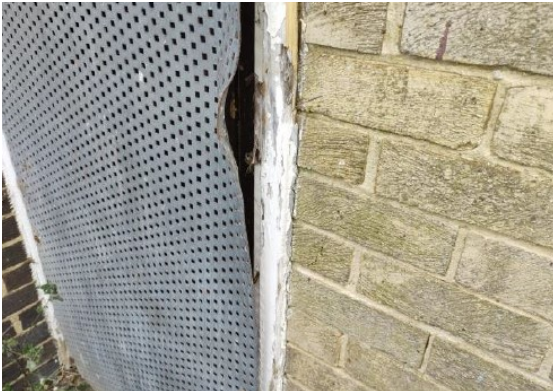
Item 62 Ref: 21-38916-8

The frame sealant to outhouse door (External) does not contain asbestos.

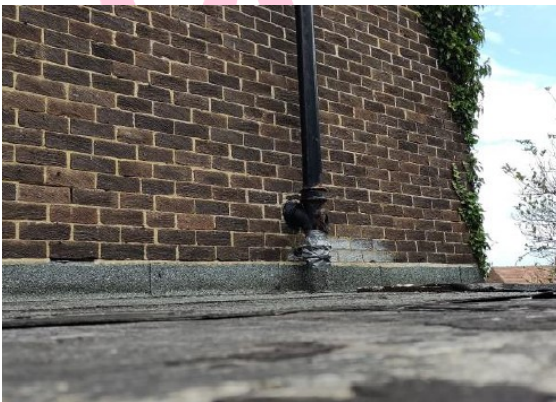
Item 63 Ref: 21-38916-9

The insulation joint compound to soil pipe (External) contains asbestos.
