ASBESTOS SURVEY REPORT FOR GLEBE COLLIERY WELFARE PARK, WASHINGTON

Glebe Colliery Welfare Park, Washington

Premises Manager / Samo: - Tenant Date: 06 January 2026

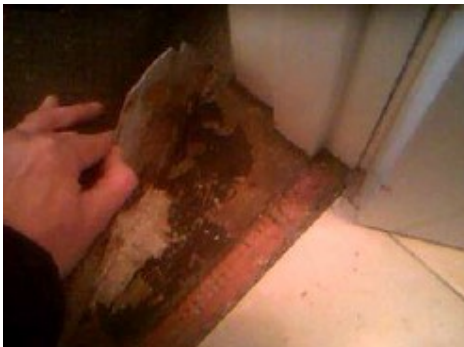
Item 2 - Ref: CB008862

The bitumen to concrete floor in Room 1 (Lobby) contains asbestos.

Any change in its appearance should be recorded and passed to Property Services.

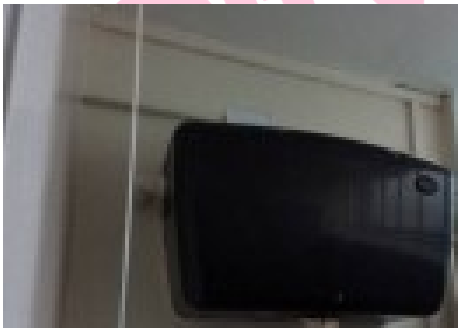
Item 3 - Ref: QY000252

The cisterns in Room 2 (Men's WC) contain asbestos.

Any change in its appearance should be recorded and passed to Property Services.

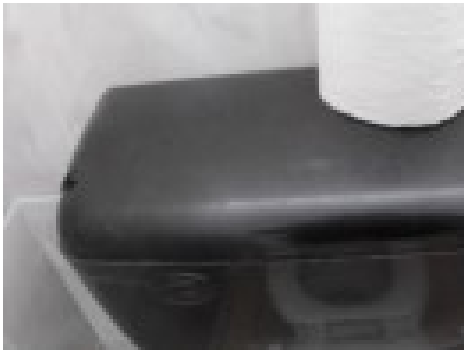
Item 4 - Ref: As QY000252

The cisterns in Room 3 (Ladies WC) contain asbestos.

Any change in its appearance should be recorded and passed to Property Services.

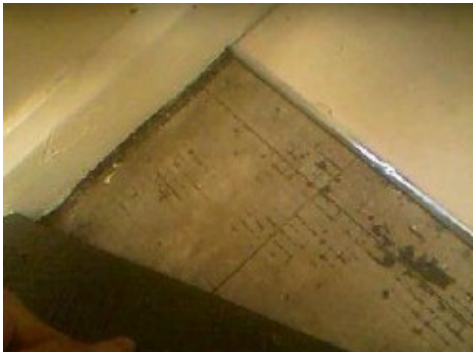
Item 5 - Ref: CB008864

The floor tiles beneath the carpet in Room 4 (Kitchen) contain asbestos.

Any change in its appearance should be recorded and passed to Property Services.

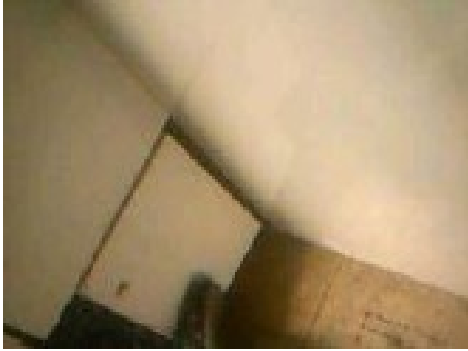
Item 7 - Ref: As CB008864

The floor tiles beneath the carpet in Room 5 (Lounge) contain asbestos.

Any change in its appearance should be recorded and passed to Property Services.

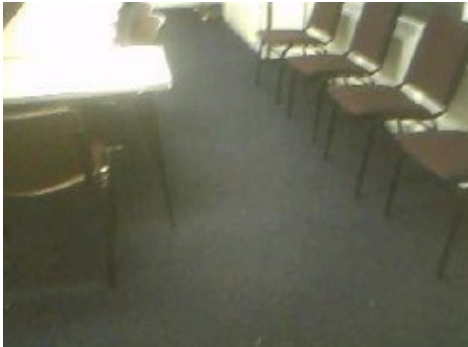
Item 8 - Ref: As CB008862

The bitumen to concrete floor in Room 5 (Lounge) contains asbestos.

Any change in its appearance should be recorded and passed to Property Services.

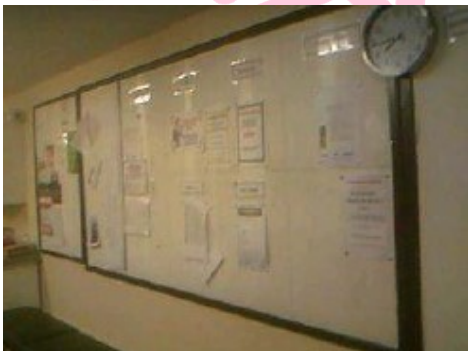
Item 9 - Ref: CB008865

The fibre board notice boards in Room 5 (Lounge) do not contain asbestos.

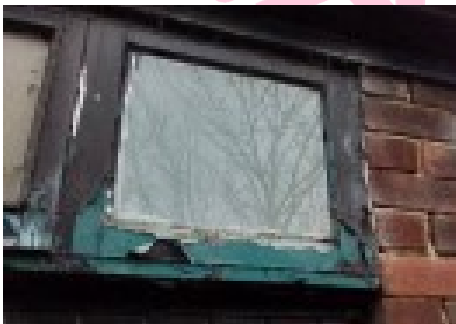
Item 12 Ref: QY000248

The Window - Beading Outer frame to wall (External) contains asbestos.

Removed April 2024

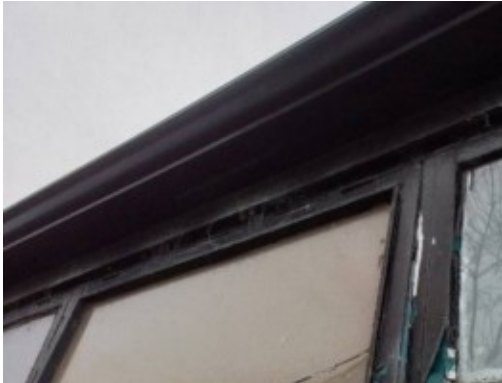
Item 13 Ref: QY000249

Window Putty/seal (External)
does not contain asbestos.

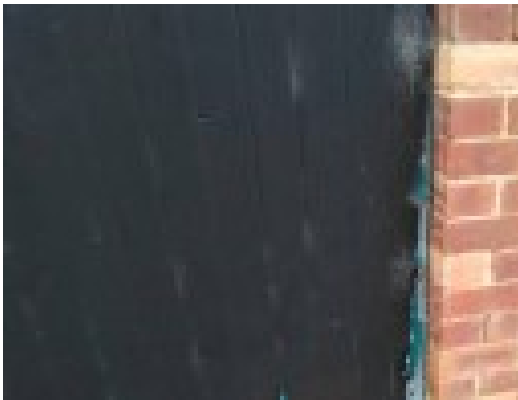
Item 14 Ref: QY000250

The Wall - Sheet/Cladding
Beading to wall (External)
contains asbestos.

Removed April 2024

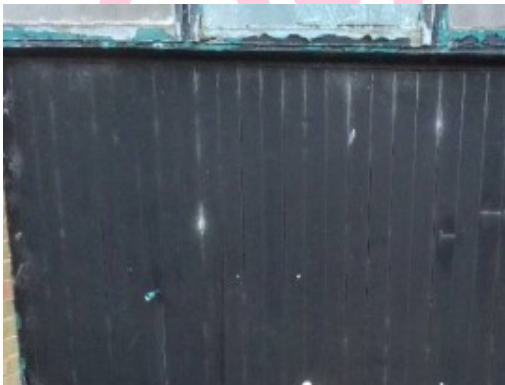
Item 15 Ref: QY000251

Wall - Lining Behind timber
cladding (External) does not
contain asbestos.
