ASBESTOS SURVEY REPORT FOR FULWELL DAY CENTRE FULWELL ROAD, SUNDERLAND, SR6 9QW.

Asbestos Register for Fulwell Day Centre, Fulwell Road, Sunderland

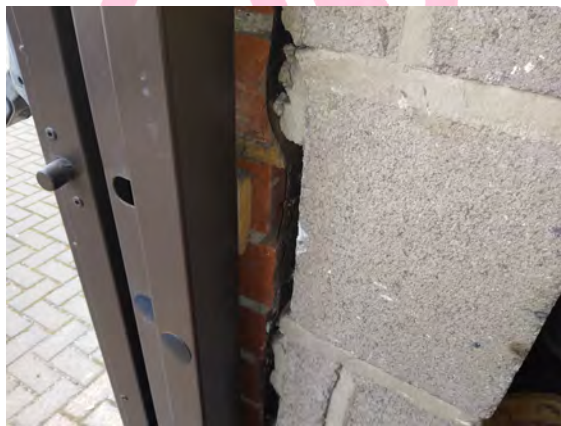
Item 3 Ref: 403866-30

The damp proof course in 0/002/Boiler Room does not contain asbestos.

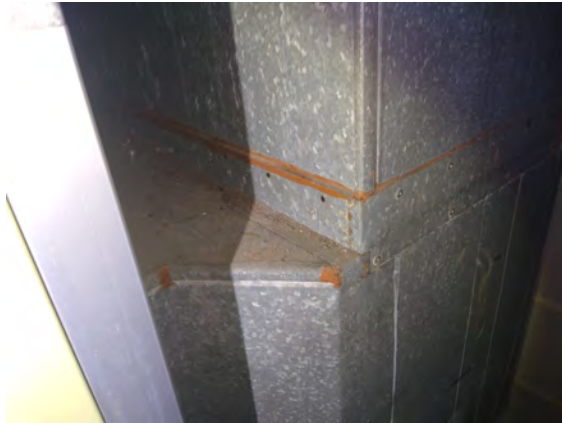
Item 4 Ref: 403866-28

The mastic to ducting in 0/004/Changing room 2 void above does not contain asbestos.

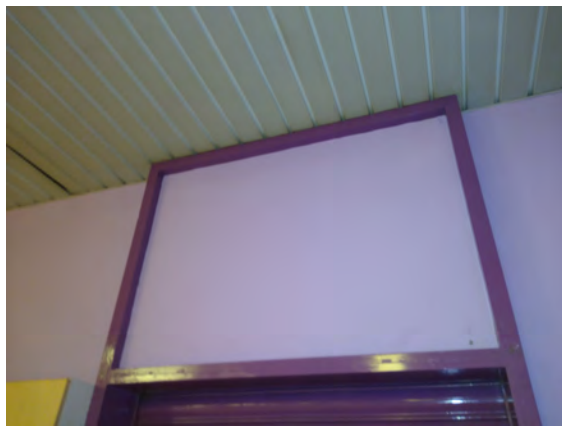
Item 5 Ref: 403866-27

The panel above servery in 0/10/Purple Room does not contain asbestos.

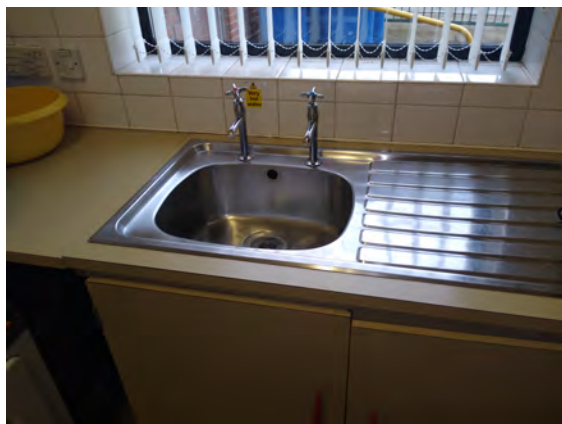
Item 6 Ref: 403866-29

The sink pad in 0/11/Laundry Room does not contain asbestos.

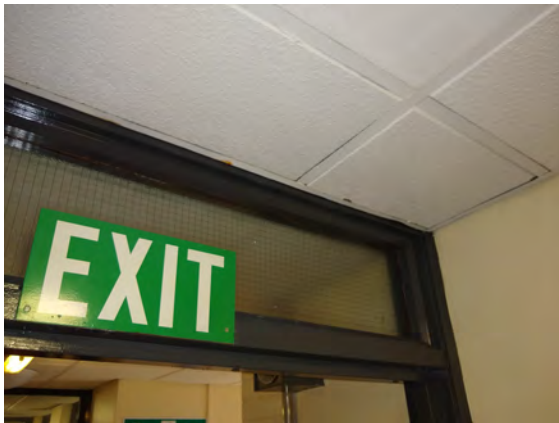
Item 8 Ref: 403866-19

The putty to glass door headers in 0/020/Corridor does not contain asbestos.

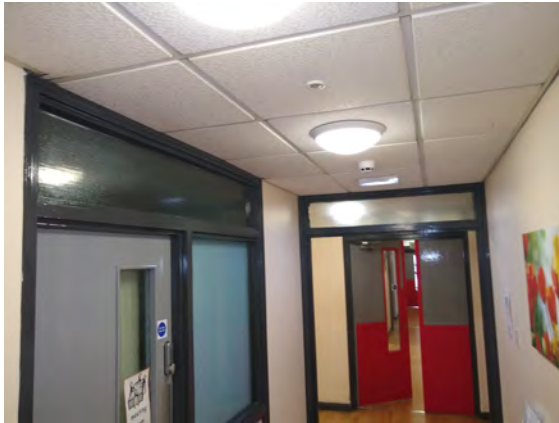
Item 10 Ref: 403866-31

The putty to glass door headers in 0/020a/Corridor does not contain asbestos.

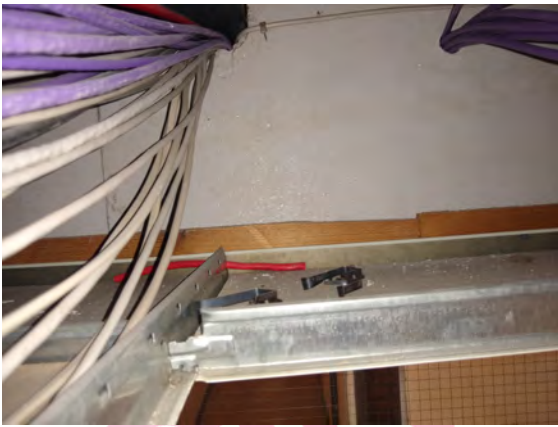
Item 14 Ref: 403866-16

The debris to top of ceiling tiles in 0/030/Corridor to stairwell void above does not contain asbestos.

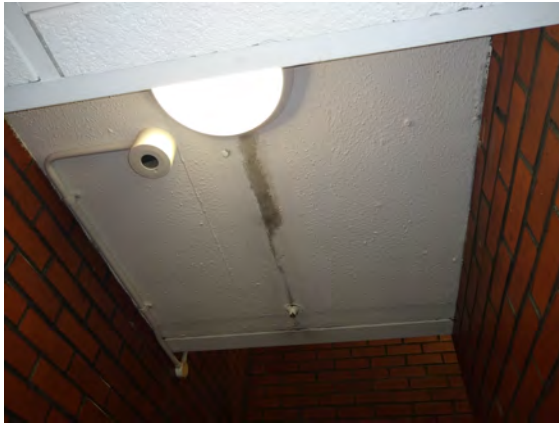
Item 16 Ref: 403866-18

The underside of floor above in 0/030b/Staircase contains asbestos.

Any change in its appearance should be recorded and passed to Property Services.

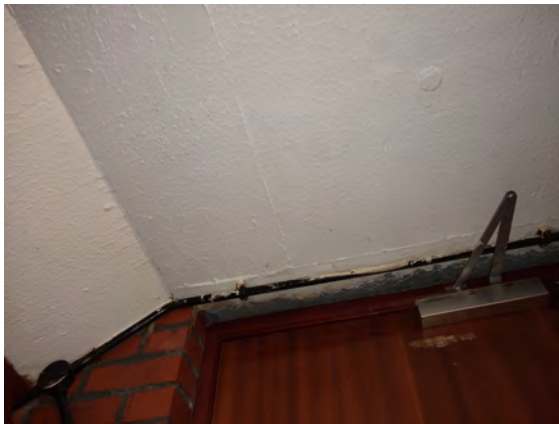
Item 17 Ref: 403866-32

The ceiling in 0/033/ Switchroom & lockers contains asbestos.

Any change in its appearance should be recorded and passed to Property Services.

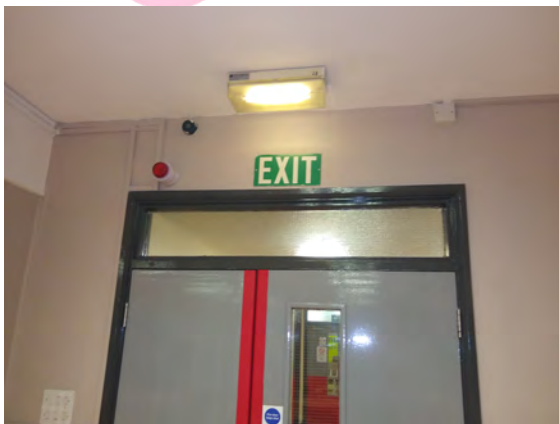
Item 18 Ref: As 403866-31

The putty to glass door headers in 0/033/Switchroom & lockers does not contain asbestos.

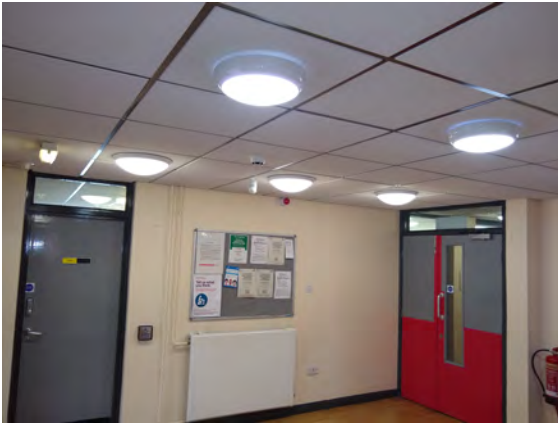
Item 19 Ref: As 403866-19

The putty to glass door headers in 0/034/Waiting area does not contain asbestos.

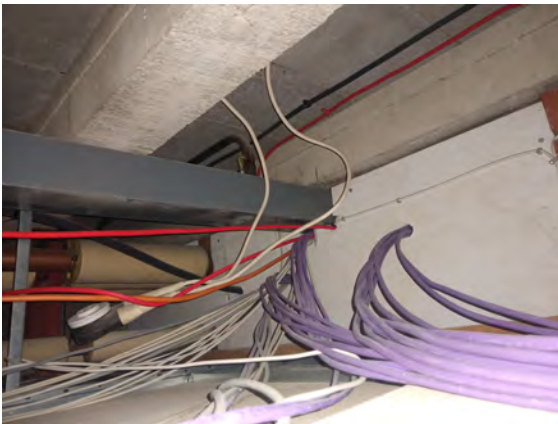
Item 20 Ref: 403866-1

The panels above doors in 0/034/Waiting area void above does not contain asbestos.

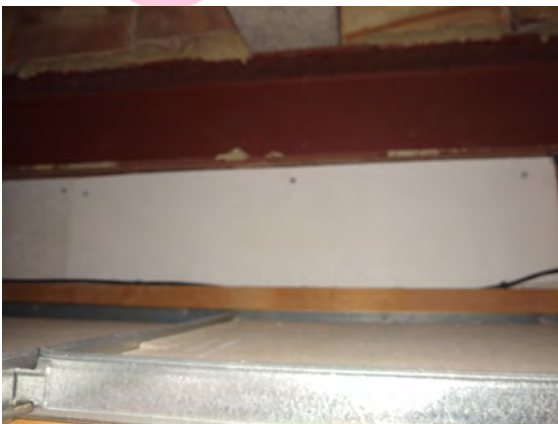
Item 21 Ref: As 403866-1

The panel to beam above reception in 0/034/Waiting area void above does not contain asbestos.

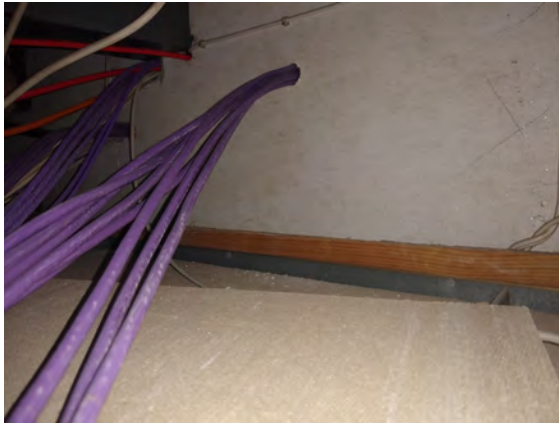
Item 22 Ref: 403866-2

The debris to ceiling tiles below door panel in 0/034/Waiting area void above does not contain asbestos.

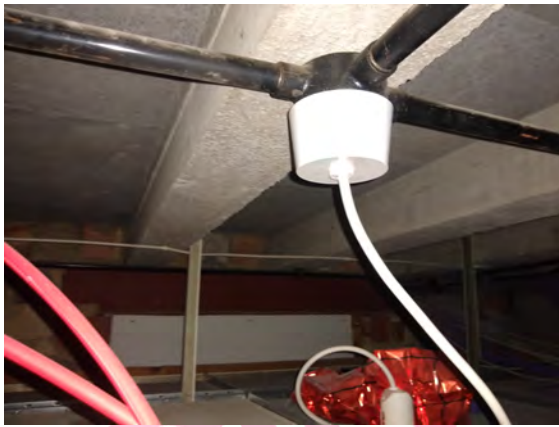
Item 23 Ref: As 403866-1

The panel to beam in 0/036/Reception void above does not contain asbestos.

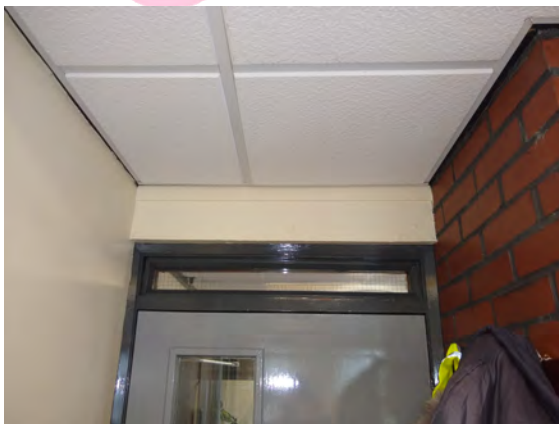
Item 24 Ref: 403866-4

The door header in 0/037/Office does not contain asbestos.

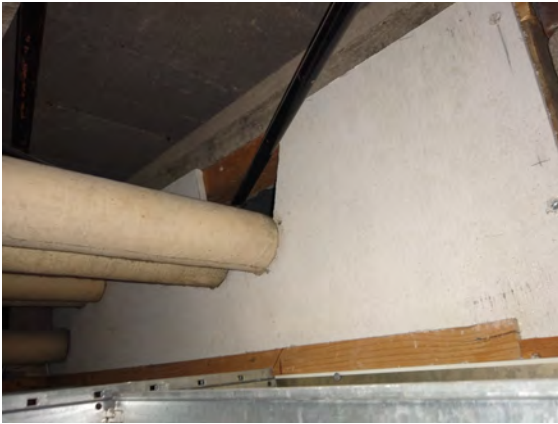
Item 25 Ref: As 403866-1

The panel above cupboard door in 0/040/Kitchen void above does not contain asbestos.

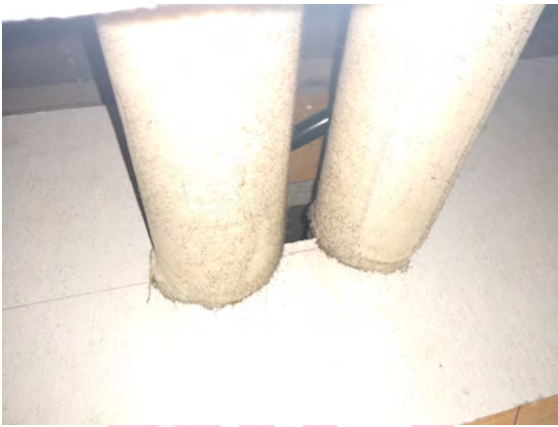
Item 26 Ref: As 403866-1

The panel above cupboard door in 0/040/Kitchen cupboard void above does not contain asbestos.

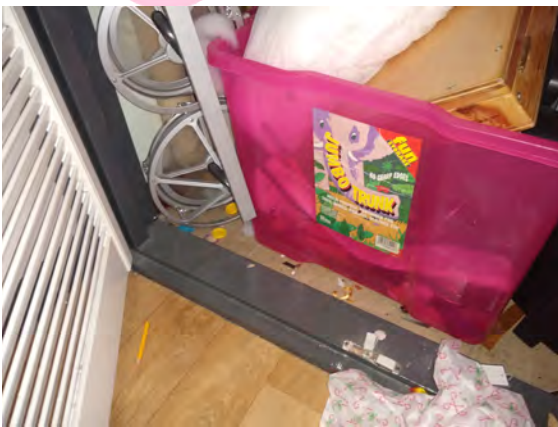
Item 27 Ref: 403866-3

The floor covering in 0/040a/Kitchen Cupboard does not contain asbestos.

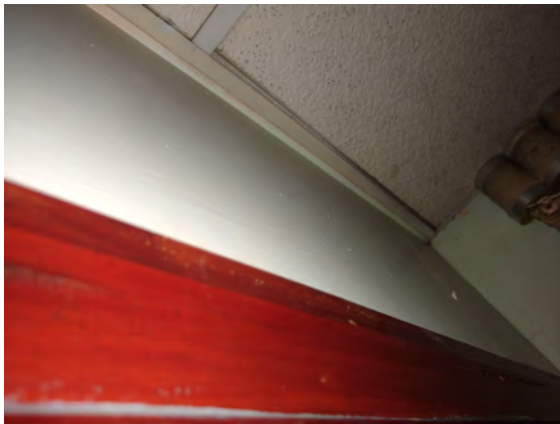
Item 28 Ref: As 403866-1

The door header in 0/040a/Kitchen Cupboard does not contain asbestos.

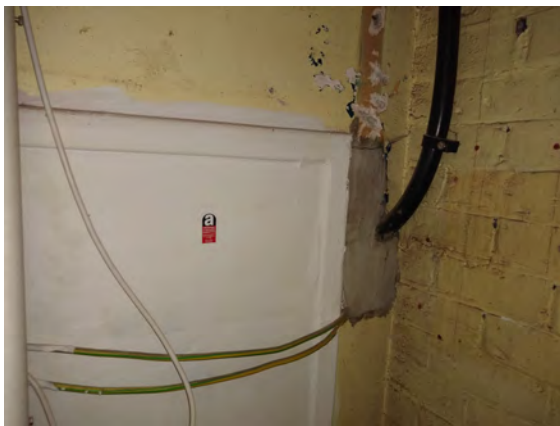
Item 29 Ref: 403866-33

The panel to rear of electrics in 0/043a/Dining room electrical cupboard contains asbestos.

Any change in its appearance should be recorded and passed to Property Services.

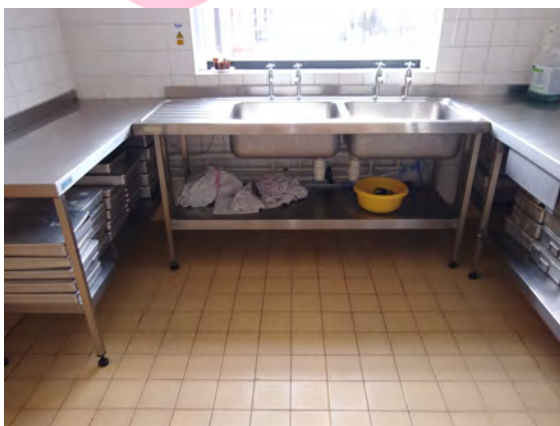
Item 30 Ref: 403866-34

The sink pad in 0/044/Kitchen does not contain asbestos.

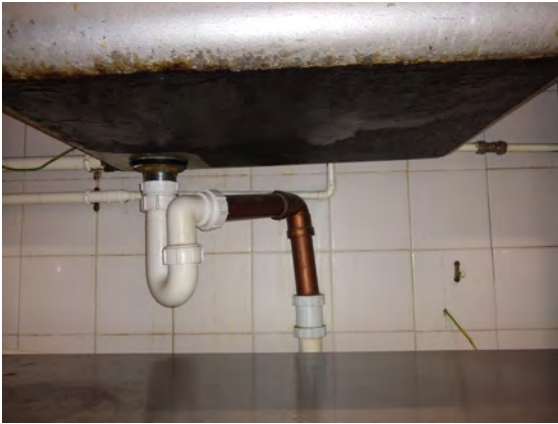
Item 31 Ref: 403866-35

The sink paint in 0/045/Service area does not contain asbestos.

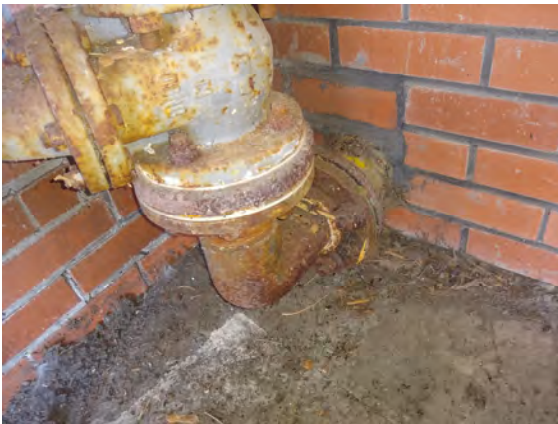
Item 32 Ref: 403866-38

The pipework flange gasket in 0/049/Gas meter cupboard contains asbestos.

Any change in its appearance should be recorded and passed to Property Services.

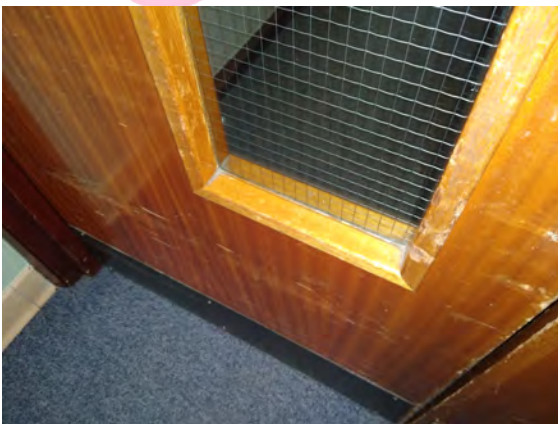
Item 33 Ref: As 403866-7

The sealant to door glazing in 1/048/Communal lounge does not contain asbestos.

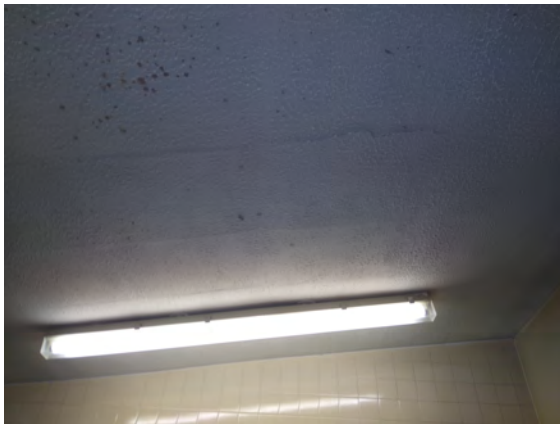
Item 41 Ref: 403866-25

The ceiling in 1/049a/Store contains asbestos.

Any change in its appearance should be recorded and passed to Property Services.

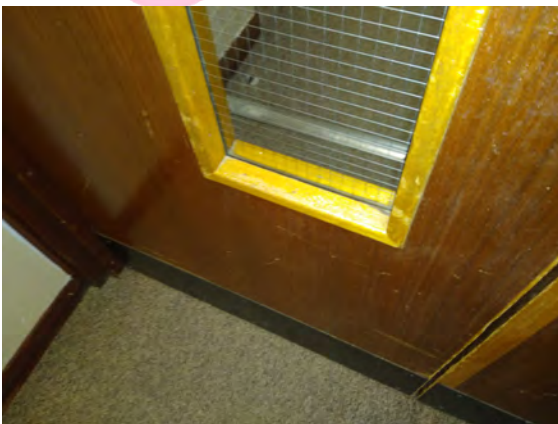
Item 60 Ref: As 403866-7

The sealant to door glazing in 1/053b/Corridor does not contain asbestos.
