ASBESTOS SURVEY REPORT FOR PENNYWELL CA, PORTSMOUTH ROAD,  
SUNDERLAND

## Asbestos Register for

**PENNYWELL CA, PORTSMOUTH ROAD  
SUNDERLAND**

**Date: 13 May 2026**

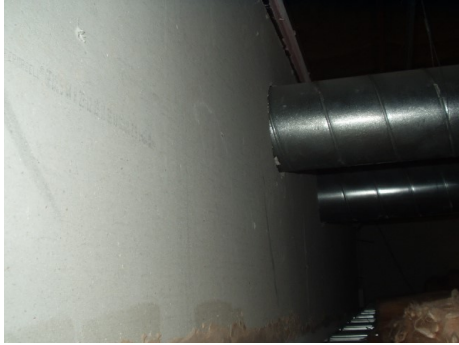
### **Item 1 Ref: AW0099/08**

The fire break to the ceiling void in the multipurpose room (Rm 0/01) does not contain asbestos.

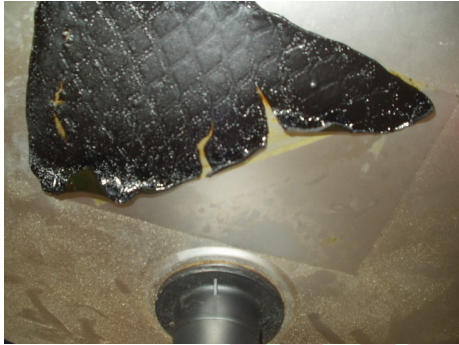
### **Item 2 - Ref: AW0100/08**

The sink pad to the small kitchen (Rm 0/08) does not contain asbestos.

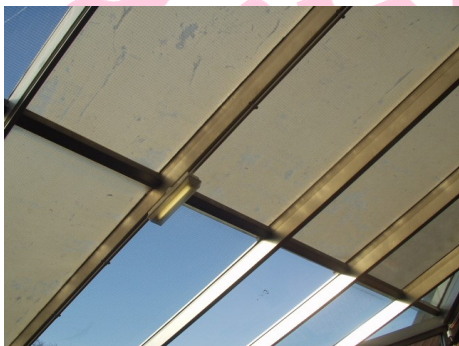
### **Item 3 - Ref: Presumed**

The window gaskets to the porch (Rm 0/12) are presumed to contain asbestos.

Any change in its appearance should be recorded and passed to Property Services.

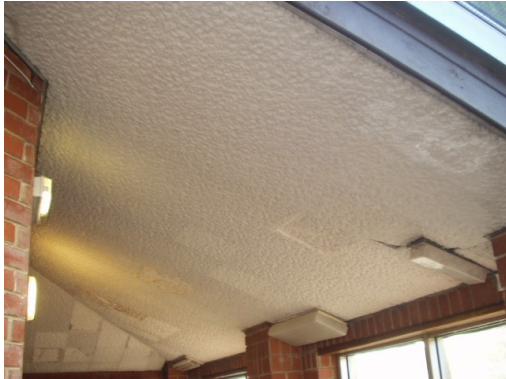
### **Item 4 - Ref: AW0101/08**

The suspended ceiling tile to the porch (Rm 0/12) does not contain asbestos.

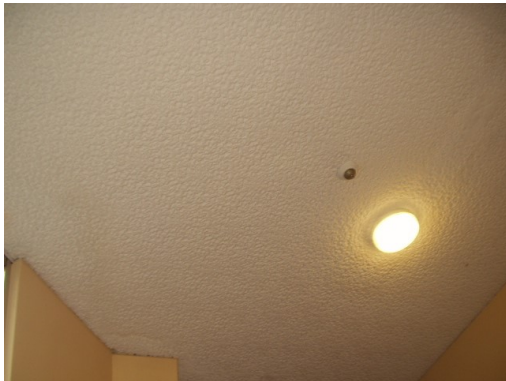
### **Item 5 - Ref: AW0102/08**

The ceiling tiles to the waiting room (Rm 0/13) do not contain asbestos.

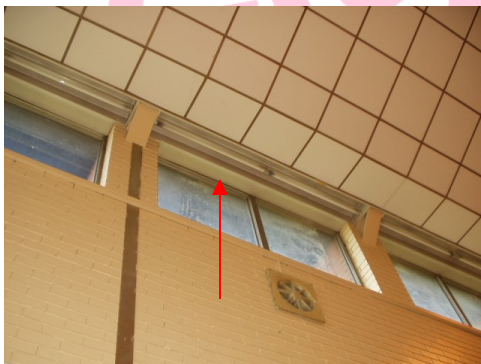
### **Item 6 - Ref: Presumed**

The soffits above the windows/lights in the main hall (Rm 0/14) are presumed to contain asbestos.

Any change in its appearance should be recorded and passed to Property Services.

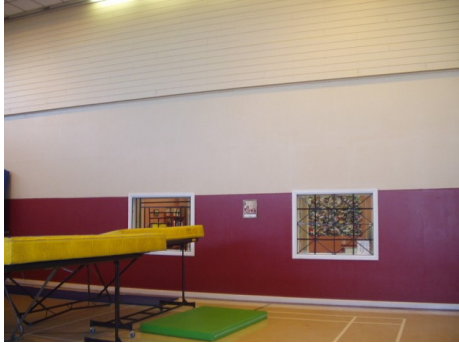
### **Item 7 - Ref: AW0103/08**

The partition wall to the main hall (Rm 0/14) does not contain asbestos.

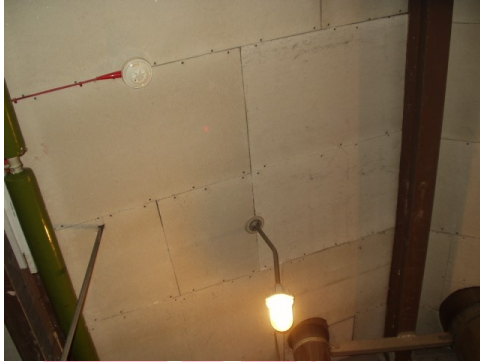
### **Item 8 - Ref: AW0104/08**

The ceiling to the boiler room (Rm 0/25) does not contain asbestos.

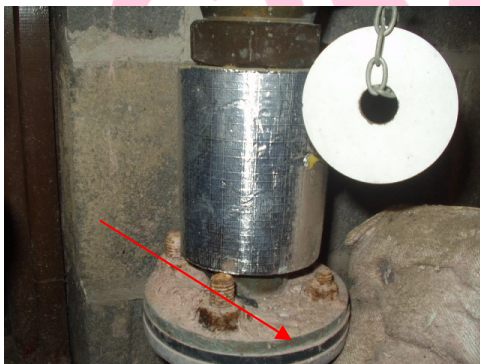
### **Item 9 - Ref: Presumed**

The pipework flange gaskets to the pipework in the boiler room (Rm 0/25) are presumed to contain asbestos.

Any change in its appearance should be recorded and passed to Property Services.

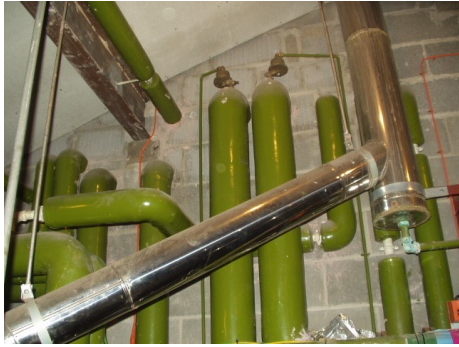
### **Item 10 - Ref: AW0106/08**

The insulation to the pipework in the boiler room (Rm 0/25) does not contain asbestos.

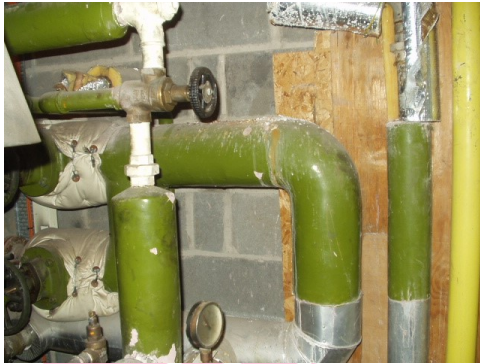
### **Item 11 - Ref: AW0107/08**

The insulation to the pipework in the boiler room (Rm 0/25) does not contain asbestos.

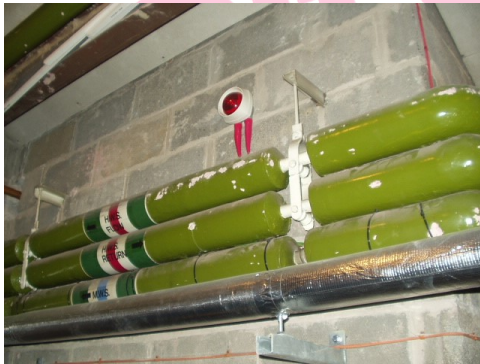
### **Item 12 - Ref: AW0105/08**

The insulation to the pipework in the boiler room (Rm 0/25) does not contain asbestos.

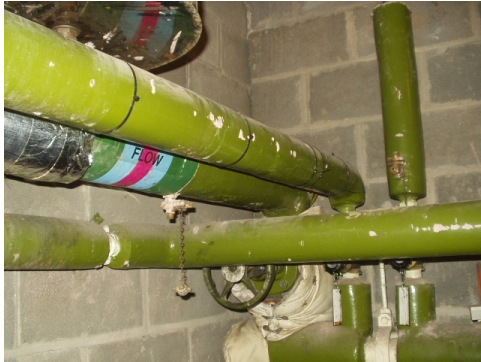
### **Item 13 - Ref: AW0108/08**

The insulation to the pipework in the boiler room (Rm 0/25) does not contain asbestos.

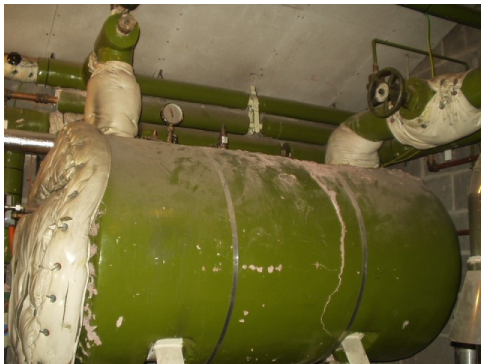
### **Item 14 - Ref: AW0109/08**

The insulation to the tank in the boiler room (Rm 0/25) does not contain asbestos.

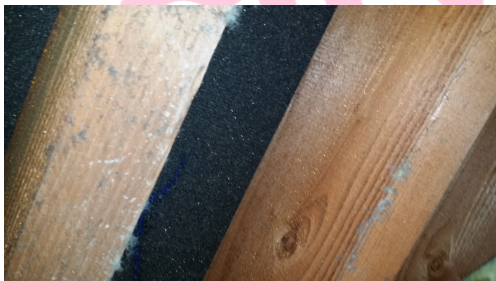
### **Item 15 - Ref: 220084-2**

The Sarking- bituminous felt in the multipurpose room-void above suspended ceiling- localised to proposed refurb works (Rm 0/01) - does not contain asbestos.

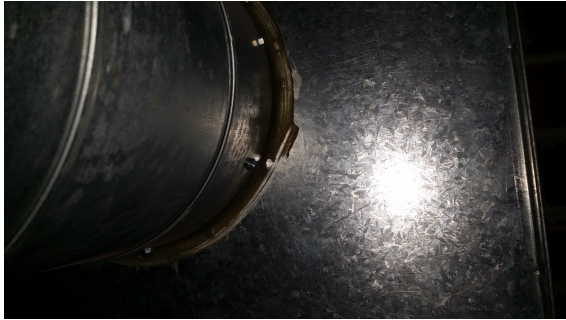
### **Item 16 - Ref: 220084-3**

The Sealant to ductwork in the multipurpose room -void above suspended ceiling- localised to proposed refurb works (Rm 0/01) - does not contain asbestos.

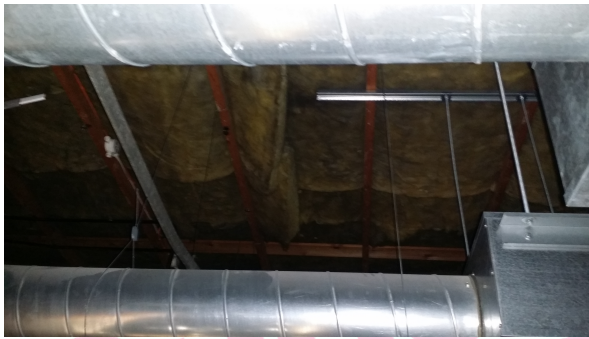
### **Item 17-Ref: As 220084-2**

The Sarking- bituminous felt in the computer room/coffee area-void above suspended ceiling- localised to proposed refurb works (Rm 0/02) - does not contain asbestos.

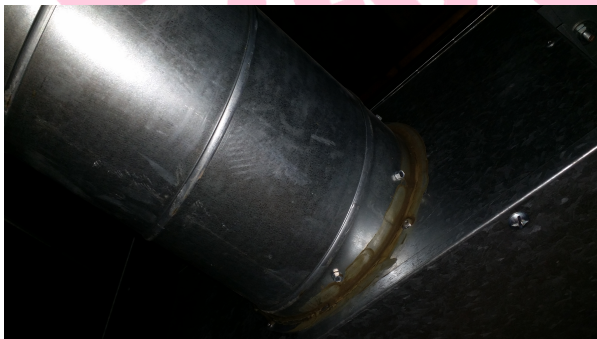
### **Item 18-Ref: As 220084-3**

The Sealant to ductwork in the computer room/coffee area - void above suspended ceiling- localised to proposed refurb works (Rm 0/02) - does not contain asbestos.

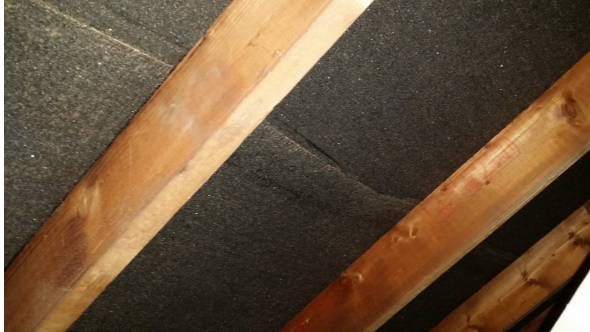
**Item 19-Ref: 220084-1**

The Roof Sarking bituminous felt in the Kitchen-void above suspended ceiling- localised to proposed refurb works (Rm 0/03) - does not contain asbestos.

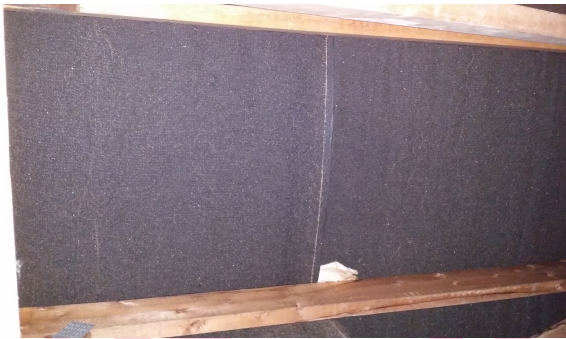
**Item 20-Ref: As 220084-1**

The Roof Sarking bituminous felt in the Utility room-void above suspended ceiling- localised to proposed refurb works (Rm 0/04) - does not contain asbestos.

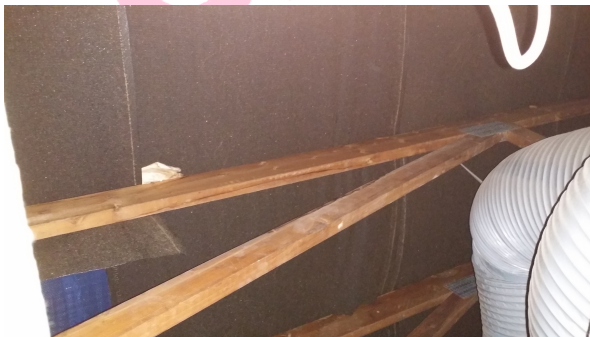
**Item 21-Ref: As 220084-1**

The Roof Sarking bituminous felt in the Corridor-void above suspended ceiling- localised to proposed refurb works (Rm 0/05) - does not contain asbestos.

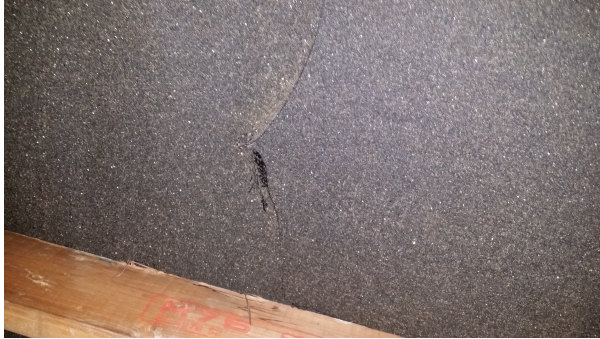
**Item 22-Ref: As 220084-1**

The Roof Sarking bituminous felt in the Female WC-void above suspended ceiling- localised to proposed refurb works (Rm 0/06) - does not contain asbestos.

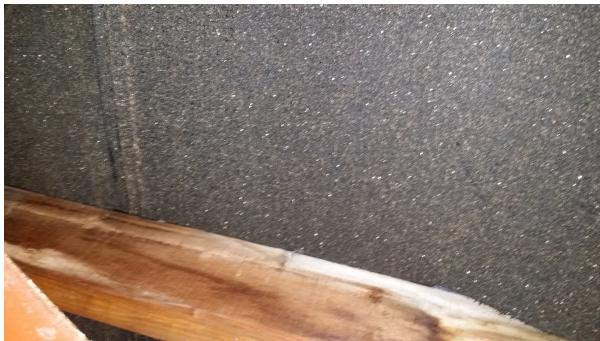
**Item 23-Ref: As 220084-1**

The Roof Sarking bituminous felt in the Male WC-void above suspended ceiling- localised to proposed refurb works (Rm 0/07) - does not contain asbestos.

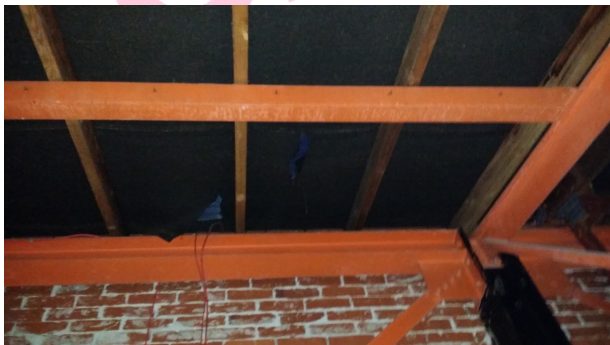
**Item 24-Ref: As 220084-2**

The Roof Sarking bituminous felt in the snack bar-void above suspended ceiling- localised to proposed refurb works (Rm 0/08) - does not contain asbestos.

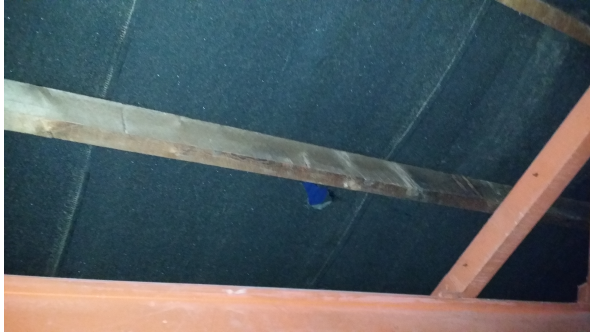
**Item 25-Ref: As 220084-2**

The Roof Sarking bituminous felt in the Office-void above suspended ceiling- localised to proposed refurb works (Rm 0/09) - does not contain asbestos.

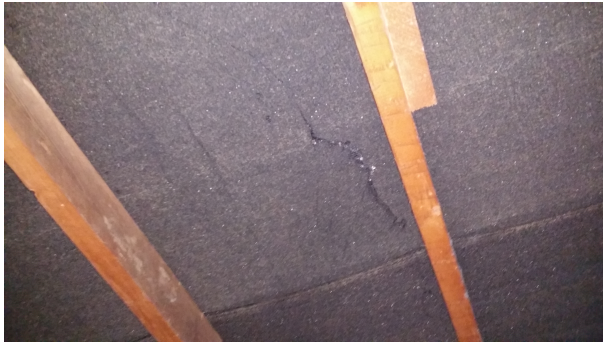
**Item 26-Ref: As 220084-1**

The Roof Sarking bituminous felt in the Caretakers Store-void above suspended ceiling- localised to proposed refurb works (Rm 0/10) - does not contain asbestos.

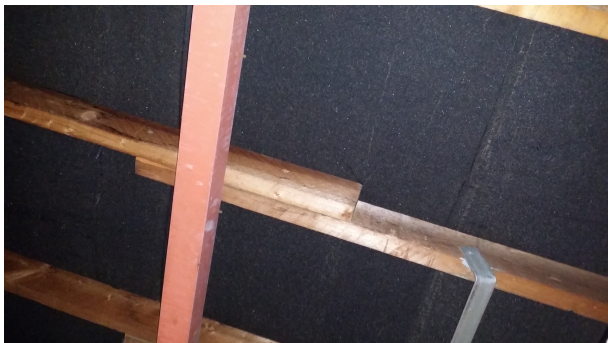
**Item 27-Ref: As 220084-1**

The Roof Sarking bituminous felt in the Caretakers Office-void above suspended ceiling- localised to proposed refurb works (Rm 0/11) - does not contain asbestos.

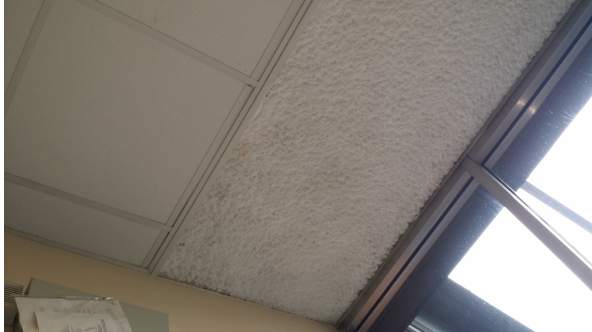
**Item 28-Ref: 220084-4**

The Previous suspended ceiling tiles in the games room- localised to proposed refurb works (Rm 0/13) - does not contain asbestos.

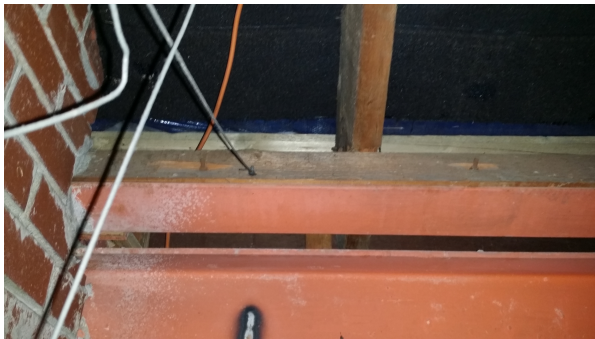
**Item 29-Ref: As 220084-2**

The Sarking bituminous felt in the games room-void above suspended ceiling- localised to proposed refurb works (Rm 0/13) - does not contain asbestos.

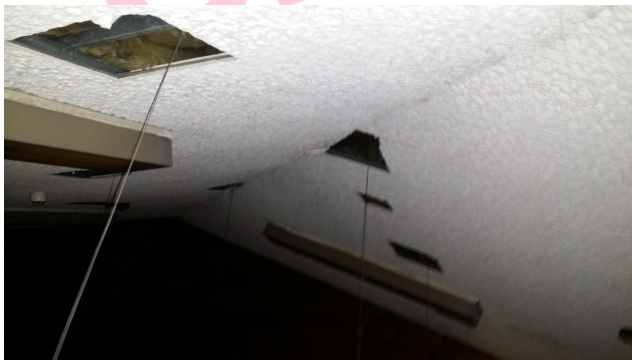
**Item 30-Ref: As 220084-4**

The Previous suspended ceiling tiles in the games room- localised to proposed refurb works (Rm 0/13) - does not contain asbestos.

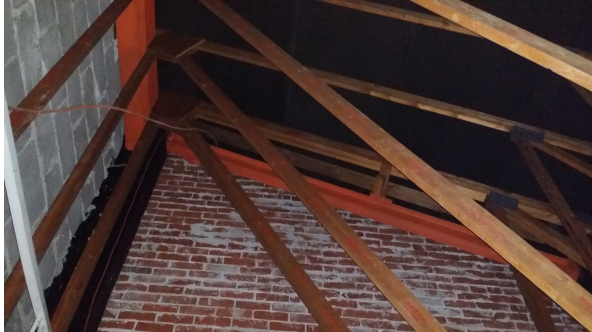
### **Item 31-Ref: 220084-5**

The Roof Sarking in the loft space- localised to proposed refurb works (Rm 1/01) - does not contain asbestos.

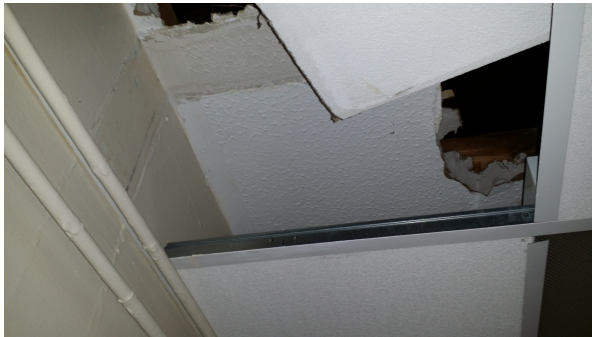
### **Item 32-Ref: 220084-6**

The coating to previous fixed ceiling in the loft space (Rm 1/01) is presumed to contain asbestos.

Any change in its appearance should be recorded and passed to Property Services.

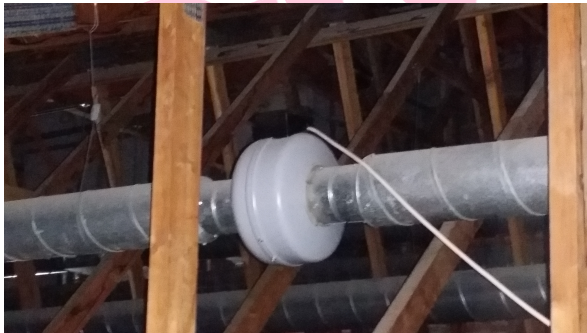
### **Item 33-Ref: As 220084-3**

The Sealant to ductwork in the loft space-localised to proposed refurb works (Rm 1/01) - does not contain asbestos.

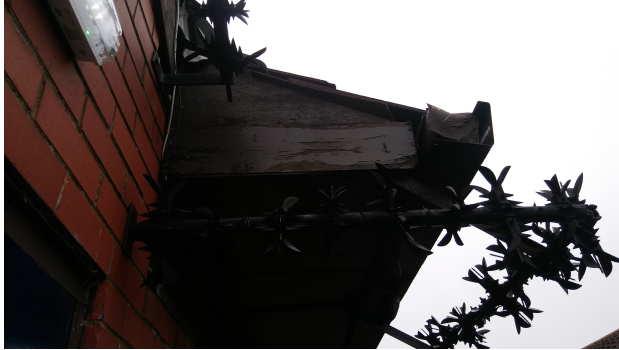
### **Item 34 : Ref 253789-8**

The Undercloak Fillet (Externals) contains asbestos. (Identified on survey carried out in boiler room for Pennywell Early Years)

Any changes should be reported to Property Services.

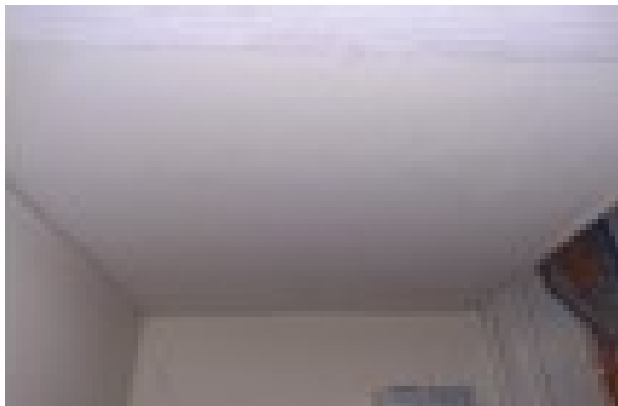
### **Item 36 : RT000198**

The Insulating board to ceiling (Electrical cupboard G/01) does not contain asbestos.
