ASBESTOS SURVEY REPORT FOR HOUGHTON RACECOURSE COMMUNITY CENTRE, BURDON AVENUE, HOUGHTON LE SPRING.

Asbestos Register for HOUGHTON RACECOURSE COMMUNITY CENTRE

UPRN: - 181279

Premises Manager / Samo: - Tenant Date: 30 May 2025

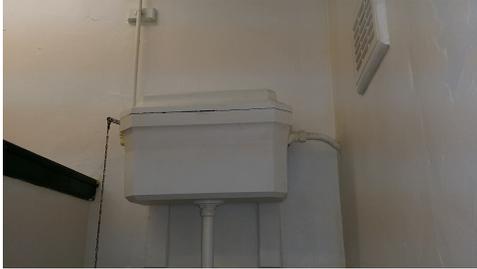
Item 1 Ref: 181279-3

181279-3 – Toilet cistern (Male WC) (Item 1) – Removed April 2017

The toilet cistern in the Male WC (Room 001) contain asbestos.

(Item has been removed April 2017)

Any change in its appearance should be recorded, and passed to Property Services.

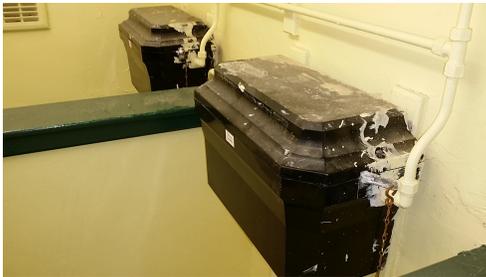
Item 2: As 181279-3

As 181279-3 – Toilet cistern (Female WC) (Item 2) – Removed April 2017

The toilet cistern in the Female WC (Room 003) contain asbestos.

(Item has been removed April 2017)

Any change in its appearance should be recorded, and passed to Property Services.

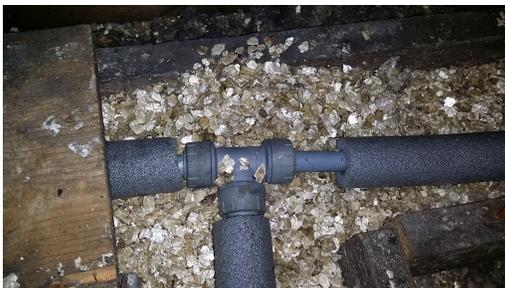
Item 3 Ref: 181279-1

181279-1 – Loose insulation (Female WC) (Item 3) – No Risk

The loose insulation in the loft void of the Female WC (Room 003) does not contain asbestos.

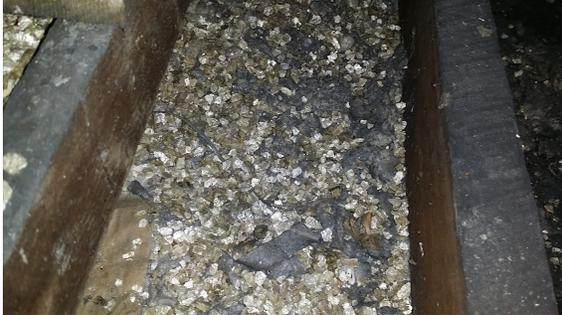
Item 4 Ref: As 181279-1

AS 181279-1 – Loose insulation (Female WC) (Item 4) – No Risk

The loose insulation in the loft void of the Female WC (Room 003) does not contain asbestos.

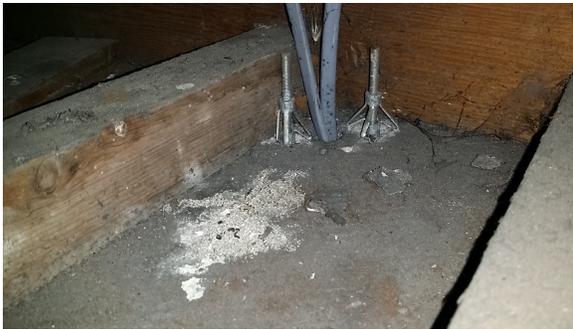
Item 5 Ref: 181279-2

181279-2 – Debris to top of canopy (Female WC) (Item 5) – Very Low Risk

The debris to the top of the canopy in the loft void of the Female WC (Room 003) contain asbestos.

Item 3	No asbestos	Is present		
Item 4	No asbestos	Is present		
Item 5	Debris - Female WC	Very Low Risk	12 monthly To be checked by analytical contractor	06.04.2026

Any change in its appearance should be recorded, and passed to Property Services.

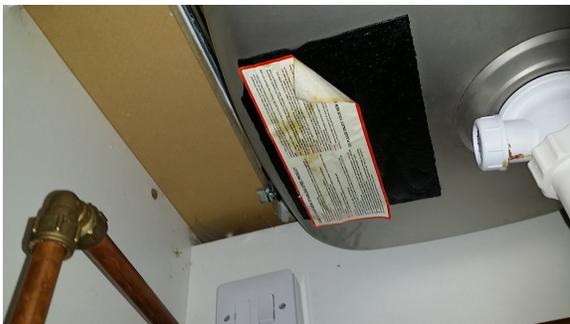
Item 6 Ref: 181279-4

181279-4 – Sink Pad (Kitchen) (Item 6) – No Risk

The sink pad in the kitchen (Room 004) does not contain asbestos.

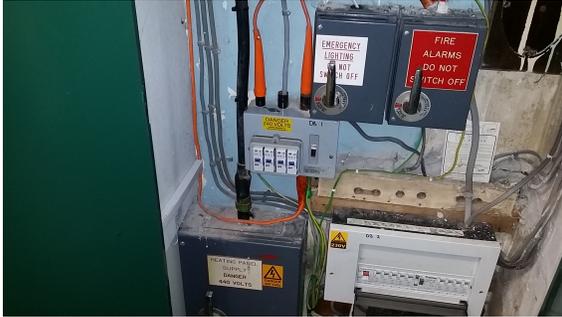
Item 7 Ref: Presumed

Presumed – Electrics (Kitchen) (Item 7) – Removed confirmed on reinspection survey J152715

The flash guards in the electric cupboard in the kitchen (Room 004) are presumed to contain asbestos.

Removed confirmed on reinspection survey J152715

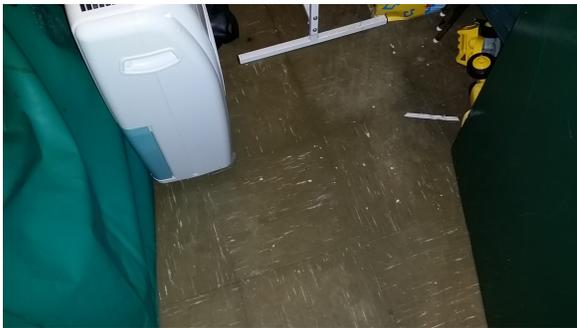
Item 8 Ref: 181279-7

181279-7 – Floor tile with bitumen adhesive (Store) (Item 8) – Very Low Risk

The floor tiles and adhesive in the Store (Room 007) contain asbestos.

Any change in its appearance should be recorded, and passed to Property Services.

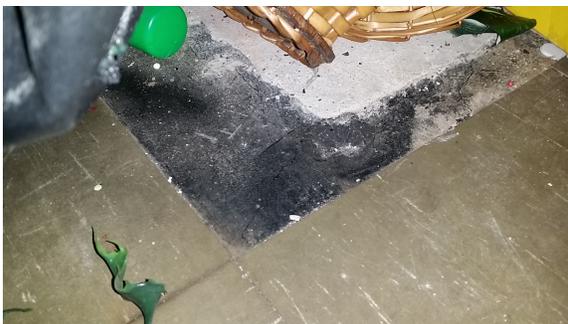
Item 9 Ref: 181279-8

181279-8 – Floor covering below floor tile (Store) (Item 9) – Very Low Risk

The floor covering below the floor tiles in the Store (Room 007) contain asbestos.

Any change in its appearance should be recorded, and passed to Property Services.

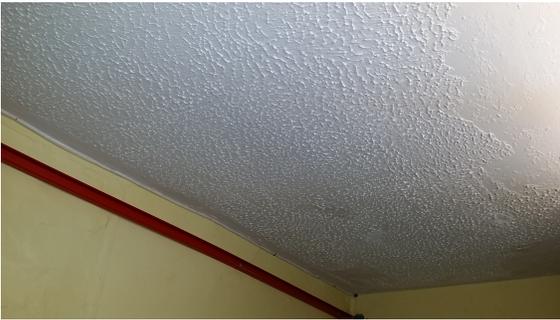
Item 10 Ref: 181279-5

181279-5 – Textured coating (Lobby) (Item 10) – No Risk

The textured coating in the Lobby (Room 008) does not contain asbestos.

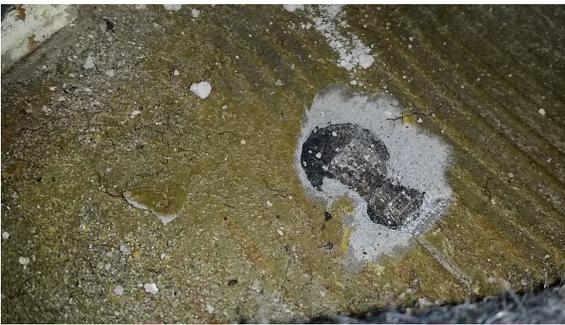
Item 11 Ref: 181279-6

181279-6 – Floor covering below carpet (Lobby) (Item 11) – No Risk

The floor covering below the carpet in the Lobby (Room 008) does not contain asbestos.

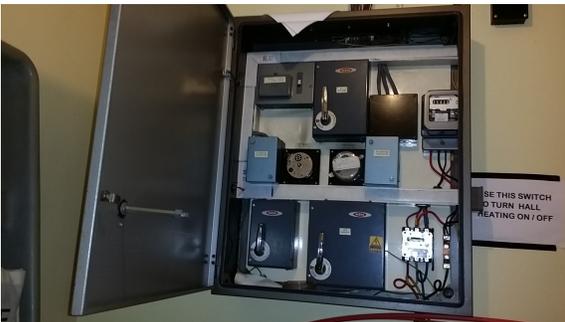
Item 12 Ref: Presumed

Presumed – Electrics (Lobby) (Item 12) – Removed confirmed on reinspection survey J152715

The Electrics in the Lobby (Room 008) are presumed to contain asbestos.

Removed confirmed on reinspection survey J152715

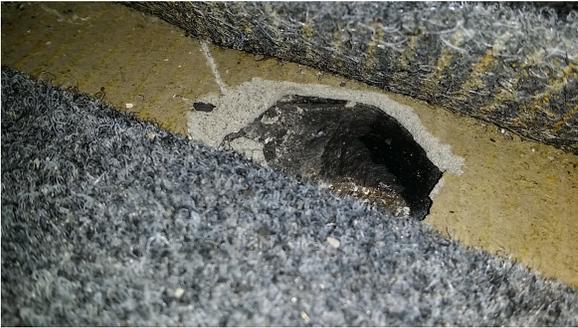
Item 13 Ref: As 181279-6

As 181279-6 – Floor covering below carpet (Computer Room) (Item 13) – No Risk

The floor covering below the carpet in the Computer Room (Room 009) does not contain asbestos.

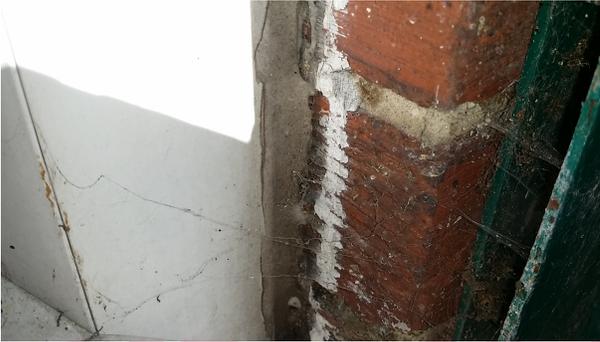
Item 14 Ref: 181279-9

181279-9 – Mastic in brick reveals (External) (Item 14) – No Risk

The mastic in brick (External) does not contain asbestos.

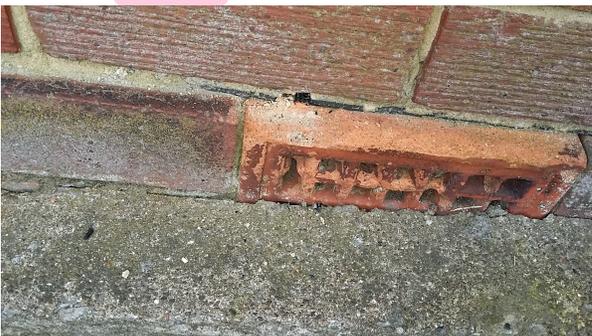
Item 15 Ref: 181279-10

181279-10 – Damp proof course (External) (Item 15) – No Risk

The damp proof course (External) does not contain asbestos.

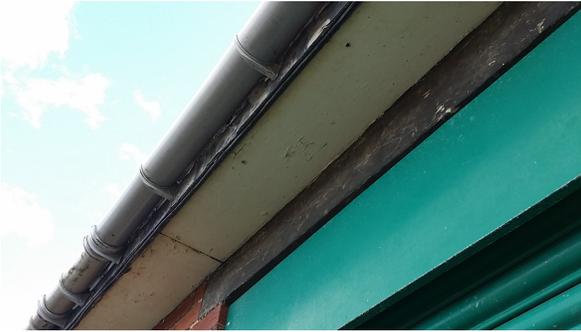
Item 16 Ref: 181279-11

181279-11 – Soffit to eaves (External) (Item 16) – Very Low Risk

The soffit to the eaves (External) does contain asbestos.

Any change in its appearance should be recorded, and passed to Property Services.

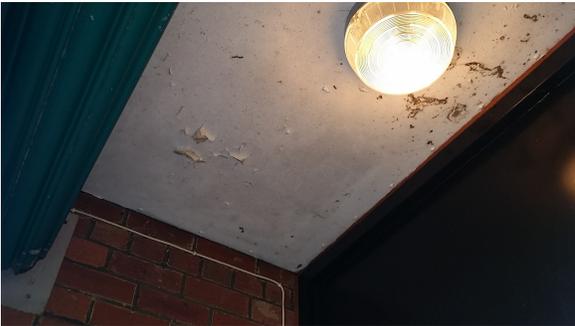
Item 17 Ref: As 181279-11

As 181279-11 – Soffit in main entrance (External) (Item 17) – Very Low Risk

The soffit in the main entrance (External) does contain asbestos.

Any change in its appearance should be recorded, and passed to Property Services.

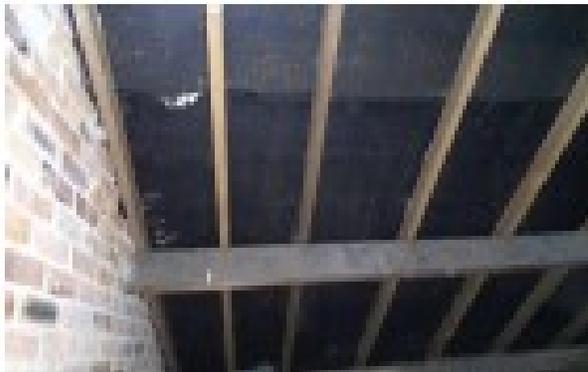
Item 18 Ref: KG000459

KG000459 – Sarking Roof (Loft void above WC L/01) (Item 18) – No Risk

The sarking roof (Loft void above WC L/01) does not contain asbestos.

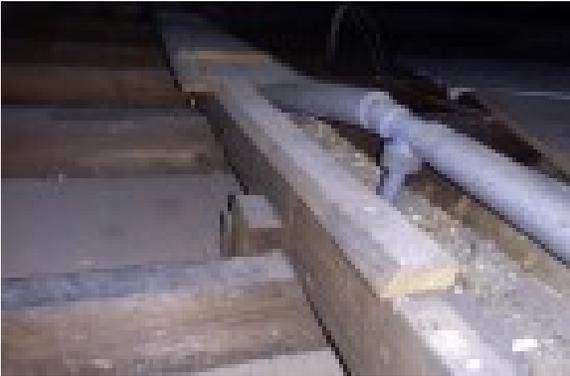
Item 19 Ref: KG000460

KG000460 – Insulation floor (Loft void above WC L/01) (Item 19) – No Risk

The insulation floor in the loft void above WC (L/01) does not contain asbestos.

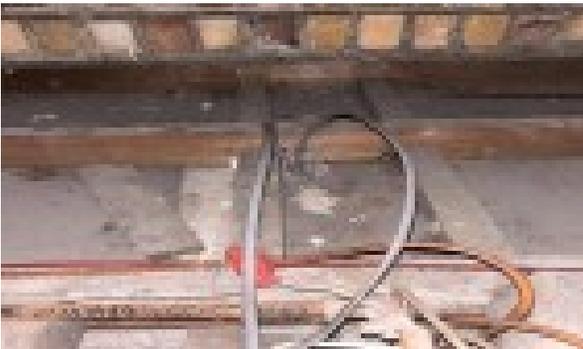
Item 20 Ref: As KG000458

As KG000458 – Cement debris and panel soffit above entrance (Loft void above WC L/01) (Item 20) – Low Risk

The cement debris and panel soffit above entrance (Loft void above WC L/01) does contain asbestos.

Any change in its appearance should be recorded, and passed to Property Services.
