ASBESTOS SURVEY REPORT FOR HOUGHTON RACECOURSE COMMUNITY CENTRE, BURDON AVENUE, HOUGHTON LE SPRING.

Asbestos Register for

HOUGHTON RACECOURSE COMMUNITY CENTRE

UPRN: - 181279

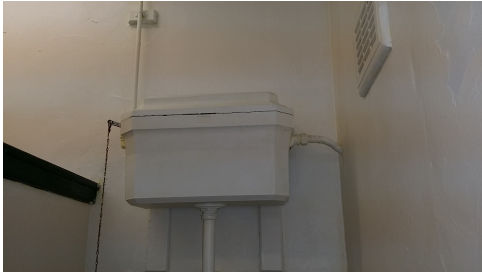
Item 1 Ref: 181279-3

The toilet cistern in the Male WC (Room 001) contains asbestos.

(Item has been removed - April 2017)

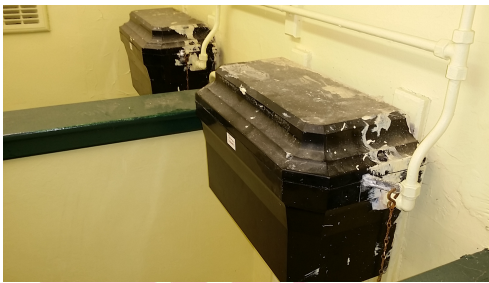
Item 2: As 181279-3

The toilet cistern in the Female WC (Room 003) contains asbestos.

(Item has been removed - April 2017)

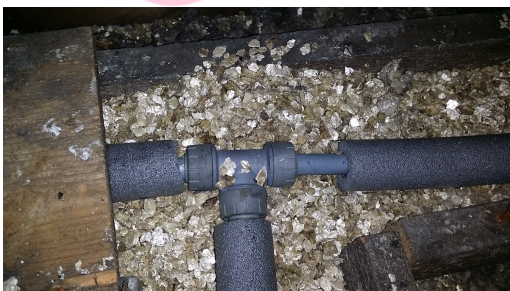
Item 3 Ref: 181279-1

The loose insulation in the loft void of the Female WC (Room 003) does not contain asbestos.

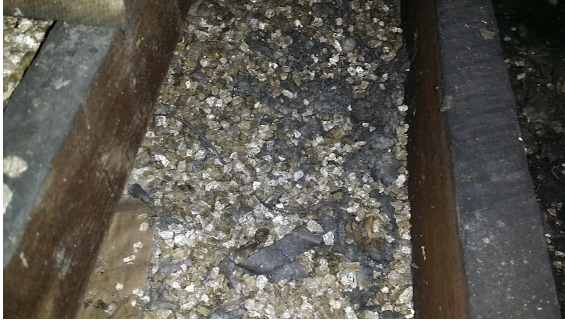
Item 4 Ref: As 181279-1

The loose insulation in the loft void of the Female WC (Room 003) does not contain asbestos.

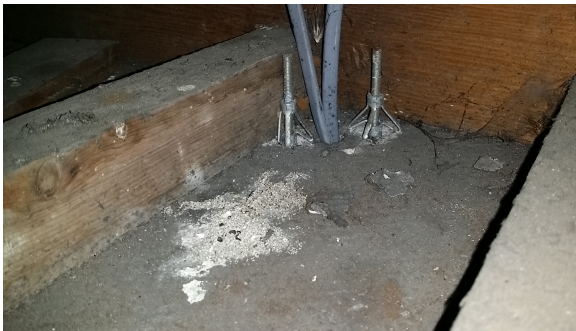
Item 5 Ref: 181279-2

The debris to the top of the canopy in the loft void of the Female WC (Room 003) contain asbestos.

Duplicated item – see Item 20

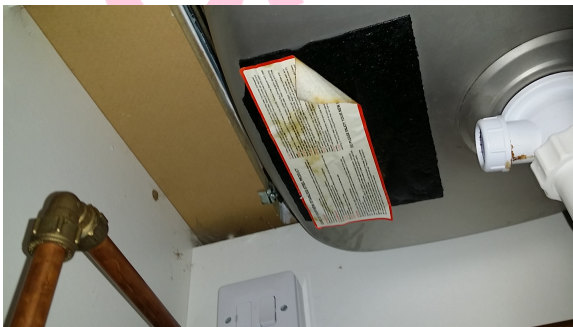
Item 6 Ref: 181279-4

The sink pad in the kitchen (Room 004) does not contain asbestos.

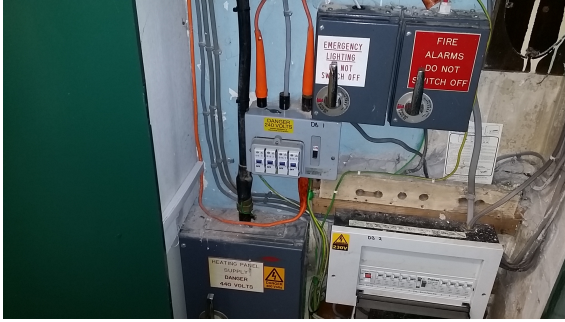
Item 7 Ref: Presumed

The flash guards in the electric cupboard in the kitchen (Room 004) are presumed to contain asbestos.

Removed confirmed on reinspection survey J152715

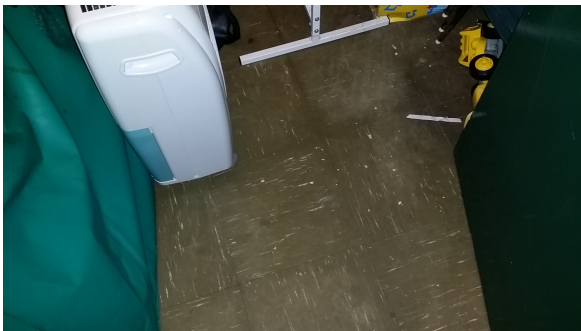
Item 8 Ref: 181279-7

181279-7 – Floor tile with bitumen adhesive (Store) (Item 8) – Very Low Risk

The floor tiles and adhesive in the Store (Room 007) contain asbestos.

Any change in its appearance should be recorded and passed to Property Services.

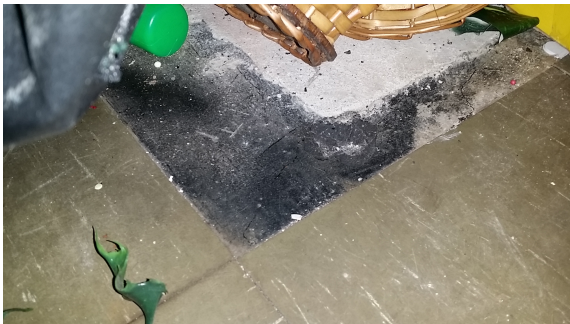
Item 9 Ref: 181279-8

181279-8 – Floor covering below floor tile (Store) (Item 9) – Very Low Risk

The floor covering below the floor tiles in the Store (Room 007) contain asbestos.

Any change in its appearance should be recorded and passed to Property Services.

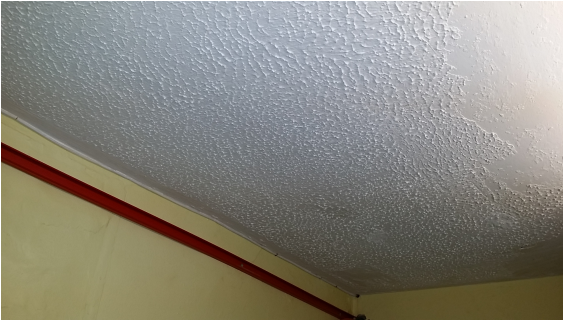
Item 10 Ref: 181279-5

The textured coating in the Lobby (Room 008) does not contain asbestos.

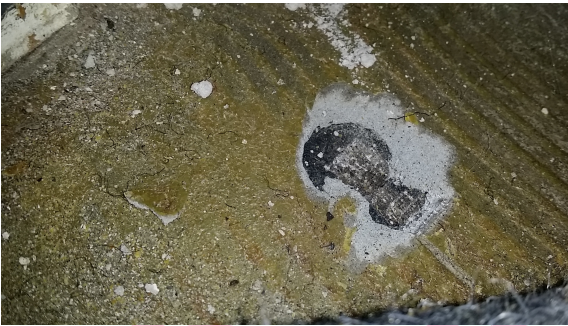
Item 11 Ref: 181279-6

The floor covering below the carpet in the Lobby (Room 008) does not contain asbestos.

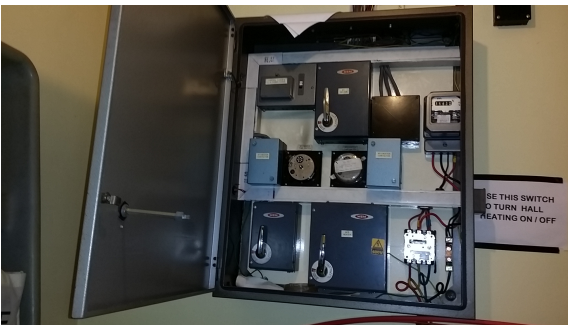
Item 12 Ref: Presumed

The Electrics in the Lobby (Room 008) are presumed to contain asbestos.

Removed confirmed on reinspection survey J152715

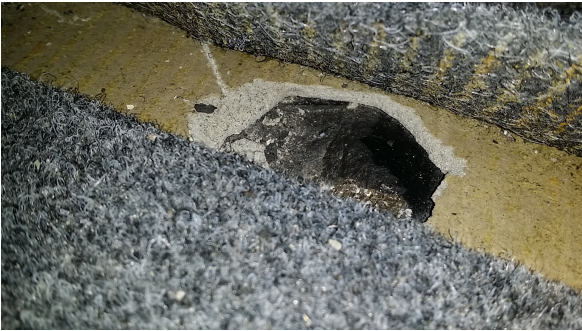
Item 13 Ref: As 181279-6

The floor covering below the carpet in the Computer Room (Room 009) does not contain asbestos.

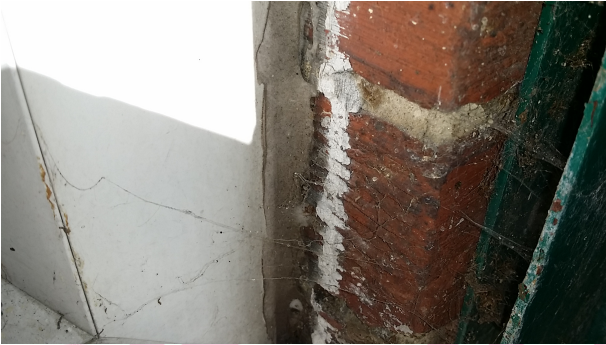
Item 14 Ref: 181279-9

The mastic in brick reveals (External) does not contain asbestos.

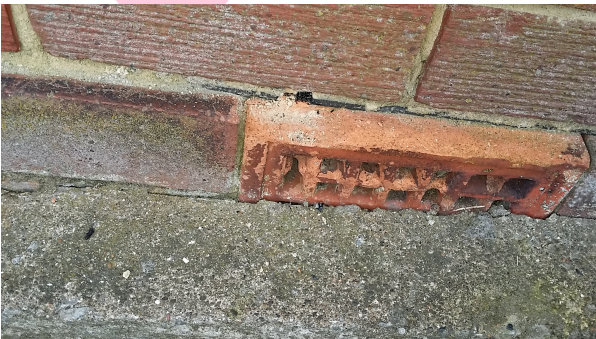
Item 15 Ref: 181279-10

The damp proof course (External) does not contain asbestos.

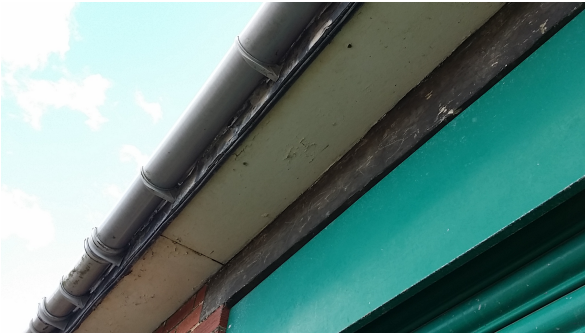
Item 16 Ref: 181279-11

181279-11 – Soffit to eaves (External) (Item 16) – Very Low Risk

The soffit to the eaves (External) does contain asbestos.

Any change in its appearance should be recorded and passed to Property Services.

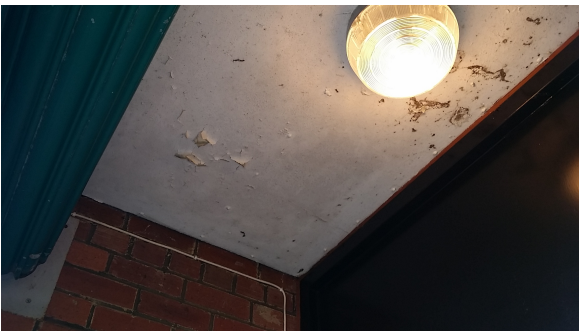
Item 17 Ref: As 181279-11

As 181279-11 – Soffit in main entrance (External) (Item 17) – Very Low Risk

The soffit in the main entrance (External) does contain asbestos.

Any change in its appearance should be recorded and passed to Property Services.

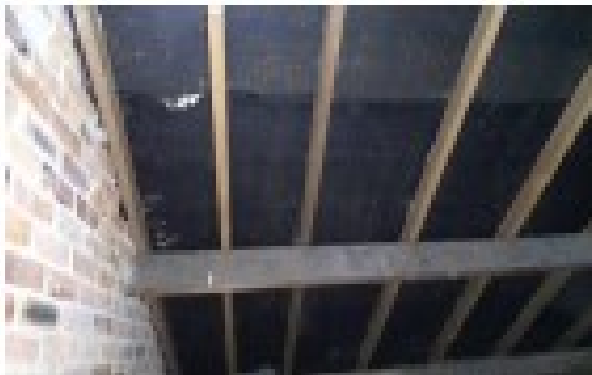
Item 18 Ref: KG000459

The sarking roof (Loft void above WC L/01) does not contain asbestos.

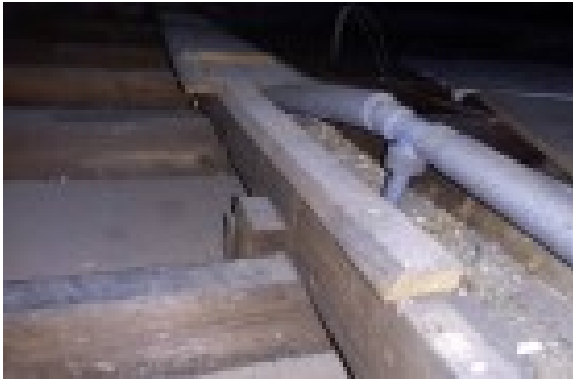
Item 19 Ref: KG000460

The insulation floor in the loft void above WC (L/01) does not contain asbestos.

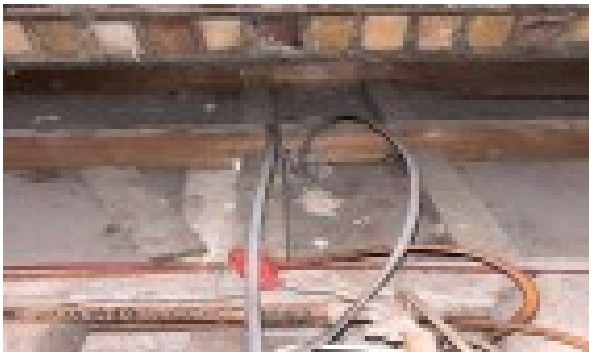
Item 20 Ref: As KG000458

As KG000458 – Cement debris and panel soffit above entrance (Loft void above WC L/01) (Item 20) – Low Risk

The cement debris and panel soffit above entrance (Loft void above WC L/01) does contain asbestos.

Any change in its appearance should be recorded and passed to Property Services.
