ASBESTOS SURVEY REPORT FOR 22-29 BURLINGTON CLOSE, SUNDERLAND

Asbestos Register for

22-29 Burlington Close, SUNDERLAND

Date: 25th September 2025

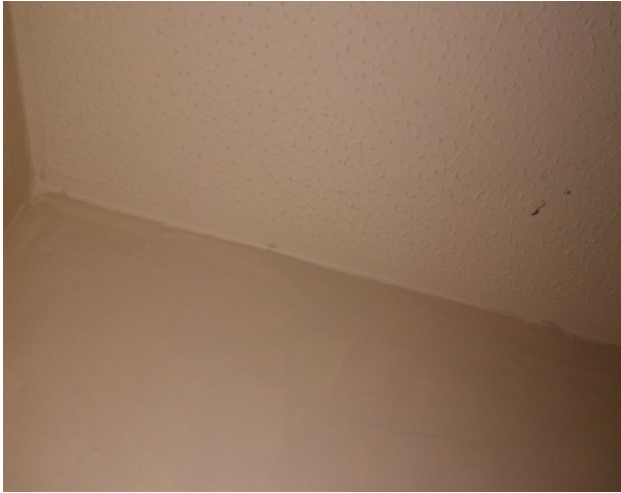
Item 1: 218354-1

The textured coating to the ceiling in the cupboard of 22 Burlington Close does contain asbestos.

Any change in its appearance should be recorded and passed to Property Services.

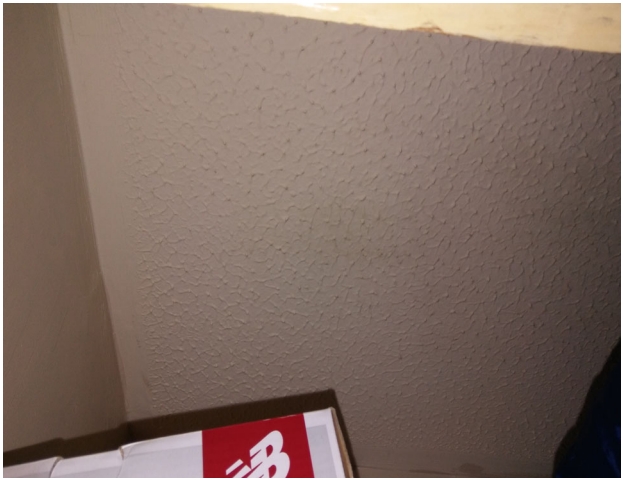
Item 2: As 218354-1

The textured coating to the ceiling in the cupboard of 25 Burlington Close does contain asbestos.

Any change in its appearance should be recorded and passed to Property Services.

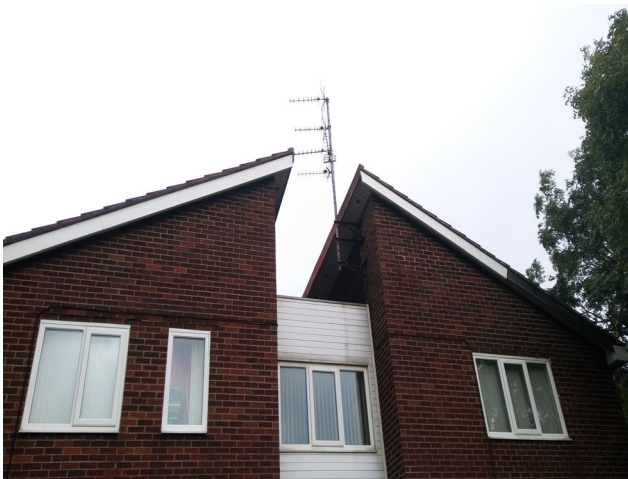
Item 3: 218354-2

The cement roof undercloak to the external of 25 Burlington Close does contain asbestos.

Any change in its appearance should be recorded and passed to Property Services.

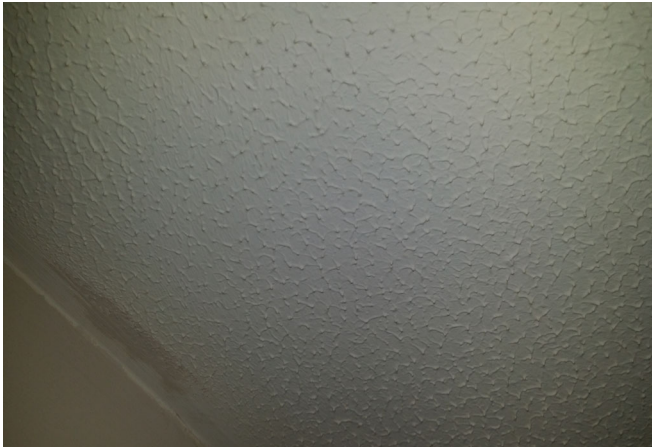
Item 4: 218354-7

The textured coating to the ceiling in the cupboard of 26 Burlington Close does contain asbestos.

Any change in its appearance should be recorded and passed to Property Services.

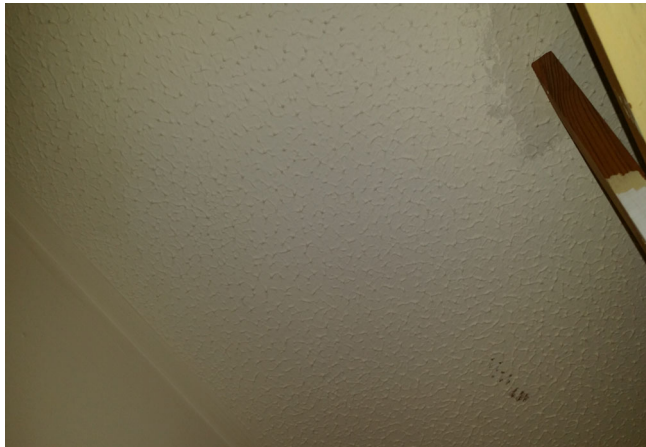
Item 5: 218354-4

The textured coating to the ceiling in the cupboard of 27 Burlington Close does contain asbestos.

Any change in its appearance should be recorded and passed to Property Services.

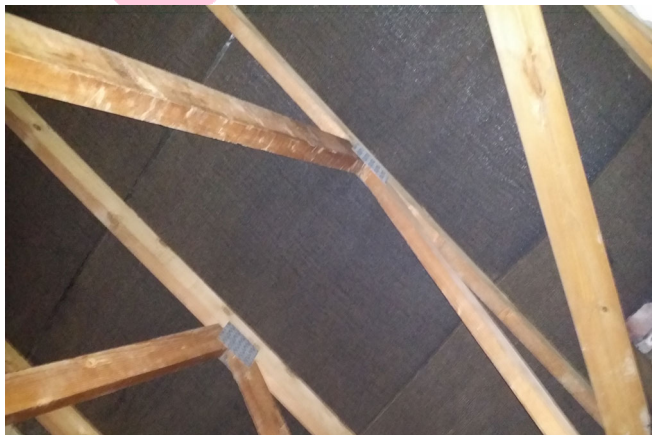
Item 6: 218354-3

The roof felt in the roof void of 27 Burlington Close does not contain asbestos.

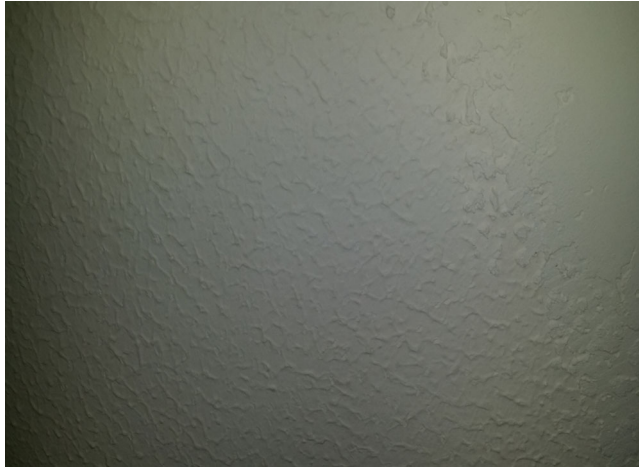
Item 7: 218354-5

The textured coating to the ceiling in the cupboard of 28 Burlington Close does contain asbestos.

Any change in its appearance should be recorded and passed to Property Services.

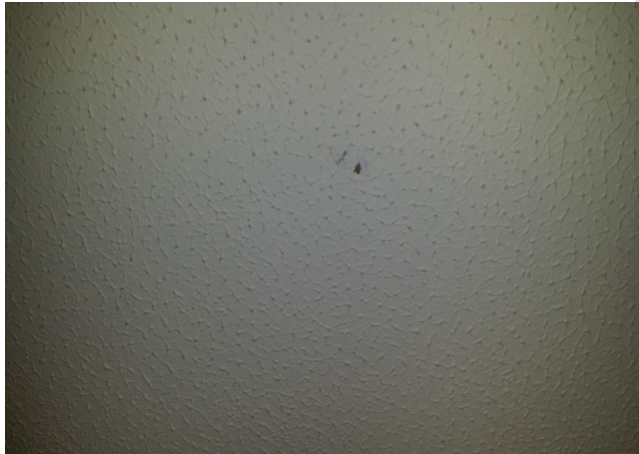
Item 8: 218354-6

The textured coating to the ceiling in the cupboard of 29 Burlington Close does contain asbestos.

Any change in its appearance should be recorded and passed to Property Services.

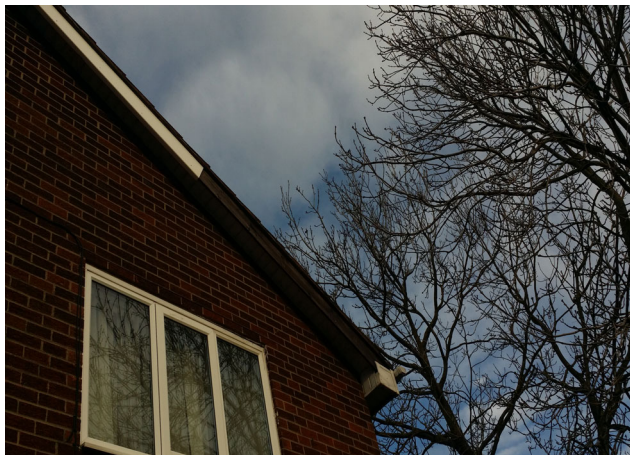
Item 9: As 218354-2

The cement roof undercloak to the external of Burlington Close does contain asbestos.

Any change in its appearance should be recorded and passed to Property Services.
