ASBESTOS SURVEY REPORT FOR SOUTHWICK CEMETERY, SUNDERLAND

Asbestos Register for

SOUTHWICK CEMETERY, SUNDERLAND

Date: 06 March 2025

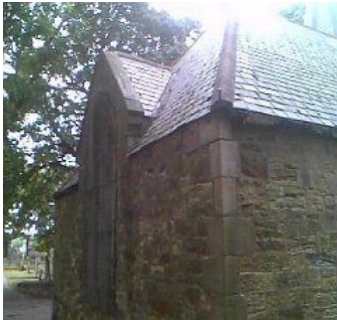
Item 1 - Ref: BB005401

BB005401 – Roof tiles (External) (Item 1) – No Risk

The roof tiles to the external of the building do not contain asbestos. There was no access to the steeple due to its height.

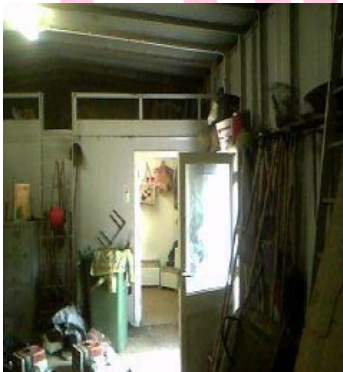
The mess room (rooms 1 and 2) were accessed and no suspect materials were found.

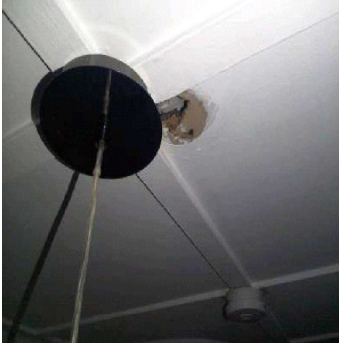
Item 2 - Ref: FB000132

FB000132 – Ceiling (Room 3) (Item 2) – No Risk

The ceiling to the hall (Room 3) does not contain asbestos.

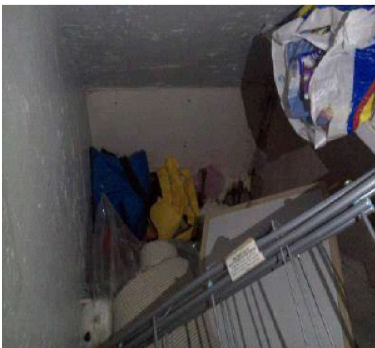
Item 3 - Ref: Presumed

NZ000573 – Panel (Room 4) (Item 3) – No Risk

The panel to the insulation board in the cupboard under the stairs (Room 4) does not contain asbestos.

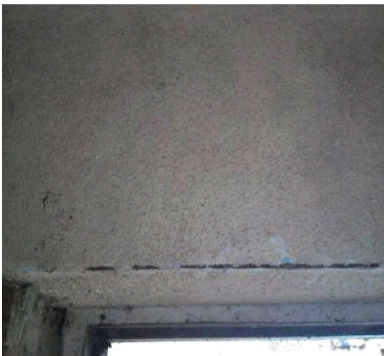
Item 4 - Ref: FB000133

FB000133 – Wall coating surrounding door (Room 1) (Item 4) – Low Risk

The textured coating to the walls to the shed to East Lodge (Room 1) was removed however there remains item surrounding door. Any change in its appearance should be noted and passed to Property Services.

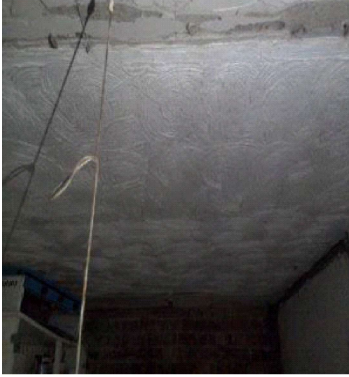
Item 5 - As: FB000133

As FB00133 – Ceiling coating (Room 1) (Item 5) – Removed 2021

The textured coating to the ceiling in the shed to East Lodge (Room 1) contains asbestos.

This item removed 2021

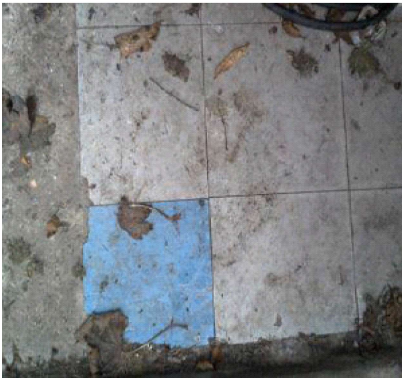
Item 6 - Ref: FB000134

FB00134 – Flooring (Room 1) (Item 6) – Low Risk

The vinyl flooring to the shed (Room 1) contains asbestos.

Any change in its appearance should be noted and passed to Property Services.

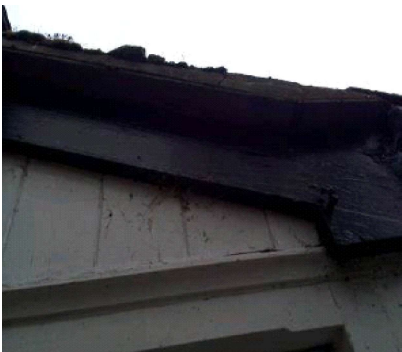
Item 7 - Ref: FB000134

FB000135 – Under cloaking (External) (Item 7) – Very Low Risk

The under cladding to the external contains asbestos.

Any change in its appearance should be noted and passed to Property Services.

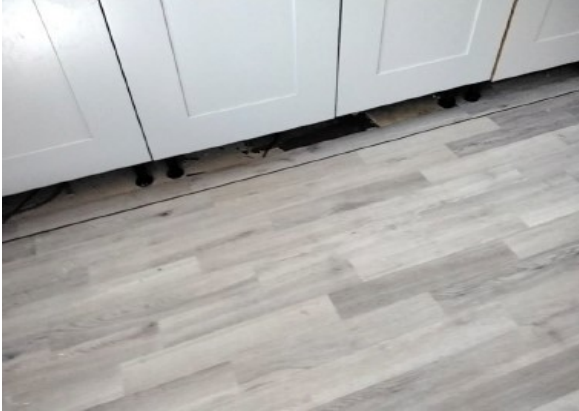
Item 11 – Ref: KX001941

The floor tile (Under floor covering) in the Kitchen (Room G/006) does not contain asbestos.

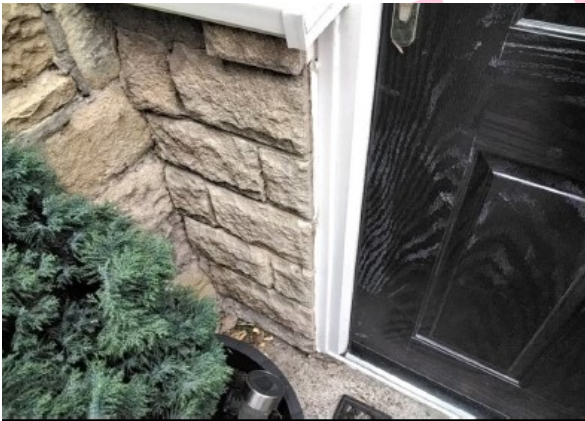
Item 12 - Ref: KX001931

The door seal remnants under modern silicon (External E/001) does not contain asbestos.

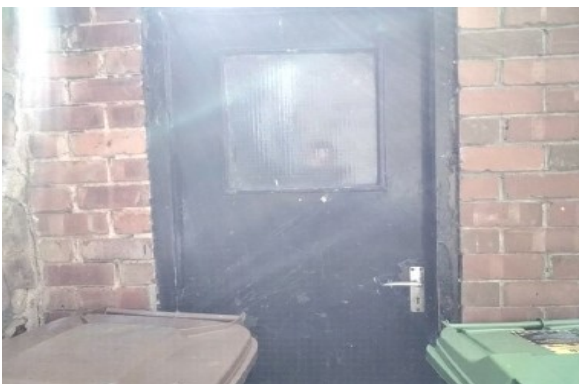
Item 13 - Ref: KX001933

The door seal gaskets to outhouse door (External E/001) does not contain asbestos.

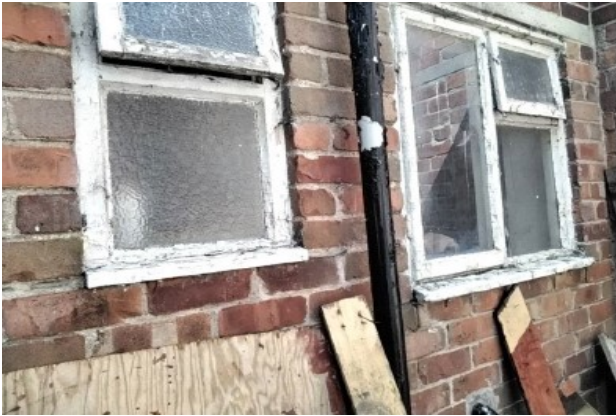
Item 14 Ref: KX001932

The window putty/seal to outhouse windows (External E/001) does not contain asbestos.

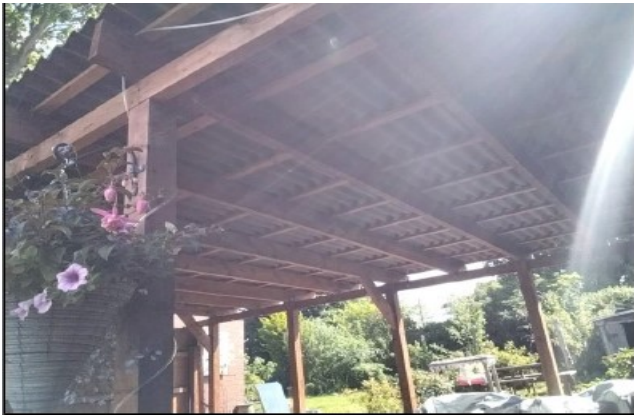
Item 15 - Ref: KX001927

The roof – sheet cladding to the conservatory/sun room (External E/002) does not contain asbestos.

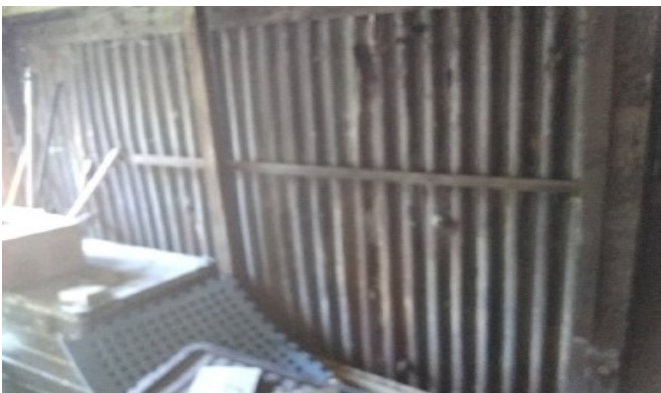
Item 16 - Ref: KX001928

The wall sheet cladding to the garage (External E/003) does not contain asbestos.

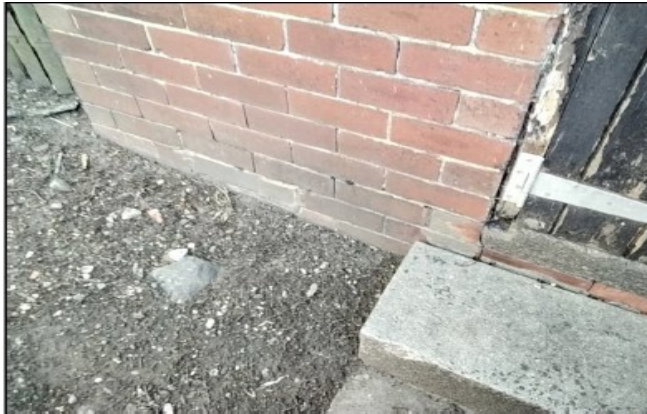
Item 17 – Ref: KX001929

The damp proof course to the toilets (External E/005) does not contain asbestos.

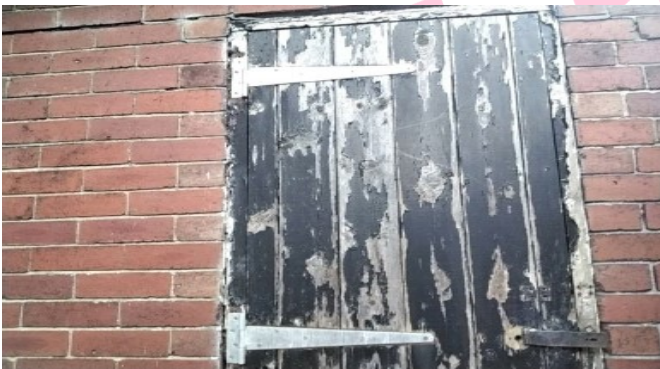
Item 18 - Ref: KX001937

The door seal/gasket to the toilets (External E/005) does not contain asbestos.

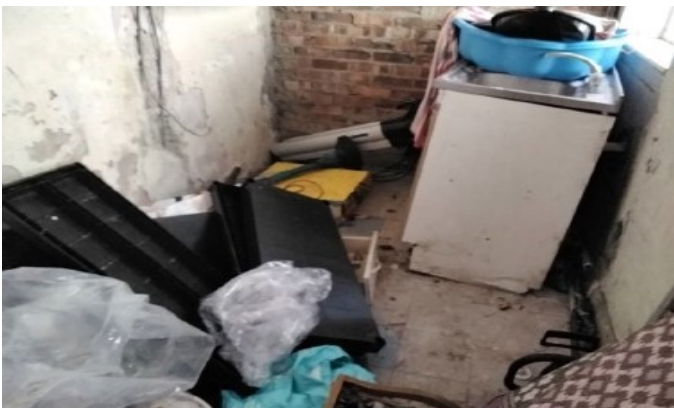
Item 19 - Ref: KX001934

KX001934 – Floor tile grey and blue (Outhouse E/006) (Item 19) – Very Low Risk

The floor tile grey and blue in the outhouse (External E/006) contains asbestos.

Any change in its appearance should be noted and passed to Property Services.

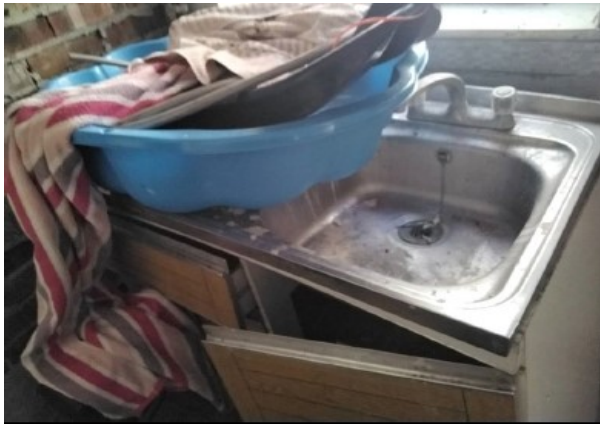
Item 20 – Ref: KX001935

The under sink mat in the outhouse (External E/006) does not contain asbestos.

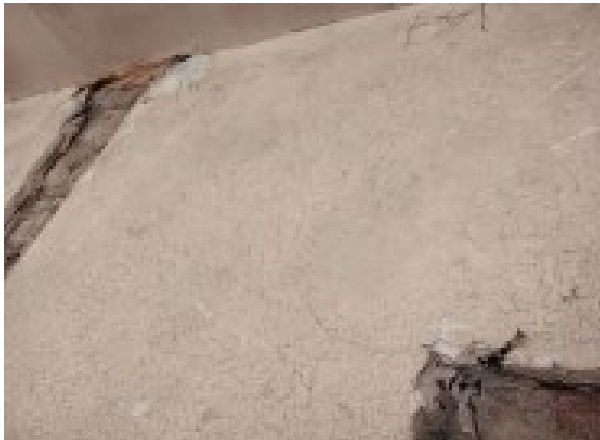
Item 21 - Ref: KX001936

KX001936 – Wall coating from around door and lintel (Outhouse E/006) (Item 21) – Low Risk

The wall coating from around the door and lintel in the outhouse (External E/006) contains asbestos.

Any change in its appearance should be noted and passed to Property Services.

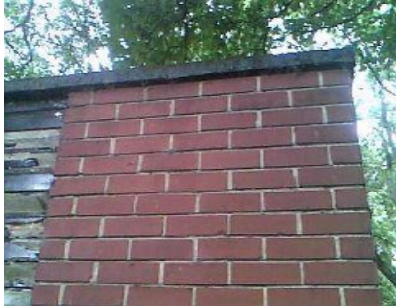
Item 8 - Ref: BB005402

The roof felt to the external of the toilet block does not contain asbestos.

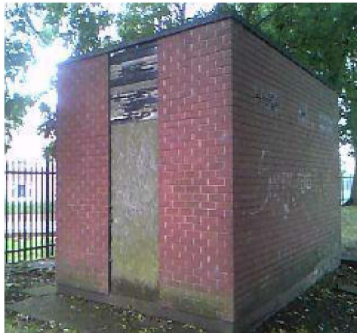
There was no access to the toilet block internally as it is boarded up.

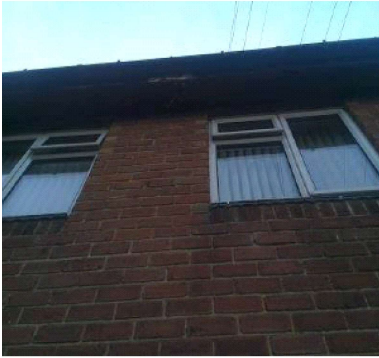
Item 10 - Presumed

Presumed – Soffits (External) (Item 10) – Very Low Risk

The soffits to the external are presumed to contain asbestos.

Any change in its appearance should be noted and passed to Property Services.

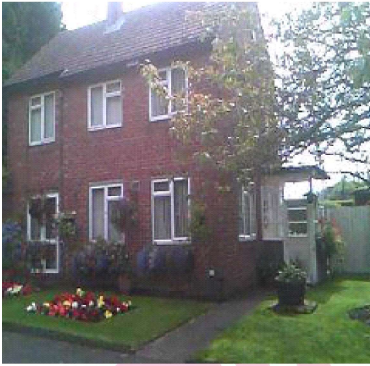
There was no access to the North East Lodge as it is tenanted and is for domestic use.

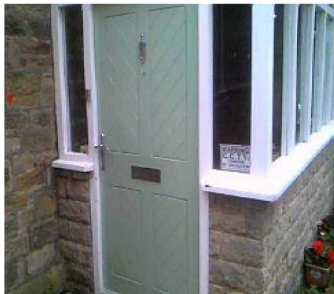
There was no access to the South West Lodge as it is tenanted and is for domestic use.
