ASBESTOS SURVEY REPORT FOR MERE KNOLLS CEMETERY, TORVER CRESCENT, SUNDERLAND

Asbestos Register for MERE KNOLLS CEMETERY, SUNDERLAND

UPRN: - J549101

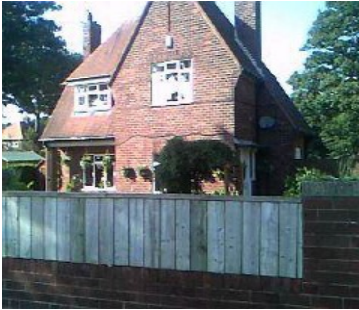
East Lodge

No access to the Lodge was granted by tenant at time of survey. This has since been purchased and is now a private property.

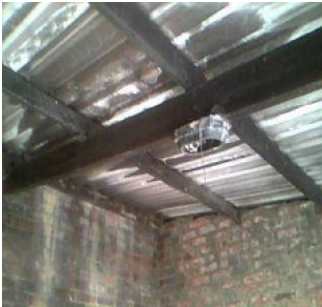
Garage 1 (Room 1) was accessed and no suspect materials were found.

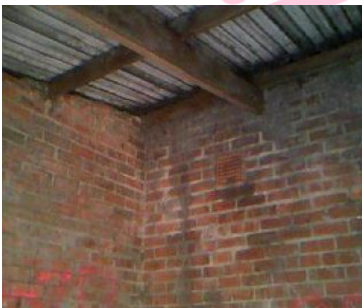
Garage 2 (Room 2) was accessed and no suspect materials were found.

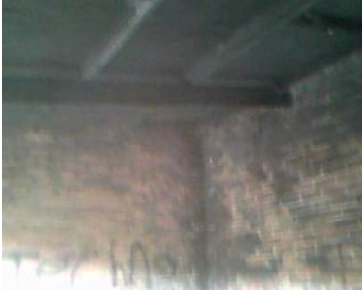
Garage 3 (Room 3) was accessed and no suspect materials were found.

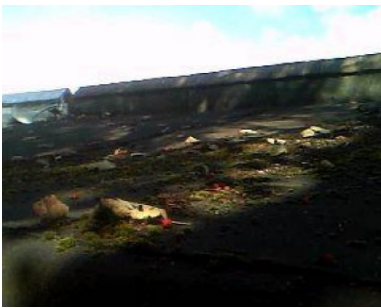
Item 1 – BB005403

BB005403 – Roof Felt (Garage3) (Item 1) – No Risk

The roof felt to garage 3 (Room 3) does not contain asbestos.

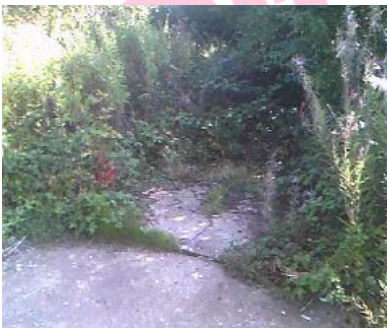
The greenhouses have been demolished, the concrete plinth remains.

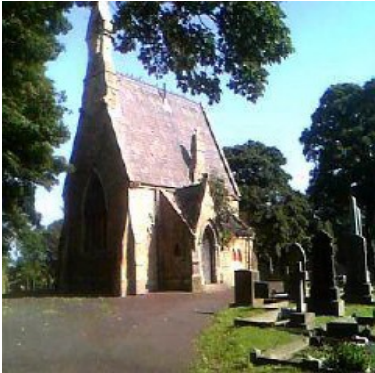
The North Chapel of Rest could not be entered due to the unsound structure of the building. Further investigation should be carried out prior to entering.

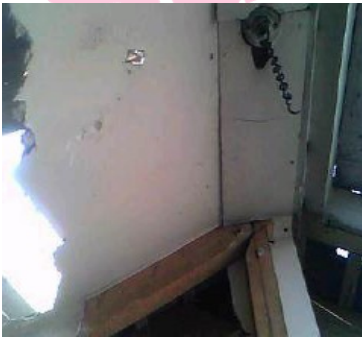
Item 2 – BB005404

The broken ceiling and upstanding panels in room 2 did not contain asbestos.

These sheds were demolished in April 2016.

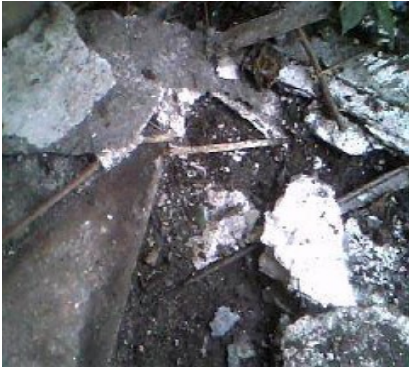
Item 3 – BB005405

The insulating board debris to all surfaces in room 2 did not contain asbestos.

These potting sheds were demolished in April 2015.

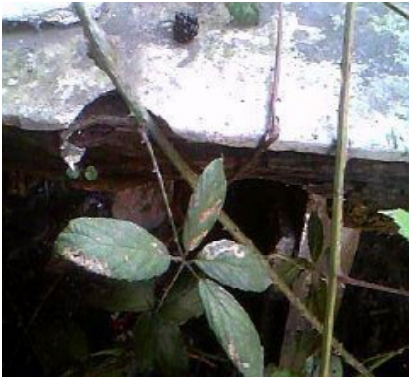
Item 4 Ref: BB005406

The bench top to room 2 contained asbestos.

The sheds were demolished in April 2015.

| Picture | Location | Risk | Inspection Frequency | Date of return |
|--|--|---|---|---|
| <i>Item 4</i> | <i>Bench top to potting sheds</i> | <i>Very Low</i> | <i>Demolished</i> | <i>April 2015</i> |

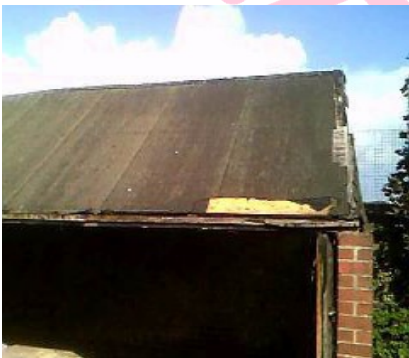
Item 5 Ref: BB005407

The roof felt to the potting sheds did not contain asbestos.

These potting sheds were demolished in April 2015.

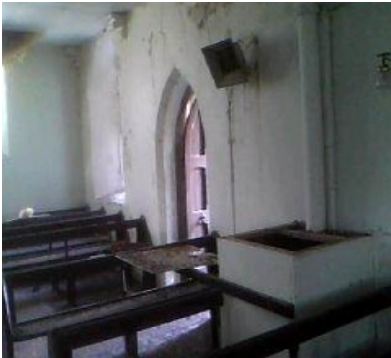
The chapel of rest was accessed and no suspect materials were found. However room 4, (Entrance 2) could not be accessed, therefore investigation should take place prior to entering.

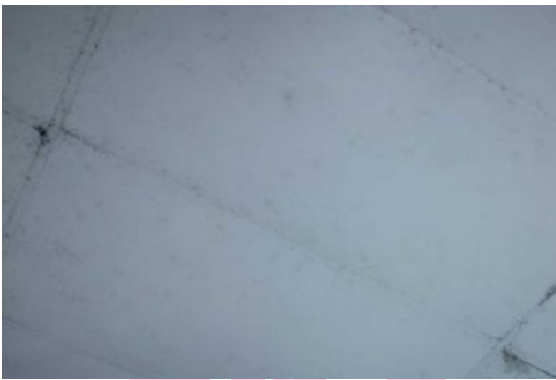
Item 11 Ref: 23-61648-1

23-61648-1 – Ceiling Tiles (Church Hall/Area 1) (Item 11) – No Risk

The ceiling tiles in the Church Hall (Area 1) does not contain asbestos.

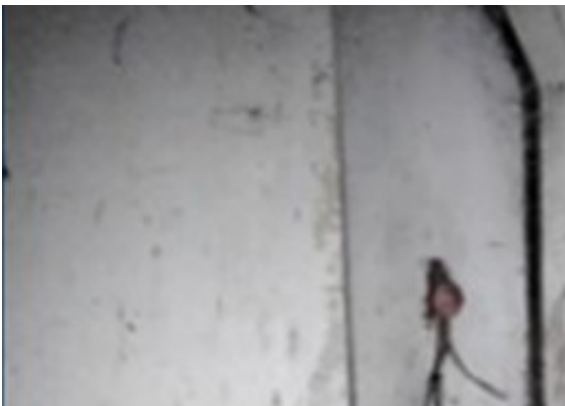
Item 12 Ref: VA006307

VA006307 – Alcove to wall insulation board (Church Hall) (Item 12) – Very Low Risk

The alcove to wall insulation board in the Church Hall does contain asbestos.

| Picture | Location | Risk | Inspection Frequency | Date of return |
|--|--|---|---|---|
| <i>Item 12</i> | <i>Alcove to wall insulation board (Church Hall)</i> | <i>Very Low Risk</i> | <i>12 monthly</i> | <i>16/01/2027</i> |

Any change in appearance should be reported to Property Services.

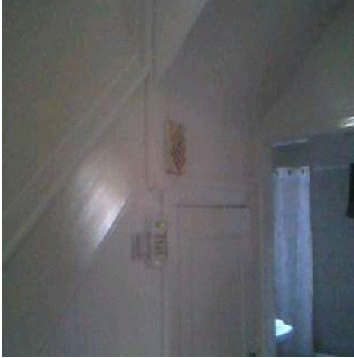
The hall (Room 1) was accessed and no suspect materials were found.

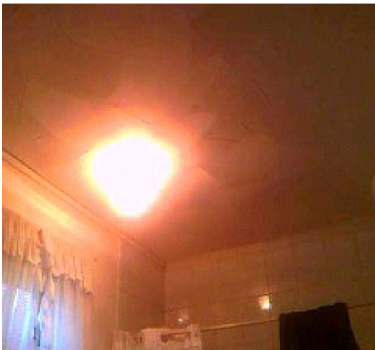
Item 6 Ref:CB008695

CB008695 – Textured coating (Room 3) (Item 6) - No Risk

The textured coating to the ceiling in the bathroom (Room 3) does not contain asbestos.

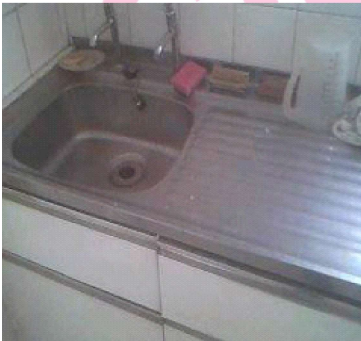
Item 7 Ref:CB008696

The sink pads to the drainer in the kitchen (Room 4) contain asbestos.

| Picture | Location | Risk | Inspection Frequency | Date of return |
|--|--|---|---|---|
| <i>Item 7</i> | <i>Sink pads – Kitchen</i> | <i>Very Low</i> | <i>12 monthly</i> | <i>Removed April 2021</i> |

Removed April 2021

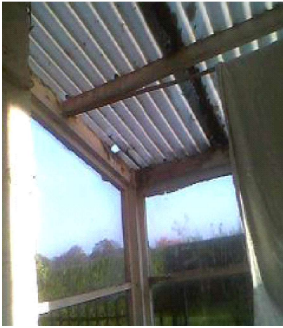
The rear porch (Room 5) was accessed and no suspect materials were found.

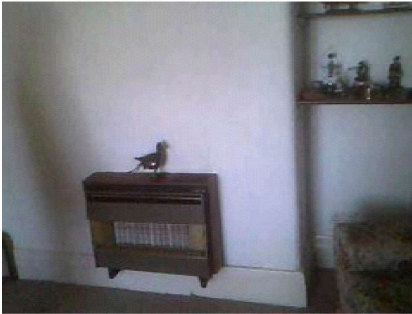
The living room (Room 6) was accessed and no suspect materials were found.

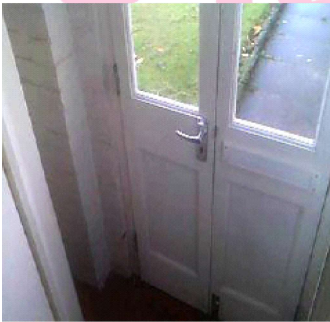
The porch (Room 7) was accessed and no suspect materials were found.

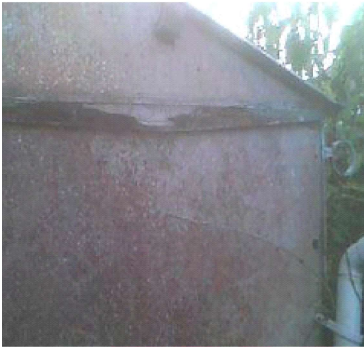
Item 9 Ref:CB008699

The cement walls to the garage (Room 8) contained asbestos.

This was demolished in October 2015.

| Picture | Location | Risk | Inspection Frequency | Date of return |
|--|--|---|---|---|
| <i>Item 9</i> | <i>South West Lodge garage - Cement walls</i> | <i>Very Low</i> | | <i>Demolished October 2015</i> |

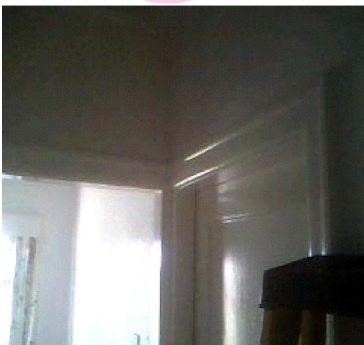
The 1st floor landing (Room 1) was accessed and no suspect materials were found.

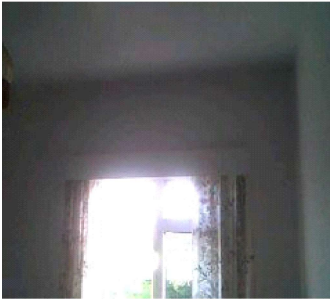
The 1st floor Bedroom 1 (Room 2) was accessed and no suspect materials were found.

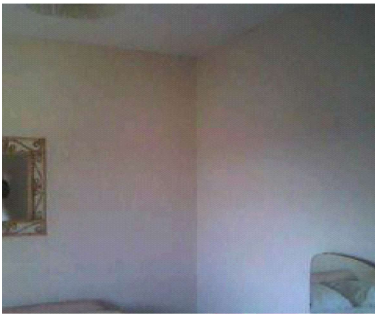
The 1st floor Bedroom 2 (Room 3) was accessed and no suspect materials were found.

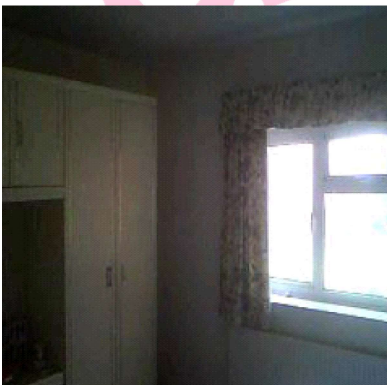
The 1st floor Bedroom 3 (Room 4) was accessed and no suspect materials were found.

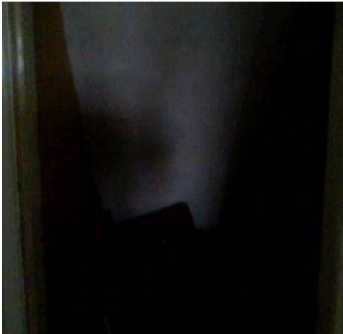
The 1st floor store room (Room 5) was accessed and no suspect materials were found.

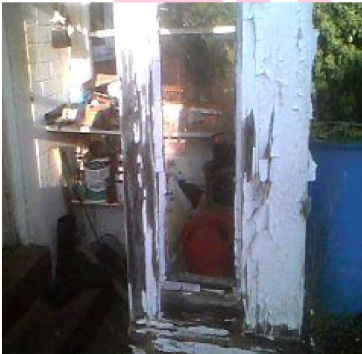
Item 10 Ref:CB008699

CB008697 – Window putty (External) (Item 10) – No Risk

The window putty to the external of the building does not contain asbestos.

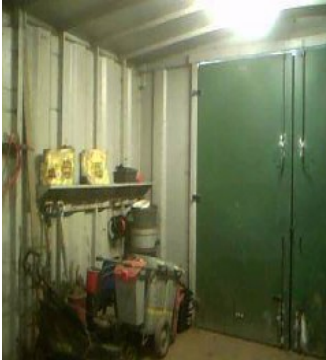
The stores (Room1) was accessed and no suspect materials were found.

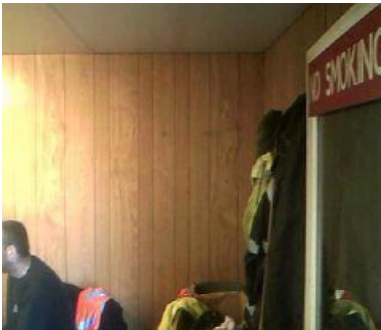
The mess room (Room 2) was accessed and no suspect materials were found.

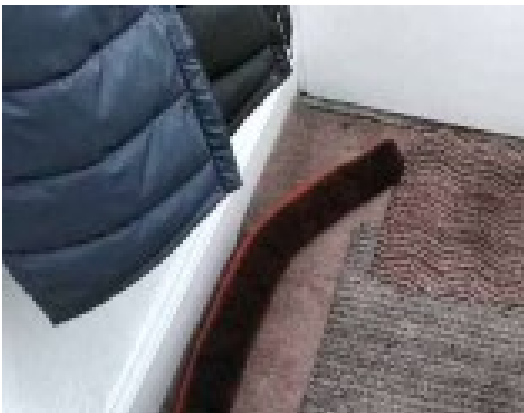
Item 13 Ref: AW005797

AW005797 – Floor covering (Porch G/001) (Item 13) – Very Low Risk

The floor covering in the Porch (Room G/001) does contain asbestos.

| Picture | Location | Risk | Inspection Frequency | Date of return |
|--|--|---|---|---|
| <i>Item 13</i> | <i>Floor covering (Porch G/001)</i> | <i>Very Low Risk</i> | <i>12 monthly</i> | <i>16/01/2027</i> |

Any change in appearance should be reported to Property Services.

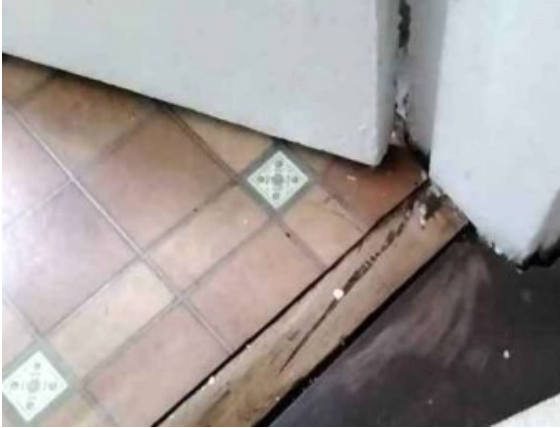
Item 14 Ref: AW005798

AW005798 – Floor covering lower layer (Kitchen G/011) (Item 14) – No Risk

The floor covering lower layer in the Kitchen (Room G/011) does not contain asbestos.

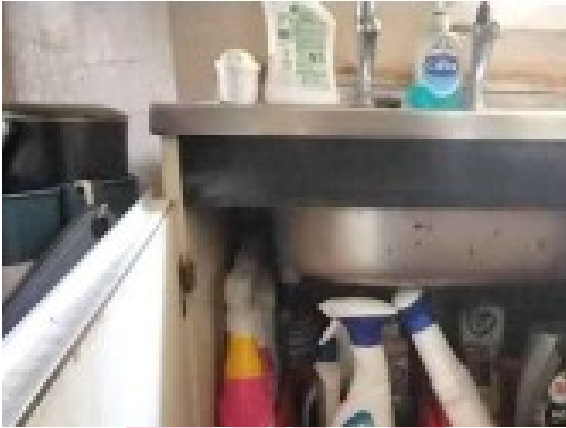
Item 15 Ref: AW005799

AW005799 – Under sink mat (Kitchen G/011) (Item 15) – Very Low Risk

The under sink mat in the Kitchen (Room G/011) does contain asbestos.

| Picture | Location | Risk | Inspection Frequency | Date of return |
|--|--|---|---|---|
| <i>Item 15</i> | <i>Under sink mat (Kitchen G/011)</i> | <i>Very Low Risk</i> | <i>12 monthly</i> | <i>16/01/2027</i> |

Any change in appearance should be reported to Property Services.

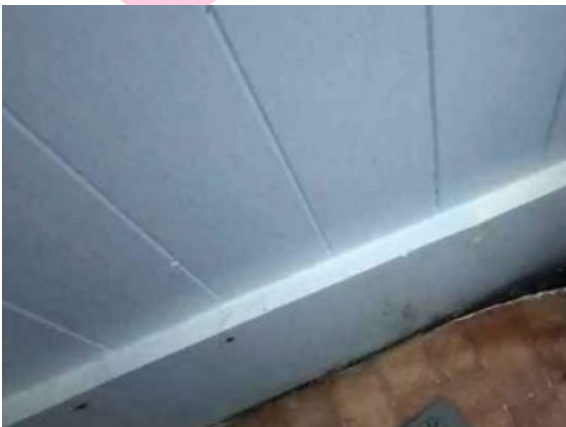
Item 16 Ref: AW005780

AW005780 – Floor covering (Store Cupboard G/013) (Item 16) – No Risk

The floor covering in the Store Cupboard (Room G/013) does not contain asbestos.

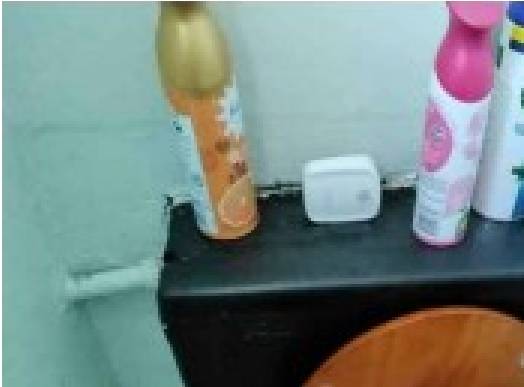
Item 17 Ref: Presumed

Presumed – Toilet Cisterns (Toilet G/015) (Item 17) – Very Low Risk

The toilet cistern in the toilet (Room G/015) does contain asbestos.

| Picture | Location | Risk | Inspection Frequency | Date of return |
|--|--|---|---|---|
| <i>Item 17</i> | <i>Toilet Cisterns (Toilet G/015)</i> | <i>Very Low Risk</i> | <i>12 monthly</i> | <i>16/01/2027</i> |

Any change in appearance should be reported to Property Services.

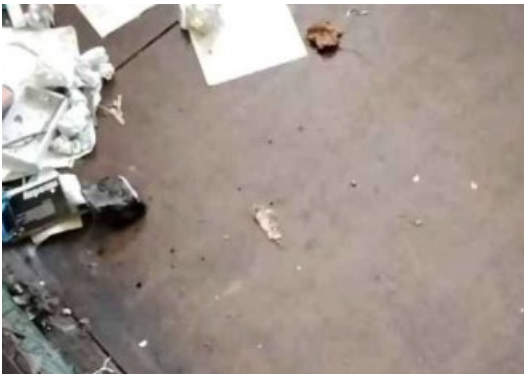
Item 18 Ref: AW005801

AW005801 – Floor covering (Office G/018) (Item 18) – No Risk

The floor covering in the Office (Room G/018) does not contain asbestos.

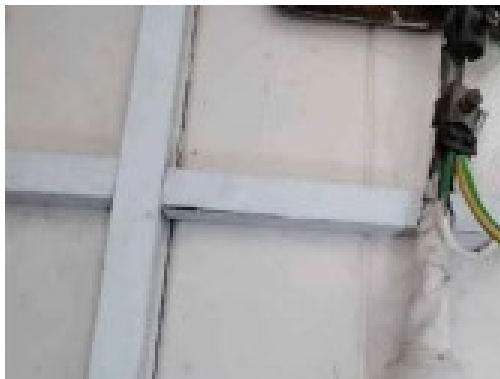
Item 19 Ref: Presumed

Presumed – Wrap to electrical mains incomer (Office G/018) (Item 19) – Very Low Risk

The wrap to electrical mains incomer in the Office (G/018) is presumed to contain asbestos.

| Picture | Location | Risk | Inspection Frequency | Date of return |
|--|--|---|---|---|
| <i>Item 19</i> | <i>Wrap to</i> | <i>Very Low</i> | <i>12 monthly</i> | <i>16/01/2027</i> |

| | electrical mains incomer (Office G/018) | Risk | | |

Any change in appearance should be reported to Property Services.

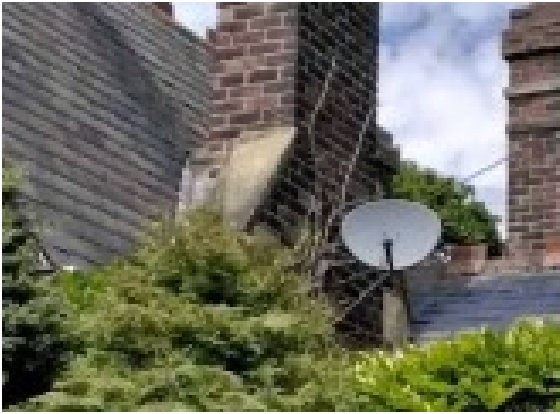
Item 20 Ref: Presumed

Presumed – Roof repair tiles (External E/001) (Item 20) – Very Low Risk

The roof repair tiles External (E/001) is presumed to contain asbestos.

| Item 20 | Roof repair tiles (External E/001) | Very Low Risk | 12 monthly | 16/01/2027 |

Any change in appearance should be reported to Property Services.

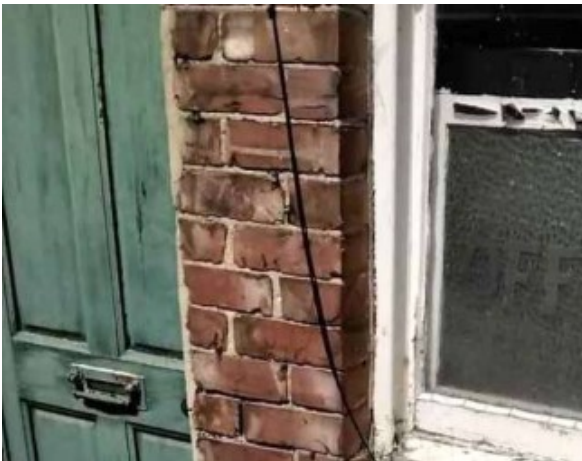
Item 21 Ref: AW005803

AW005803 – Window putty seal to timber windows (External E/001) (Item 21) – No Risk

The window putty seal to timber windows (External E/001) does not contain asbestos.

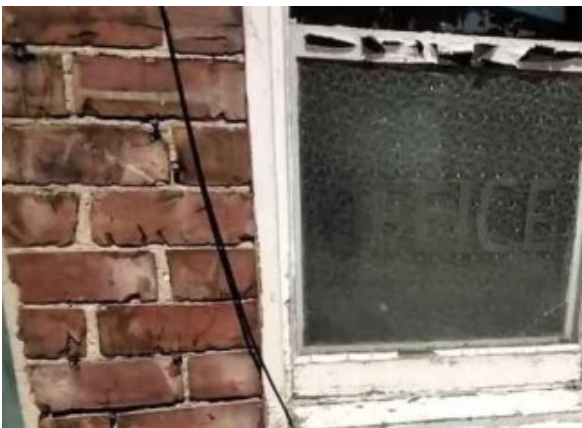
Item 22 Ref: AW005804

AW005804 – Window frame sealant (External E/001) (Item 22) – No Risk

The window frame sealant (External E/001) does not contain asbestos.

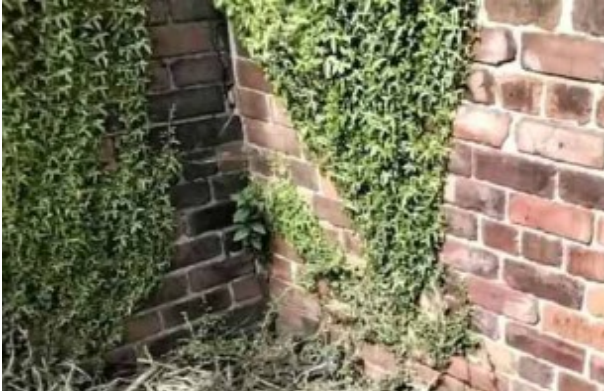
Item 23 Ref: AW005802

AW005802 - Damp proof course (Outhouse/Shed E/004) (Item 23) – No Risk

The damp proof course to the outhouse (E/004) does not contain asbestos.

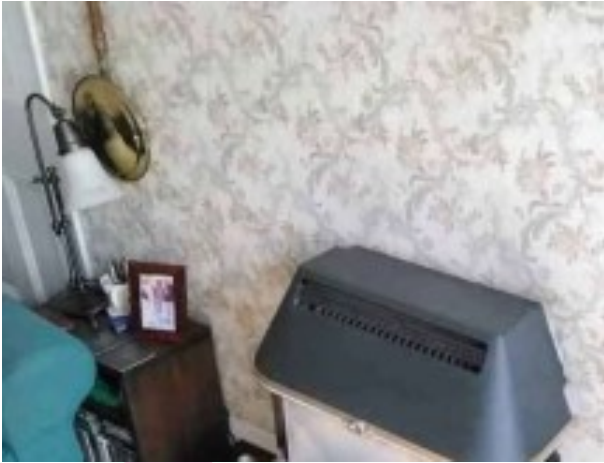
Item 24 Ref: AW006135

AW006135 – *Chimney breast internal soffit (Living Room/Lounge G/006) (Item 24) – Removed November 2024*

The chimney breast (internal soffit) in the Lounge/Living room G/006 contains asbestos.

| <i>Item 24</i> | <i>Chimney Breast - Internal Soffit (Lounge G/006)</i> | <i>Low Risk</i> | <i>6 monthly</i> | <i>Removed November 2024</i> |

Removed November 2024
