### ASBESTOS SURVEY REPORT FOR NOOK LODGE, NOOKSIDE, SUNDERLAND

**NOOK LODGE, NOOKSIDE, SUNDERLAND**

**Date: 17<sup>th</sup> January 2025**

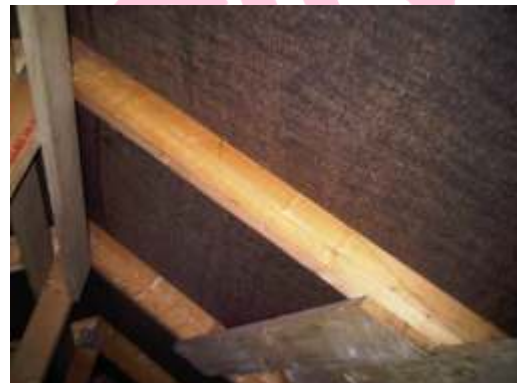
**Item 6 - Ref: As IC10/2001**

The sarking felt to loft hatch 4 does not contain asbestos.

Cross referenced with sample 385803-6

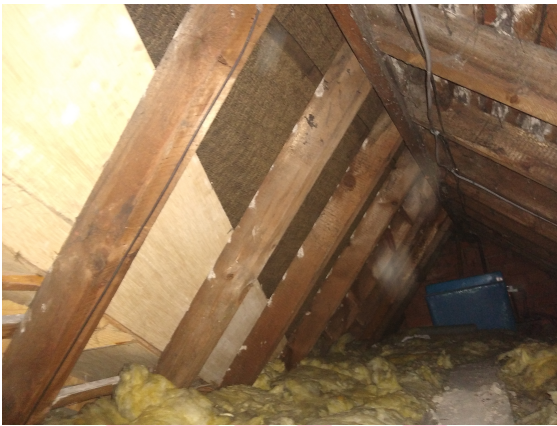
**Item 8 - Ref: 385803-1**

The sarking in Rm 001/Original Loft Space does not contain asbestos.

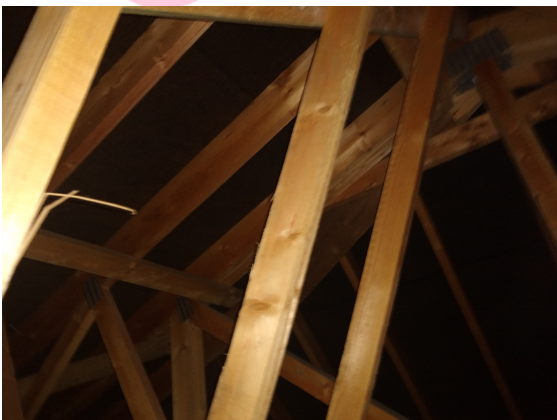
**Item 9 - Ref: 385803-2**

The sarking in Rm 002/Extension Loft Space does not contain asbestos.

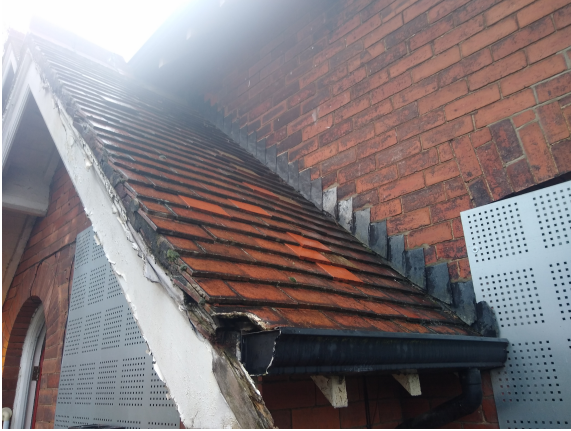
### **Item 10 - Ref: 385803-7**

385803-7 – Pitched roof flashing (External) (Item 10) Low Risk

The pitched roof flashing  
(External) contains asbestos.

| Picture | Location | Risk | Inspection Frequency | Date of return |
|---|--|---|---|---|
| <i>Item 10</i> | <i>Pitched roof flashing (External)</i> | <i>Low</i> | <i>6 monthly</i> | <i>03.01.26</i> |

Any change in its appearance  
should be recorded, and  
passed to Property Services.

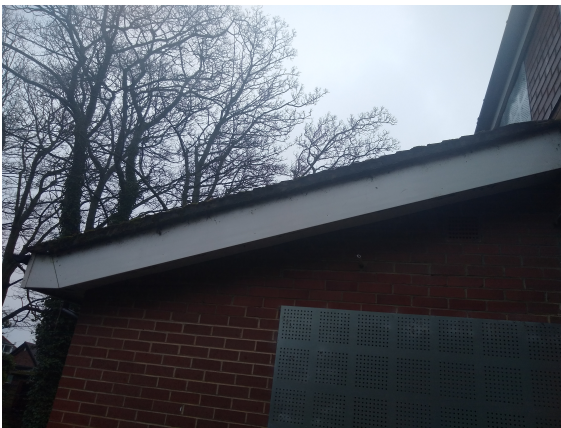
### **Item 11 - Ref: 385803-8**

385803-8 – Extension undercloaks (External) (Item 11) Very Low Risk

The extension undercloaks  
(External) contain asbestos.

| Picture | Location | Risk | Inspection Frequency | Date of return |
|---|--|---|---|---|
| <i>Item 11</i> | <i>Extension undercloaks (External)</i> | <i>Very Low</i> | <i>12 monthly</i> | <i>03.01.26</i> |

Any change in its appearance  
should be recorded, and  
passed to Property Services.

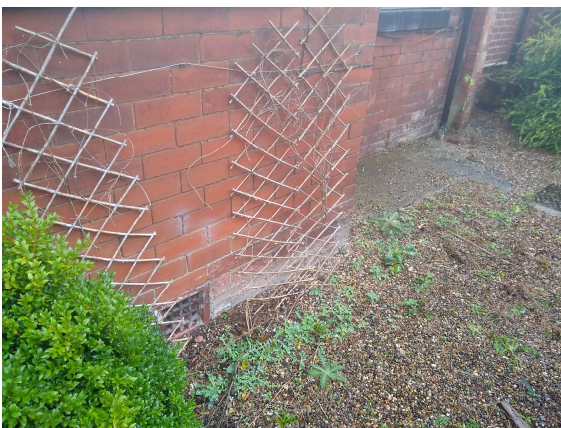
### **Item 12 - Ref: 385803-9**

The Damp proof course to  
original building (External)  
does not contain asbestos.

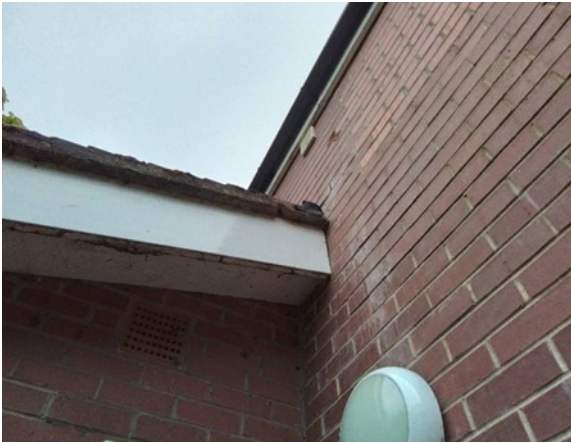
**Item 13 - Ref: KN001533**

The roof felt flashing (External)  
does not contain asbestos.
