ASBESTOS SURVEY REPORT FOR BARLEY MOW PARK, RYHOPE ROAD, SUNDERLAND, SR2 7DN.

Barley Mow Park, Ryhope Road, SR2 7DN

Date: 03 April 2025

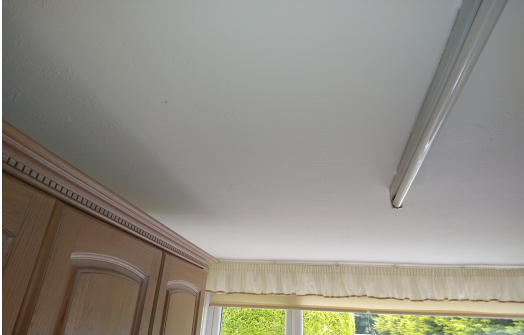
Item 1 Ref: 416023-5

The ceiling in the kitchen (Rm 0/004) does not contain asbestos.

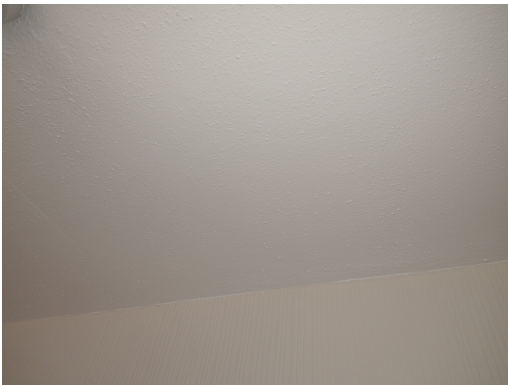
Item 2 Ref: 416023-6

The ceiling in the landing (Rm 1/001) does not contain asbestos.

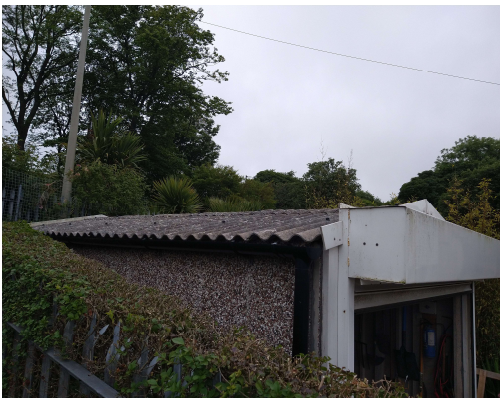
Item 3 Ref: 416023-7

The roof to the garage (External) does not contain asbestos.

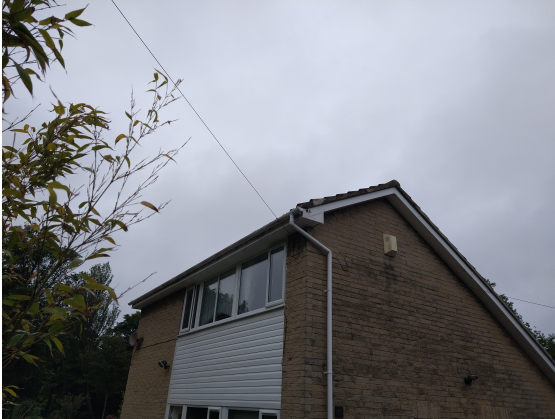
Item 4 Ref: Presume

The Undercloak fillet to the roof (External) is presumed to contain asbestos.

Any change in appearance should be reported to Property Services.

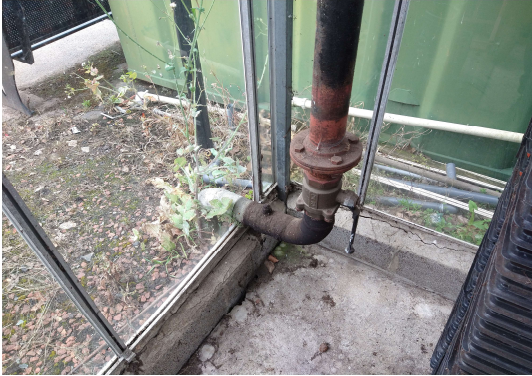
Item 5 Ref: Presume

The pipework flange gasket in Greenhouses potting area 1 (Rm 0/001) is presumed to contain asbestos.

Any change in appearance should be reported to Property Services.

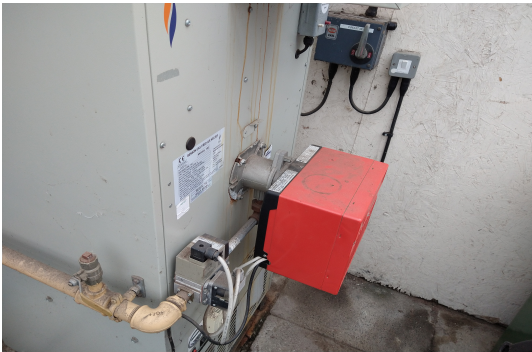
Item 6 Ref: As 416023-8

The gasket to the Benson heater in the Greenhouses potting area 2 (Rm 0/002) does not contain asbestos.

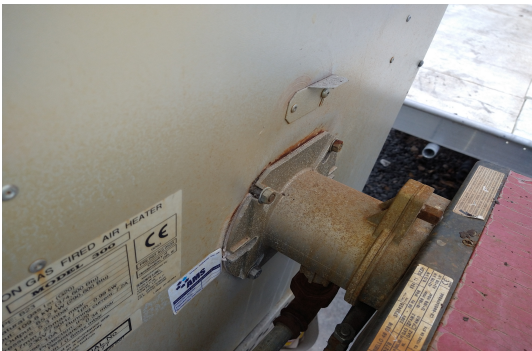
Item 7 Ref: 416023-8

The gasket to the Benson heater in the Greenhouse 1 (Rm 0/003) does not contain asbestos.

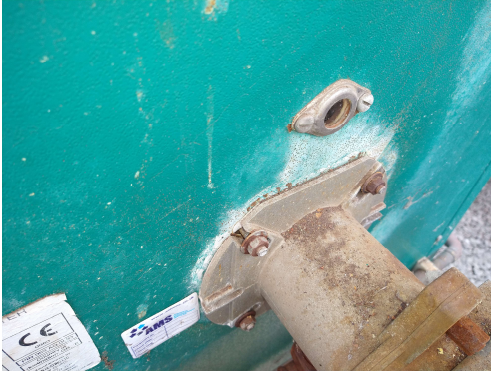
Item 8 Ref: As 416023-8

The gasket to the Benson heater in the Greenhouse 2 (Rm 0/004) does not contain asbestos.

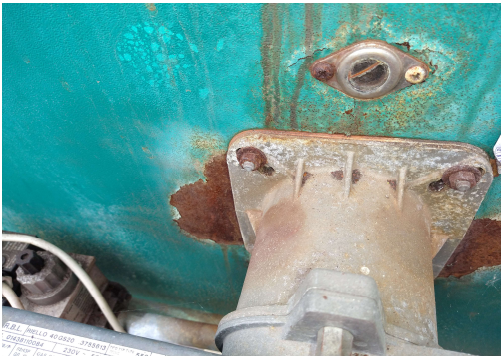
Item 9 Ref: As 416023-8

The gasket to the Benson heater in the Greenhouse 3 (Rm 0/005) does not contain asbestos.

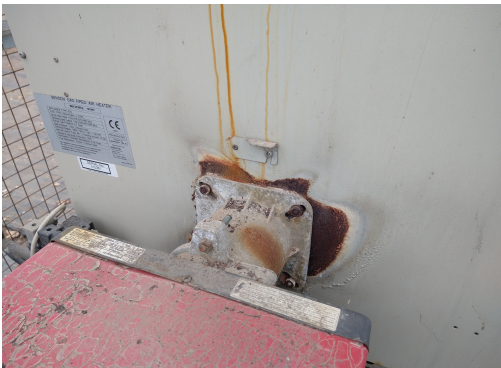
Item 10 Ref: As 416023-8

The gasket to the Benson heater in the redundant polythene tunnels (External) does not contain asbestos.

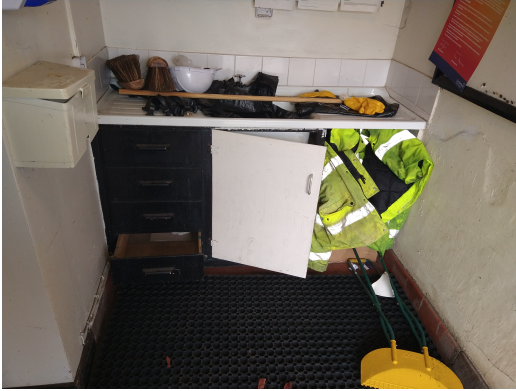
Item 11 Ref: 416023-1

The paint to the underside of the sink in the Lobby (Rm 0/001) does not contain asbestos.

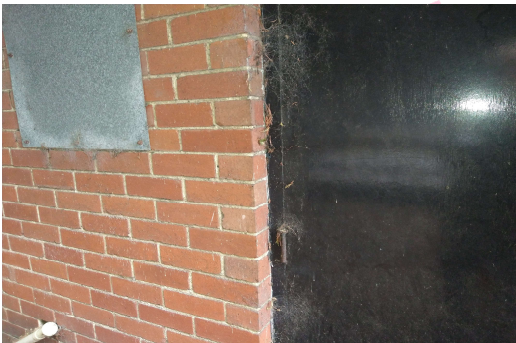
Item 12 Ref: 416023-2

The mastic to the door frames of the old workers mess (external) contains asbestos.

Any change in appearance should be reported to Property Services.

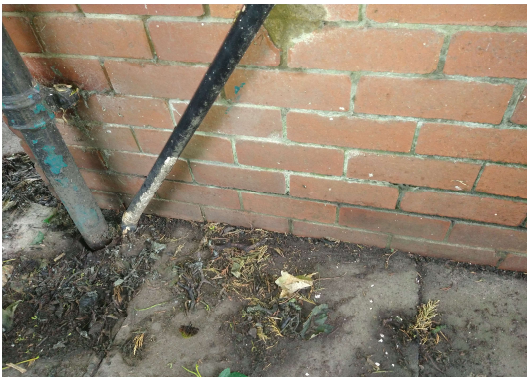
Item 13 Ref: 416023-3

The damp proof course (external) does not contain asbestos.

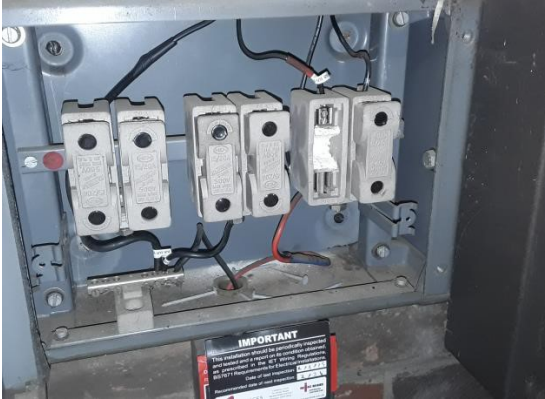
Item 15 Ref: 20-29035-2

The flashguards (Electric Meter Cupboard) contain asbestos.

Removed April 2021

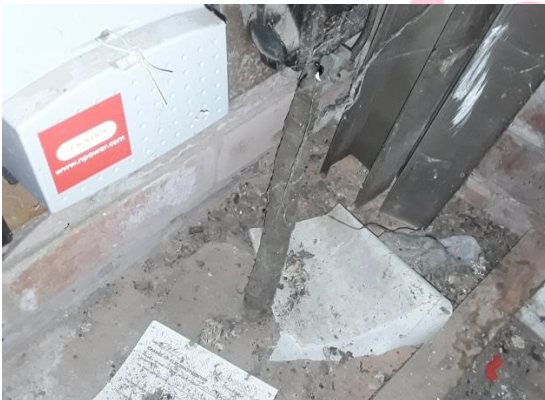
Item 16 Ref: 20-29035-3

The sheath to mains electric cable (Electric Meter Cupboard) does not contain asbestos.

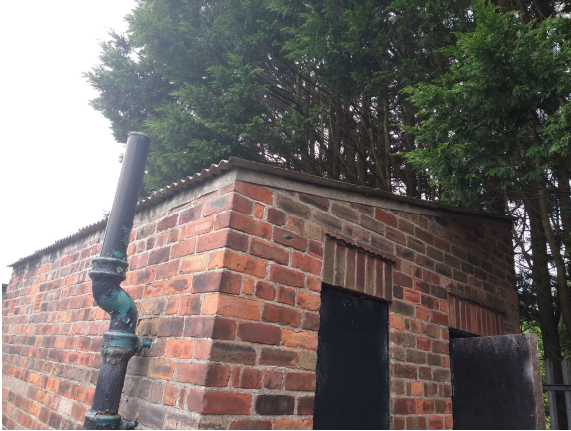
Item 14 Ref: 416023-4

The roof to the stores
(external) contains asbestos.

Any change in appearance
should be reported to Property
Services.

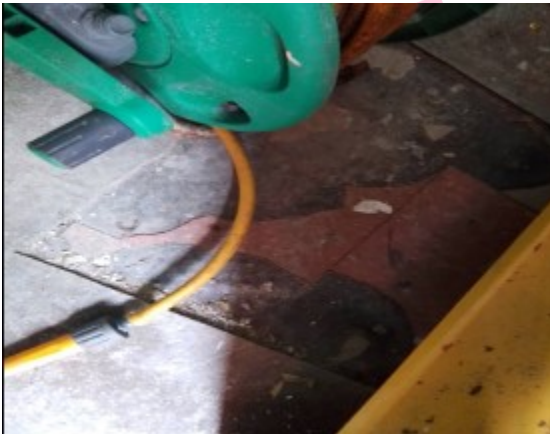
Item 17 Ref: KN002295

The floor tile with adhesive in
the Office (G/001) does not
contain asbestos.

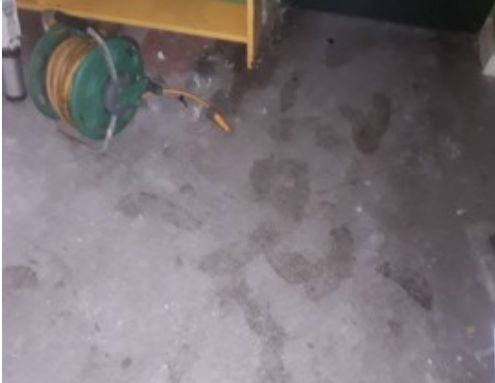
Item 18 Ref: NZ000678

The floor tiles with adhesive remnants under modern flooring (Entrance Hall/Foyer Lobby Rm G/001) do not contain asbestos.

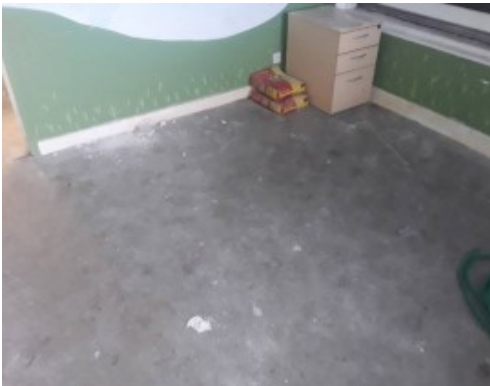
Item 19 Ref: NZ000679

The floor adhesive under modern flooring and screed (Entrance Hall/Foyer Lobby Rm G/001) does not contain asbestos.

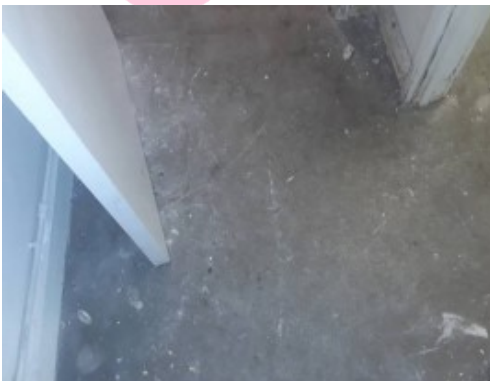
Item 20 Ref: As NZ000679

The floor adhesive under modern flooring and screed (Hallway/Passageway Rm G/002) does not contain asbestos.

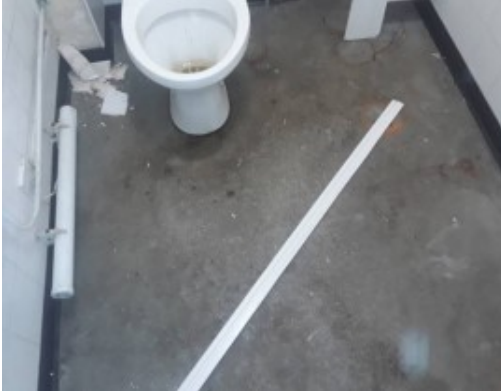
Item 21 Ref: As NZ000679

The floor adhesive under modern flooring and screed (Toilets Rm G/003) does not contain asbestos.

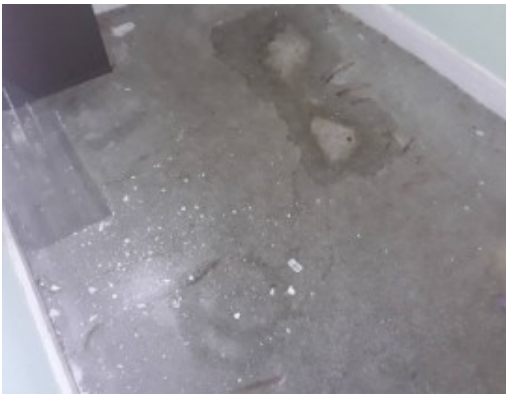
Item 22 Ref: As NZ000679

The floor adhesive under modern flooring and screed (Office Rm G/004) does not contain asbestos.

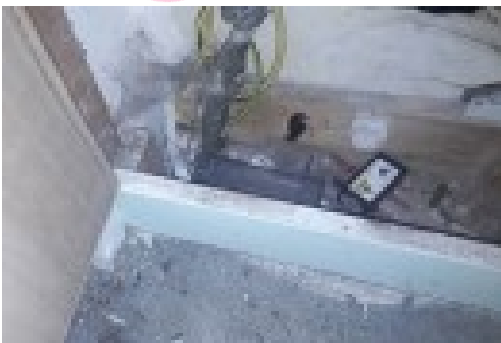
Item 23 Ref: Presumed

The cable braiding/insulation live services (Office Rm G/004) is presumed to contain asbestos.

Any change in appearance should be reported to Property Services.

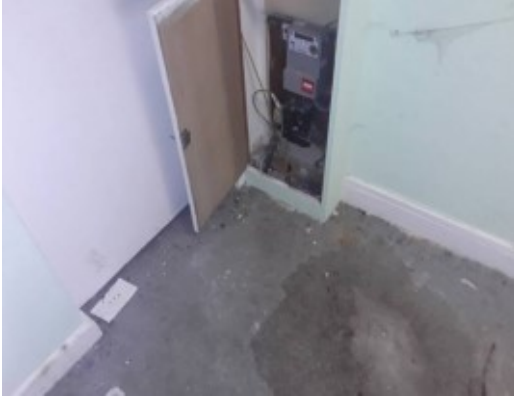
Item 24 Ref: As NZ000678

The floor tiles with adhesive remnants within electrical services boxing (Office Rm G/004) do not contain asbestos.

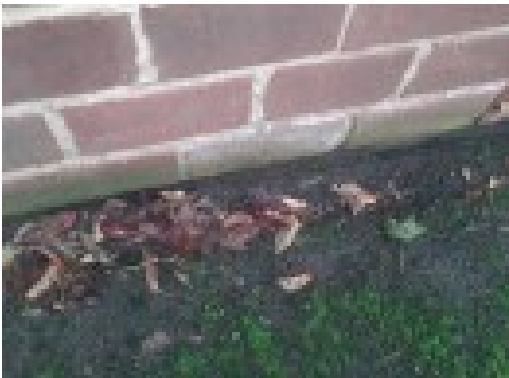
Item 25 Ref: Presumed

The damp proof course (External E/001) is presumed to contain asbestos.

Any change in appearance should be reported to Property Services.

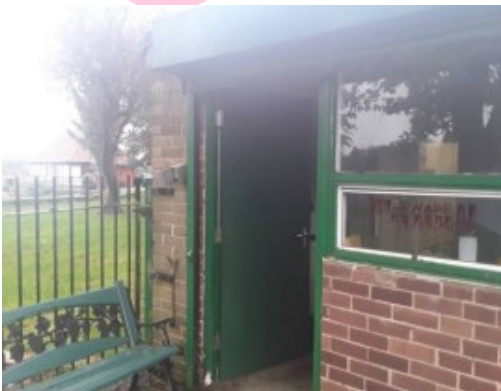
Item 26 Ref: NZ000680

The window putty to frame wall door and windows (External E/001) does not contain asbestos.

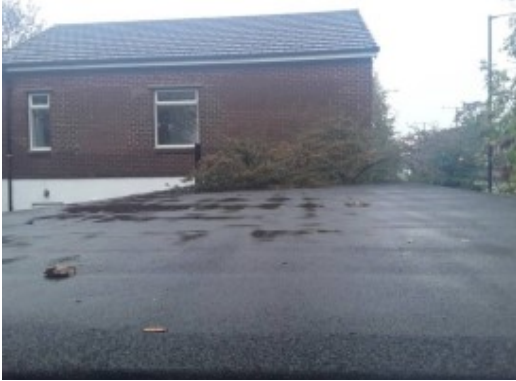
Item 27 Ref: NZ000681

The roof felt (External E/001) does not contain asbestos.

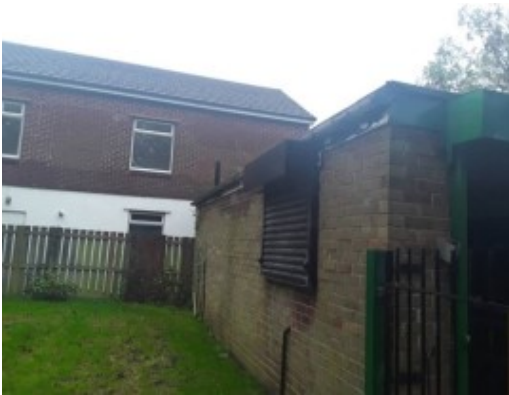
Item 28 Ref: NZ000682

The rainwater goods seal to joints (External E/001) does not contain asbestos.
