ASBESTOS SURVEY REPORT FOR BARLEY MOW PARK, RYHOPE ROAD, SUNDERLAND, SR2 7DN.

Asbestos Register for

Barley Mow Park, Ryhope Road, SR2 7DN

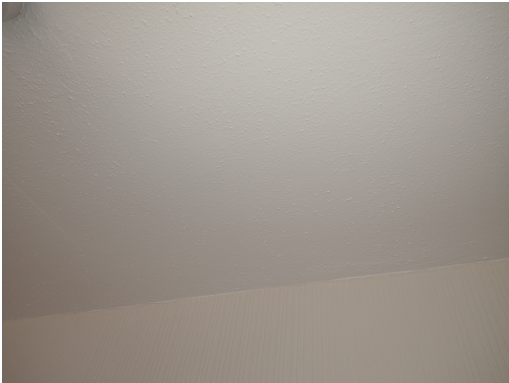
Item 2 Ref: 416023-6

The ceiling in the landing (Rm 1/001) does not contain asbestos.

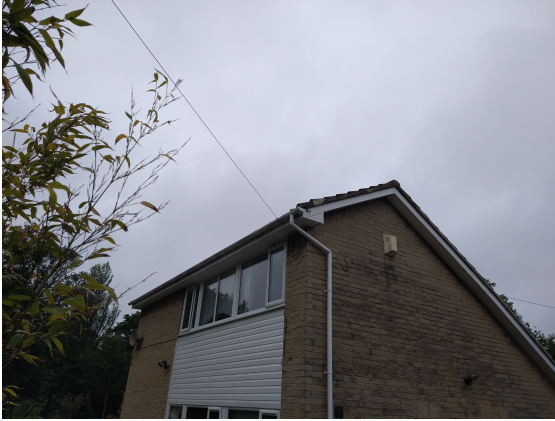
Item 4 Ref: Presume

The Undercloak fillet to the roof (External) is presumed to contain asbestos.

Any change in appearance should be reported to Property Services.

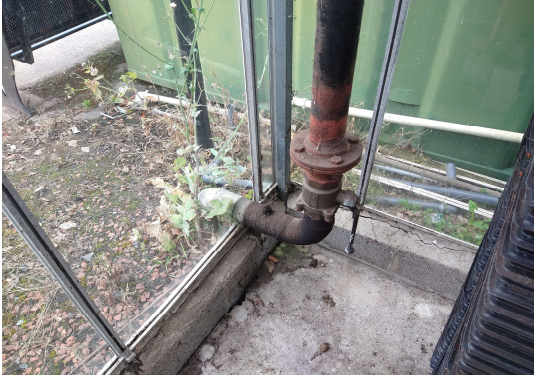
Item 5 Ref: Presume

The pipework flange gasket in Greenhouses potting area 1 (Rm 0/001) is presumed to contain asbestos.

Any change in appearance should be reported to Property Services.

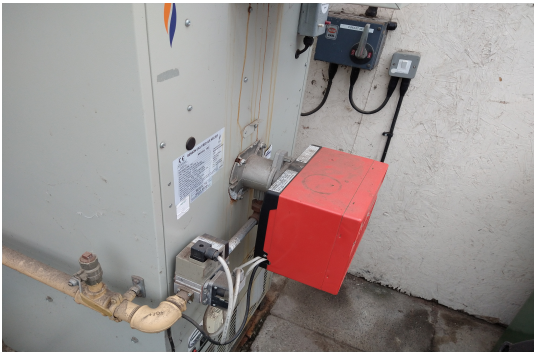
Item 6 Ref: As 416023-8

The gasket to the Benson heater in the Greenhouses potting area 2 (Rm 0/002) does not contain asbestos.

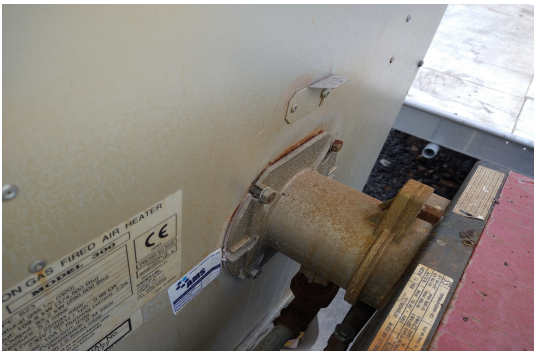
Item 7 Ref: 416023-8

The gasket to the Benson heater in the Greenhouse 1 (Rm 0/003) does not contain asbestos.

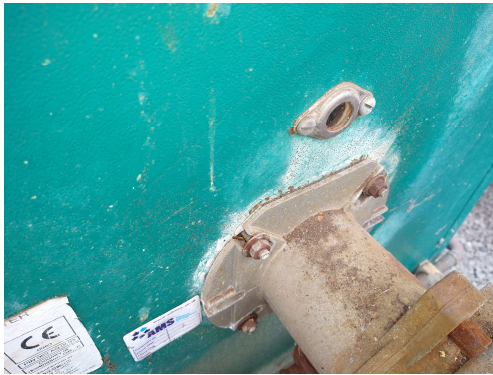
Item 8 Ref: As 416023-8

The gasket to the Benson heater in the Greenhouse 2 (Rm 0/004) does not contain asbestos.

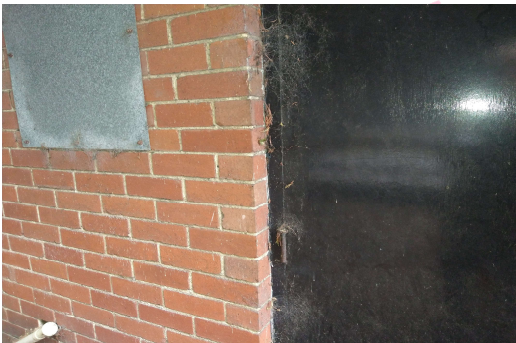
Item 12 Ref: 416023-2

The mastic to the door frames of the old workers mess (external) contains asbestos.

Any change in appearance should be reported to Property Services.

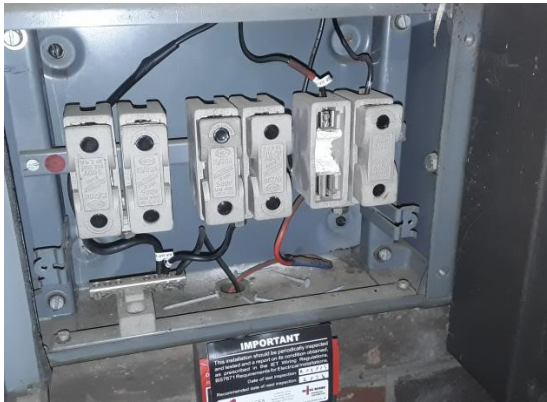
Item 15 Ref: 20-29035-2

The flashguards (Electric Meter Cupboard) contain asbestos.

Removed April 2021

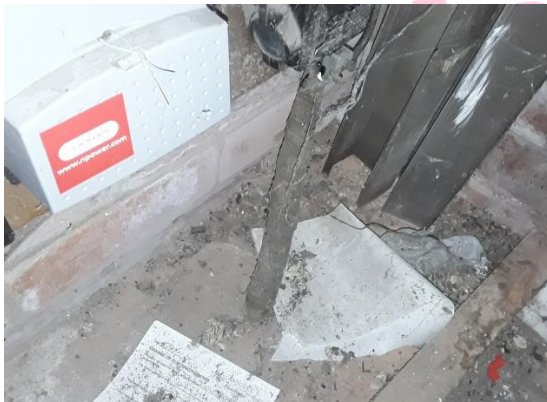
Item 16 Ref: 20-29035-3

The sheath to mains electric cable (Electric Meter Cupboard) does not contain asbestos.

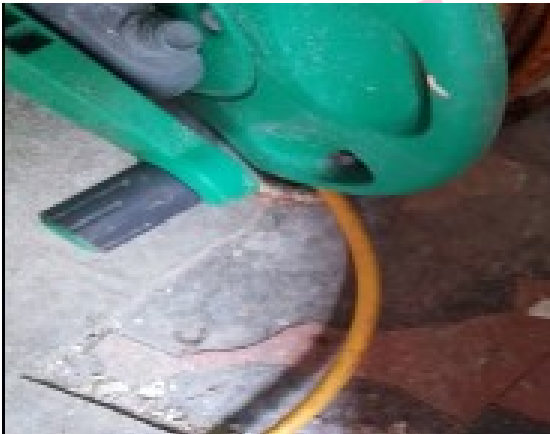
Item 17 Ref: KN002295

The floor tile with adhesive in the Office (G/001) does not contain asbestos.

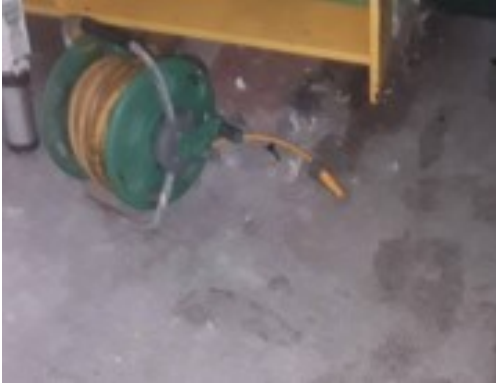
Item 18 Ref: NZ000678

The floor tiles with adhesive remnants under modern flooring (Entrance Hall/Foyer Lobby Rm G/001) do not contain asbestos.

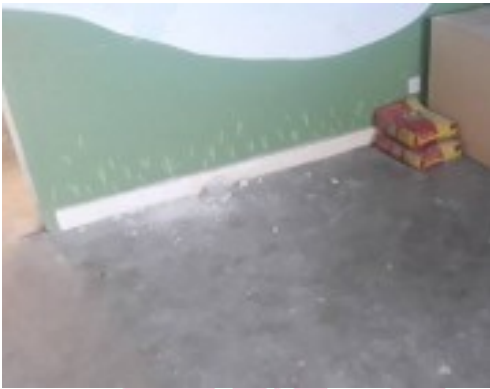
Item 19 Ref: NZ000679

The floor adhesive under modern flooring and screed (Entrance Hall/Foyer Lobby Rm G/001) does not contain asbestos.

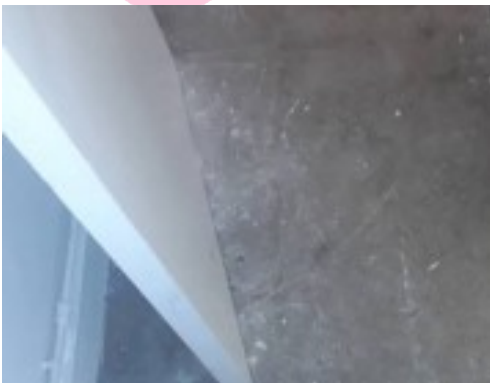
Item 20 Ref: As NZ000679

The floor adhesive under modern flooring and screed (Hallway/Passageway Rm G/002) does not contain asbestos.

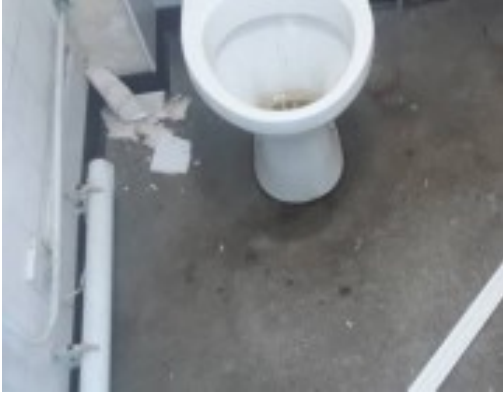
Item 21 Ref: As NZ000679

The floor adhesive under modern flooring and screed (Toilets Rm G/003) does not contain asbestos.

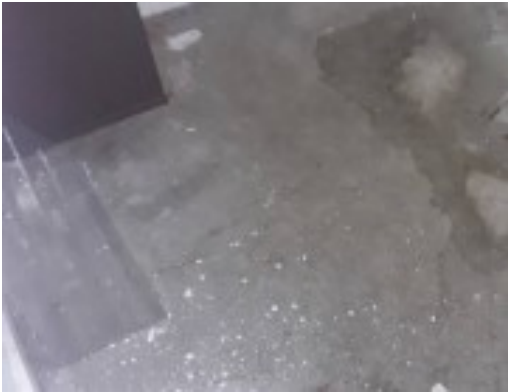
Item 22 Ref: As NZ000679

The floor adhesive under modern flooring and screed (Office Rm G/004) does not contain asbestos.

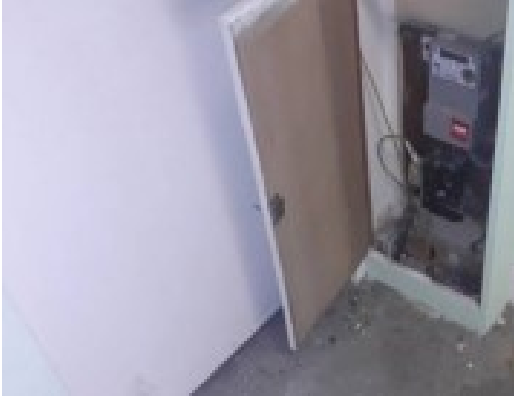
Item 24 Ref: As NZ000678

The floor tiles with adhesive remnants within electrical services boxing (Office Rm G/004) do not contain asbestos.

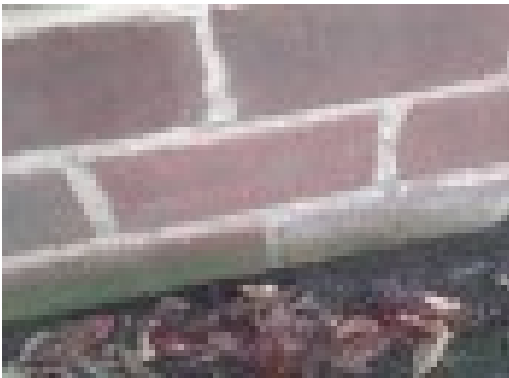
Item 25 Ref: Presumed

The damp proof course (External E/001) is presumed to contain asbestos.

Any change in appearance should be reported to Property Services.

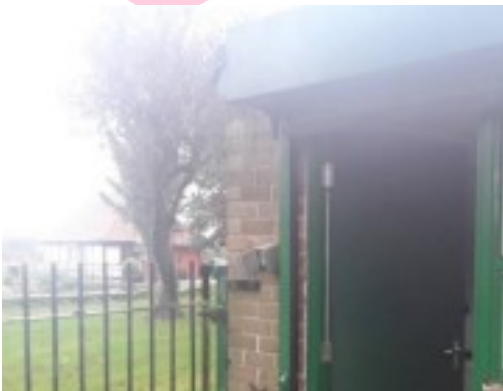
Item 26 Ref: NZ000680

The window putty to frame wall door and windows (External E/001) does not contain asbestos.

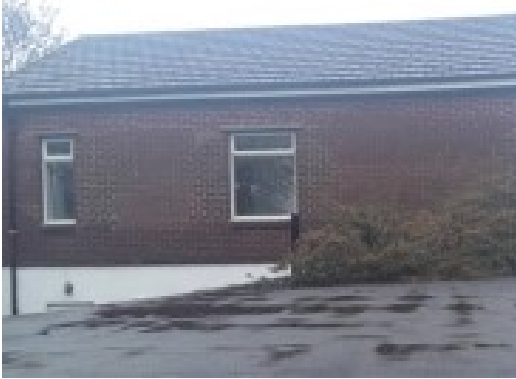
Item 27 Ref: NZ000681

The roof felt (External E/001) does not contain asbestos.

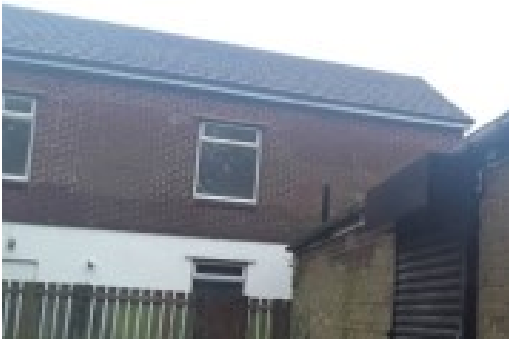
Item 28 Ref: NZ000682

The rainwater goods seal to joints (External E/001) does not contain asbestos.

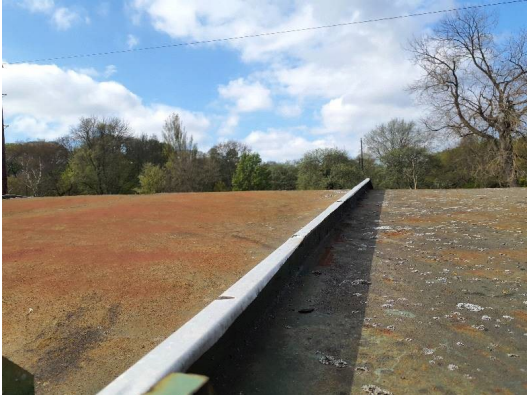
Item 29 Ref: RC000649

The bitumen - joints of roof
(External - Steel Container 1
E/001) do not contain
asbestos.

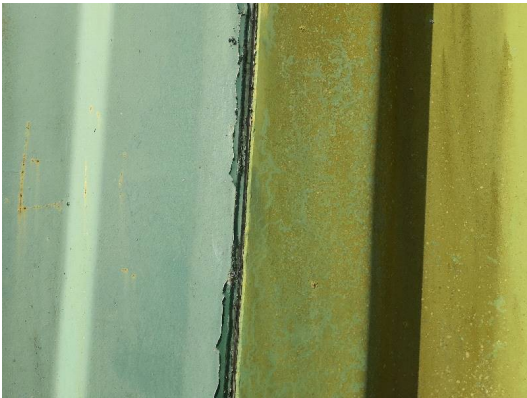
Item 30 Ref: RC000650

The mastics - joints of walls
(External - Steel Container 1
E/001) do not contain asbestos.

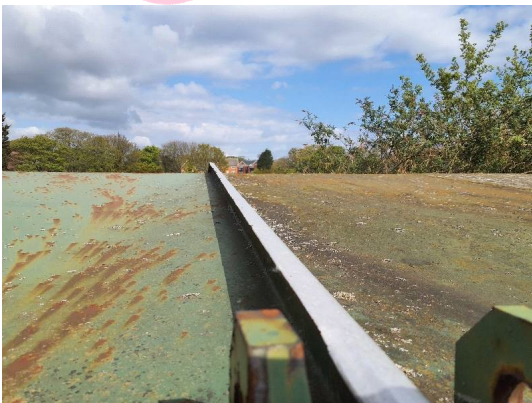
Item 31 Ref: RC000651

The bitumen - joints of roof
(External - Steel Container 2
E/002) do not contain asbestos.

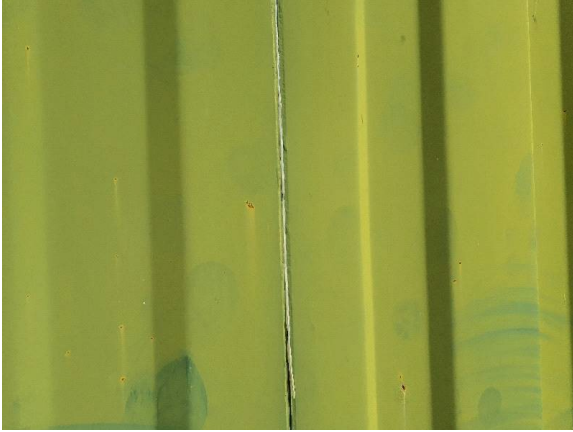
Item 32 Ref: RC000652

The mastic - joints of walls
(External - Steel Container 2
E/002) do not contain asbestos.
