### ASBESTOS SURVEY REPORT FOR WASHINGTON TOWN CENTRE LIBRARY, WASHINGTON

*Control of Asbestos  
Regulations 2012*

**WASHINGTON TOWN CENTRE LIBRARY,  
WASHINGTON**

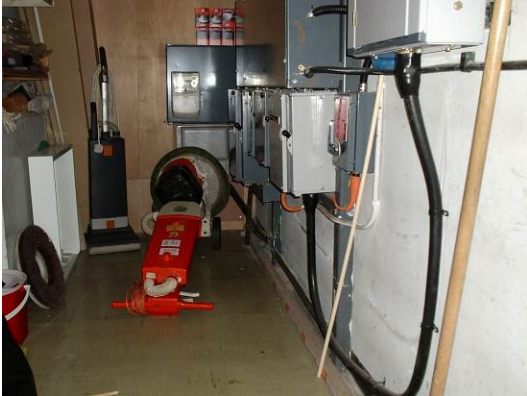
**Ref: JP0126/07**

The cream floor tile to the service cupboard under the stairs (Rm 0/2) contained asbestos.

*These were removed in May 2008.*

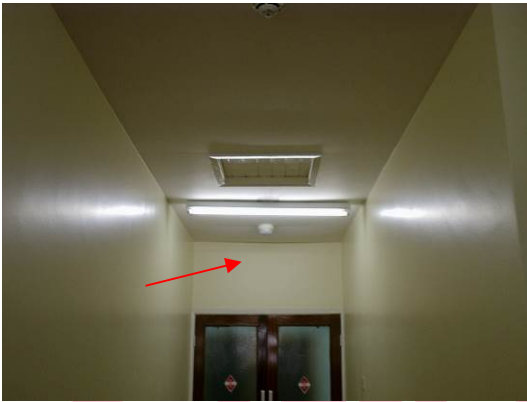
**Ref: As JP0127/07**

The header panel above the glass door in the corridor fire escape (Rm 0/3) contained asbestos.

*This was removed in May 2008.*

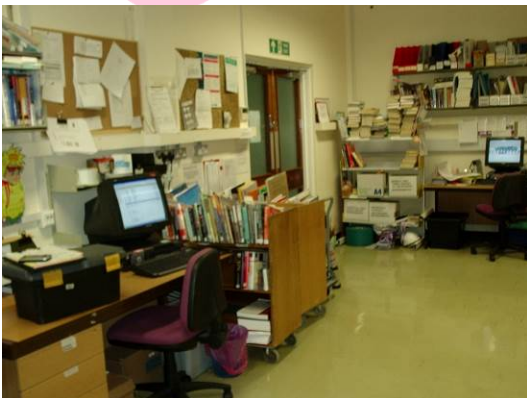
**Ref: JP0128/07**

The cream floor tiles to the Office/Store room (Rm 0/12) contained asbestos. Similar flooring is located in rooms 0/13, 0/14 and 0/16.

*These were all removed in May 2008.*

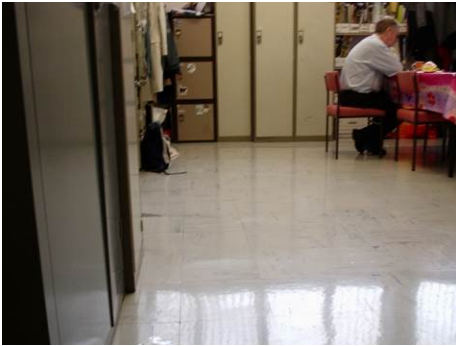
**Ref: JP0129/07**

The marbled floor tiles to the staff room (Rm 0/18) contained asbestos.

*These were removed in May 2008 along with JP0130/07 – Lino which did not contain asbestos*

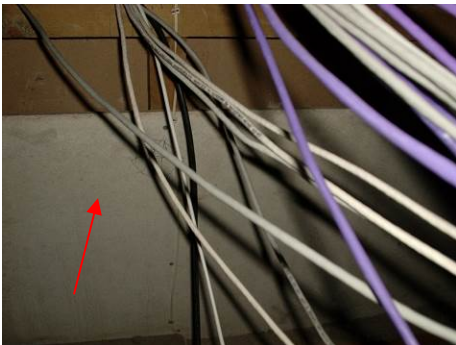
**Ref: JP0127/07**

The fire break in the loft space above the doors on the ground floor (L0/3) contained asbestos.

*This was removed in May 2008.*

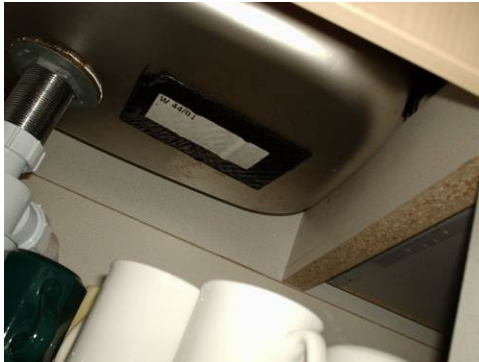
### **Item 1 - Ref: JP0131/07**

The sink pad to the staff room (Rm 0/18) does not contain asbestos.

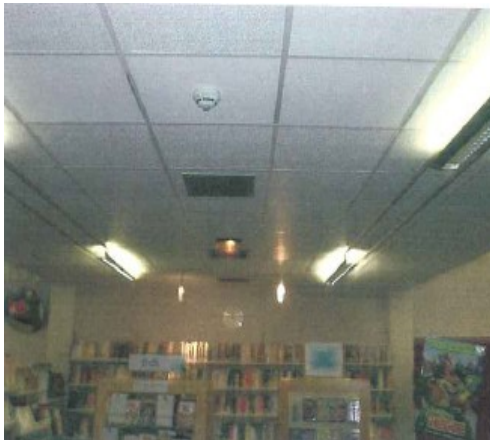
### **Item 2 - Ref: JP0121/07**

The ceiling tiles to the children's library (Rm 1/1) does not contain asbestos.

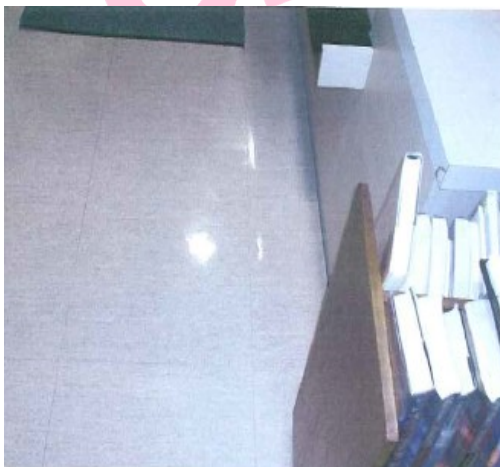
### **Item 3 - Ref: JP0030/07**

The floor tiles in the first floor reception (Rm 1/3) does not contain asbestos.

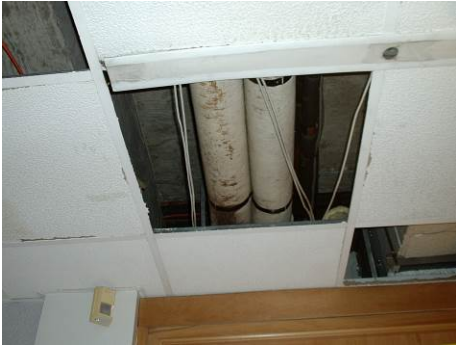
**Item 4 - Ref: JP0031/07**

The pipework insulation to the first floor reception (Rm 1/3) does not contain asbestos.

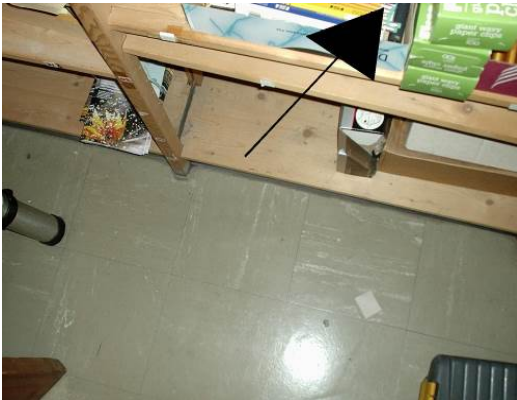
**Item 8 - Ref: JP0124/07**

The floor tile in the first floor store cupboard (Rm 1/6) does not contain asbestos.

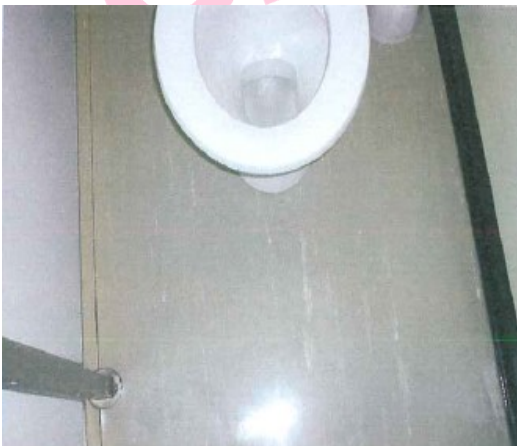
**Item 9 - Ref: JP0122/07**

The floor covering in the first floor female toilets (Rm 1/7) does not contain asbestos.

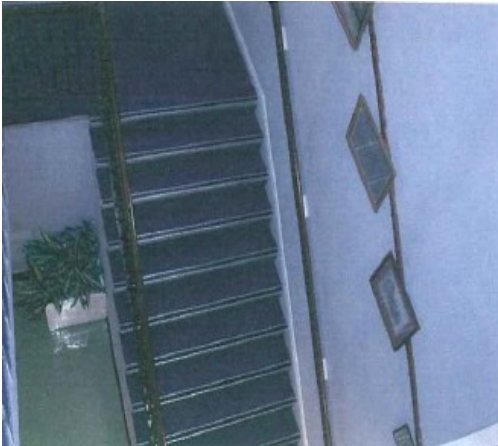
### **Item 10 - Ref: JP0125/07**

The stair nosing to staircase (Rm 1/8) does not contain asbestos.

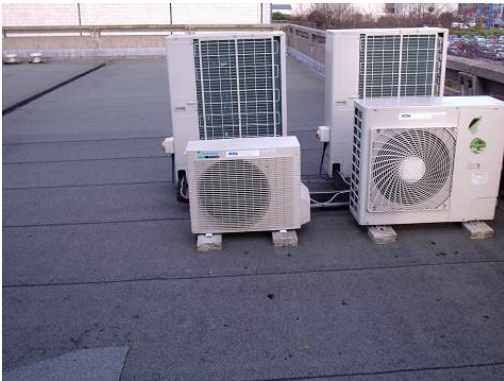
### **Item 11 - Ref: JP0133/07**

The roof felt to the external (E/1) does not contain asbestos.

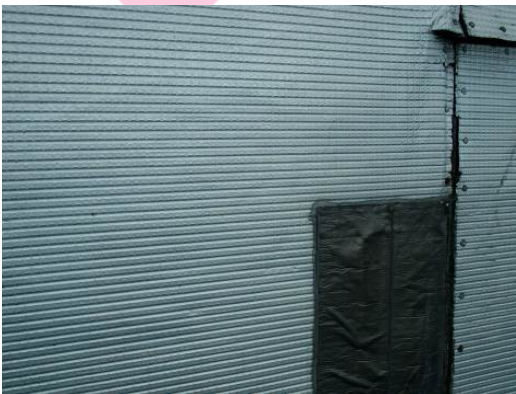
### **Item 12 - Ref: JP0132/07**

The wall lining around the plant and life machinery room does not contain asbestos.

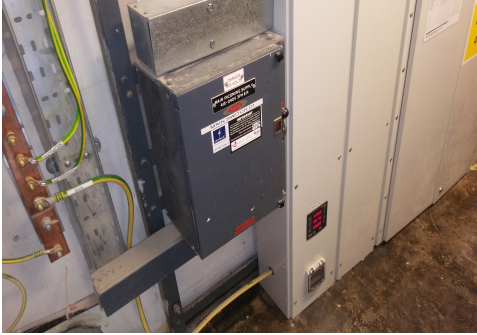
### **Item 13 - Ref: Presumed**

The MEM isolation switch in the understairs electrical cupboard is presumed to contain asbestos.

Any planned works will require further investigation.

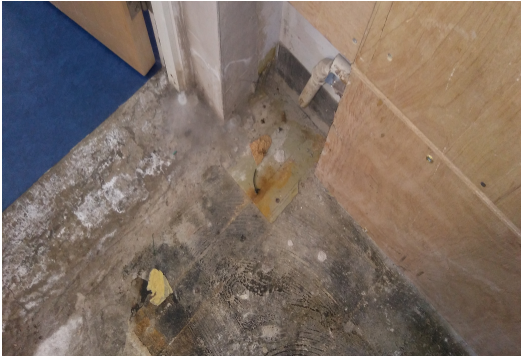
### **Item 14 - Ref: 334398-1**

*The remnant floor covering in the understairs electrical cupboard contains asbestos.*

*Removed 2026*

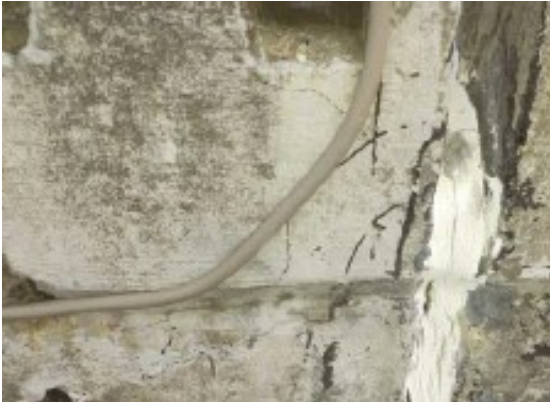
### **Item 16 - Ref: 22-41634-1**

The putty between expansion joints in the walls (Area 1/External) does not contain asbestos.

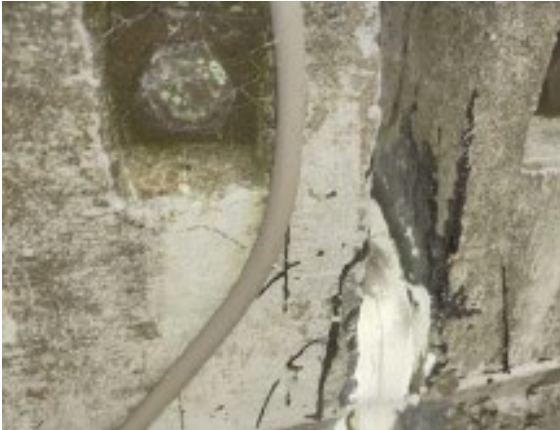
### **Item 17 - Ref: 22-41634-2**

The residue to parapet around expansion joints in the walls (Area 1/External) does not contain asbestos.

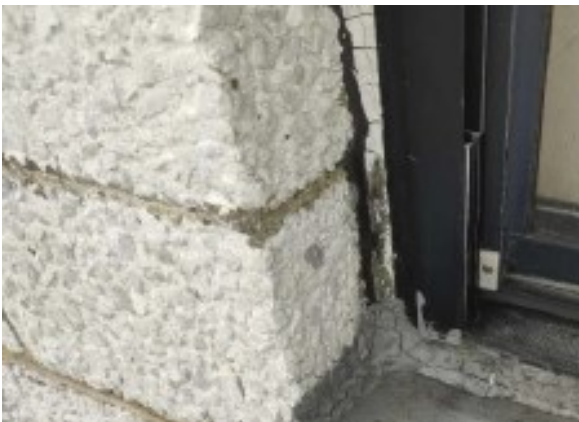
### **Item 18 - Ref: 22-41634-3**

The sealant around the windows to the connexions building (Area 1/External) does not contain asbestos.

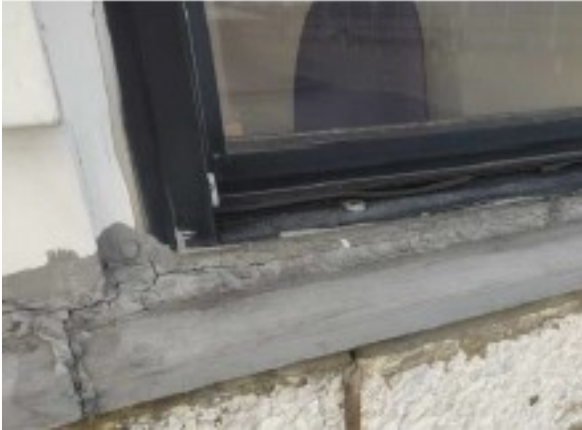
### **Item 19 - Ref: 22-41634-4**

The sills below the windows to the connexions building (Area 1/External) does not contain asbestos.

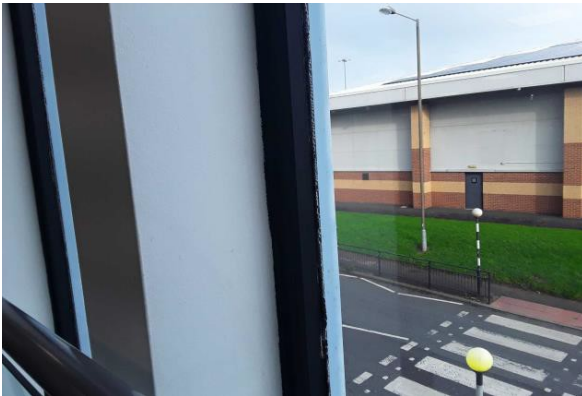
### **Item 20 Ref: 22-52610-1**

The window - internal nsl frames (Mastic) (Area: 25 External) do not contain asbestos.

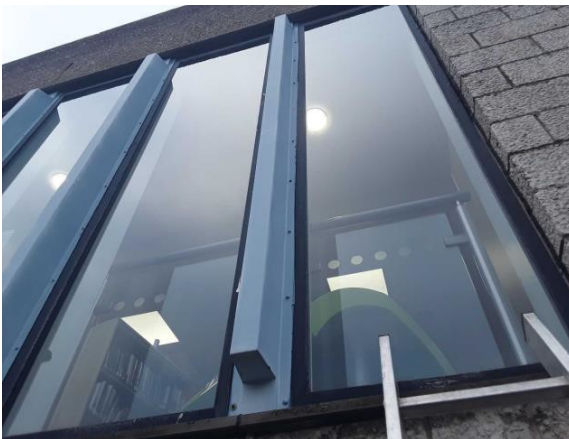
### **Item 21 Ref: 22-52610-2**

The external metal windows (Putty) (Area: 25 External) do not contain asbestos.

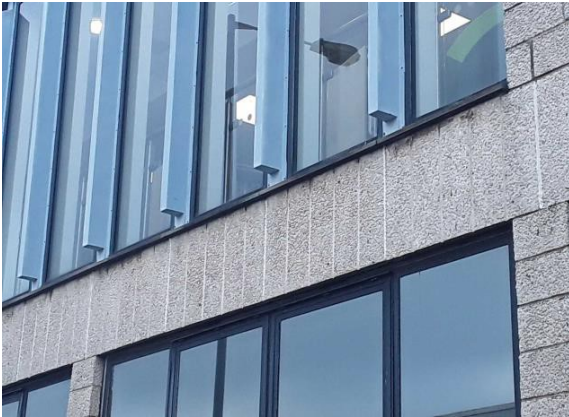
### **Item 22 Ref: 22-52610-3**

The window – external sills (Cement) (Area: 25 External) do not contain asbestos.

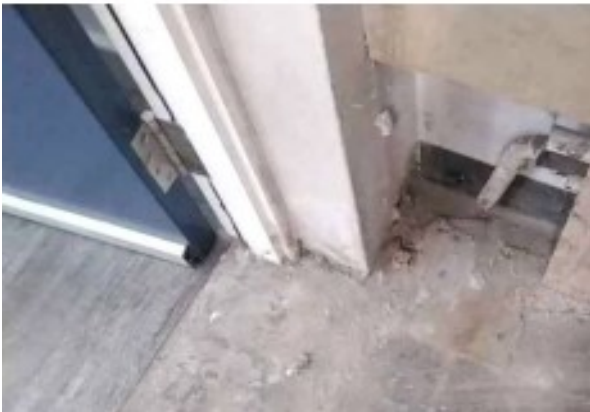
### **Item 23 Ref: Presumed**

The floor tiles and adhesive in the Switch Room (Z1/001) is presumed to contain asbestos.

(Item duplicated – see items 14 & 15)

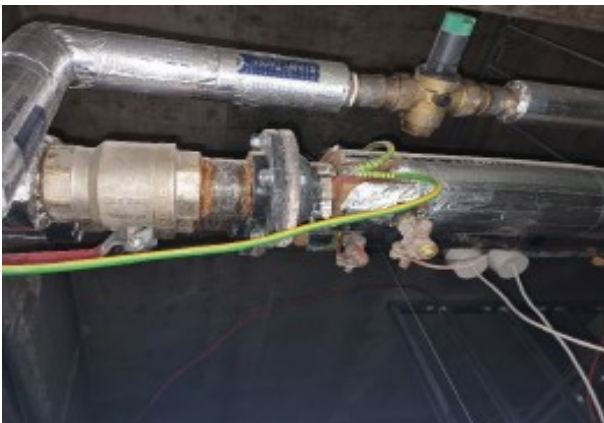
### **Item 24 Ref: Presumed**

The gaskets to pipework in corridor (G/01) are presumed to contain asbestos.

<b>Item 24</b>	<b>Gaskets to pipework – Corridor G/01</b>	<b>Low Risk</b>	<b>6 monthly visual from ground level only</b>	<b>19/11/2026</b>
----------------	--	-----------------	--	-------------------

Any change in appearance should be reported to Property Services.
