ASBESTOS SURVEY REPORT FOR UNITS 11 PHOENIX WAY, RAINTON BRIDGE INDUSTRIAL ESTATE, SUNDERLAND, DH4 5SA

**Units 11 Phoenix Way, Rainton Bridge Industrial Estate,
Sunderland, DH4 5SA**

Date: 05 February 2026

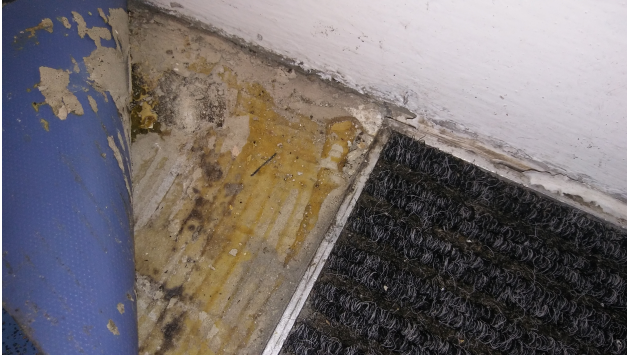
Item 1 Ref: 359885-1

The Remnant adhesive below modern screed (Room 001/Lobby) does not contain asbestos.

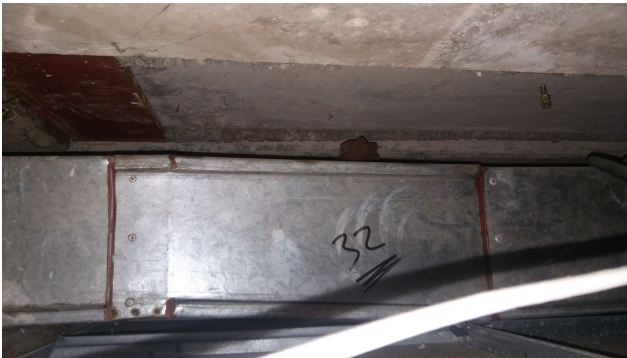
Item 2 Ref: 359885-2

The Red mastic to ductwork (Room 001/lobby – void above) does not contain asbestos.

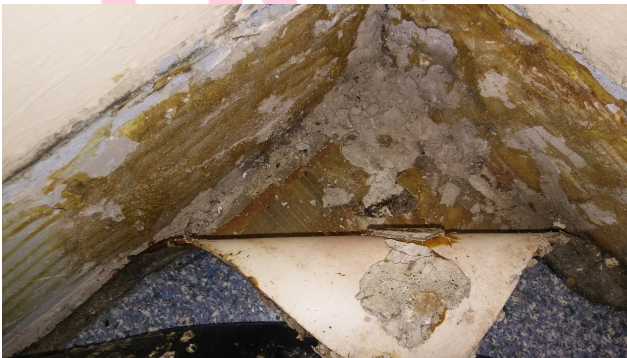
Item 3 Ref: As 359885-1

The Remnant adhesive below modern screed (Room 002/male wc and lobby) does not contain asbestos.

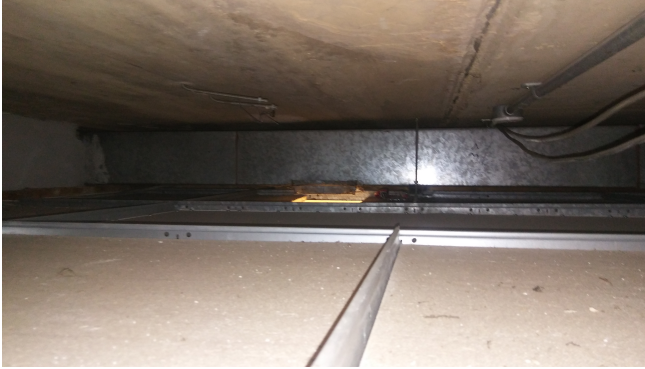
Item 4 Ref: As 359885-2

The Red mastic to ductwork (Room 002/male wc and lobby – void above) does not contain asbestos.

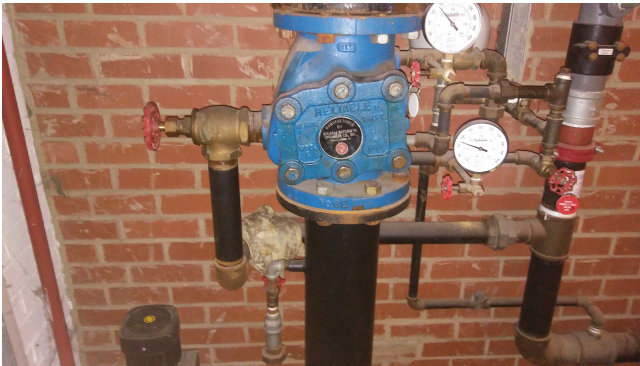
Item 5 Ref: 359885-3

- (Item 5) Ref: 359885-3 – Pipework flange gasket to bottom flange (Room 003/plant room) – Very Low Risk
- (Item 6) Ref: 359885-4 – Floor covering (Room 005/stairwell) – No Risk

The Pipework flange gasket to bottom flange (Room 003/plant room) contains asbestos.

Any change in its appearance should be recorded and passed to Property Services.

Item 5	Pipework flange gasket (Room 003/plant room)	Very Low	12 monthly	25.09.2026
<i>Item 6</i>	<i>No asbestos</i>	<i>Is present</i>		
<i>Item 7</i>	<i>No asbestos</i>	<i>Is present</i>		
<i>Item 8</i>	<i>No asbestos</i>	<i>Is present</i>		
<i>Item 9</i>	<i>No asbestos</i>	<i>Is present</i>		
<i>Item 10</i>	<i>No asbestos</i>	<i>Is present</i>		
<i>Item 11</i>	<i>No asbestos</i>	<i>Is present</i>		
<i>Item 12</i>	<i>No asbestos</i>	<i>Is present</i>		
<i>Item 13</i>	<i>No asbestos</i>	<i>Is present</i>		
<i>Item 14</i>	<i>No asbestos</i>	<i>Is present</i>		
<i>Item 15</i>	<i>No asbestos</i>	<i>Is present</i>		
<i>Item 16</i>	<i>No asbestos</i>	<i>Is present</i>		
<i>Item 17</i>	<i>No asbestos</i>	<i>Is present</i>		
<i>Item 18</i>	<i>No asbestos</i>	<i>Is present</i>		
<i>Item 19</i>	<i>No asbestos</i>	<i>Is present</i>		
<i>Item 20</i>	<i>No asbestos</i>	<i>Is present</i>		
<i>Item 21</i>	<i>No asbestos</i>	<i>Is present</i>

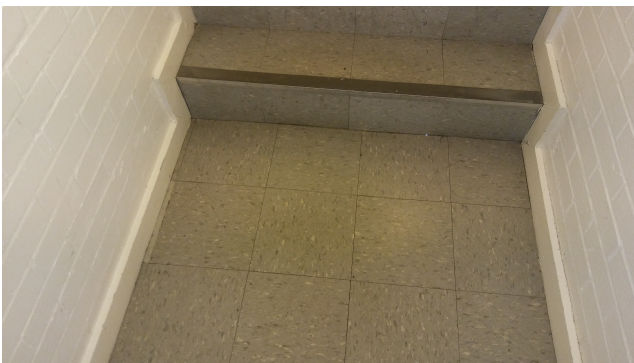
Item 6 Ref: 359885-4

The Floor covering (Room 005/stairwell) does not contain asbestos.

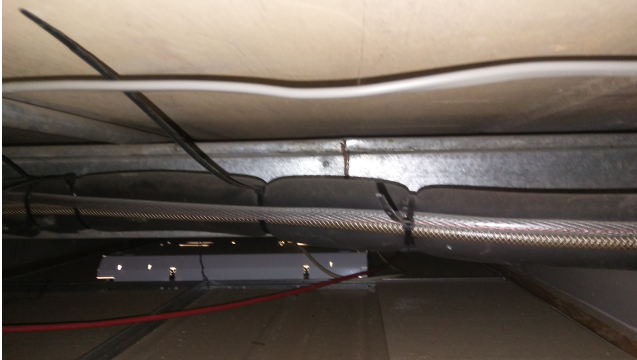
Item 7 Ref: 359885-7

The Red mastic to ductwork (Room 006/corridor and changing room – void above) does not contain asbestos.

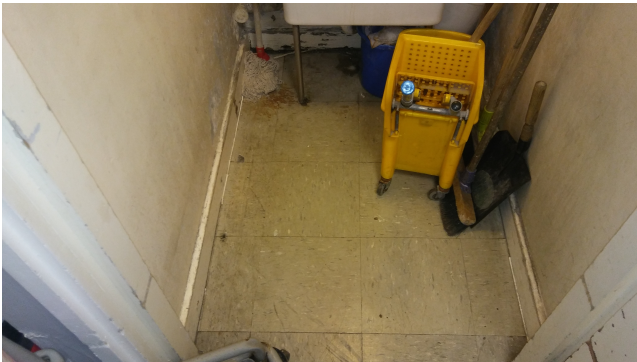
Item 8 Ref: 359885-5

The Floor covering (Room 007/store) does not contain asbestos.

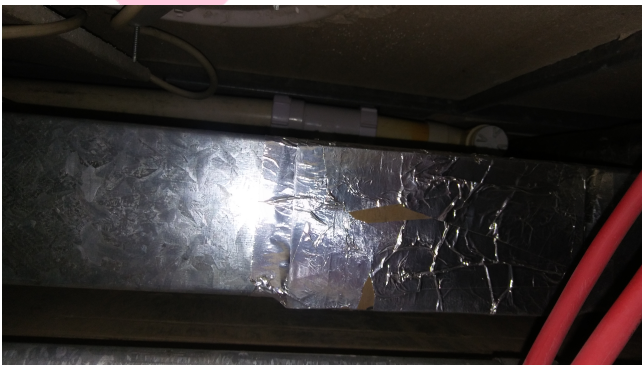
Item 9 Ref: As 359885-2

The Red mastic to ductwork (Room 007/store – void above) does not contain asbestos.

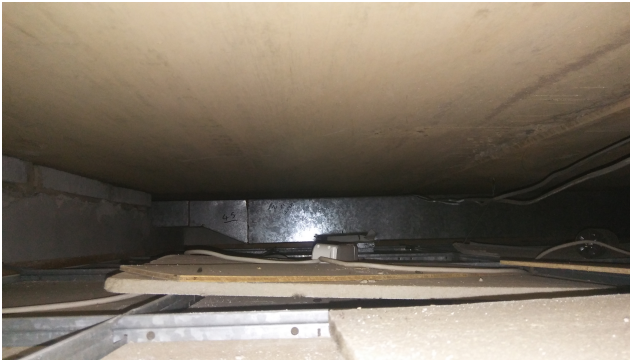
Item 11 Ref: As 359885-2

The Red mastic to ductwork (Room 008/female wc and lobby – void above) does not contain asbestos.

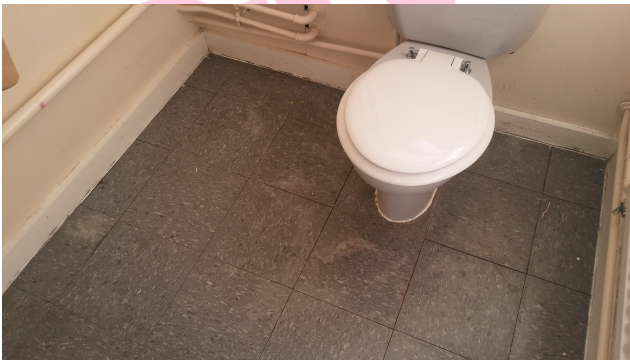
Item 12 Ref: 359885-6

The Floor covering (Room 009/disabled wc) does not contain asbestos.

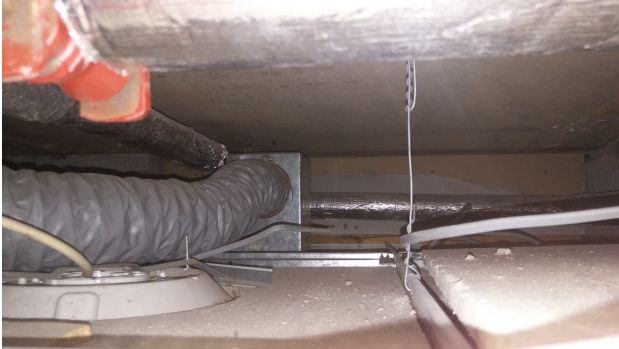
Item 13 Ref: As 359885-2

The Red mastic to ductwork (Room 009/disabled wc – void above) does not contain asbestos.

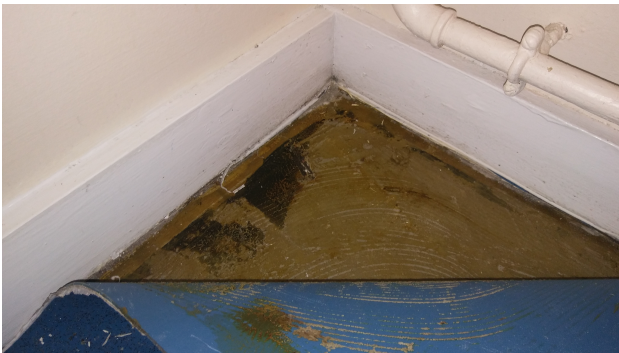
Item 14 Ref: 359885-8

The Remnant adhesive below modern screed (Room 011/male wc and lobby) does not contain asbestos.

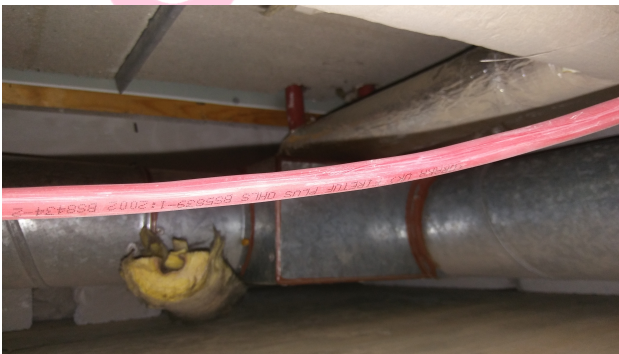
Item 15 Ref: As 359885-7

The Red mastic to ductwork (Room 011/male wc and lobby – void above) does not contain asbestos.

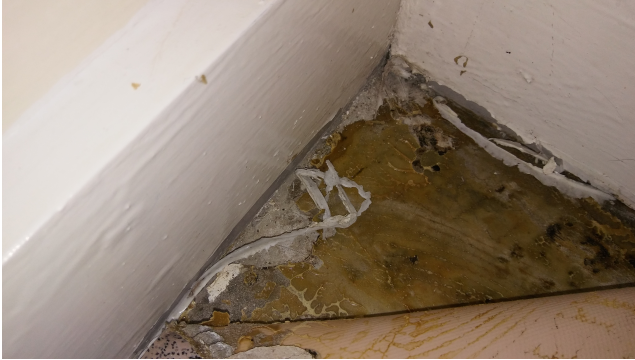
Item 16 Ref: As 359885-8

The Remnant adhesive below modern screed (Room 012/female wc and lobby) does not contain asbestos.

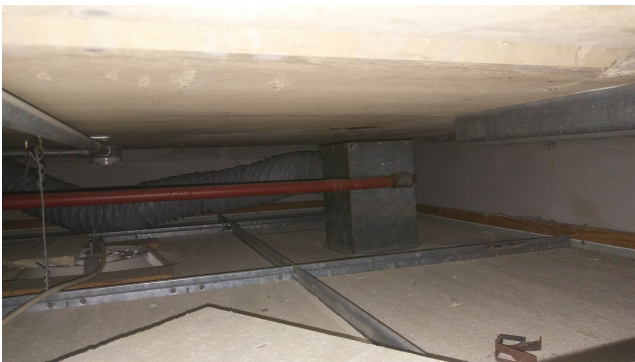
Item 17 Ref: As 359885-7

The Red mastic to ductwork (Room 012/female wc and lobby – void above) does not contain asbestos.

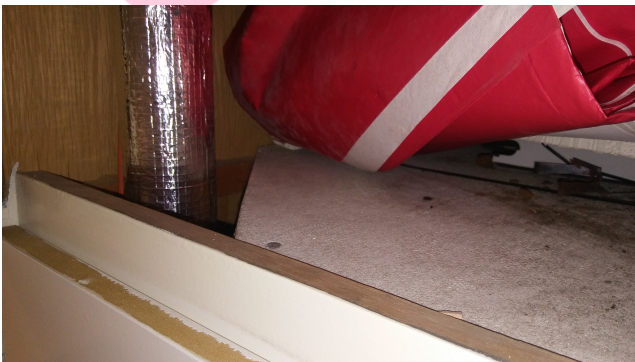
Item 18 Ref: 359885-9

The Shelf panels within cupboard and to base of heater (Room 013/medial room) does not contain asbestos.

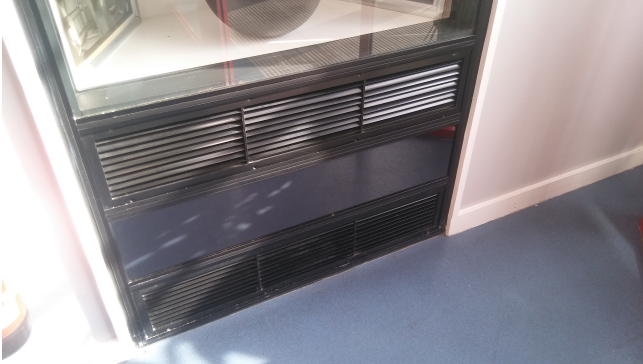
Item 19 Ref: As 359885-9

The Panels to low level heater (Room 014/main reception) does not contain asbestos.

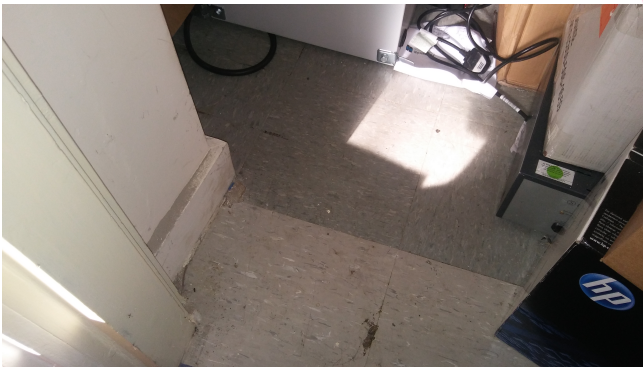
Item 20 Ref: 359885-10

The Floor covering (Room 015/store) does not contain asbestos.

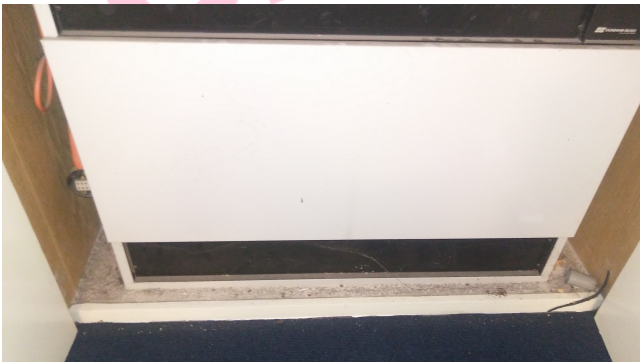
Item 21 Ref: As 359885-9

The Shelf panels within cupboard and base of heater (Room 017/meeting room 1) does not contain asbestos.

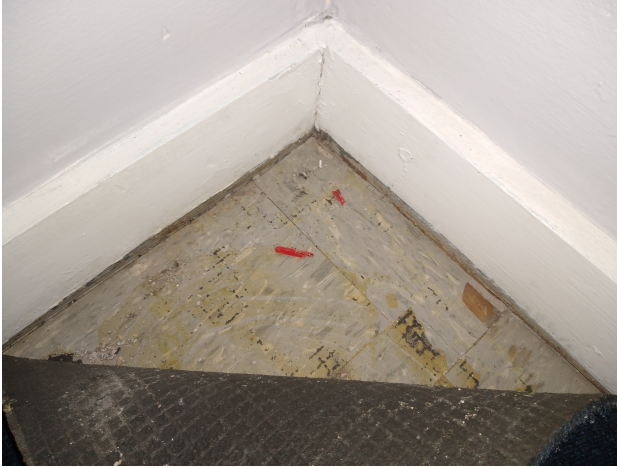
Item 22 Ref: 359885-11

The Subfloor covering (Room 020/lobby and stairwell) does not contain asbestos.

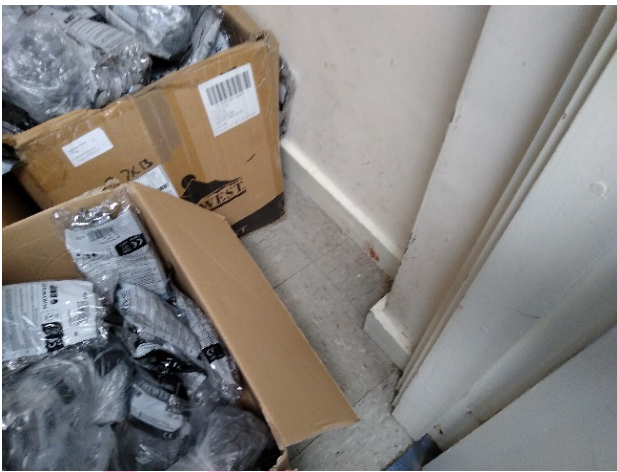
Item 23 Ref: As 359885-10

The Floor covering (Room 021/cupboard) does not contain asbestos.

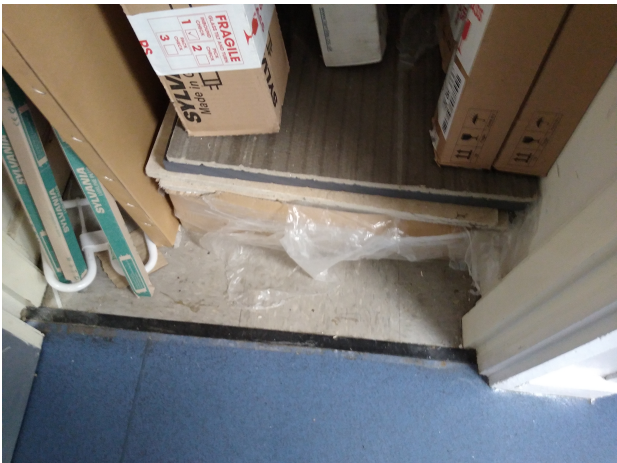
Item 24 Ref: As 359885-11

The Floor covering (Room 022a/cupboard) does not contain asbestos.

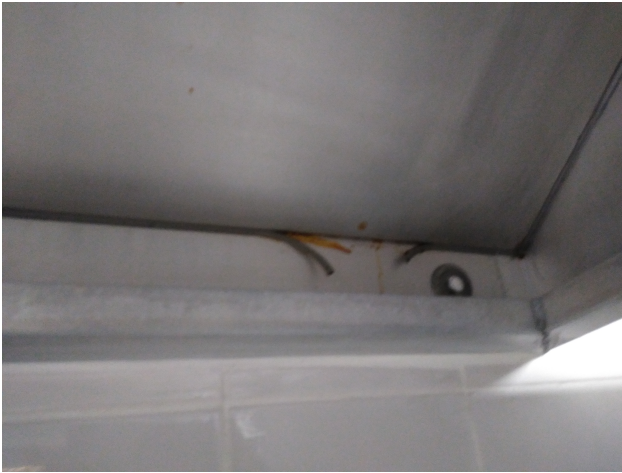
Item 25 Ref: 359885-12

The Mastic to cooker hood (Room 024/kitchen) does not contain asbestos.

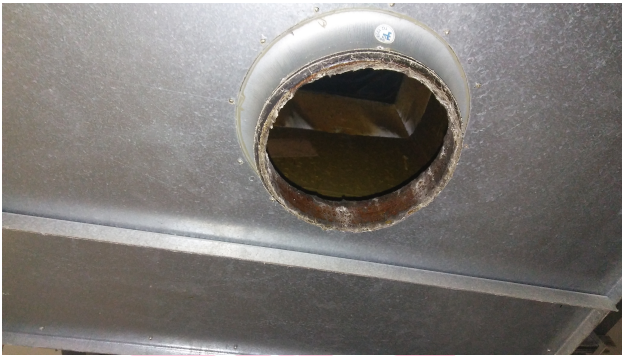
Item 26 Ref: 359885-17

The Mastic to redundant ductwork highlevel (Room 033/main factory) does not contain asbestos.

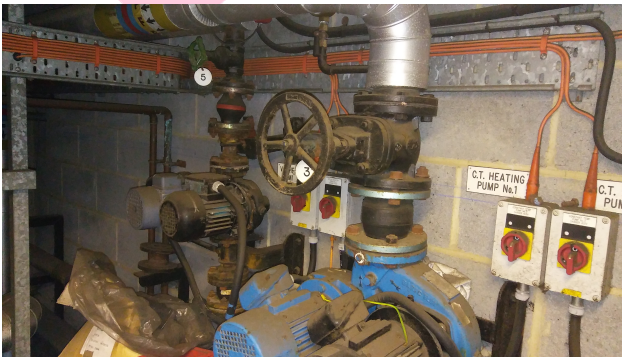
Item 27 Ref: 359885-15

- (Item 27) Ref: 359885-15 – Pipework flange gasket to north wall (Room 038/plant room) – Very Low Risk
- (Item 28) Ref: 359885-16 – Pipework flange gasket to boilers (Room 038/plant room) – Very Low Risk

The Pipework flange gasket to north wall (Room 038/plant room) contains asbestos.

Any change in its appearance should be recorded and passed to Property Services.

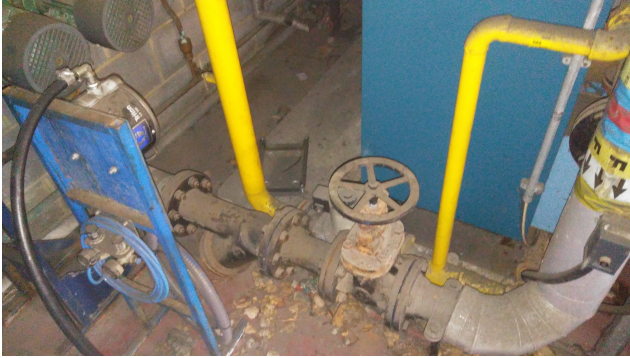
Item 28 Ref: 359885-16

The Pipework flange gasket to boilers (Room 038/plant room) contains asbestos.

Any change in its appearance should be recorded and passed to Property Services.

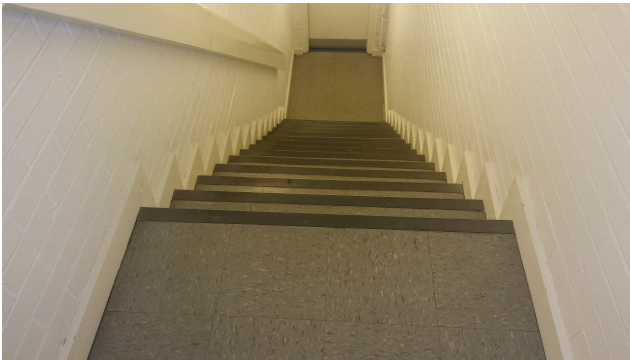
Item 29 Ref: 359885-13

The Floor covering (Level 1 Room 003/stairwell) does not contain asbestos.

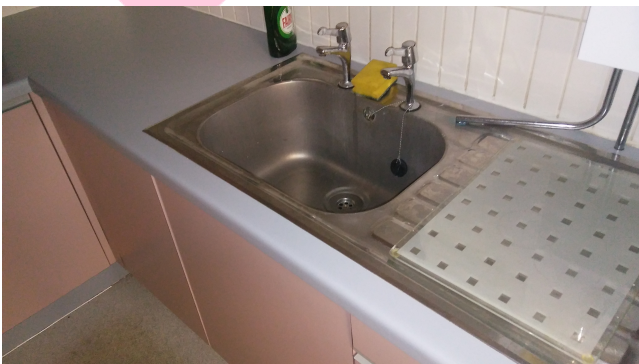
Item 30 Ref: 359885-14

The Sink pad (Level 1 Room 004/beverage bay) does not contain asbestos.

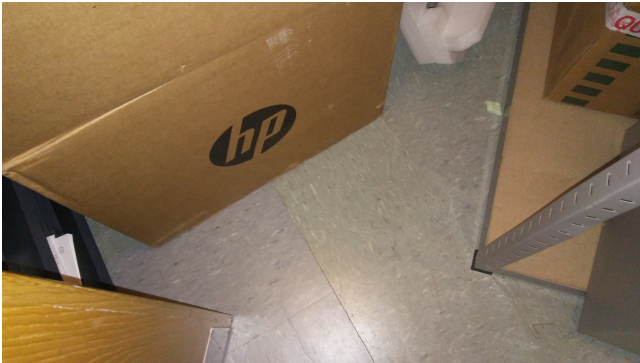
Item 31 Ref: As 359885-13

The Floor covering (Level 1 Room 007/store) does not contain asbestos.

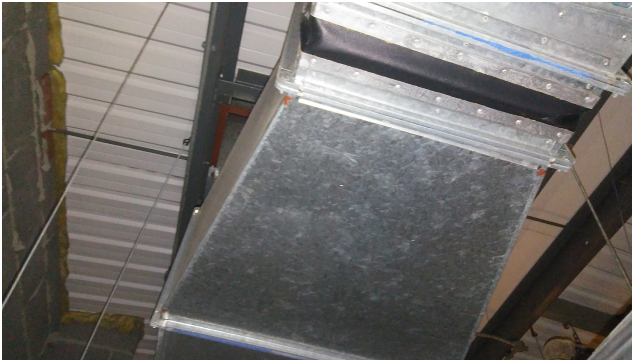
Item 32 Ref: As 359885-2

The Red mastic to ductwork (Level 1 Room 010/female wc – void above) does not contain asbestos.

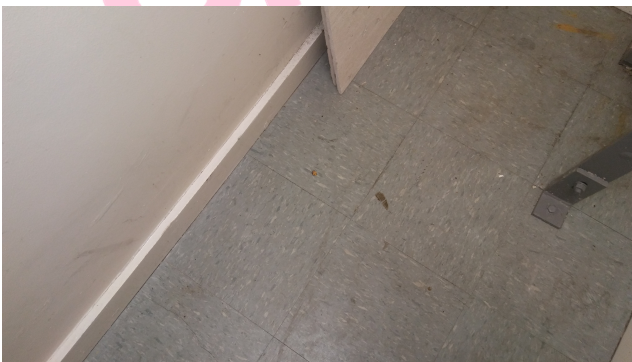
Item 33 Ref: As 359885-13

The Floor covering (Level 1 Room 011/roof access room) does not contain asbestos.

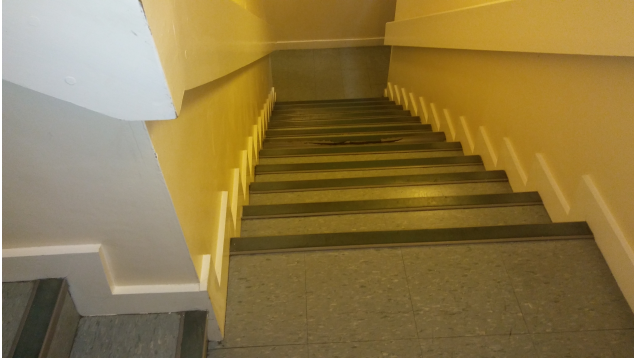
Item 34 Ref: As 359885-13

The Floor covering (Level 1 Room 024/stairwell) does not contain asbestos.

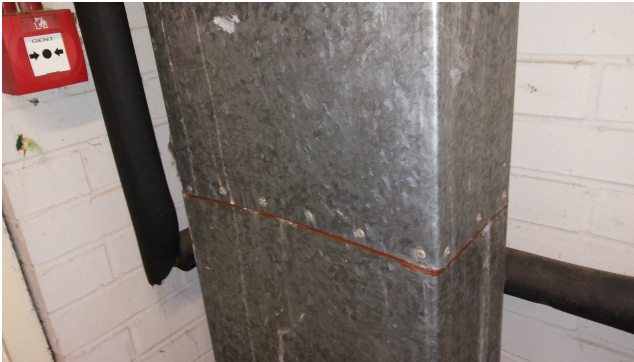
Item 35 Ref: As 359885-2

The Red mastic to ductwork (Level 1 Room 025/plant room) does not contain asbestos.

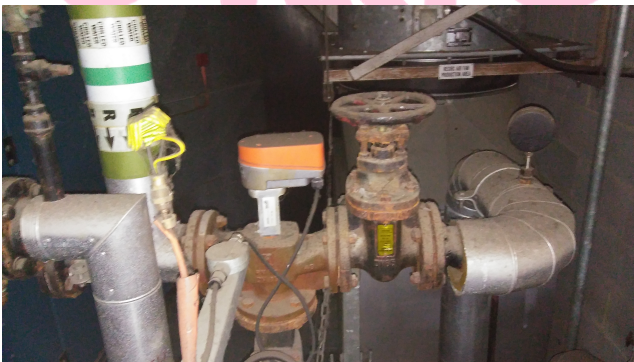
Item 36 Ref: As 359885-15

- (Item 35) Ref: As 359885-2 – Red mastic to ductwork (Level 1 Room 025/plant room) – No Risk
- (Item 36) Ref: As 359885-15 – Pipework flange gasket (Level 1 Room 026/plant room – above 0/038) – Very Low Risk

The Pipework flange gasket (Level 1 Room 026/plant room – above 0/038) contains asbestos.

Any change in its appearance should be recorded and passed to Property Services.

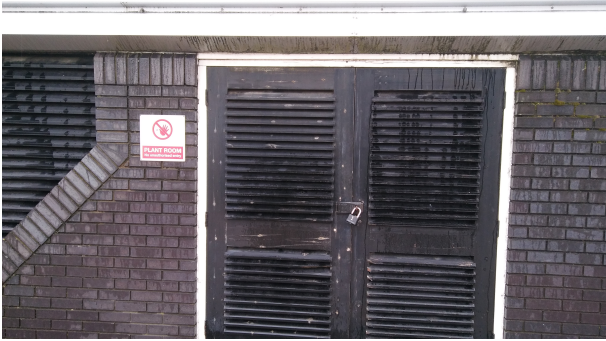
Item 37 Ref: 359885-18

The Mastic to plant room door (999-externals) does not contain asbestos.

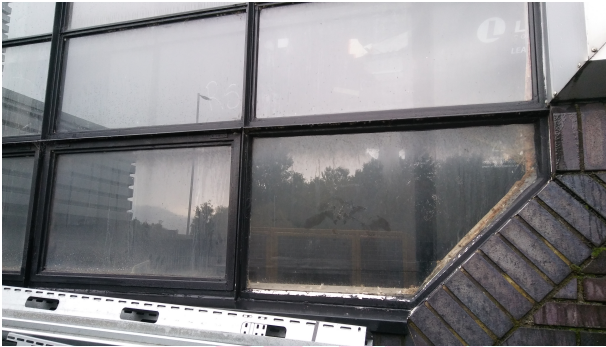
Item 38 Ref: 359885-19

The Mastic to windows East (999-externals) does not contain asbestos.

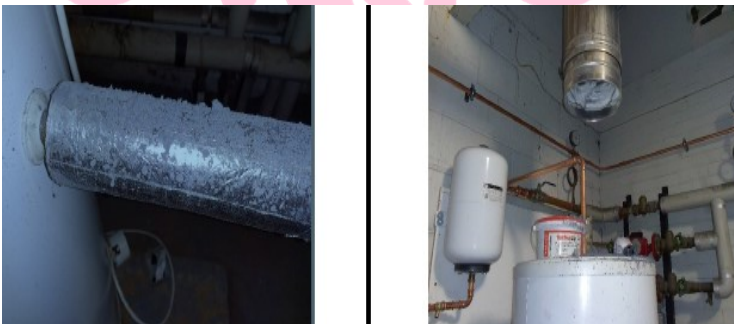
Item 39 Ref: NX001251

The pipe lagging debris to the floor, boiler and pipework in the Plant/boiler room (1/01) does not contain asbestos.

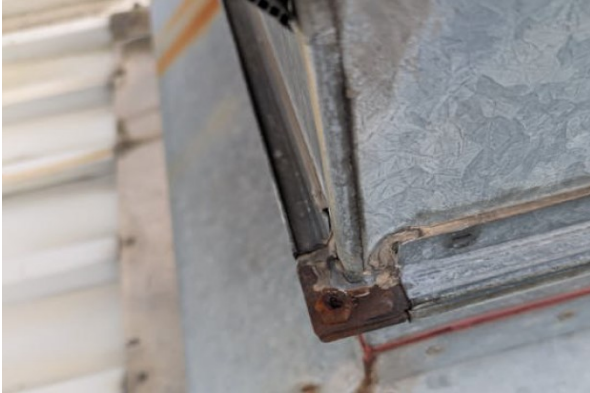
Item 40 Ref: LC/001

The Mastic to ductwork units to plant room roof (999-externals) does not contain asbestos.
