ASBESTOS SURVEY REPORT FOR ROKER PARK, ROKER, SUNDERLAND

Asbestos Register for Roker Park, Sunderland

Plan of Building and Samples Location

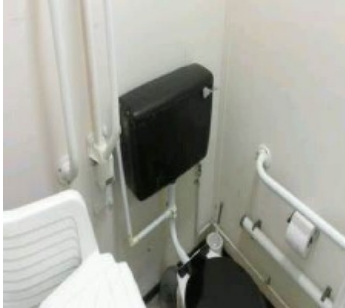
Item 1 – EC002367

The cistern to the Gents WC (Room 2) does not contain asbestos.

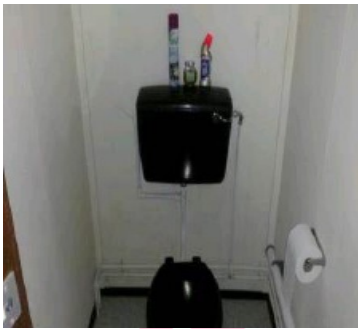
Item 2 As EC002367

The cisterns to the Ladies WC (Room 4) does not contain asbestos.

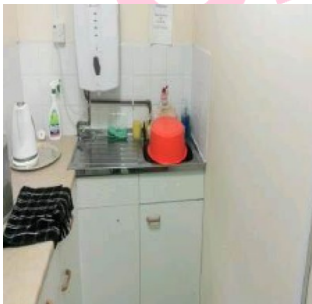
Item 3 Ref: EC002368

The sink pad to the kitchen (Room 5) does not contain asbestos.

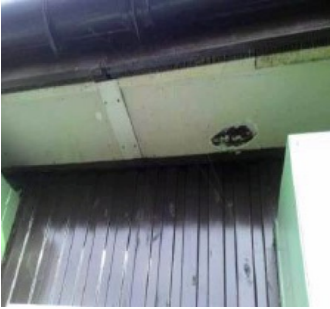
Item 4 Ref: EC002369

The soffit board to the external of the building does not contain asbestos.

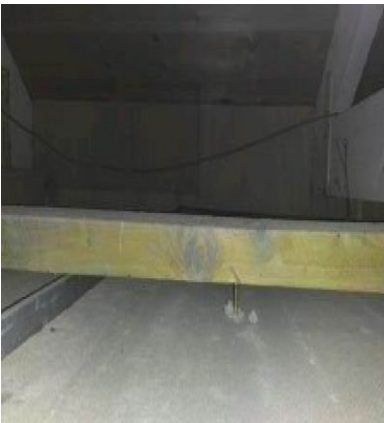
Item 5 Ref: EC002370

The random debris top the ceiling void in above the kitchen (Room 6) does not contain asbestos.

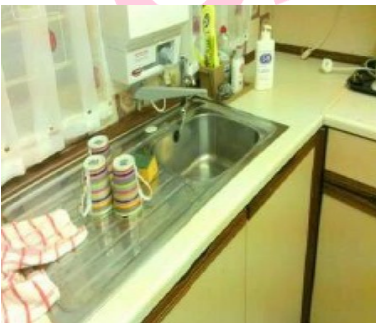
Item 6 Ref: EC002371

The sink pad to the kitchen (Room 6) does not contain asbestos.

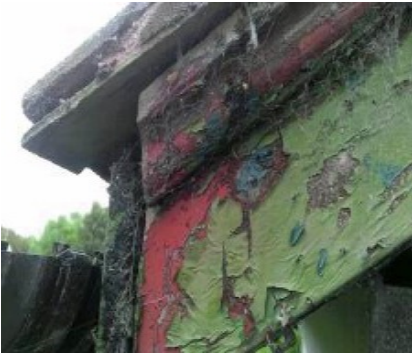
Item 7 Ref: EC002372

The cement verging to the external cement roof tiles does not contain asbestos.

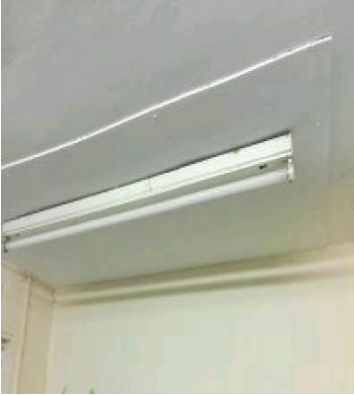
Item 8 Ref: EC002366

The ceiling boards to the Mess room (Room 7) do not contain asbestos.

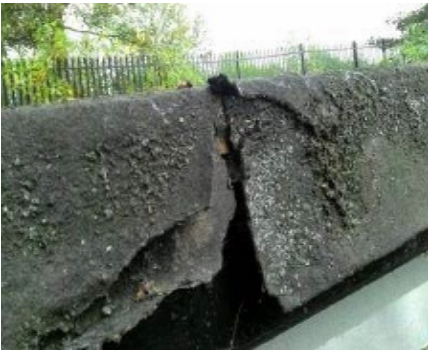
Item 9 Ref: EC002365

The roof felt to the external does not contain asbestos.

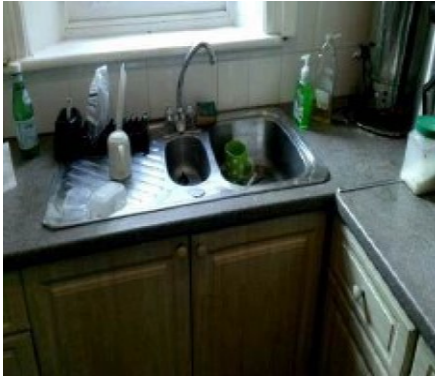
Item 10 Ref: EC002362

The sink pad to the kitchen (Room 8) does not contain asbestos.

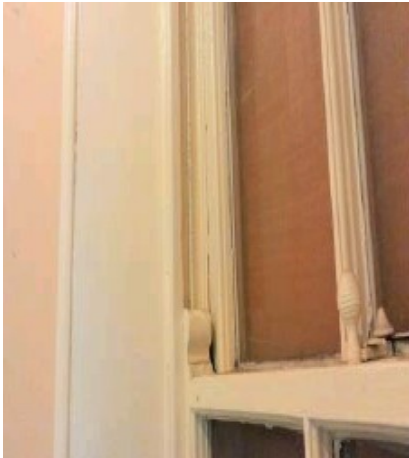
Item 11 Ref: EC002360

The composite rope pulleys to the windows throughout the property do not contain asbestos.

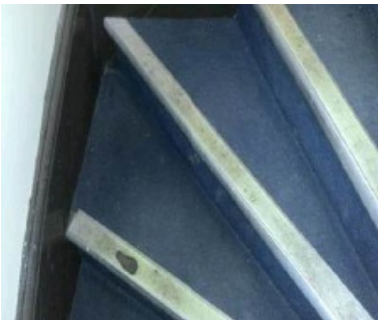
Item 12 Ref: EC002361

The stair nosing to the 1st floor landing does not contain asbestos.

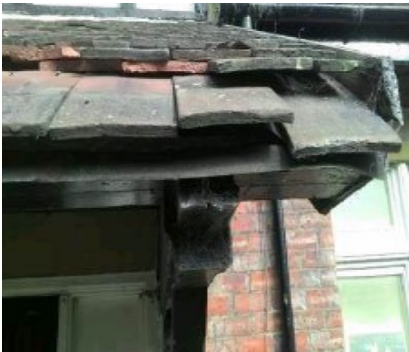
Item 13 Ref: EC002363

The roof felt to the external does not contain asbestos.

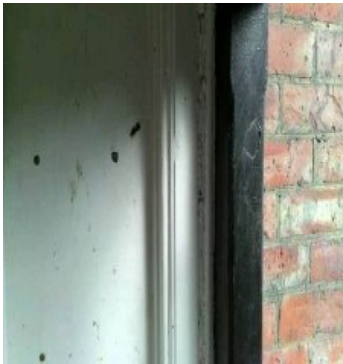
Item 14 Ref: EC002364

Door sealant to the external door does not contain asbestos.

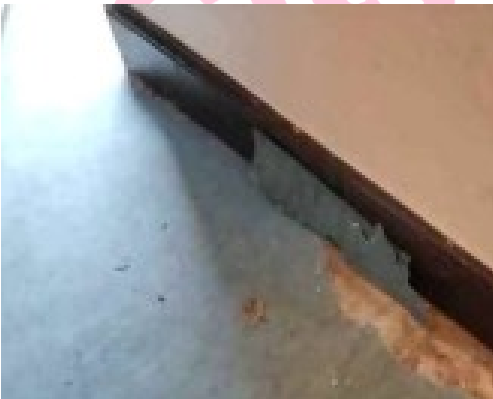
Item 15 Ref: AW005659

The floor screed in the Entrance Hall (Room G/001) does not contain asbestos.

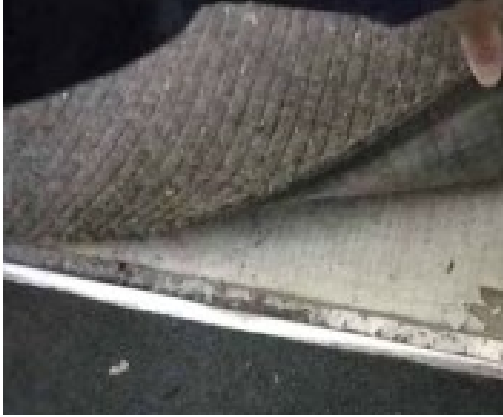
Item 16 Ref: AW005660

The floor screed in the Porch (Room G/002) does not contain asbestos.

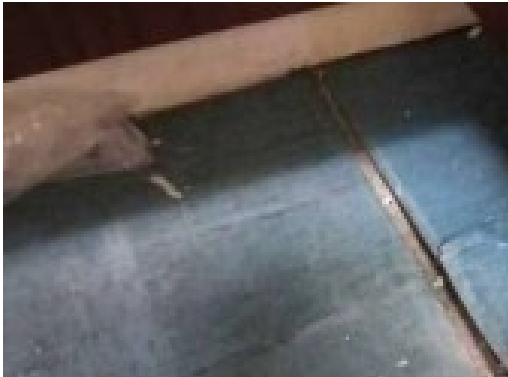
Item 17 Ref: AW005661

The floor covering lower layer in the Office (Room G/006) does not contain asbestos.

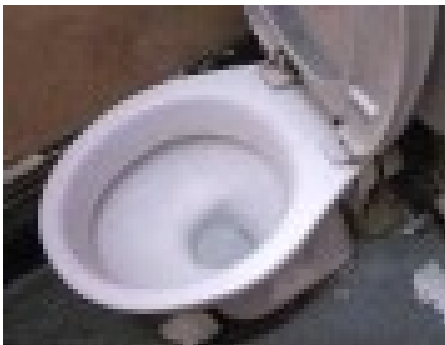
Item 18 Ref: AW005663

The floor tile beneath modern lino in the toilet (Room G/008) does contain asbestos.

Removed 2026

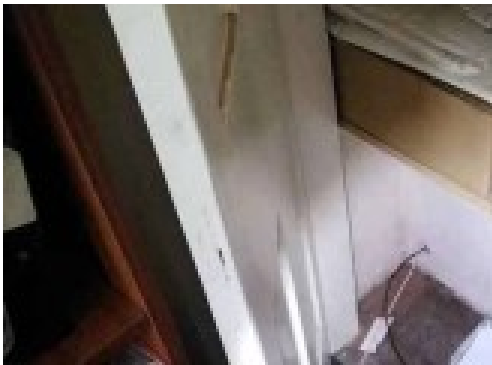
Item 20 Ref: AW005664

The floor covering in the Cupboard (Room 1/003) does not contain asbestos.

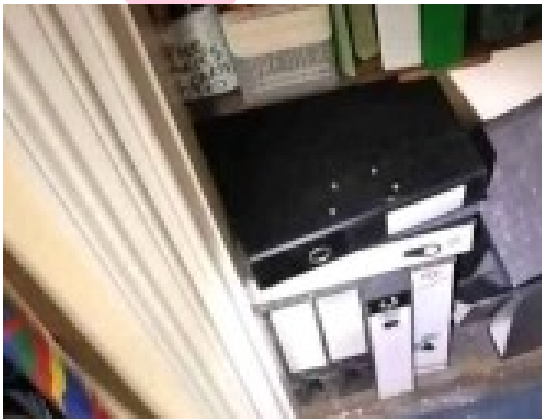
Item 21 Ref: As AW005664

The floor covering in the Cupboard (Room 1/004) does not contain asbestos.

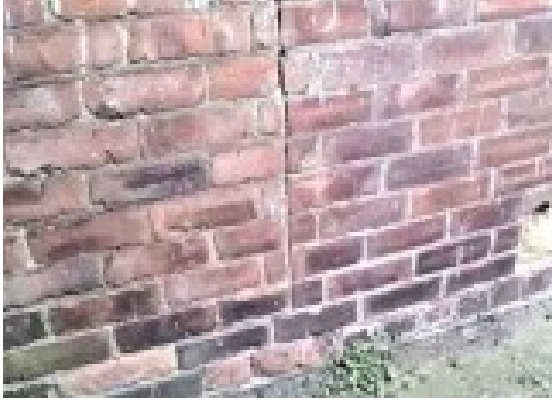
Item 22 Ref: AW005665

The damp proof course
External (E/001) does not
contain asbestos.

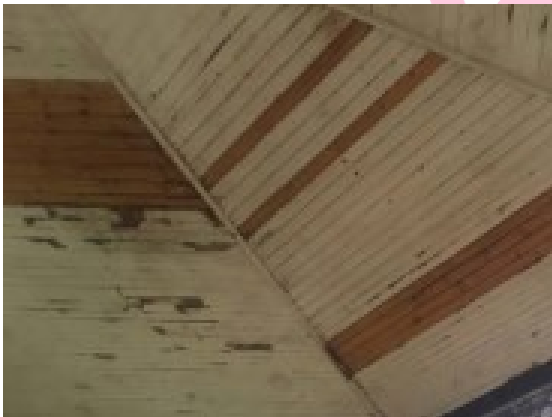
Item 23 Ref: NZ001432

The roof - sheet/cladding
jointing compound to roof
(Putty) (External E/001) does
not contain asbestos.
