### ASBESTOS SURVEY REPORT FOR CONNEXIONS CENTRE, THE GALLERIES, WASHINGTON.

**Connexions Centre, The Galleries, Washington,  
NE38 7RZ**

**Date: 24 September 2025**

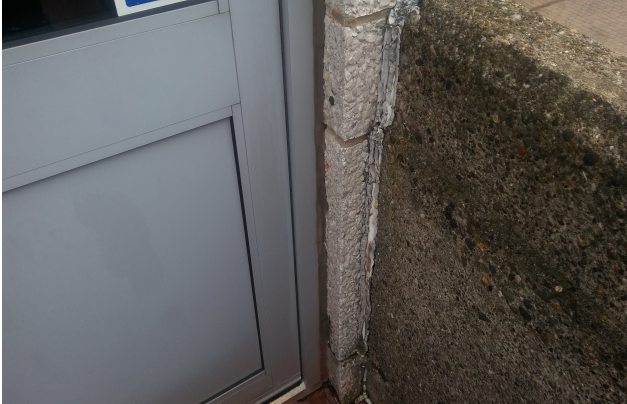
### **Item 1 Ref: 218435-1**

218435-1 Mastic to door frame (External) (Item 1) – No Risk

The mastic around the door frame (External) does not contain asbestos.

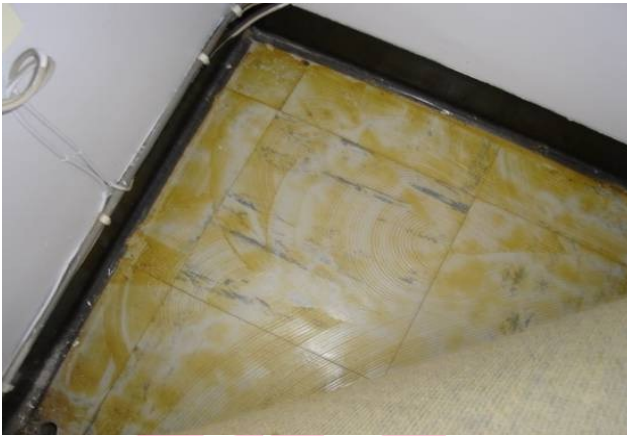
### **Item 2 Ref:As FP09-453-3**

As FP09-453-3 – Floor tiles below carpet - Tiles removed bitumen remains (Interview Rm 9 / Rm 0/002) (Item 2) – Very Low Risk (*Pattinsons Survey ref 21-30945-1/Office 6/Interview Room 1*)

The floor tiles – below carpet in Interview Room 9 (Rm 0/002) do contain asbestos. Tiles removed bitumen remains. Any change in its appearance should be recorded and passed to Property Services.

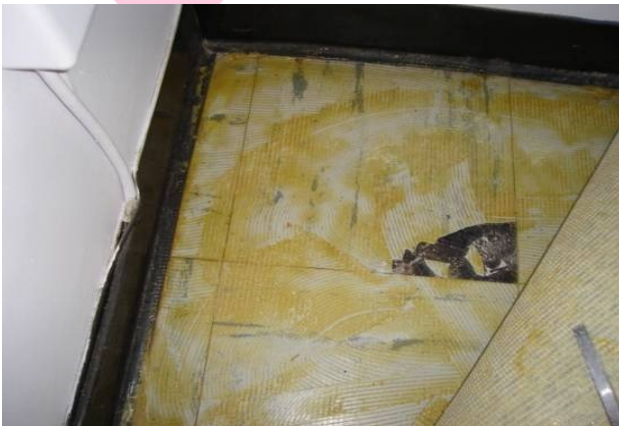
### **Item 3 Ref: FP09-453-3**

FP09-453-3 – Floor tiles (Kitchen / Rm 0/003) (Item 3) – Very Low Risk (*Pattinsons Survey ref 21-30945-1/Kitchen*)

The floor tiles in the Kitchen (Rm 0/003) do contain asbestos.

Any change in its appearance should be recorded and passed to Property Services.

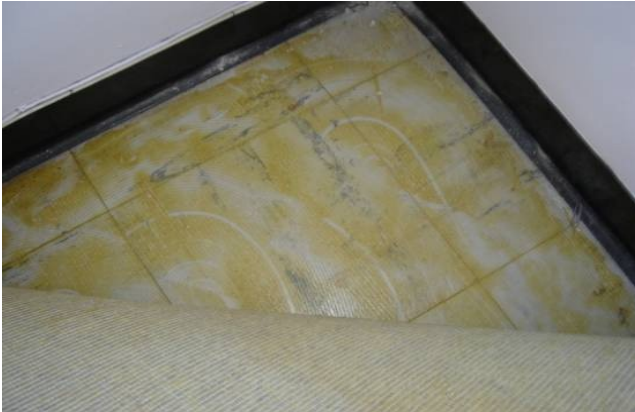
### **Item 4 Ref:As FP09-453-3**

As FP09-453-3 – Floor tiles below carpet - Tiles removed bitumen remains (Interview Rm 3 & 4 / Rm 0/004) (Item 4) – Very Low Risk (*Pattinsons Survey ref 21-30945-1/Interview Room 2/3*)

The floor tiles – below carpet in Interview Rooms 3 & 4 (Rm 0/004) do contain asbestos.  
- Tiles removed bitumen remains  
Any change in its appearance should be recorded and passed to Property Services.

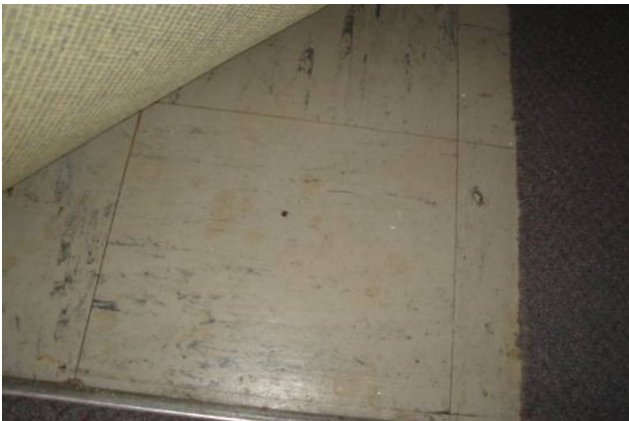
### **Item 5 Ref: FP09-453-5**

FP09-453-5 – Floor tiles below carpet - Tiles removed bitumen remains (Cleaners Cupboard / Rm 0/005) (Item 5) – Very Low Risk (*Pattinsons Survey ref 21-30945-1/Cleaners Cupboard*)

The floor tiles – below carpet in the Cleaners Cupboard (Rm 0/005) do contain asbestos.  
- Tiles removed bitumen remains  
Any change in its appearance should be recorded and passed to Property Services.

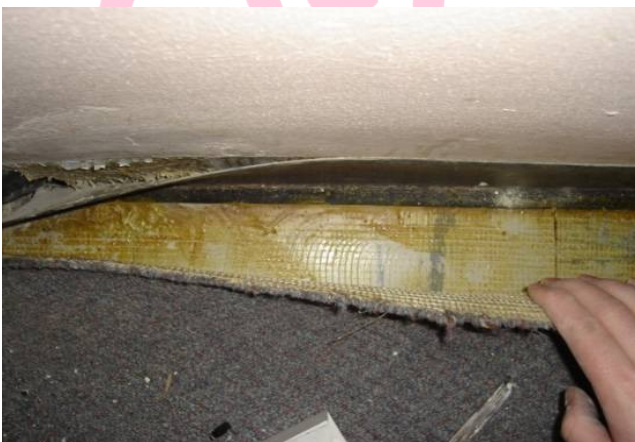
### **Item 6 Ref:As FP09-453-5**

As FP09-453-5 – Floor tiles below carpet - Tiles removed bitumen remains (Store / Rm 0/006) (Item 6) – Very Low Risk (*Pattinsons Survey ref 21-30945-1/Server Room*)

The floor tiles – below carpet in the Store (Rm 0/006) do contain asbestos.  
- Tiles removed bitumen remains  
Any change in its appearance should be recorded and passed to Property Services.

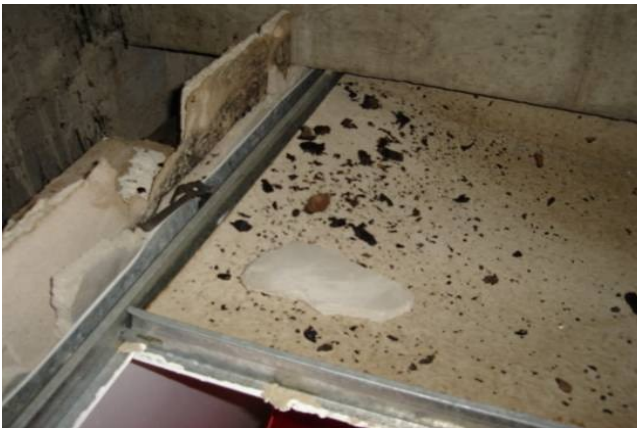
### **Item 8 Ref: FP09-453-1**

FP09-453-1 – Debris (Interview Rms 9 & 10 – ceiling void / Rm 0/002) (Item 8) – No Risk

The roof debris in Interview Rooms 9 & 10 ceiling void (Rm 0/002) does not contain asbestos.

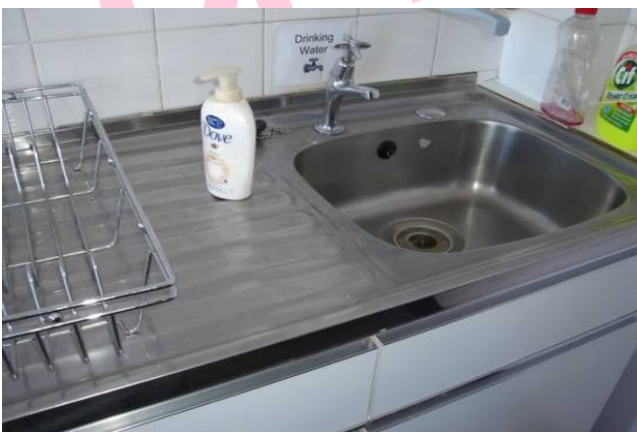
### **Item 9 Ref: FP09-453-2**

FP09-453-2 – Sink Pad (Kitchen / Rm 0/003) (Item 9) – No Risk

The sink pad in the Kitchen (Rm 0/003) does not contain asbestos.

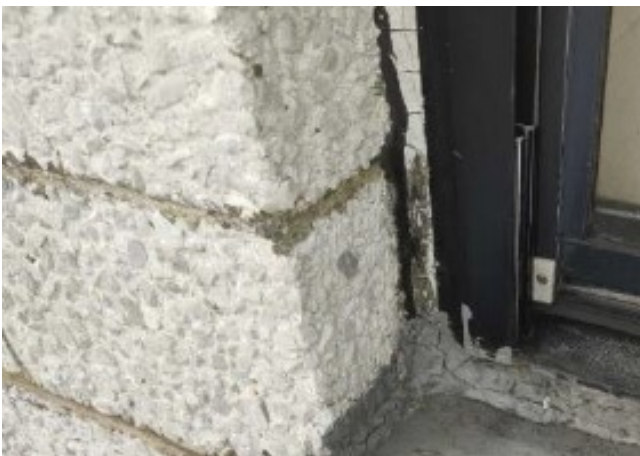
**Item 12 Ref: 22-41634-3**

22-41634-3 – Sealant around windows to connexions building (Area 1/External) (Item 12) – No Risk

The sealant around windows to connexions building (Area 1/External) does not contain asbestos.

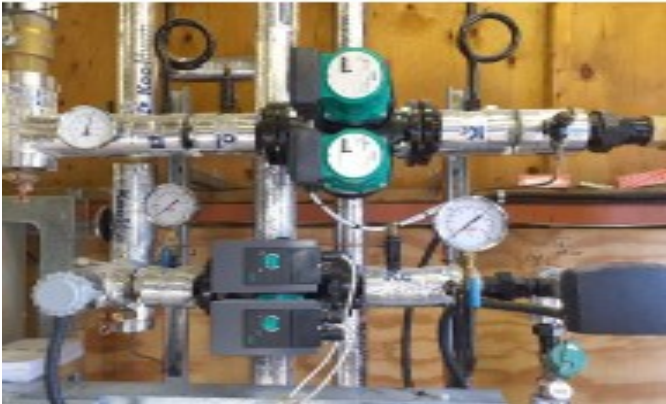
**Item 14 Ref: RT000432**

RT000432 – Gaskets to pipework flanges (Boiler Room 2/01) (Item 14) – No Risk

The gaskets to pipework flanges in the Boiler Room (2/01) does not contain asbestos.

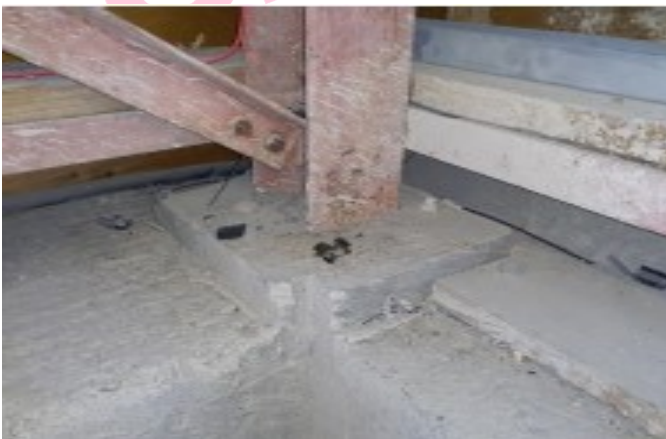
**Item 15 Ref: RT000433**

RT000433 – Bitumen residue atop of walls (Boiler Room 2/01) (Item 15) – No Risk

The bitumen residue atop of walls. Only appears to be by steel corners as per the photo in the Boiler Room (2/01) does not contain asbestos.
