ASBESTOS SURVEY REPORT FOR 9 MERCANTILE ROAD, HOUGHTON LE SPRING, DH4 5PH

## Asbestos Register for

**9 Mercantile Road, Houghton le Spring**

**Date: 18 January 2024**

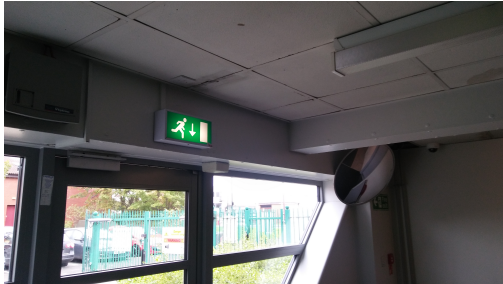
### **Item 1 Ref: As 218357-10**

The boxing to beams in the staff entrance (Rm 001) does not contain asbestos.

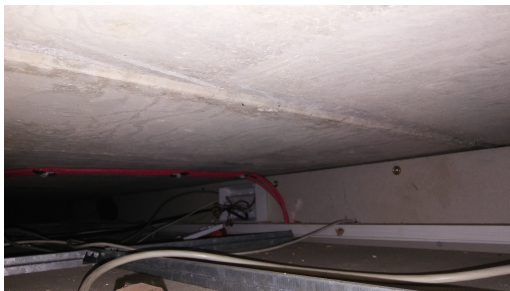
### **Item 2 Ref: 218357-10**

The boxing to beams in the staff entrance void above (Rm 001) does not contain asbestos.

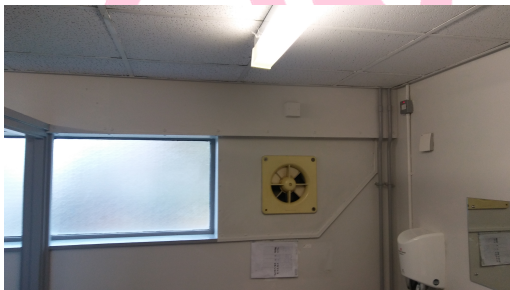
### **Item 3 Ref: As 218357-10**

The boxing to beams in the ladies toilet (Rm 003) does not contain asbestos.

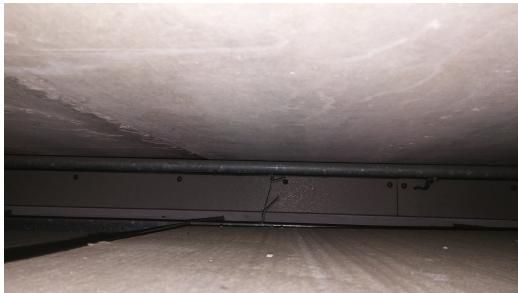
#### **Item 4 Ref: As 218357-10**

The boxing to beams in the void above the ladies toilet (Rm 003) does not contain asbestos.

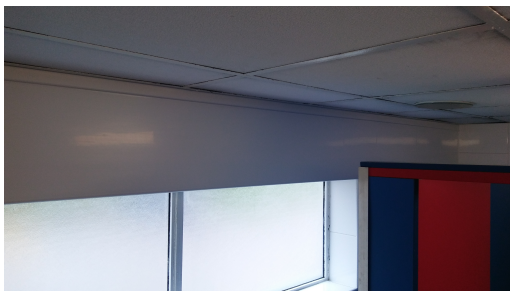
#### **Item 5 Ref: As 218357-10**

The boxing to beams in the mens toilet (Rm 004) does not contain asbestos.

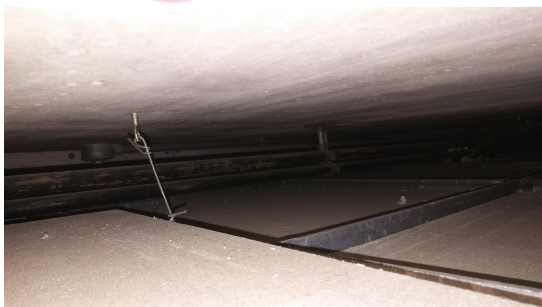
#### **Item 6 Ref: As 218357-10**

The boxing to beams in the mens toilet void above (Rm 004) does not contain asbestos.

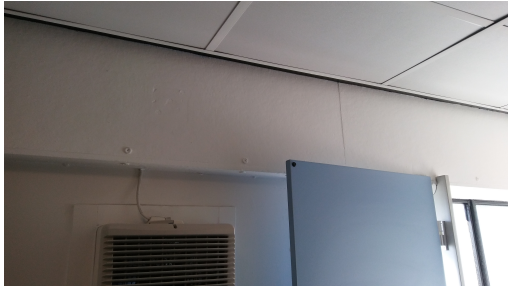
### **Item 7 Ref: As 218357-10**

The boxing to beams in the shower room (Rm 005) does not contain asbestos.

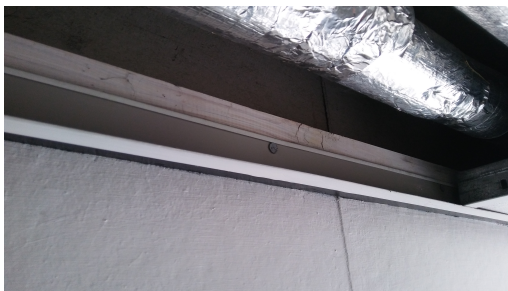
### **Item 8 Ref: As 218357-10**

The boxing to beams in the shower room void above (Rm 005) does not contain asbestos.

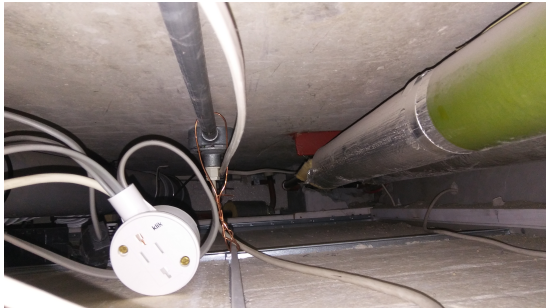
#### **Item 11 Ref: As 218357-10**

The boxing to the beams in the wc lobby room void above (Rm 011) does not contain asbestos.

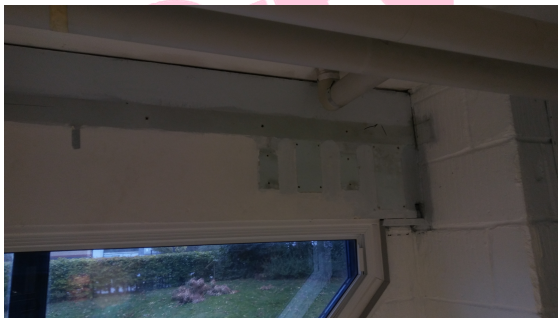
#### **Item 12 Ref: As 218357-11**

The boxing to beams in the store (Rm 015) does not contain asbestos.

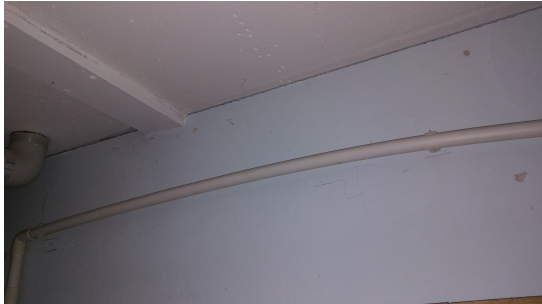
#### **Item 13 Ref: 218357-11**

The boxing to beams in the HR office void above (Rm 016) does not contain asbestos.

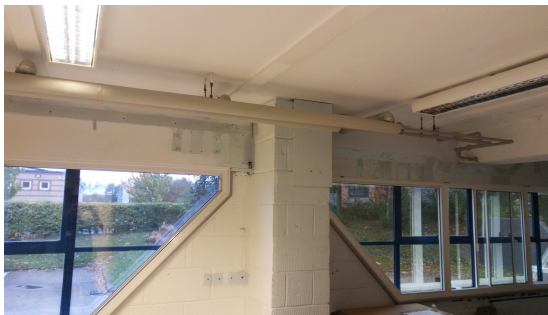
#### **Item 14 Ref: As 218357-11**

The boxing to the beams in the quality lab (Rm 017) does not contain asbestos.

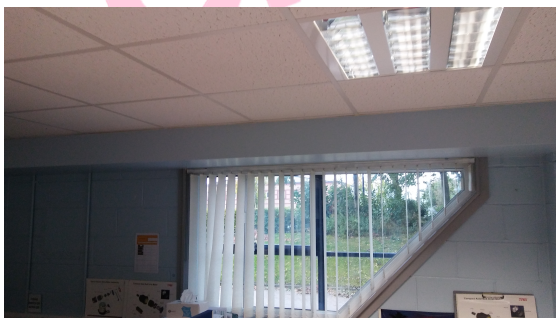
#### **Item 15 Ref: As 218357-12**

The boxing to beams in the manufacturing office (Rm 018) does not contain asbestos.

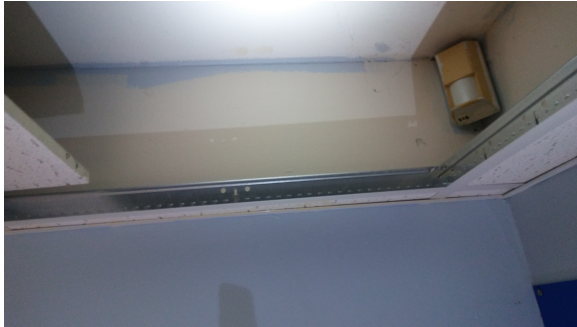
### **Item 16 Ref: 218357-12**

The boxing to beams in the manufacturing office void above (Rm 018) does not contain asbestos.

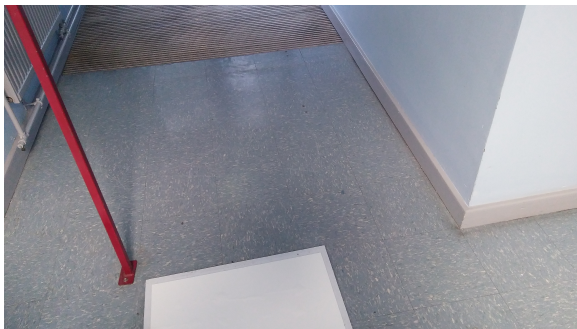
### **Item 17 Ref: 218357-13**

The floor covering to the entrance lobby (Rm 019) does not contain asbestos.

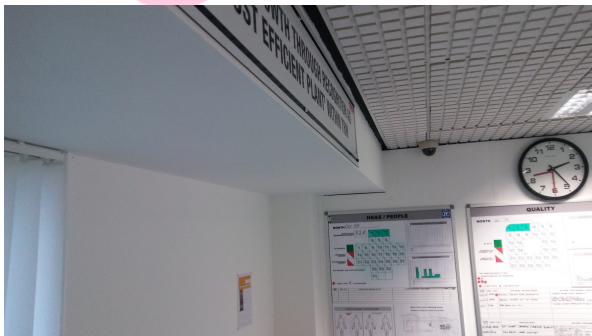
### **Item 18 Ref: As 218357-14**

The boxing to beams in the office (Rm 020) does not contain asbestos.

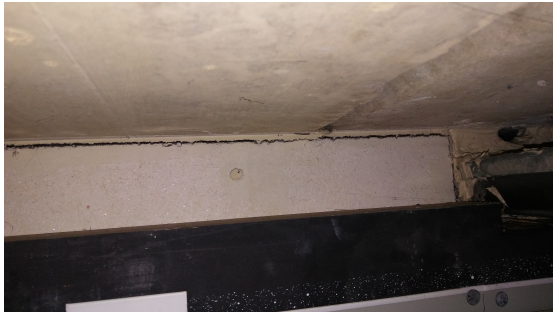
#### **Item 19 Ref: 218357-14**

The boxing to beams in the office void above (Rm 020) does not contain asbestos.

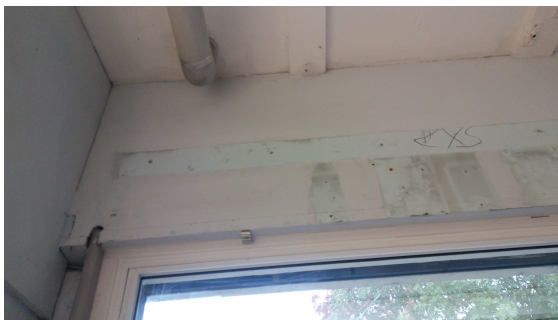
#### **Item 20 Ref: As 218357-11**

The boxing to the beams in the store (Rm 021) does not contain asbestos.

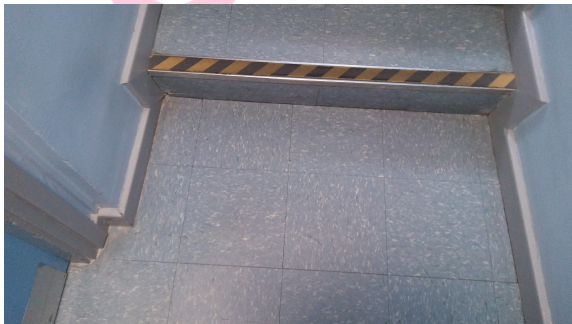
#### **Item 21 Ref: As 218357-13**

The floor covering in the stairwell (Rm 022) does not contain asbestos.

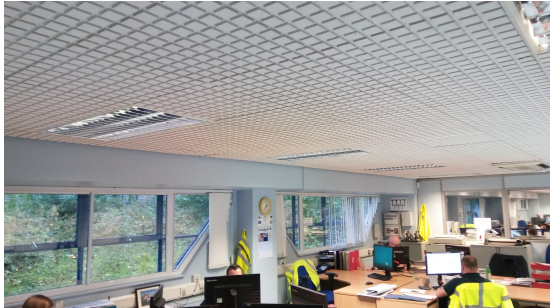
### **Item 22 Ref: As 218357-14**

The boxing to beams in the office (Rm 023) does not contain asbestos.

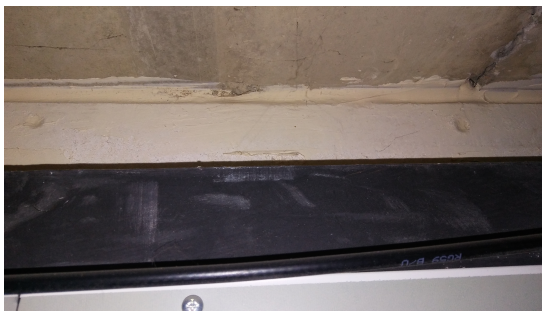
### **Item 23 Ref: As 218357-14**

The boxing to the beams in the office void above (Rm 023) does not contain asbestos.

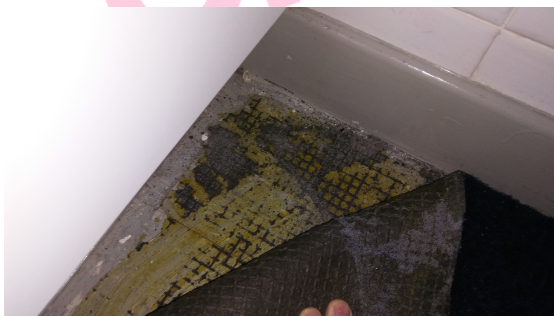
### **Item 24 Ref: As 218357-13**

The floor covering in the store (Rm 024) does not contain asbestos.

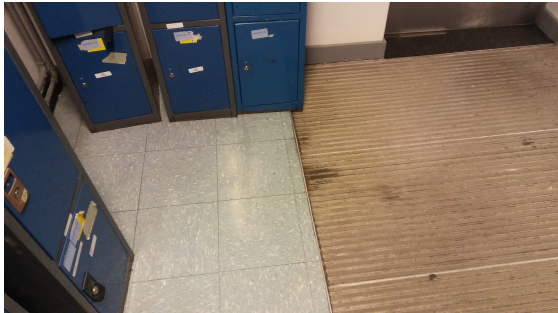
#### **Item 25 Ref: As 218357-13**

The floor covering in the locker room (Rm 026) does not contain asbestos.

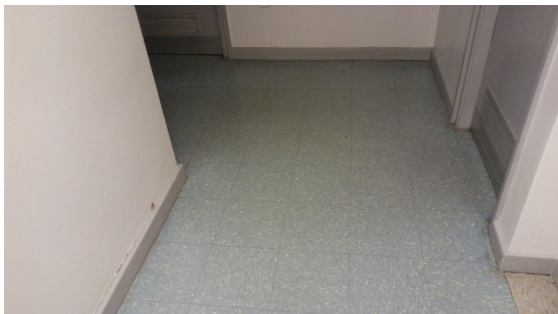
#### **Item 26 Ref: As 218357-13**

The floor covering in the corridor (Rm 030) does not contain asbestos.

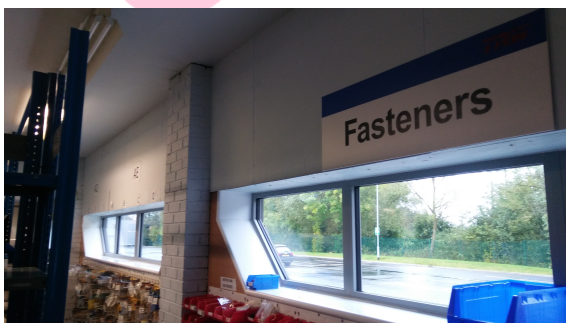
#### **Item 27 Ref: 218357-15**

The boxing to the beams in the maintenance store (Rm 031) does not contain asbestos.

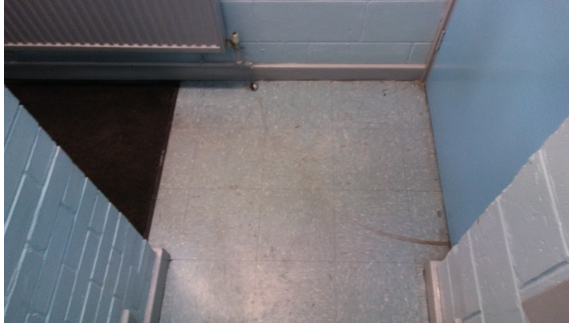
#### **Item 28 Ref: As 218357-13**

The floor covering in the stairwell lobby (Rm 047) does not contain asbestos.

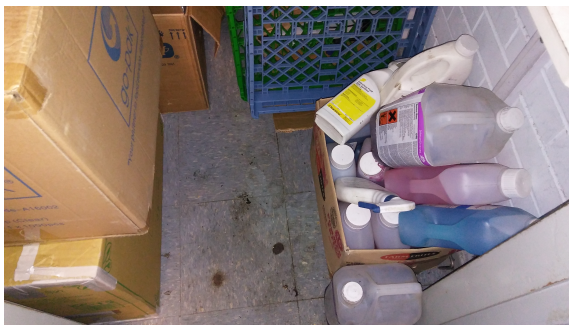
#### **Item 29 Ref: As 218357-13**

The floor covering in the cleaners cupboard (Rm 048) does not contain asbestos.

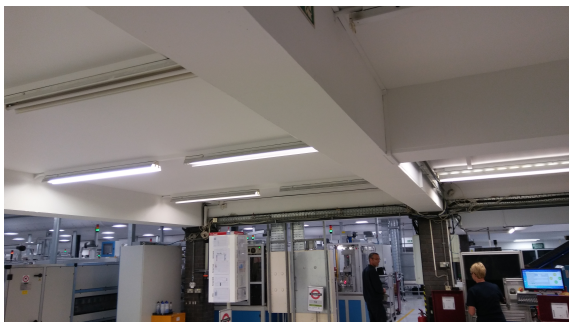
#### **Item 30 Ref: 218357-16**

The boxing to the beams in the production floor (Rm 054) does not contain asbestos.

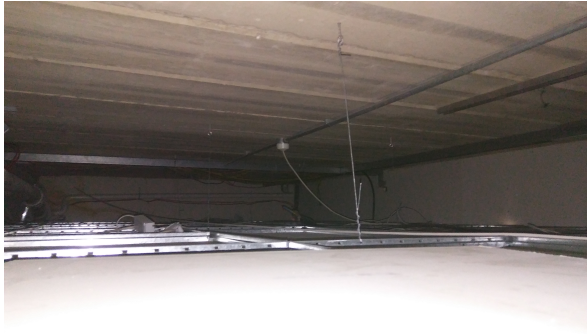
**Item 31 Ref: 218357-17**

The ceiling up stands and wall top in the production area ceiling void outside PCC room (Rm 054a) does not contain asbestos.

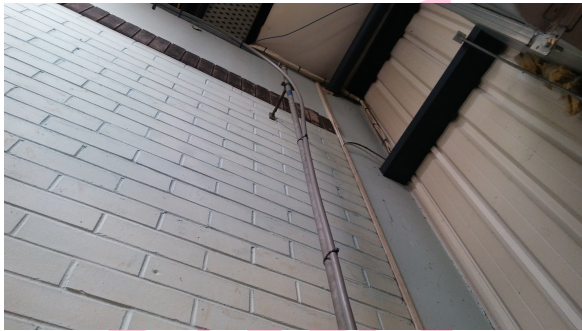
**Item 32 Ref: As 218357-16**

The wall top firebreak and riser panel in the electrics room (Rm 058) does not contain asbestos.

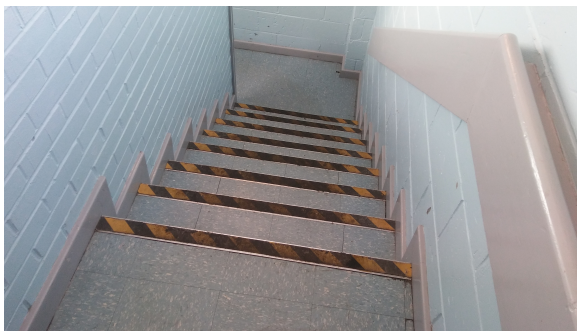
**Item 33 Ref: 218357-1**

The floor covering in the stairwell (Rm 1/05) does not contain asbestos.

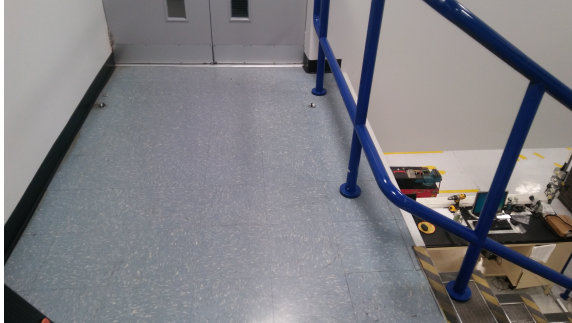
#### **Item 34 Ref: As 218357-1**

The floor covering in the stairwell (Rm 1/06) does not contain asbestos.

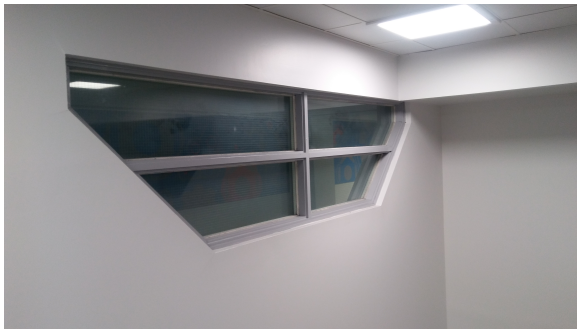
#### **Item 35 Ref: Presumed**

- (Item 33) Ref: 218357-1 Floor covering (Room 1/05) – No Risk
- (Item 34) Ref: As 218357-1 Floor covering (Room 1/06) – No Risk
- (Item 35) Ref: Presume Beading to corridor window (Room 1/06) – Low Risk

The beading to the corridor window (Rm 1/06) does contain asbestos.

Any change in appearance should be reported to Property Services.

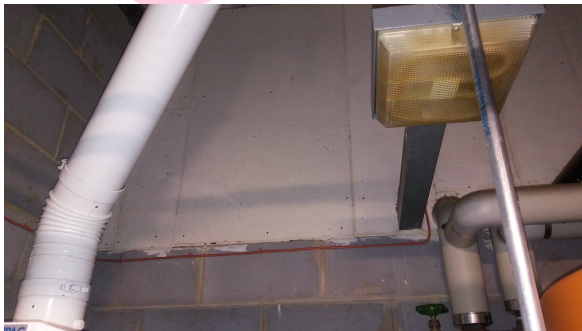
#### **Item 36 Ref: 218357-2**

The wall top firebreak in the boiler room (Rm 1/08) does not contain asbestos.

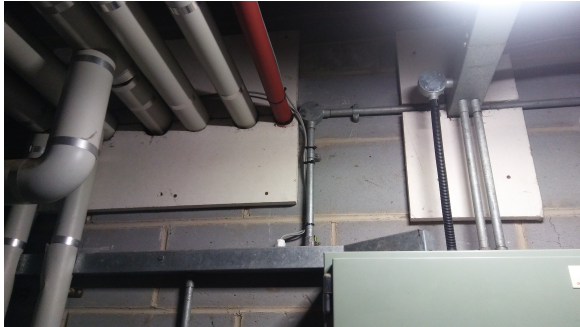
#### **Item 37 Ref: 218357-3**

The pipework penetration panel in the boiler room (Rm 1/08) does not contain asbestos.

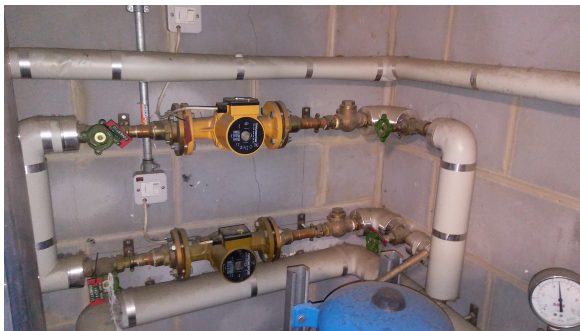
#### **Item 38 Ref: 218357-4**

- (Item 36) Ref: 218357-2 Wall top firebreak (Room 1/08) – No Risk
- (Item 37) Ref: 218357-3 Pipework penetration panel (Room 1/08) – No Risk
- (Item 38) Ref: 218357-4 Pipework flange gasket (Room 1/08) – Very Low Risk

The pipework flange gasket in the boiler room (Rm 1/08) does contain asbestos.

Any change in appearance should be reported to Property Services.

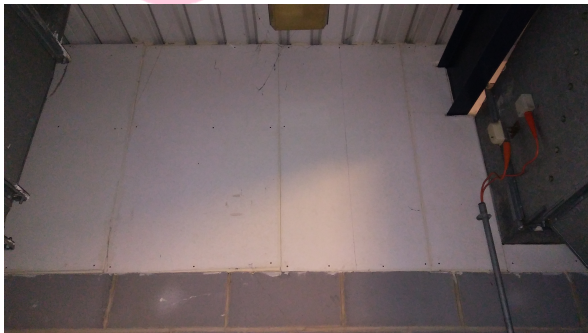
#### **Item 39 Ref: As 218357-2**

The wall top firebreak in the plant room (Rm 1/09) does not contain asbestos.

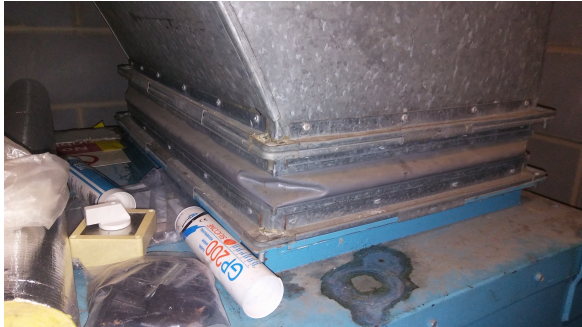
#### **Item 40 Ref: 218357-5**

The mastic to the ducts in the plant room (Rm 1/09) does not contain asbestos.

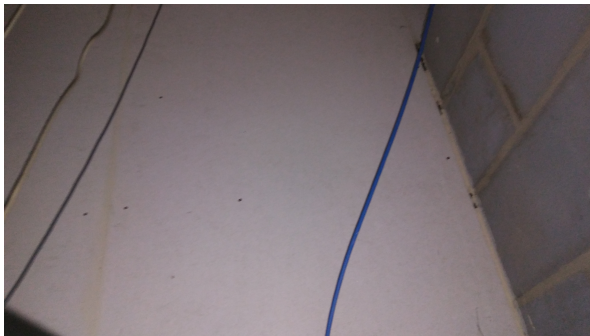
#### **Item 41 Ref: As 218357-2**

The wall top firebreak in the corridor void above (Rm 1/10) does not contain asbestos.

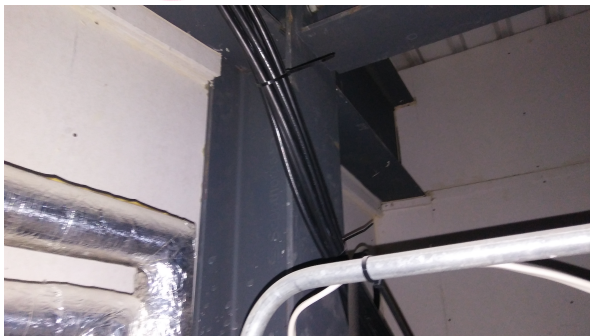
#### **Item 42 Ref: As 218357-2**

The wall top firebreak in the ladies toilet void above (Rm 1/12) does not contain asbestos.

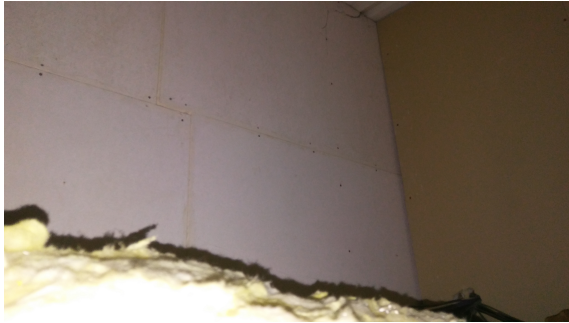
#### **Item 43 Ref: 218357-6**

The wall top firebreak in the toilet block corridor void above (Rm 1/14) does not contain asbestos.

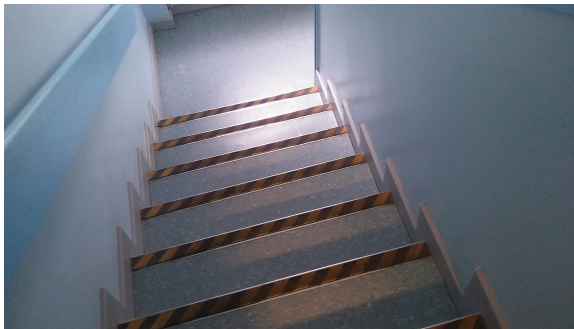
#### **Item 44 Ref: 218357-7**

The floor covering in the stairwell (Rm 1/15) does not contain asbestos.

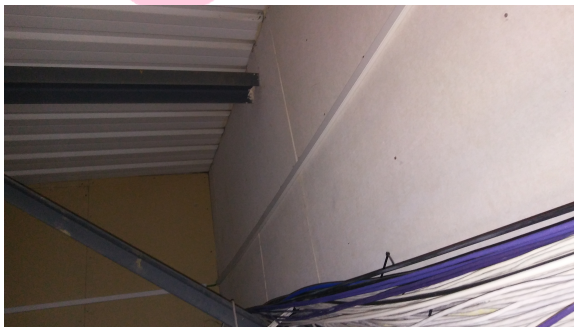
#### **Item 45 Ref: As 218357-6**

The wall top firebreak in the corridor void above (Rm 1/23) does not contain asbestos.

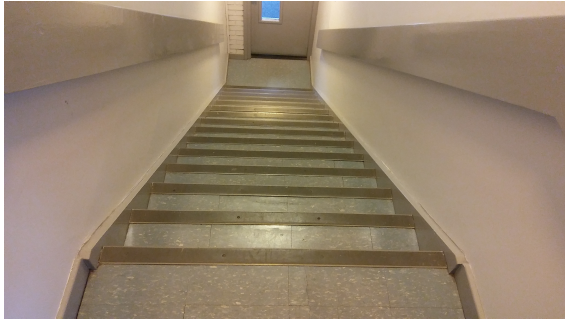
#### **Item 46 Ref: As 218357-7**

The floor covering in the stairwell (Rm 1/27) does not contain asbestos.

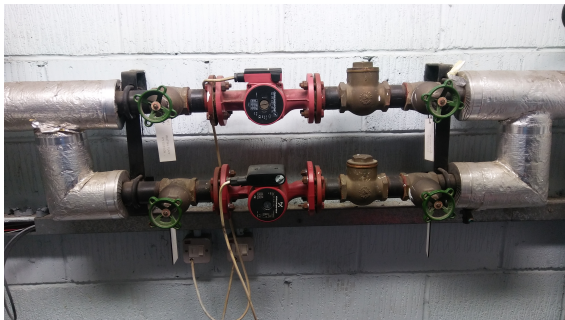
#### **Item 47 Ref: 218357-8**

The pipework flange gasket in the boiler room (Rm 1/28) does contain asbestos.

Any change in appearance should be reported to Property Services.

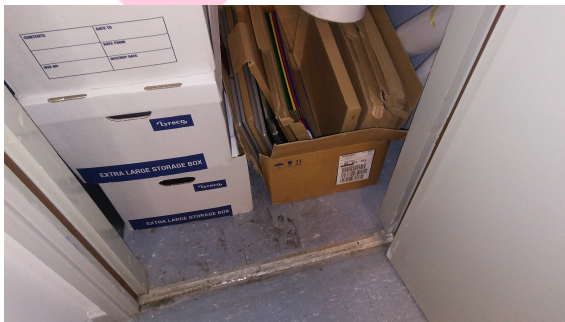
#### **Item 48 Ref: 218357-9**

The floor covering in the file store (Rm 1/29) does not contain asbestos.

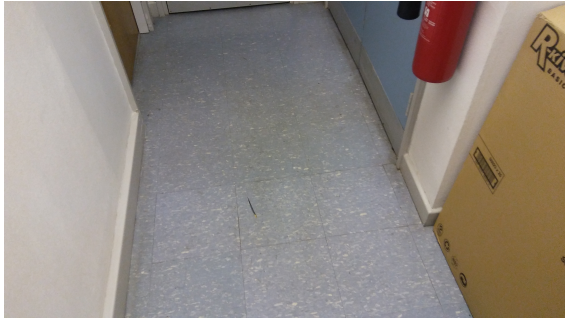
### **Item 49 Ref: As 218357-9**

The floor covering in the lobby (Rm 1/30) does not contain asbestos.

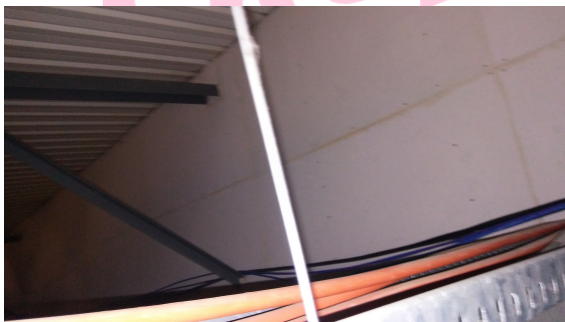
### **Item 51 Ref: As 218357-6**

The wall top firebreak in the office void above (Rm 1/33) does not contain asbestos.

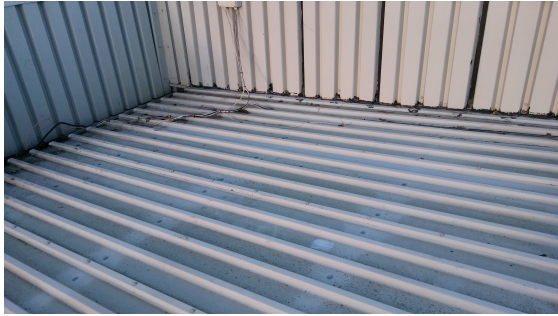
#### **Item 52 Ref: 295948-1**

The powder coating to roof adjacent middle parret wall to front elevation (External) does not contain asbestos.

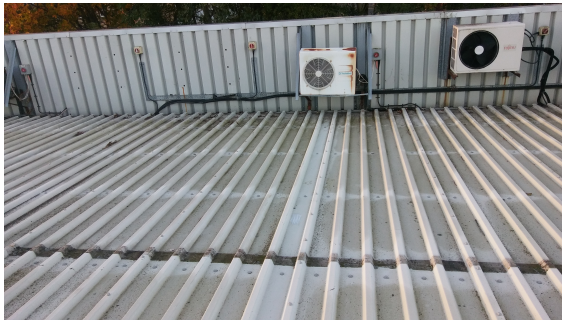
#### **Item 53 Ref: 295948-2**

The powder coating to roof adjacent to front elevation (External) does not contain asbestos.

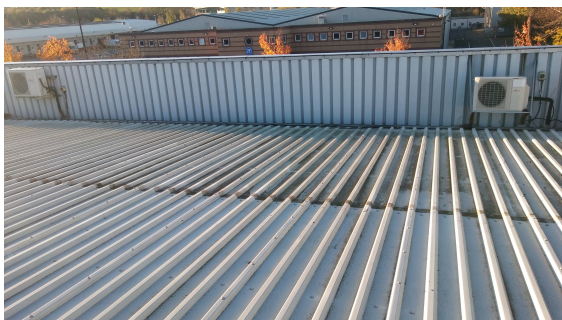
#### **Item 54 Ref: 295948-3**

The powder coating to roof adjacent to front elevation (External) does not contain asbestos.

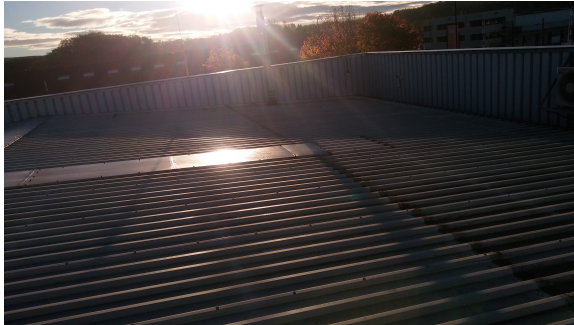
#### **Item 55 Ref: 295948-4**

The powder coating to roof adjacent gable end parret wall to front elevation (External) does not contain asbestos.

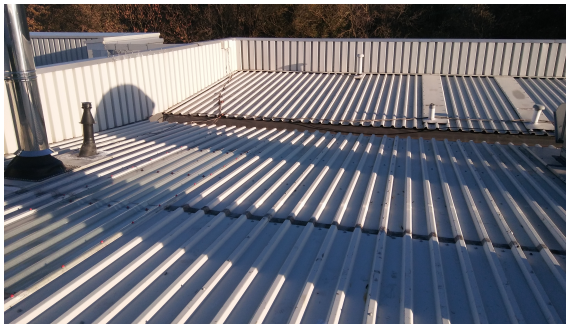
#### **Item 56 Ref: 295948-8**

The powder coating to roof adjacent to middle parret wall to rear elevation (External) does not contain asbestos.

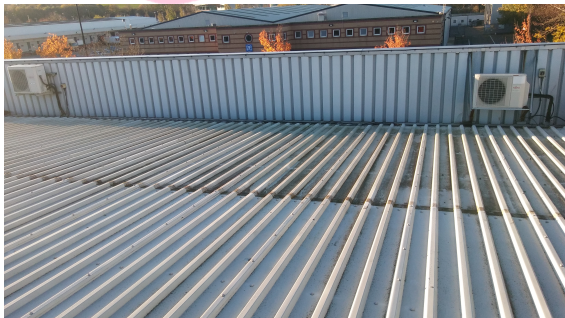
#### **Item 57 Ref: 295948-7**

The powder coating to roof adjacent to rear elevation (External) does not contain asbestos.

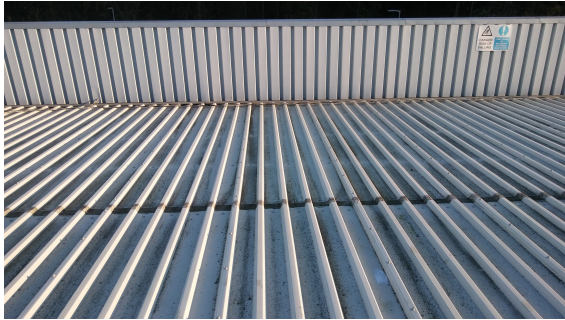
#### **Item 58 Ref: 295948-6**

The powder coating to roof adjacent to rear elevation (External) does not contain asbestos.

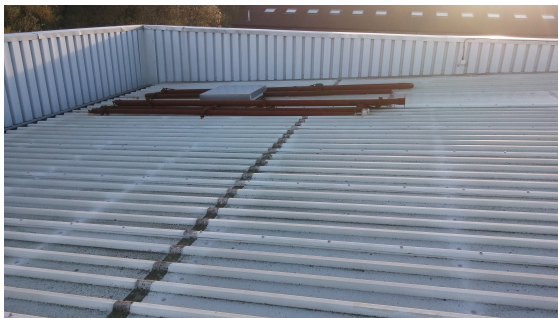
#### **Item 59 Ref: 295948-5**

The powder coating to roof adjacent to gable end parret wall to rear elevation (External) does not contain

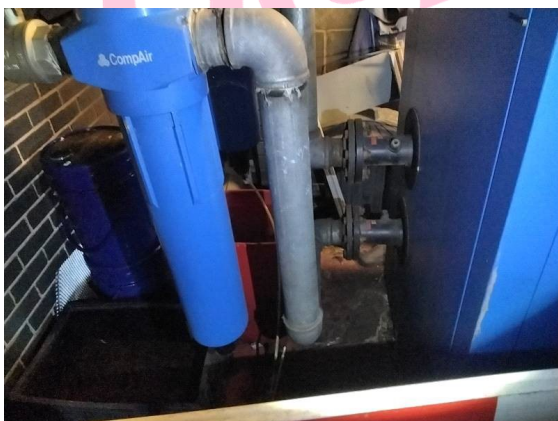
#### **Item 60 Ref: CF005384/01**

The pipework gasket (Rm G/01 Plant Room) does not contain asbestos.

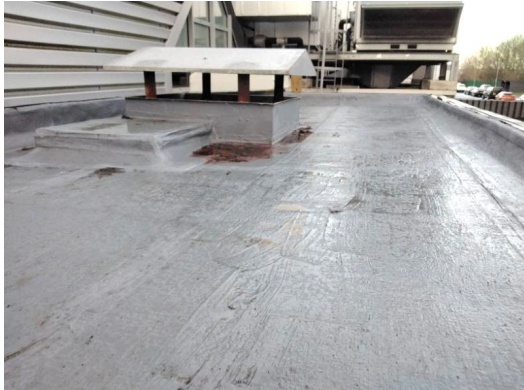
#### **Item 61 Ref: CF005385/02**

The bitumen flat roof  
(External) does not contain  
asbestos.

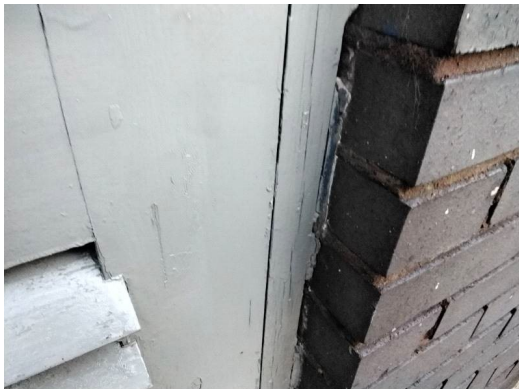
#### **Item 62 Ref: CF005386/03**

The door reveal casing  
(mastic) (External) does not  
contain asbestos.  
asbestos.

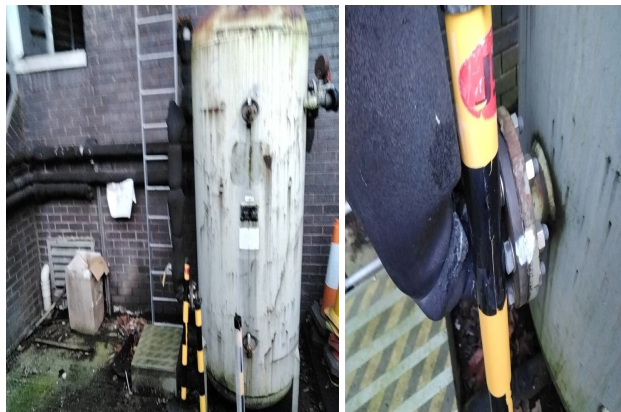
#### **Item 63 Ref: CF005387/04**

The pipework gasket x 2  
(External) contains asbestos.

Any change in appearance  
should be reported to Property  
Services.

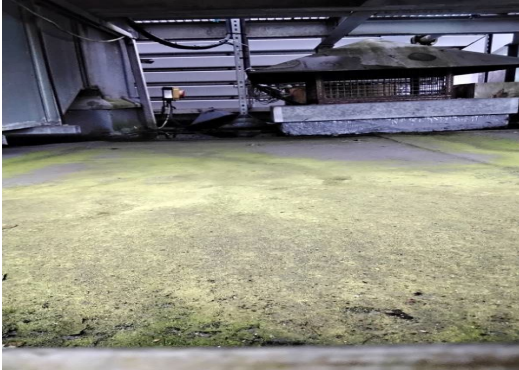
#### **Item 64 Ref: CF005388/05**

The bitumen roof felt  
(External) does not contain  
asbestos.

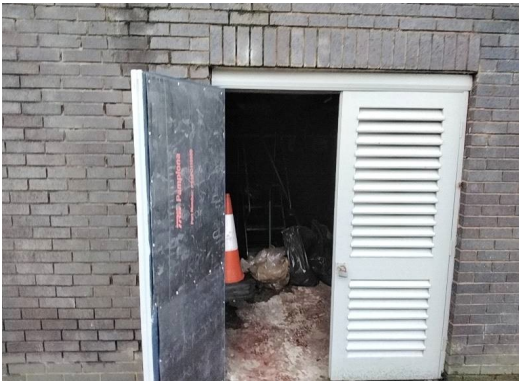
#### **Item 65 Ref: CF005389/06**

The door mastic (External)  
does not contain asbestos.  
asbestos.
