ASBESTOS SURVEY REPORT FOR HYLTON ROAD PLAYING FIELDS, HYLTON ROAD SUNDERLAND

Hylton Road Playing Fields Sunderland

Date: 25 September 2025

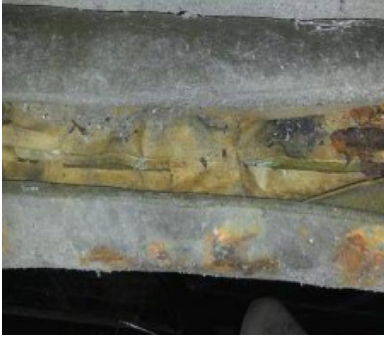
Item 1 – EF003174

The insulation paper to the plant room (Room 1) does not contain asbestos.

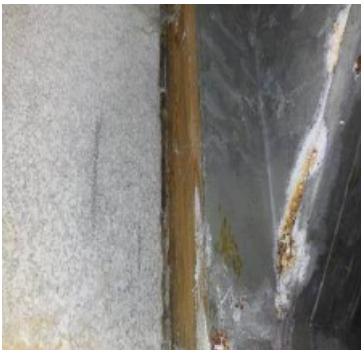
Item 2 – EF003175

The mastic to the duct seal in the plant room (Room 1) does not contain asbestos.

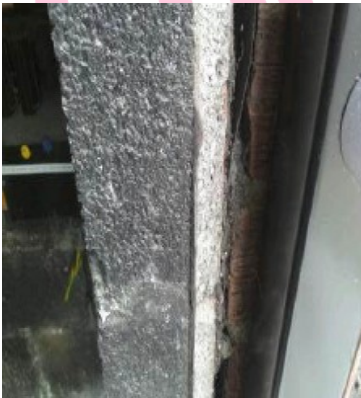
Item 3 – EF003176

The mastic to the door in the plant room (Room 1) does not contain asbestos.

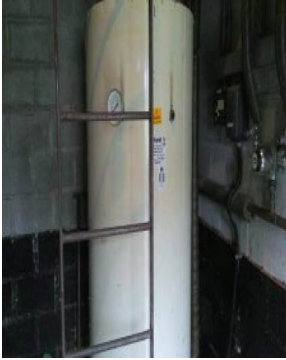
Item 4– 417760-5

The gaskets to the plant room (Room 1) contain asbestos.

Removed October 2020

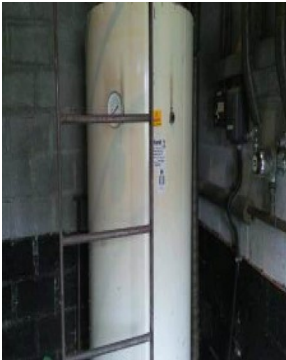
Item 5– 417760-2

The boiler insulation to the plant room (Room 1) does not contain asbestos.

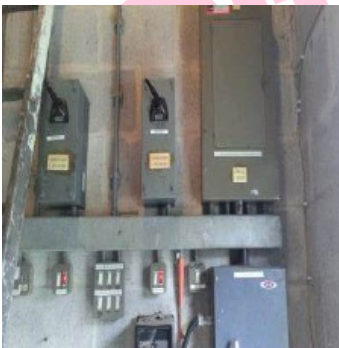
Item 6– Presumed

The flash guards to the plant room (Room 1) are presumed to contain asbestos.

Any change in its appearance should be noted and passed to property services.

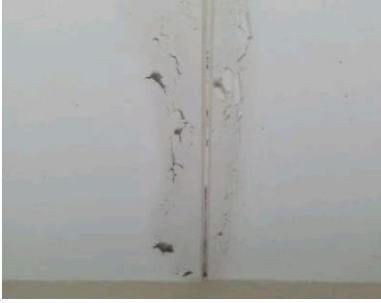
Item 7 – EF003177

The textured coating to the ceiling in corridor 1 (Room 2) does not contain asbestos.

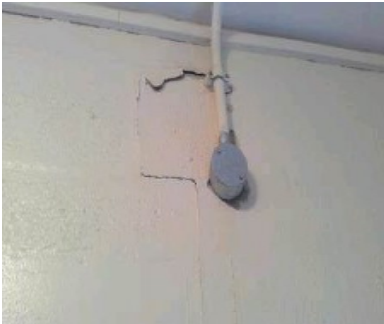
Item 8 – EF003178

The textured coating to the walls in corridor 1 (Room 2) does not contain asbestos.

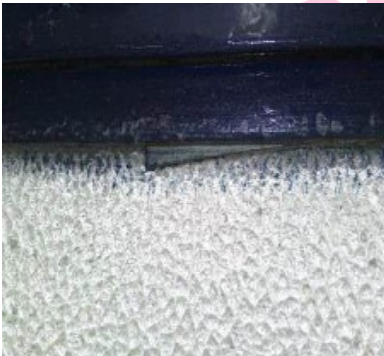
Item 9 – EF003179

The window putty to changing room 1 (Room 3) does not contain asbestos.

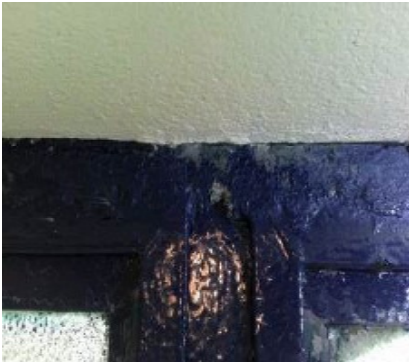
Item 10 – EF003180

The window mastic to Changing Room1 (Room 3) does not contain asbestos.

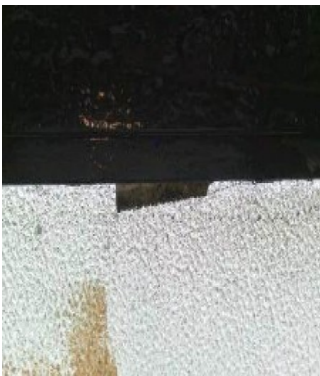
Item 11 As EF003179

The window putty to changing room 2 (Room 4) does not contain asbestos.

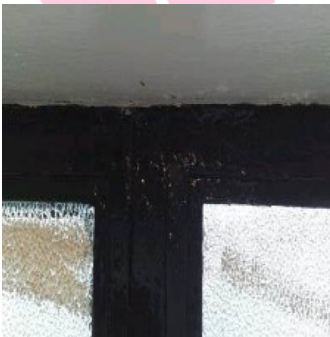
Item 12 As EF003180

The window mastic to changing room 2 (Room 4) does not contain asbestos. materials were found.

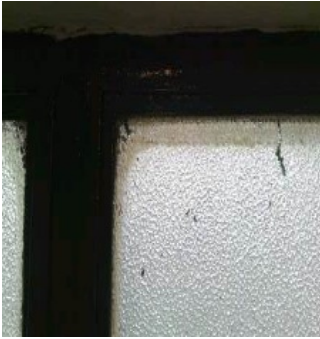
Item 13 As EF0031879

The window putty to changing room 3 (Room 6) does not contain asbestos.

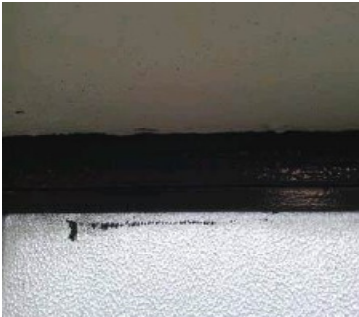
Item 14 As EF003180

The window mastic to changing room 3 (Room 6) does not contain asbestos.

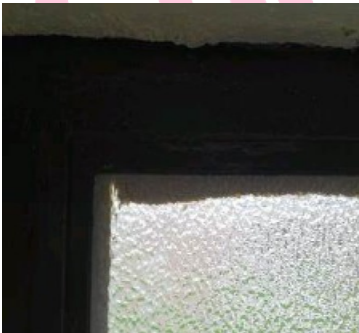
Item 15 As EF003180

The window putty to the store (Room 7) does not contain asbestos.

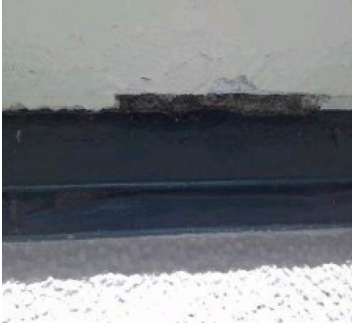
Item 16 As EF003180

The window mastic to the store (Room 7) does not contain asbestos.

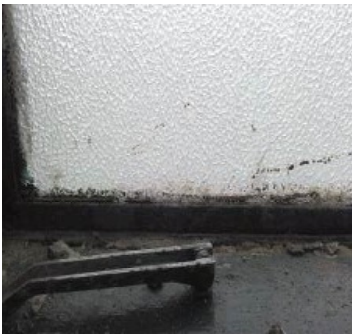
Item 17 As EF003179

The window putty to changing room 3 (Room 8) does not contain asbestos.

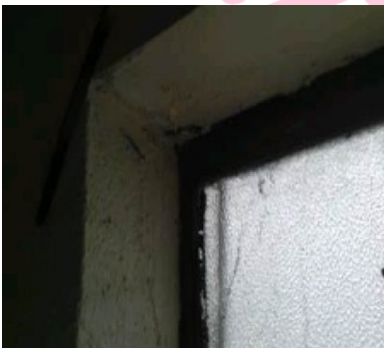
Item 18 As EF003180

The window mastic to changing room 3 (Room 8) does not contain asbestos.

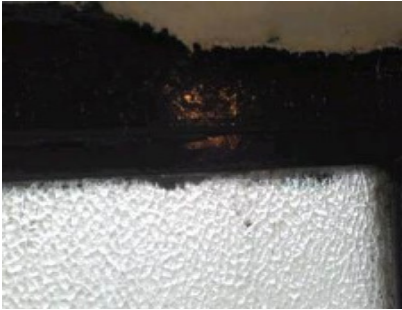
Item 19 As EF003179

The window putty to changing room 4 (Room 9) does not contain asbestos.

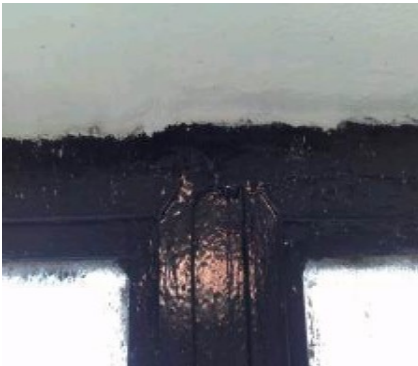
Item 20 As EF003180

The window mastic to changing room 4 (Room 9) does not contain asbestos.

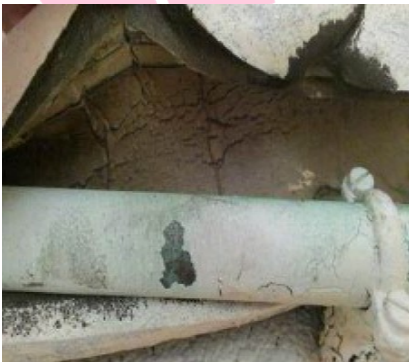
Item 21 As EF003174

The paper insulation to changing room 4 (Room 9) does not contain asbestos.

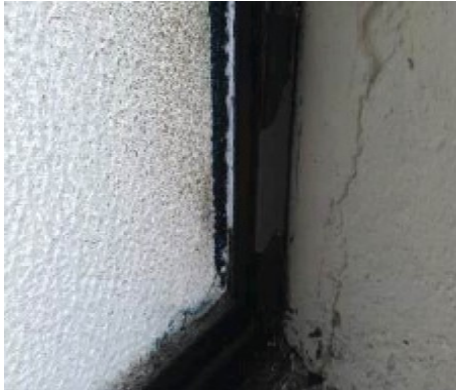
Item 22 As EF003179

The window putty to changing room 4 (Room 10) does not contain asbestos.

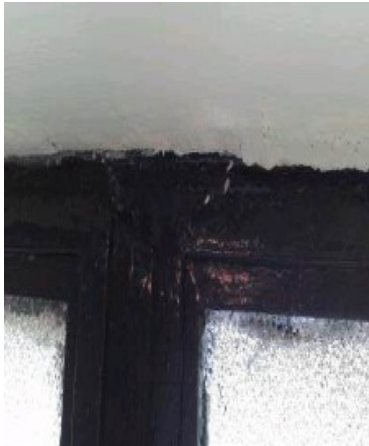
Item 23 As EF003180

The window mastic to changing room 4 (Room 10) does not contain asbestos.

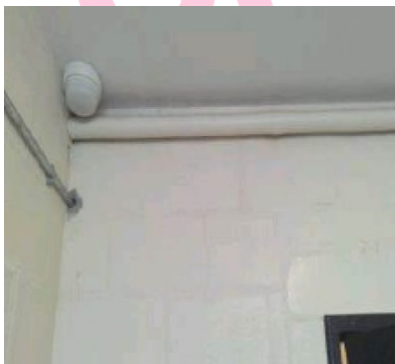
Item 24 As EF003174

The paper insulation to changing room 4 (Room 10) does not contain asbestos.

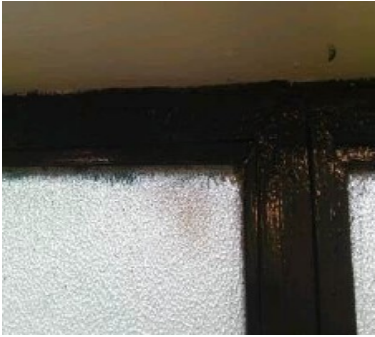
Item 25 As EF003179

The window putty to the shower (Room 11) does not contain asbestos.

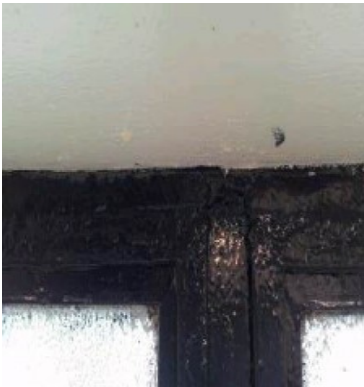
Item 26 As EF003180

The window mastic to the shower (Room 11) does not contain asbestos.

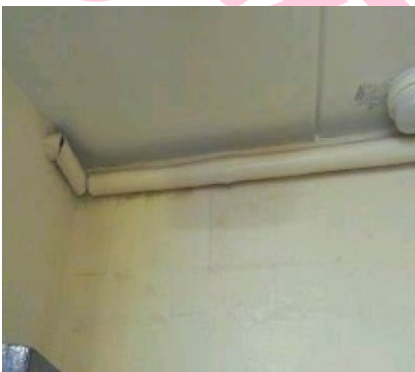
Item 27 As EF003174

The paper insulation to the shower (Room 11) does not contain asbestos.

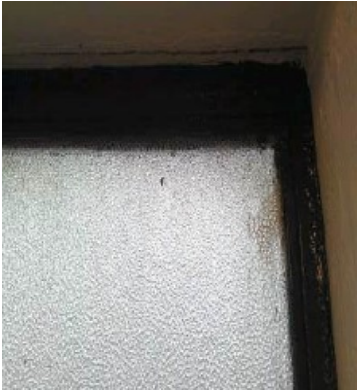
Item 28 As EF003179

The window putty to the shower room 2 (Room 12) does not contain asbestos.

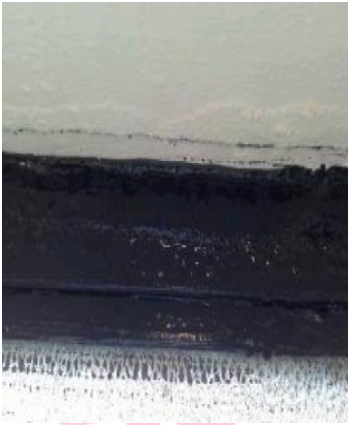
Item 29 As EF003180

The window mastic to the shower room 2 (Room 12) does not contain asbestos.

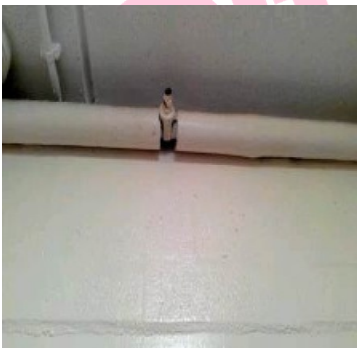
Item 30 As EF003174

The paper insulation to the shower room 2 (Room 12) does not contain asbestos.

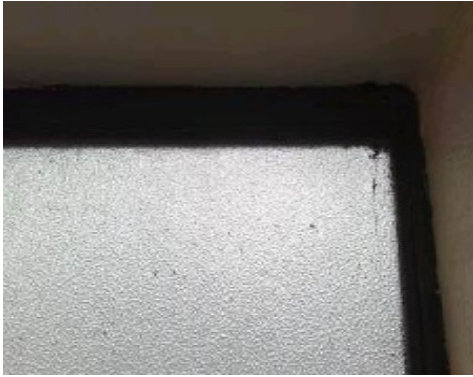
Item 31 As EF003179

The window putty to toilet 2 (Room 13) does not contain asbestos.

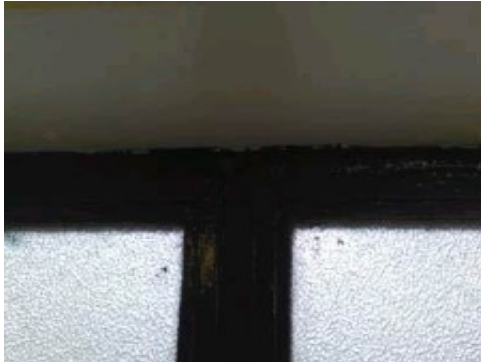
Item 32 As EF003180

The window mastic to toilet 2 (Room 13) does not contain asbestos.

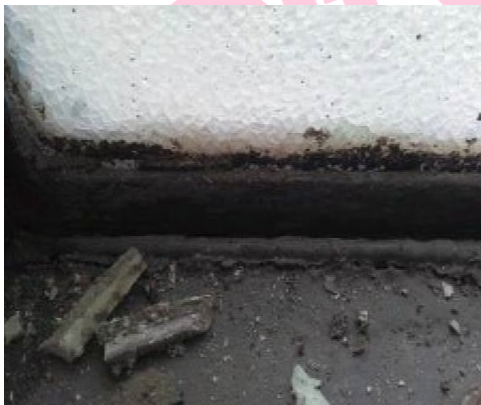
Item 33 As EF003179

The window putty to referee changing (Room 14) does not contain asbestos.

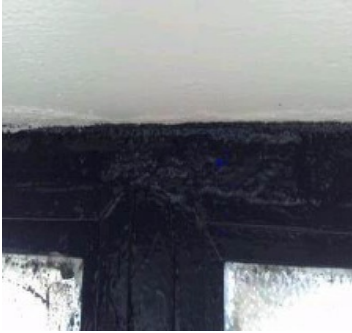
Item 34 As EF003180

The window mastic to referee changing (Room 14) does not contain asbestos.

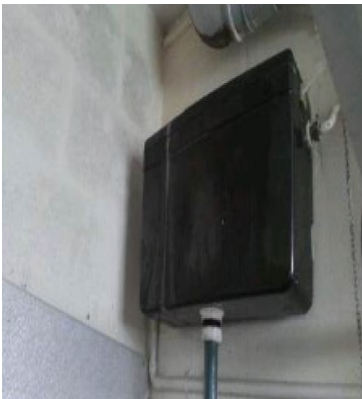
Item 35 Ref: EF003181

The WC cistern to the referees toilet (Room 15) contains asbestos.

Removed 2024 – No WCN's

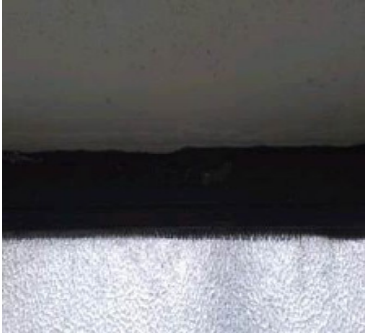
Item 37 As EF003180

The window mastic to referee changing (Room 14) does not contain asbestos.

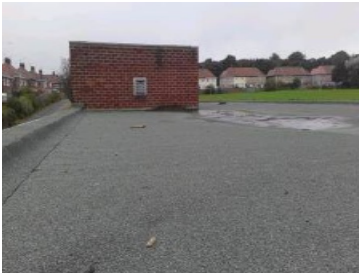
Item 38 Ref: EF003182

The roofing felt to the external of the building does not contain asbestos.

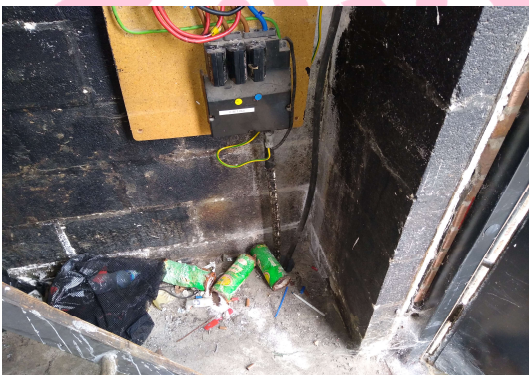
Item 39 Ref: 417760-01

The cable wrap to main incomer in the Plant room (Rm 0/01) does not contain asbestos.

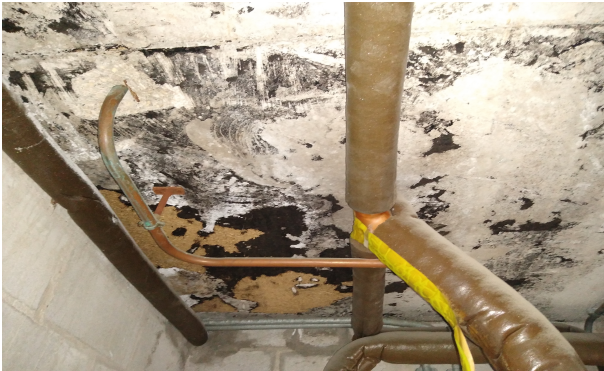
Item 40 Ref: 417760-03

The bitumen felt below concrete plinth to water tank in the Plant Room (Rm 0/01) does not contain asbestos.
