ASBESTOS SURVEY REPORT FOR THORNEY CLOSE ACTION AND ENTERPRISE CENTRE, SUNDERLAND

Asbestos Register for THORNEY CLOSE ACTION AND ENTERPRISE CENTRE SUNDERLAND

UPRN: - FP08-00429

Date: 12 May 2025

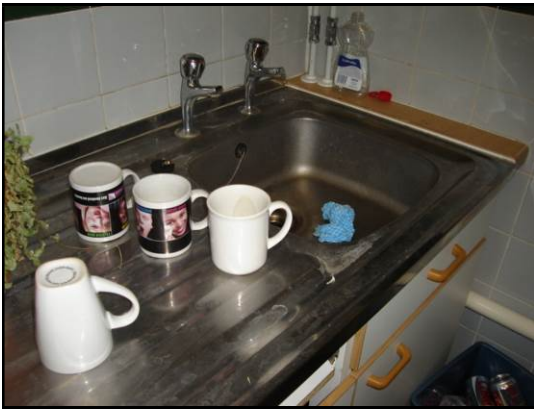
Item 2 - Ref: Sample 02

The sink pads to the offices (Rm 008) do not contain asbestos.

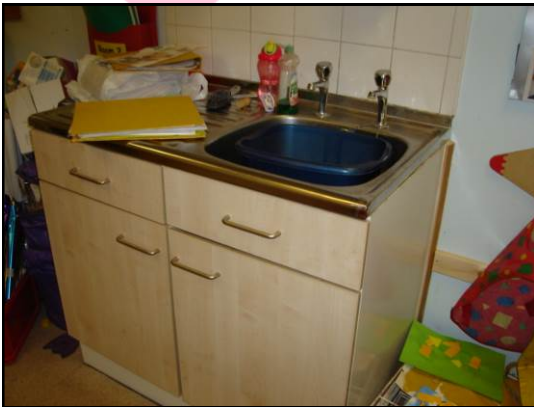
Item 3 - Ref: Sample 03

The sink pads throughout the nursery rooms (Rm 009) do not contain asbestos.

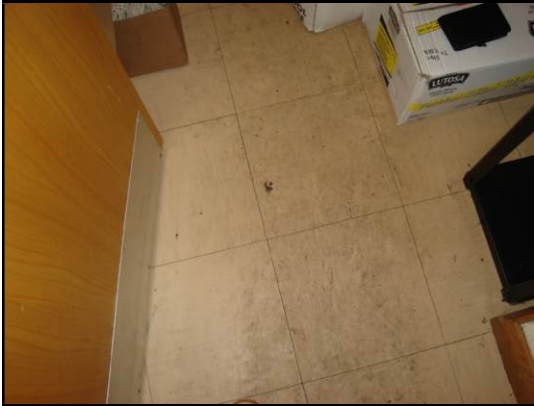
Item 4 - Ref: Sample 04

The vinyl flooring to the storerooms in the kitchen area (Rm 016) do not contain asbestos.

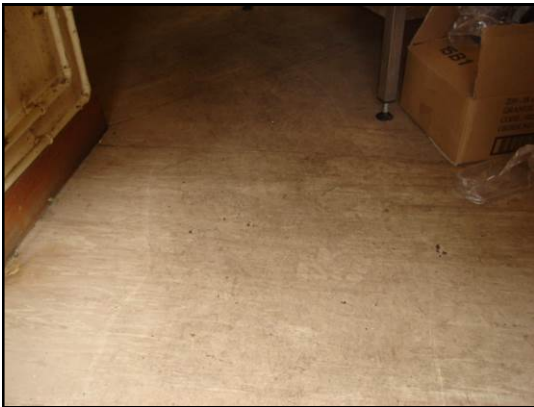
Item 5 - Ref: Sample 05

The vinyl flooring to the rear corridor floor in the kitchen area (Rm 016) does not contain asbestos.

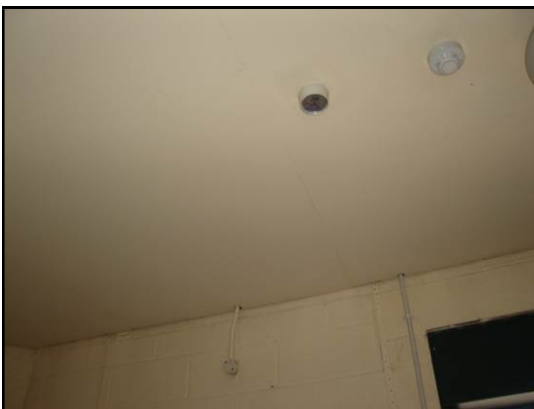
Item 6 - Ref: Sample 06 / 323690-1

The plasterboard ceiling to the bin store in the kitchen area (Rm 16) does not contain asbestos.

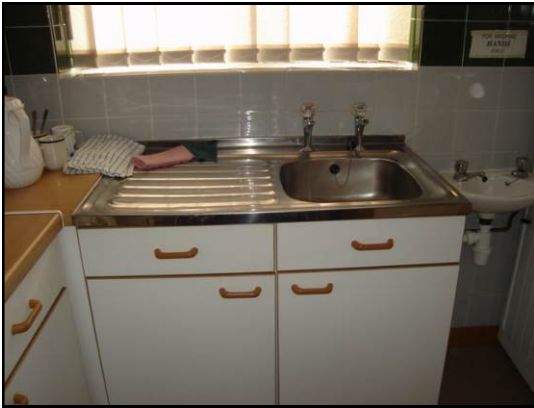
Item 7 - Ref: Sample 07

The sink pad to the kitchen (Rm 003) does not contain asbestos.

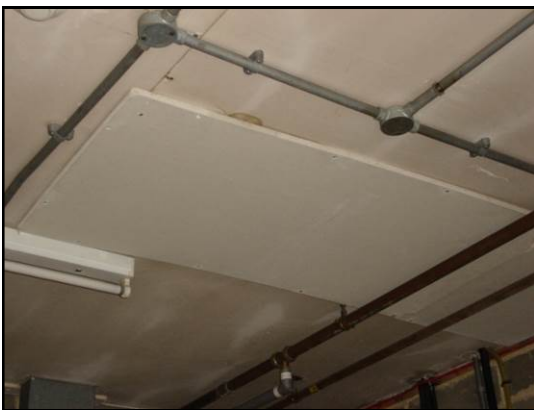
Item 8 - Ref: Sample 08 / As 323690-1

The panel to the ceiling in the boiler room (Rm 029) does not contain asbestos.

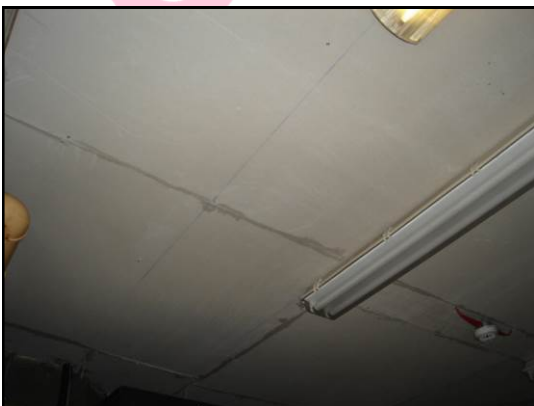
Item 9 – As Sample 08

The ceiling to the pump room (Rm 030) does not contain asbestos.

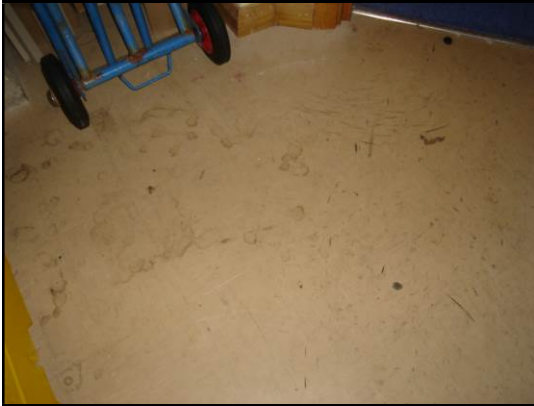
Item 10 - Ref: Sample 09

The vinyl floor tiles to the lift motor room (Rm 003) do not contain asbestos.

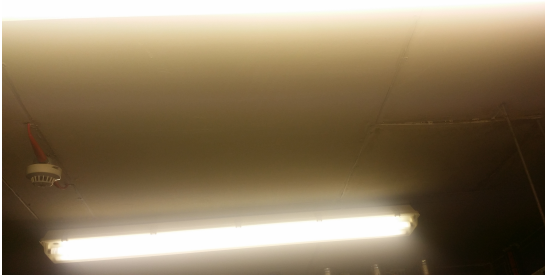
Item 11 - Ref: As 323690-1

The ceiling in room 039/boiler room does not contain asbestos.

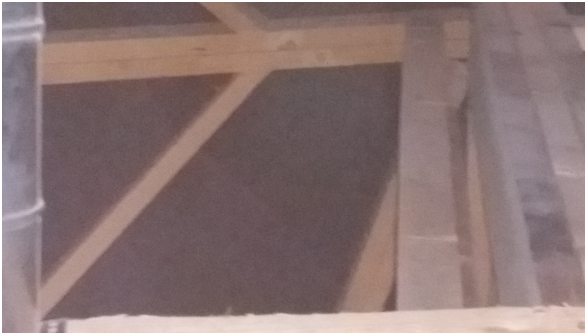
Item 13 - Ref: As 241626-1

The roof sarking in room 001/corridor (void above) does not contain asbestos.

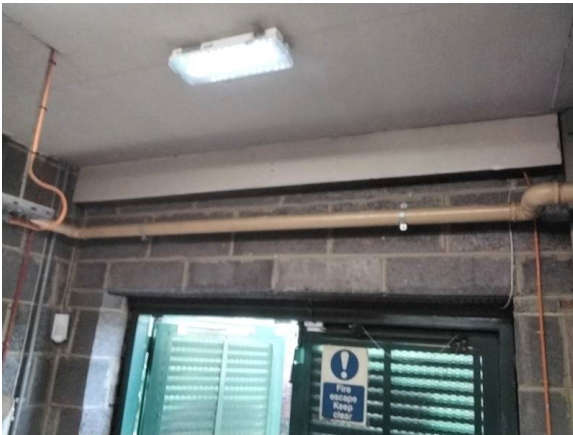
Item 19 Ref: CF005391

The pelmet above door (Boiler Room/G/001) does not contain asbestos.

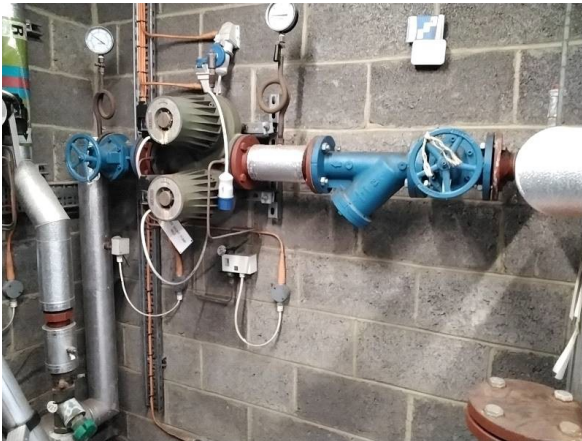
Item 20 Ref: CF005391

The pipework joint/gasket (Boiler Room/G/001) does not contain asbestos.

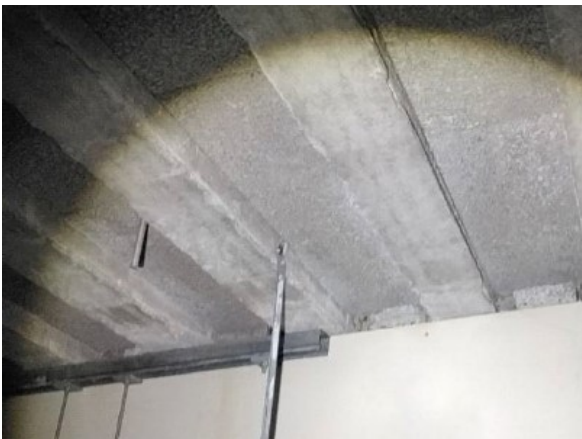
Item 21 Ref: KX001945

The ceiling void beam cladding in the Hallway/Passageway (Room G/001) does not contain asbestos.

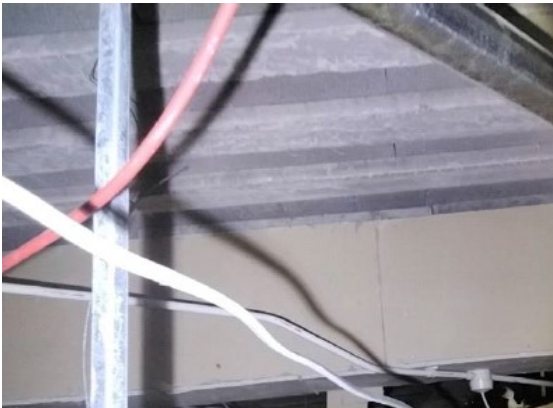
Item 22 Ref: KX001945

The ceiling void beam cladding in the reception (Room G/002) does not contain asbestos.

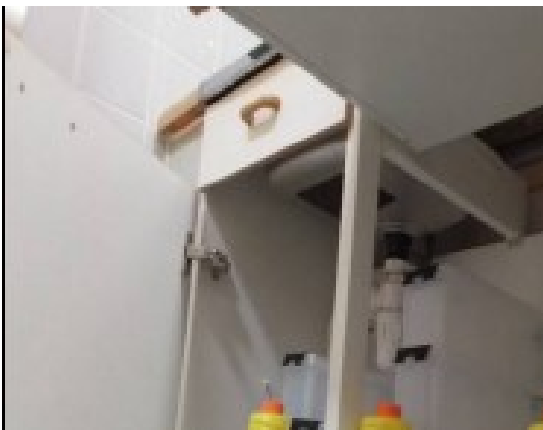
Item 27 Ref: OQ000249

The under sink mat in the Toilets (Room G/003) does not contain asbestos.

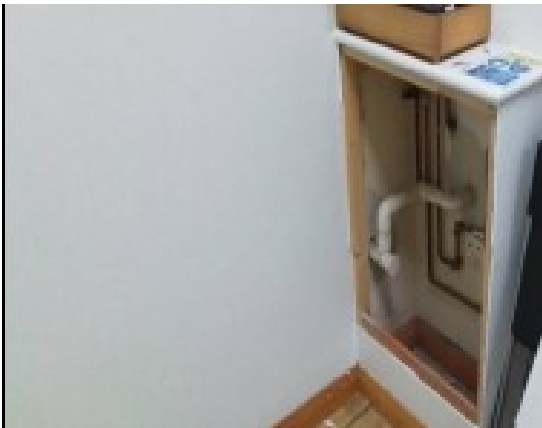
Item 29 Ref: OQ000250

The floor tile – inside boxing in the Office (Room G/004) does not contain asbestos.

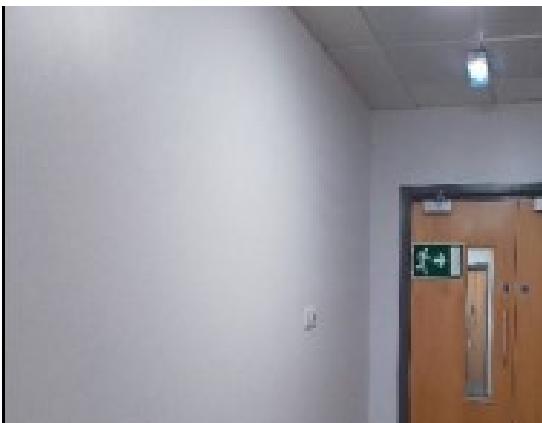
Item 30 Ref: OQ000251

The wall in the Corridor 060 (Room G/006) does not contain asbestos.

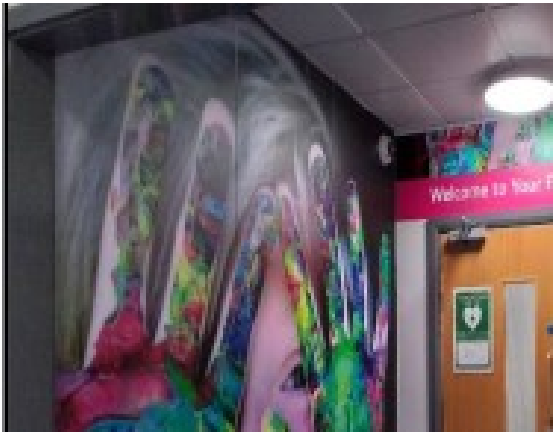
Item 31 Ref: As OQ000251

The wall in the Corridor – adj reception office (Room G/007) does not contain asbestos.
