### **ASBESTOS SURVEY REPORT FOR THORNEY CLOSE ACTION AND ENTERPRISE CENTRE, SUNDERLAND**

**THORNEY CLOSE ACTION AND ENTERPRISE CENTRE  
SUNDERLAND**

**Date: 18 May 2026**

Thorney Close Action & Ent Centre - Last updated 18/05/2026 – Version 2

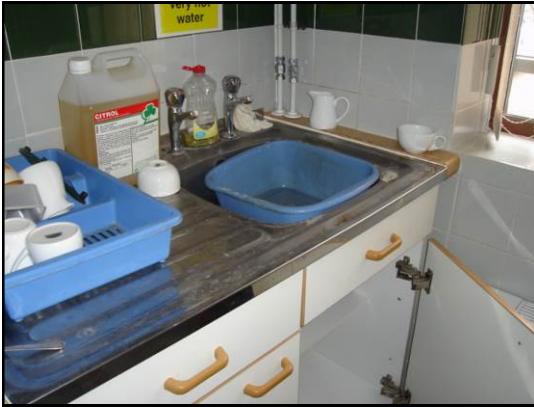
### **Item 1 Ref: Sample 01**

The sink pad to the kitchen off the large office (Rm 005) does not contain asbestos.

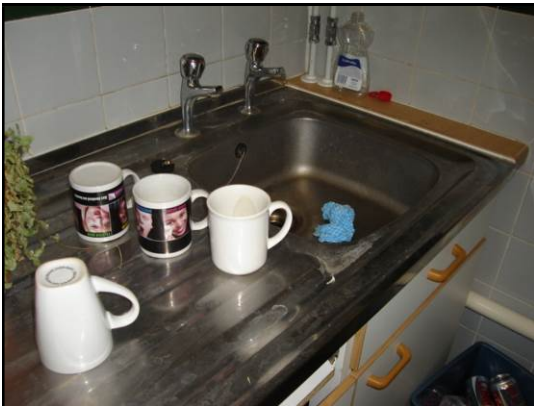
### **Item 2 - Ref: Sample 02**

The sink pads to the offices (Rm 008) do not contain asbestos.

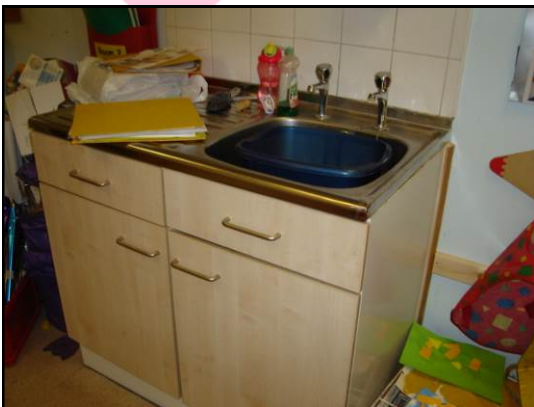
### **Item 3 - Ref: Sample 03**

The sink pads throughout the nursery rooms (Rm 009) do not contain asbestos.

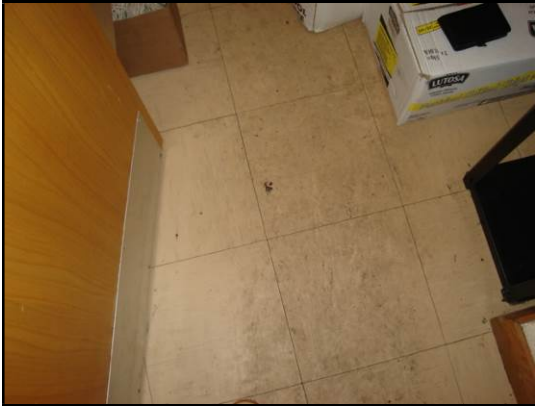
### **Item 4 - Ref: Sample 04**

The vinyl flooring to the storerooms in the kitchen area (Rm 016) do not contain asbestos.

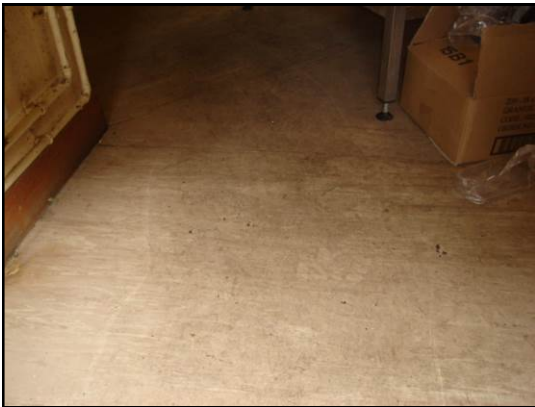
### **Item 5 - Ref: Sample 05**

The vinyl flooring to the rear corridor floor in the kitchen area (Rm 016) does not contain asbestos.

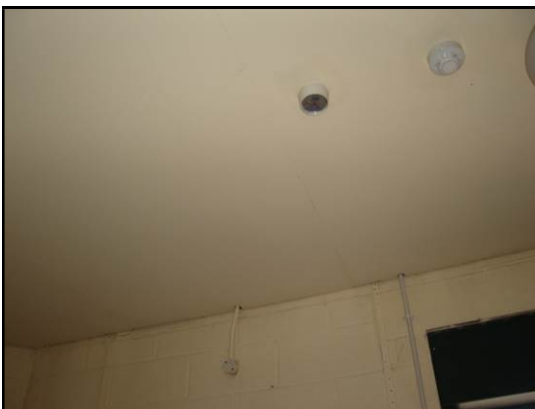
### **Item 6 - Ref: Sample 06 / 323690-1**

The plasterboard ceiling to the bin store in the kitchen area (Rm 16) does not contain asbestos.

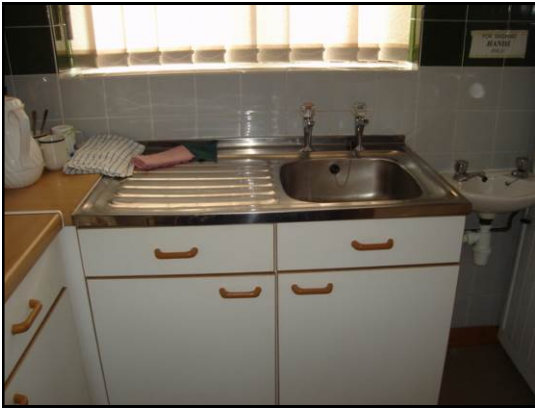
### **Item 7 - Ref: Sample 07**

The sink pad to the kitchen (Rm 003) does not contain asbestos.

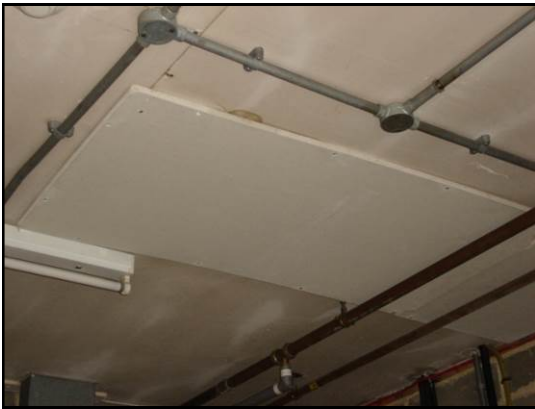
### **Item 8 - Ref: Sample 08 / As 323690-1**

The panel to the ceiling in the boiler room (Rm 029) does not contain asbestos.

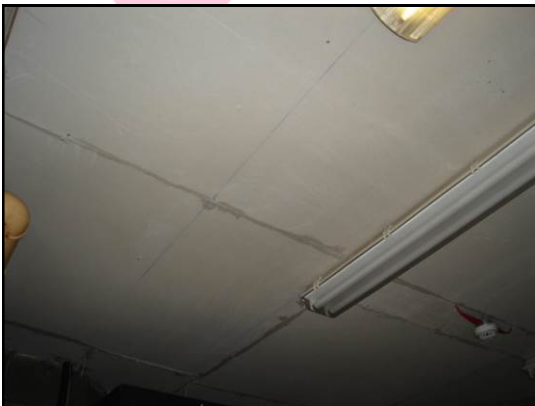
### **Item 9 – As Sample 08**

The ceiling to the pump room (Rm 030) does not contain asbestos.

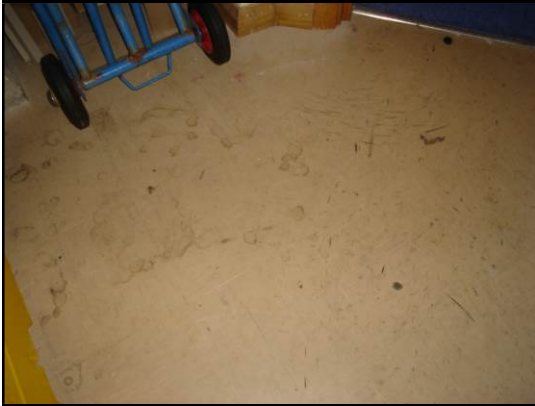
### **Item 10 - Ref: Sample 09**

The vinyl floor tiles to the lift motor room (Rm 003) do not contain asbestos.

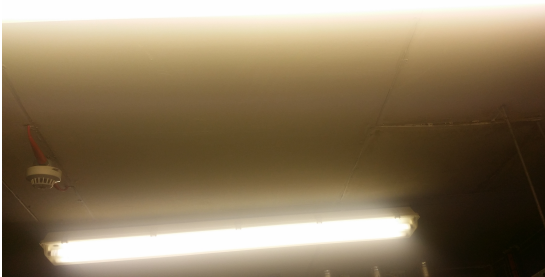
### **Item 11 - Ref: As 323690-1**

The ceiling in room 039/boiler room does not contain asbestos.

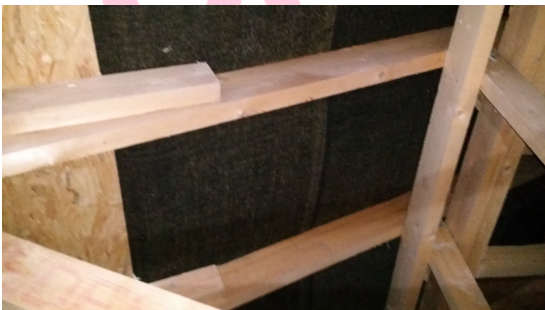
### **Item 12 - Ref: 241626-1**

The roof sarking in room 002/general office (void above) does not contain asbestos.

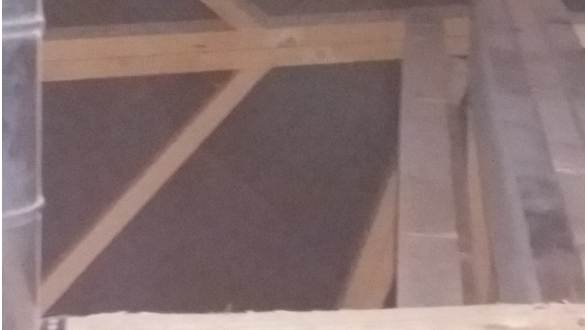
### **Item 13 - Ref: As 241626-1**

The roof sarking in room 001/corridor (void above) does not contain asbestos.

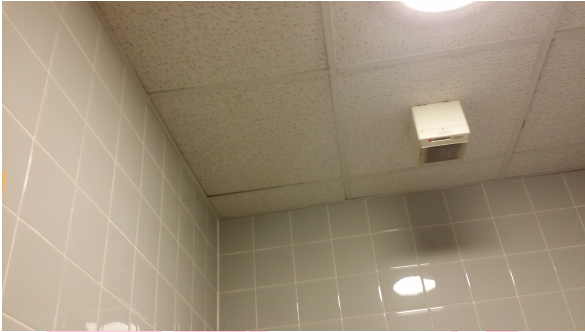
### **Item 14 - Ref: 241626-2**

The suspended ceiling in room 003/shower does not contain asbestos.

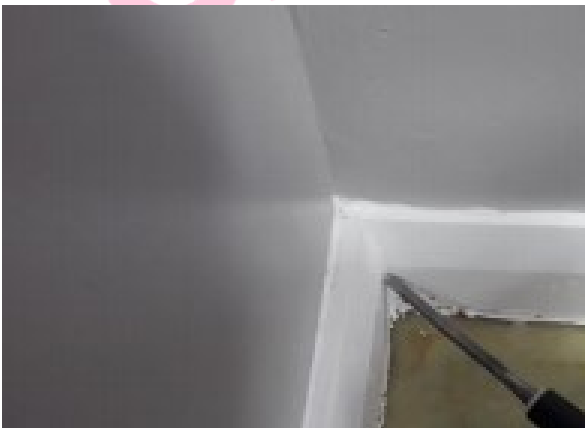
### **Item 15 - Ref: 2136652-1**

The floor beneath new vinyl lino in Team Room 1 (Area 6) does not contain asbestos.

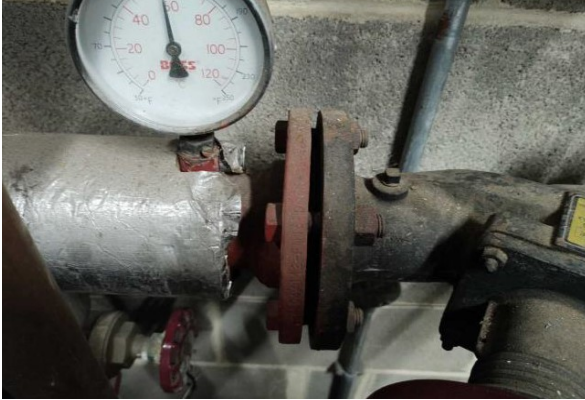
### **Item 16 - Ref: 21-41137-2**

The gaskets to 8x pipe flanges (Area 1 – Boiler Room) contain asbestos.

Item 15	No asbestos	Is present		
<b>Item 16</b>	<b>Gaskets to x8 pipe flanges (Area 1/Boiler Room)</b>	<b>Low Risk</b>	<b>6 monthly</b>	<b>04.10.2026</b>

Any change in its appearance should be recorded and passed to Property Services.

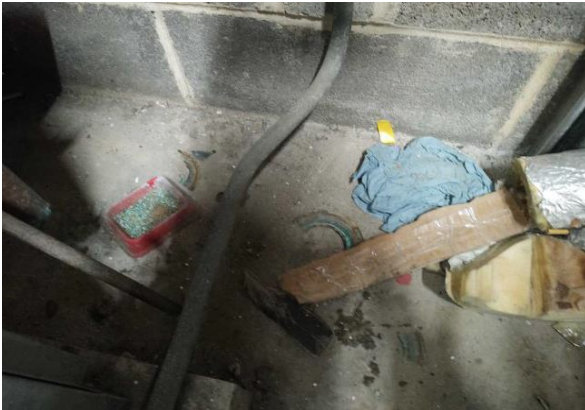
### **Item 17 - Ref: 21-41137-3**

The debris to the floor (Gasket) (Area 1 – Boiler Room) does not contain asbestos.

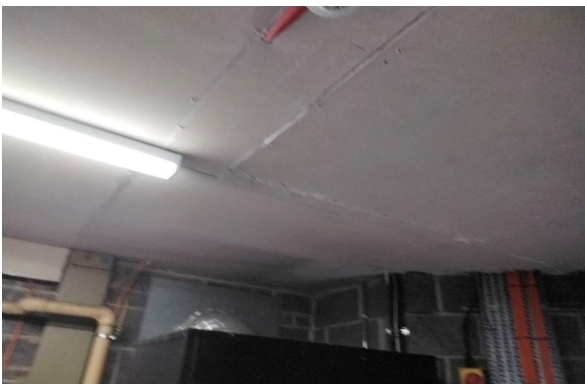
### **Item 18 Ref: CF005390**

The ceiling (Boiler Room/G/001) does not contain asbestos.

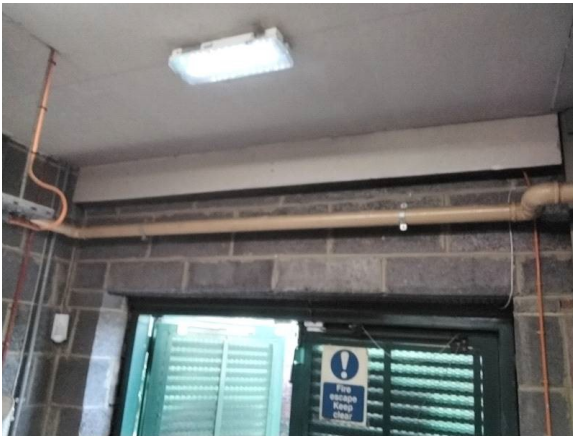
### **Item 19 Ref: CF005391**

The pelmet above door (Boiler Room/G/001) does not contain asbestos.

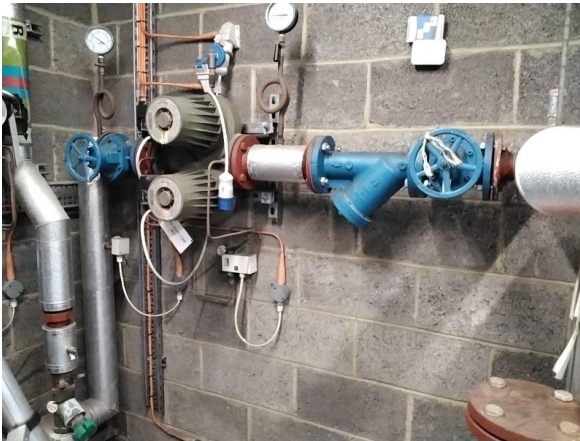
### **Item 20 Ref: CF005391**

The pipework joint/gasket (Boiler Room/G/001) does not contain asbestos.

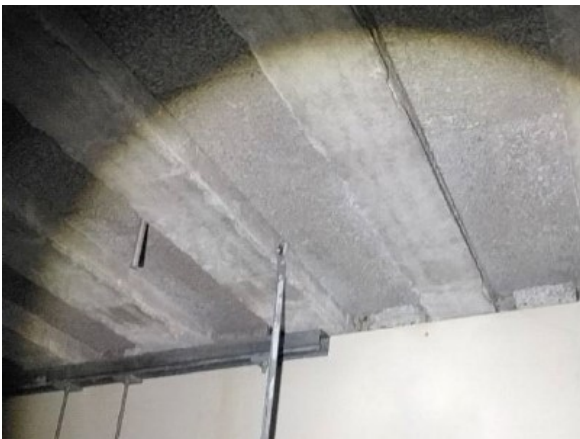
### **Item 21 Ref: KX001945**

The ceiling void beam cladding in the Hallway/Passageway (Room G/001) does not contain asbestos.

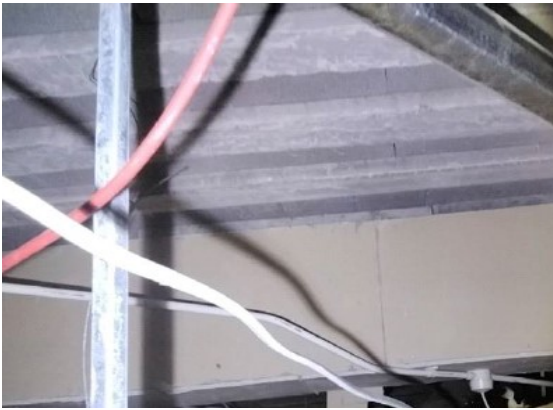
### **Item 22 Ref: KX001945**

The ceiling void beam cladding in the reception (Room G/002) does not contain asbestos.

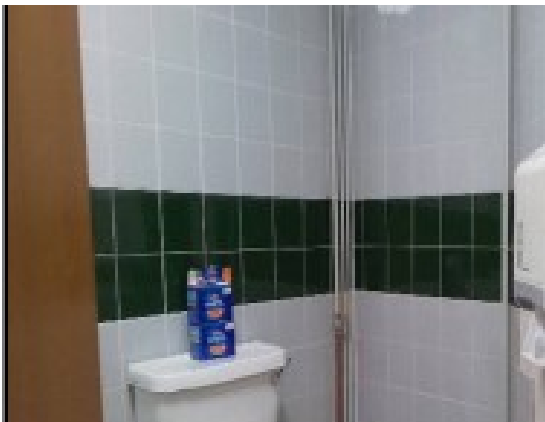
### **Item 23 Ref: OQ000247**

The wall tile adhesive in the Staff Toilets (Room G/002) does not contain asbestos.

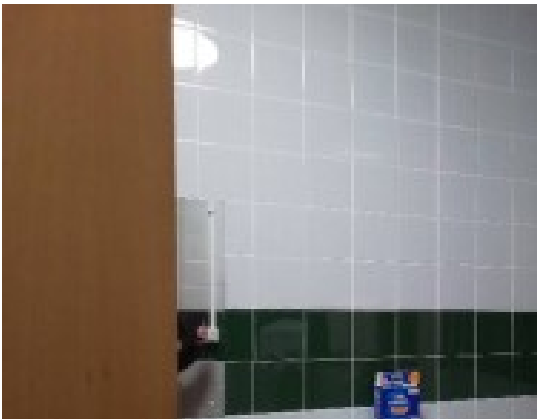
### **Item 24 Ref: OQ000248**

The wall – designated for new opening in the Staff Toilets (Room G/002) does not contain asbestos.

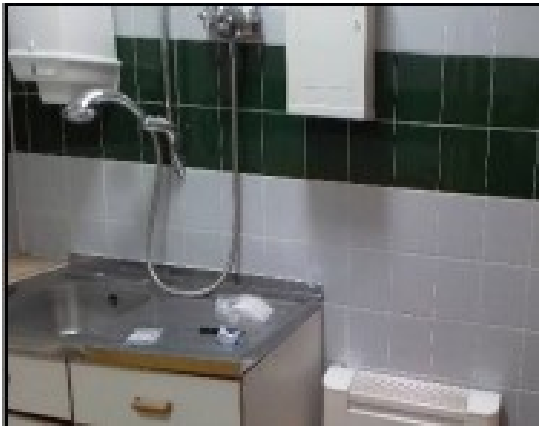
### **Item 25 Ref: As OQ000247**

The wall tile adhesive in the Toilets (Room G/003) does not contain asbestos.

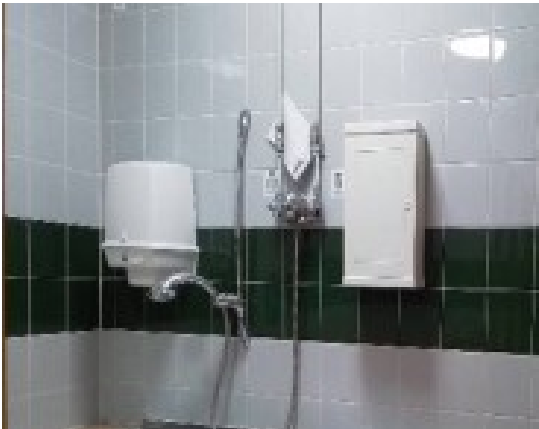
### **Item 26 Ref: As OQ000248**

The wall – designated for new opening in the Toilets (Room G/003) does not contain asbestos.

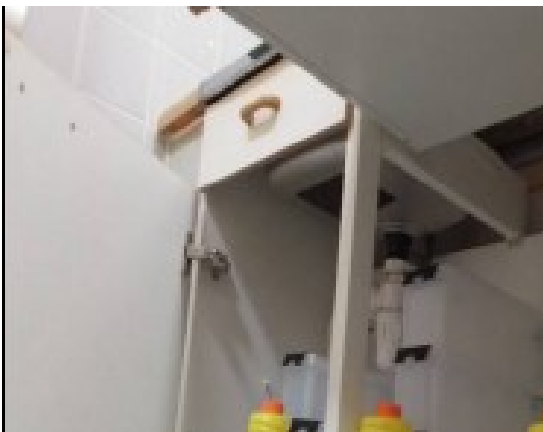
### **Item 27 Ref: OQ000249**

The under sink mat in the Toilets (Room G/003) does not contain asbestos.

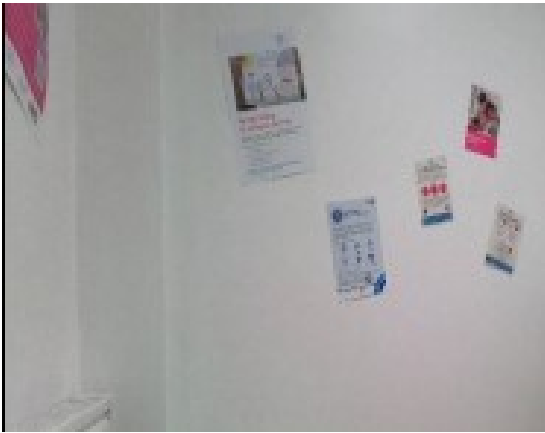
### **Item 28 Ref: As OQ000248**

The wall – designated for new opening in the Office (Room G/004) does not contain asbestos.

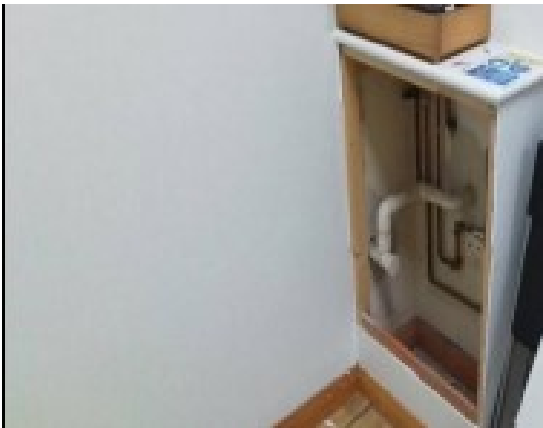
### **Item 29 Ref: OQ000250**

The floor tile – inside boxing in the Office (Room G/004) does not contain asbestos.

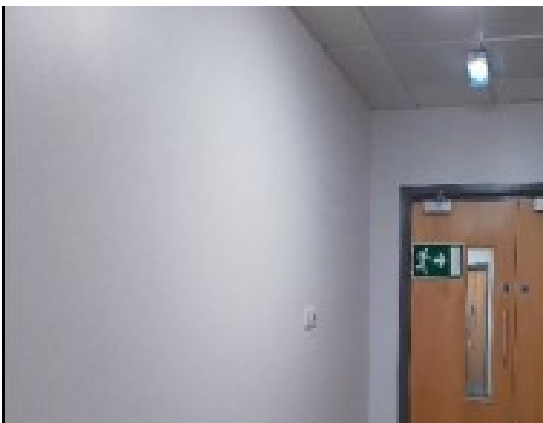
### **Item 30 Ref: OQ000251**

The wall in the Corridor 060 (Room G/006) does not contain asbestos.

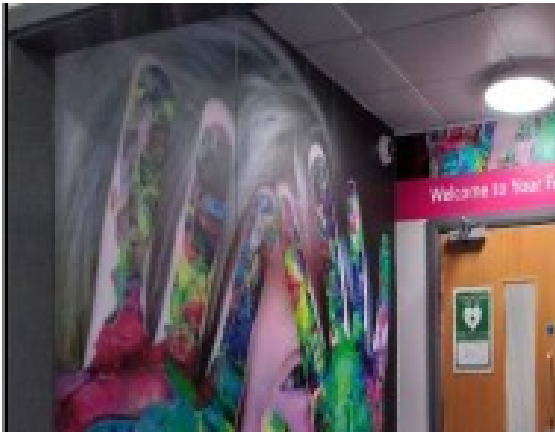
### **Item 31 Ref: As OQ000251**

The wall in the Corridor – adj reception office (Room G/007) does not contain asbestos.

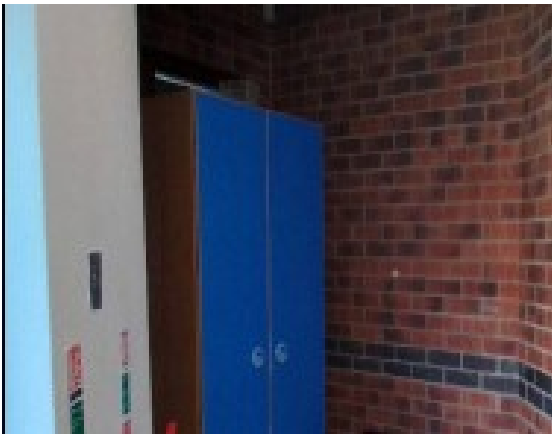
### **Item 32 Ref: OQ000252**

The wall – new door into sensory room (Room G/009) does not contain asbestos.

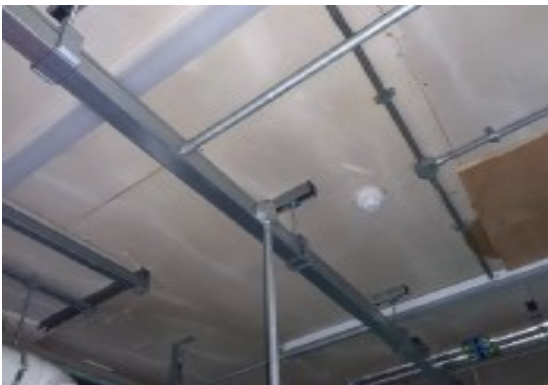
### **Item 33 Ref: PK003219**

The ceiling board in Boiler Room 1 (G/01) does not contain asbestos.

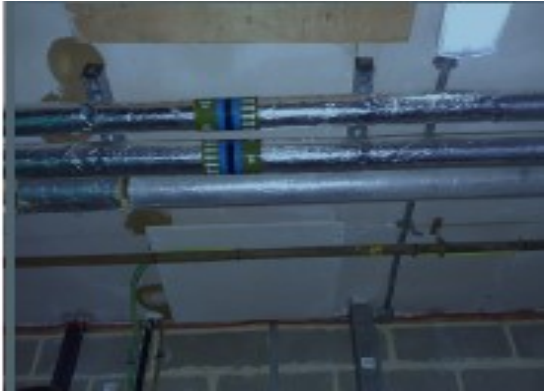
### **Item 34 Ref: PK003220**

The ceiling board panel above switch gear in Boiler Room 1 (G/01) does not contain asbestos.

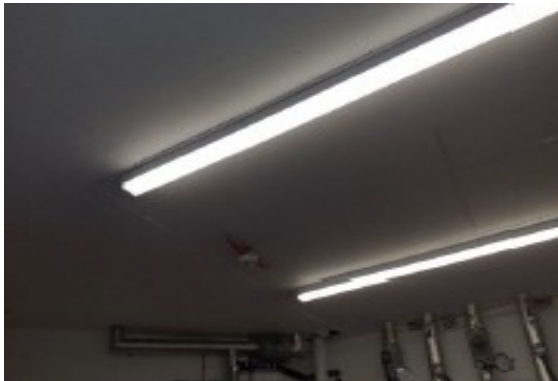
### **Item 35 Ref: PK003221**

The ceiling board in Boiler Room 2 (G/02) does not contain asbestos.
