ASBESTOS SURVEY REPORT FOR 15 NILE STREET, SUNDERLAND, SR1 1EY.

Asbestos Register for

15 Nile Street, Sunderland, SR1 1EY

Date: 30 March 2026

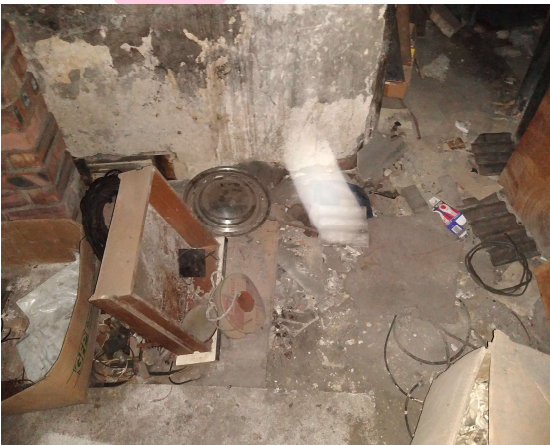
Item 3 Ref: 403295-2

The cement panel to floor in the store (Rm -1/02) contains asbestos.

Item 3	Cement panel to floor (Store/Rm - 1/002)	Low Risk	6 monthly	Removed May 2020
Item 4	Rope to cable reel (Store/Rm - 1/002)	Low Risk	6 monthly	Removed May 2020
<i>Item 5</i>	<i>No asbestos</i>	<i>Is present</i>		
<i>Item 6</i>	<i>No asbestos</i>	<i>Is present</i>

Removed May 2020.

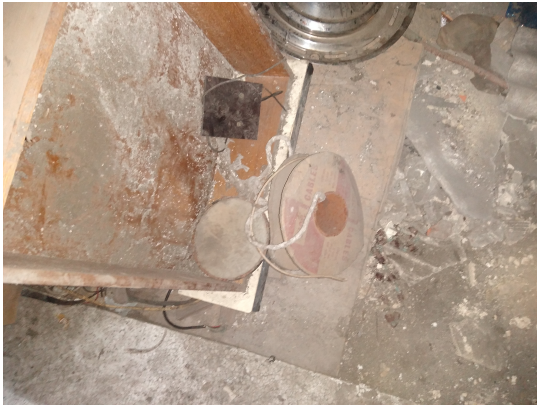
Item 4 Ref: 403295-3

The rope to cable reel in the store (Rm -1/002) does contain asbestos.

Removed May 2020

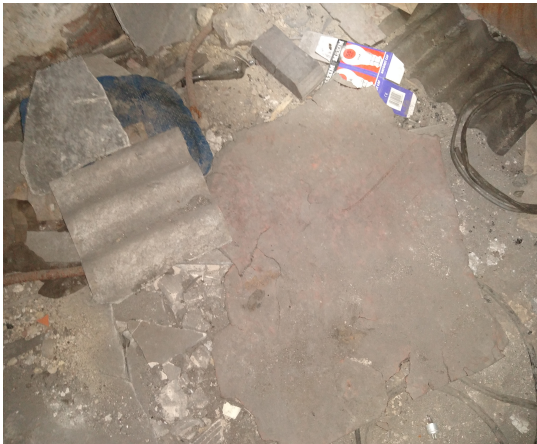
Item 5 Ref: 403295-4

The floor covering in the store (Rm -1/002) does not contain asbestos.

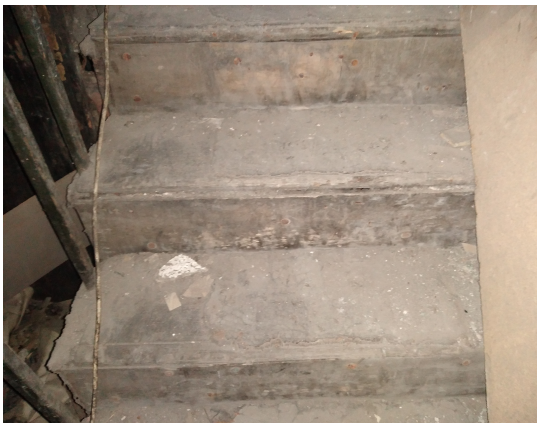
Item 6 Ref: 403295-5

The floor covering to stairs in the stairwell (Rm -1/004) does not contain asbestos.

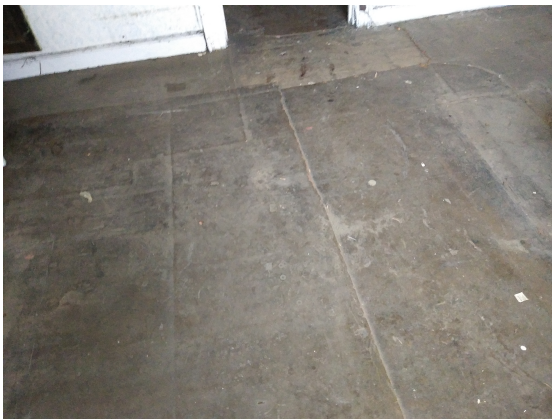
Item 9 Ref: 403295-6

The floor covering in the living room (Rm 0/003) does not contain asbestos.

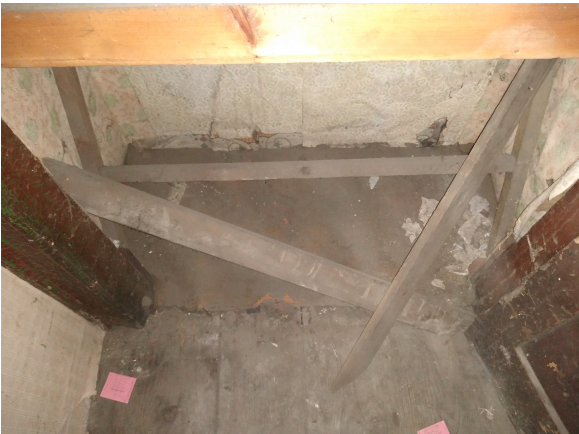
Item 12 Ref: 403295-8

The floor covering in the cupboard (Rm 0/004) does not contain asbestos.

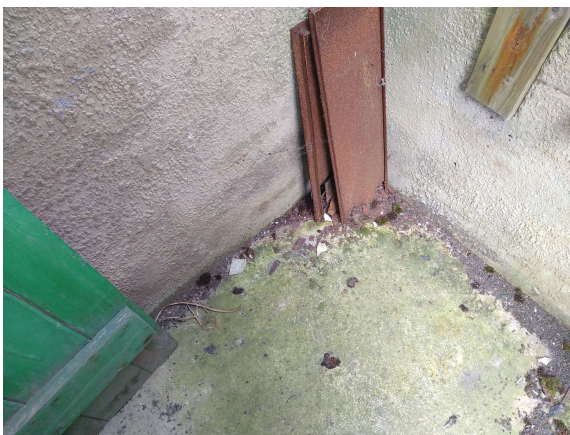
Item 15 Ref: As 403295-9

The cement debris to floor in the external wc (Rm 0/006) does contain asbestos.

Removed May 2020

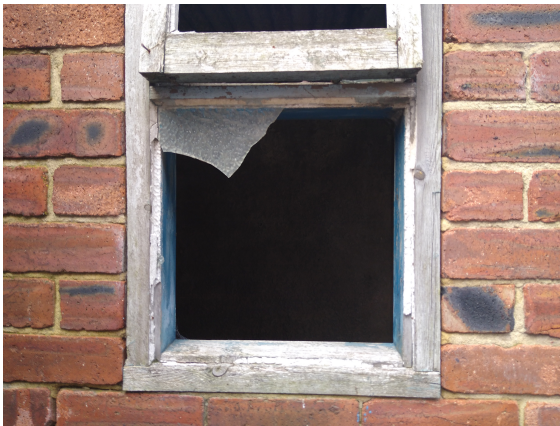
Item 16 Ref: 403295-10

The putty to the windows in the external wc (Rm 0/006) does not contain asbestos.

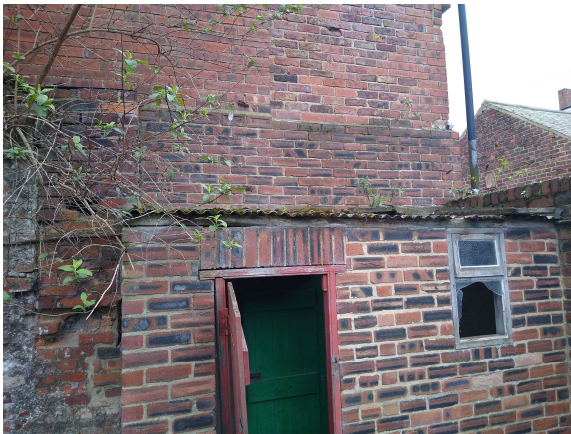
Item 17 Ref: As 403295-9

The roof covering in the external wc (Rm 0/007) does contain asbestos.

Item 17	Roof covering (External WC/Rm 0/007)	Very Low Risk	12 monthly	Removed May 2020
Item 18	Cement debris to floor (External WC/Rm 0/007)	Low Risk	6 monthly	Removed May 2020
<i>Item 19</i>	<i>No asbestos</i>	<i>Is present</i>		
<i>Item 20</i>	<i>No asbestos</i>	<i>Is present</i>		
<i>Item 21</i>	<i>No asbestos</i>	<i>Is present</i>		
<i>Item 22</i>	<i>No asbestos</i>	<i>Is present</i>

Removed May 2020

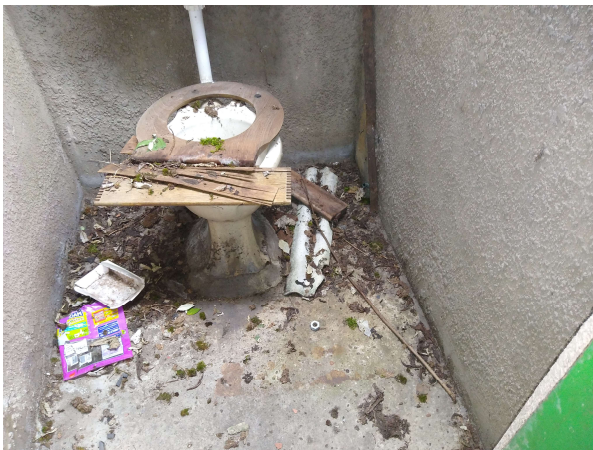
Item 18 Ref: As 403295-9

The cement debris to floor in the external wc (Rm 0/007) does contain asbestos.

Removed May 2020.

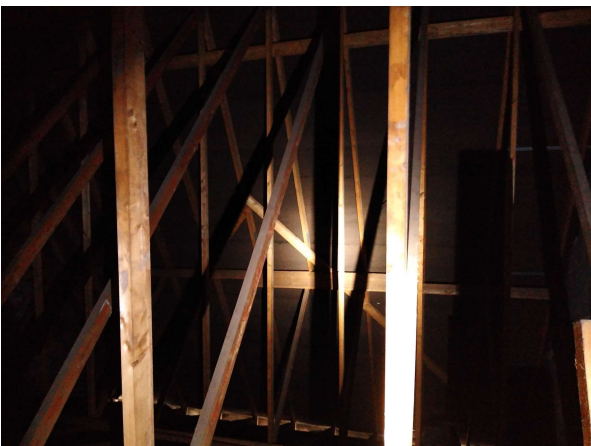
Item 21 Ref: 403295-13

The sarking in the loft void (Rm 2/001) does not contain asbestos.

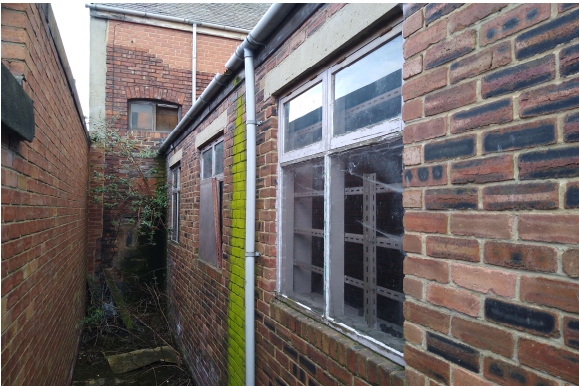
Item 22 Ref: 403295-14

The putty to the windows in the external does not contain asbestos.

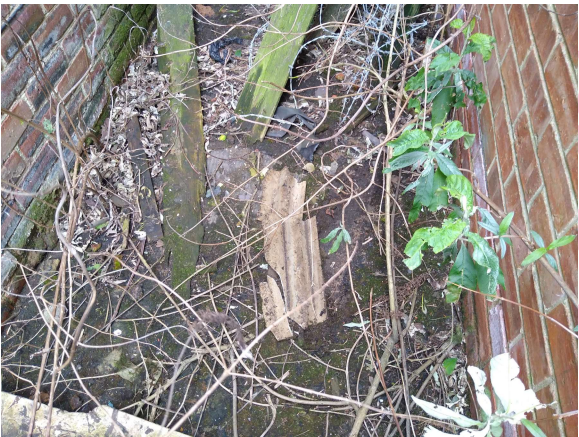
Item 23 Ref: 403295-15

The cement panels to path adjacent to workshop externally does contain asbestos.

Item 23	Cement panels	Low Risk	6 monthly	Removed

Removed May 2020
