ASBESTOS SURVEY REPORT FOR FULWELL QUARRY RECREATION AREA, SUNDERLAND

**Fulwell Quarry Recreation Area,
Sunderland**

UPRN: - J549544

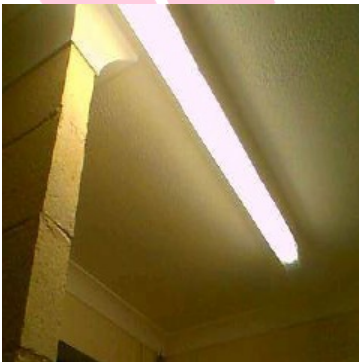
Item 3 As BB005465

The textured coating to the ceiling in the officials bathroom (Room 4) does not contain asbestos.

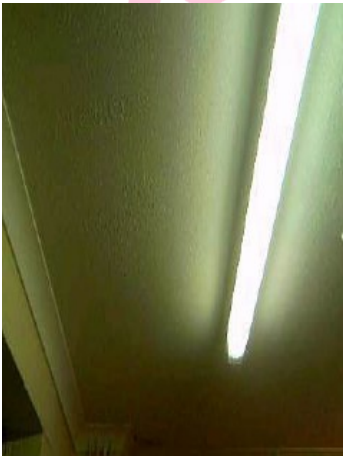
Item 6 As BB005465

The textured coating to the ceiling in the male bathroom (Room 7) does not contain asbestos.

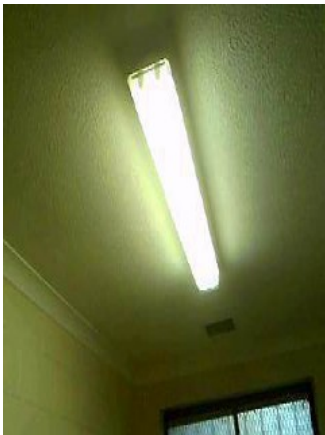
Item 8 As BB005465

The textured coating to the ceiling in the showers (Room 9) does not contain asbestos.

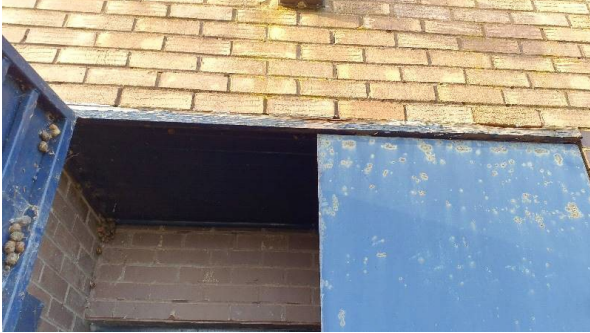
Item 10 Ref: OU001158

The residual frame sealant - Around metal doors (External) contains asbestos.

Any change in appearance should be noted and passed to Property Services.

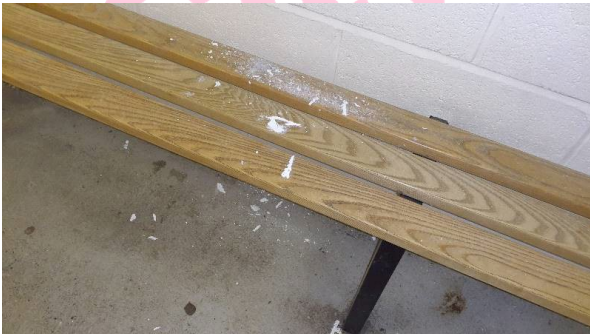
Item 12 Ref: As OU001152

The textured coating - Debris on floor (Changing room 2 G/01) does not contain asbestos.

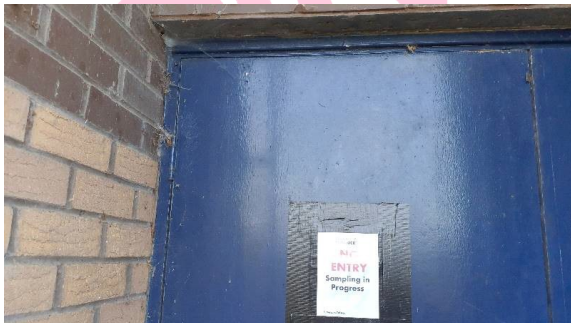
Item 15 Ref: OU001157

The frame sealant - Around timber doors (Front entrance G/11) does not contain asbestos.

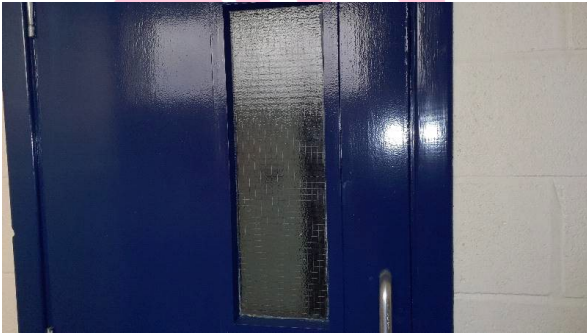
Item 18 Ref: As OU001153

The sealant - Around glass in door (Men's WC G/08) does not contain asbestos.

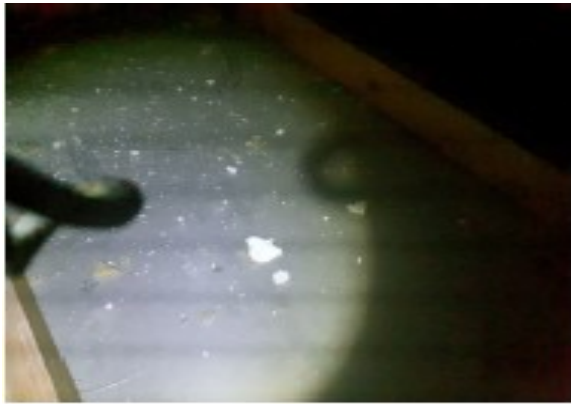
Item 20 Ref: RC000653

The textured coating debris on floor in the loft space (R/01) does not contain asbestos.

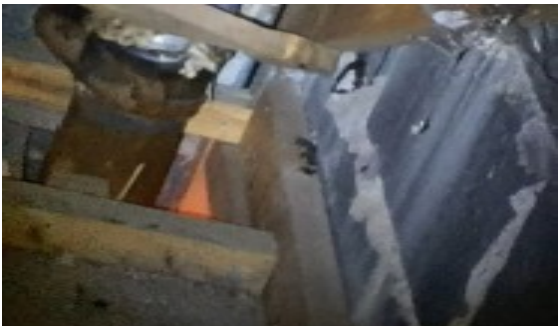
Item 21 Ref: RC000654

The bitumen around walks near soil pipe in the loft space (R/01) does not contain asbestos.

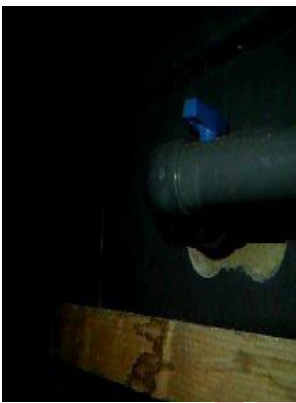
There was limited access to the loft due to height, accessed from hatch only.

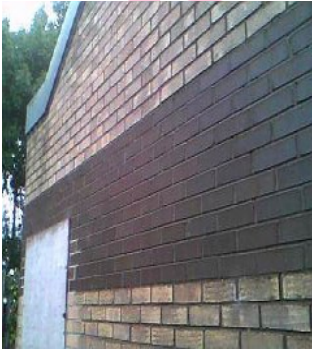
The external to the building was accessed and no suspect materials were found.
