ASBESTOS SURVEY REPORT FOR USWORTH RECREATION PARK,
MANOR PARK, USWORTH, WASHINGTON.

Asbestos Register for Usworth Recreation Park, Manor Park, Washington

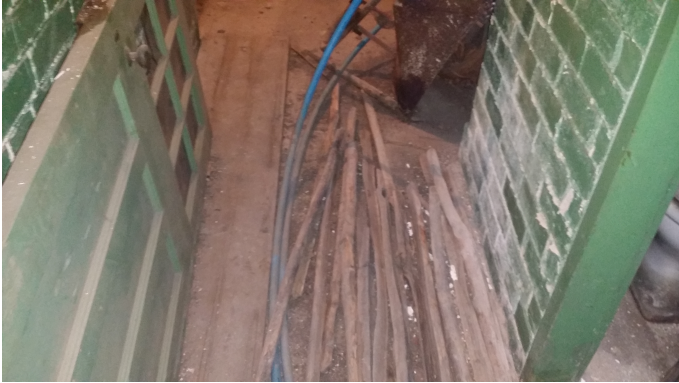
Item 1 Ref: 405955-7

The debris to floor in -1/003/Corridor contains asbestos.

Removed May 2020

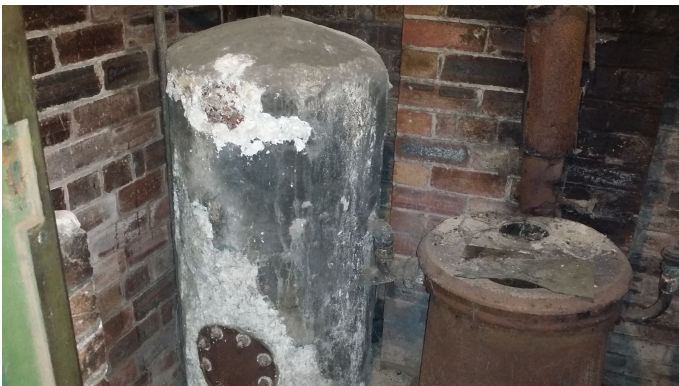
Item 2 Ref: 405955-4

The insulation to boiler in -1/007/Boiler Room contains asbestos.

Removed May 2020

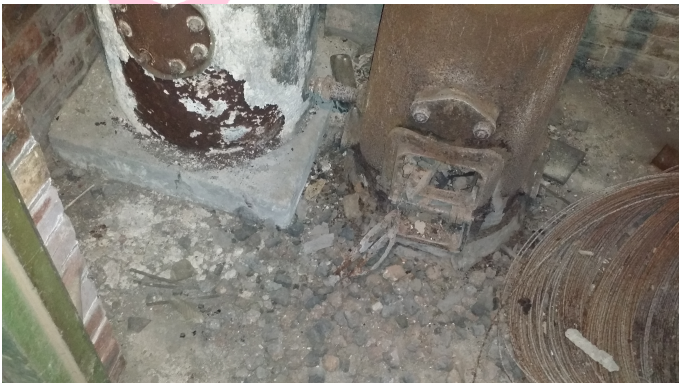
Item 3 Ref: 405955-5

The debris to horizontal surfaces in -1/007/Boiler Room contains asbestos.

Removed May 2020

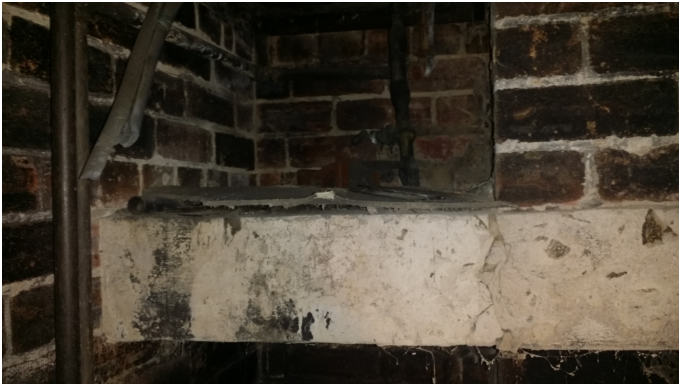
Item 4 Ref: 405955-6

The loose lying material to shelf in -1/007/Boiler Room contains asbestos.

Removed May 2020

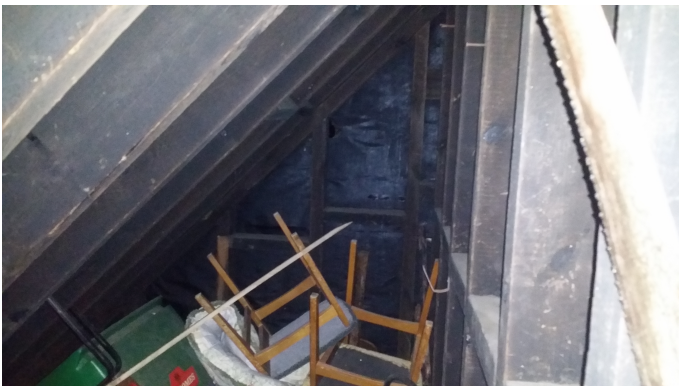
Item 5 Ref: 405955-1

The felt to wall in 0/004/Store does not contain asbestos.

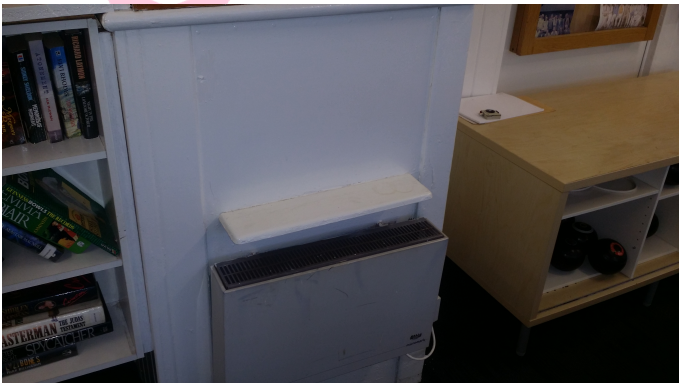
Item 6 Ref: 405955-2

The panel behind heater in 0/006/Main room contains asbestos.

Item 4	Loose lying material to shelf (-1/007/Boiler Room)	Low Risk	6 monthly	Removed May 2020
Item 5	No Asbestos	Is present		
Item 6	Panel behind heater (0/006/Main room)	Low Risk	6 monthly	06/10/2026

Any change in its appearance should be recorded and passed to Property Services.

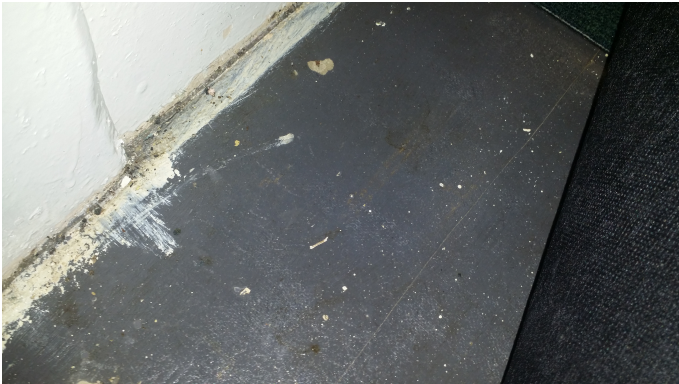
Item 7 Ref: 405955-3

The subfloor in 0/006/Main room does not contain asbestos.

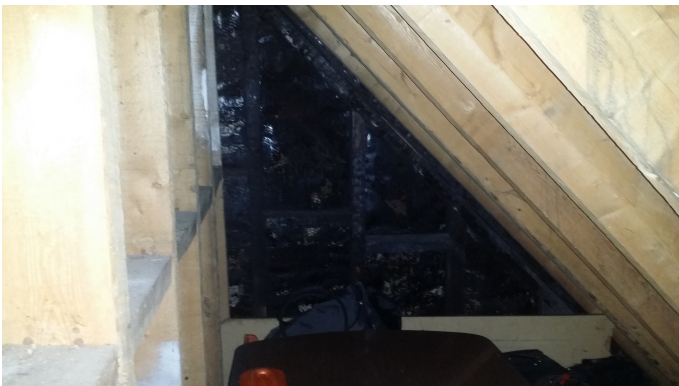
Item 8 Ref: As 405955-1

The felt to wall in 0/007/Store room does not contain asbestos.

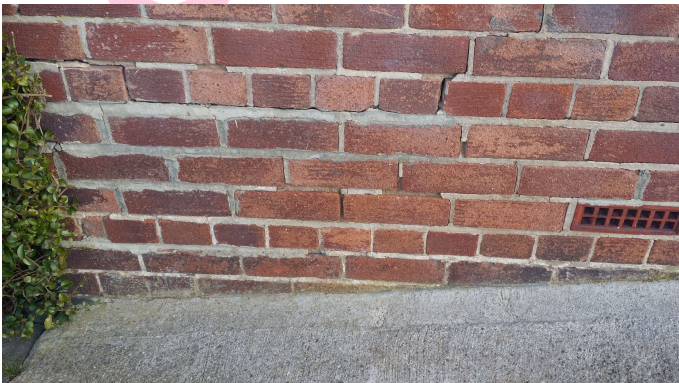
Item 9 Ref: 405955-8

The damp proof course (External) does not contain asbestos.

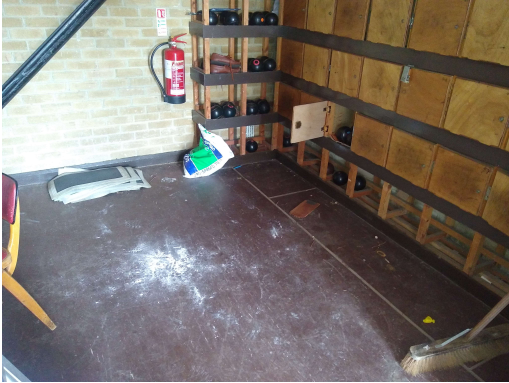
Item 10 Ref: 405955-14

The floor covering in 0/001/Lobby does not contain asbestos.

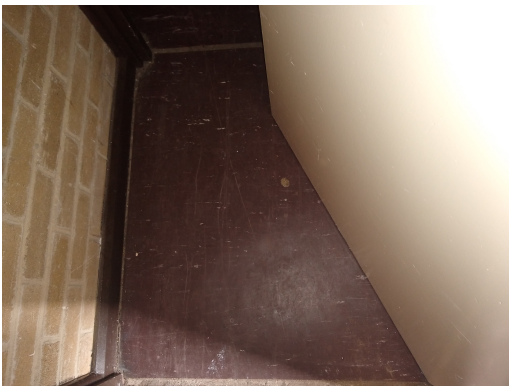
Item 11 Ref: 405955-16

The floor covering in 0/006/Male changing lobby does not contain asbestos.

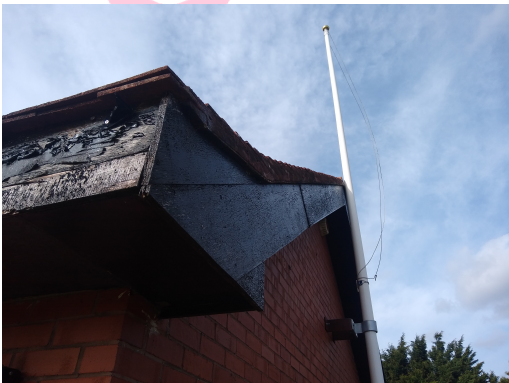
Item 12 Ref: 405955-17

The Undercloak fillet (External) contains asbestos.

Removed 2023

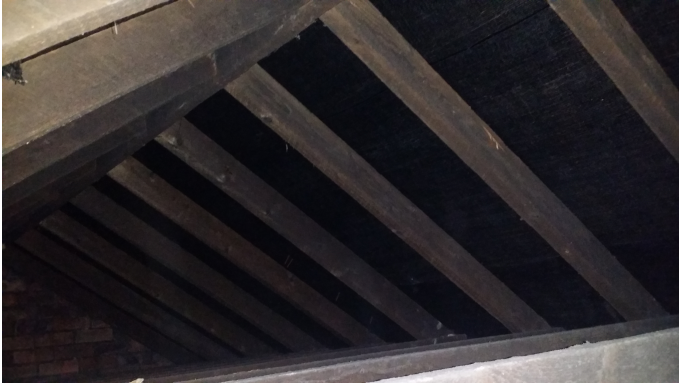
Item 13 Ref: 405955-11

The underside of roof
(External) does not contain
asbestos.

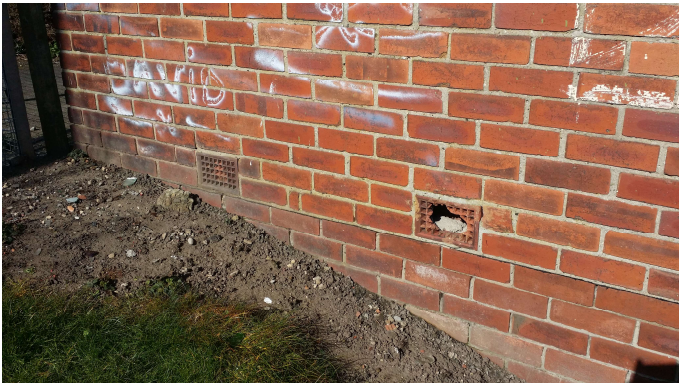
Item 14 Ref: 405955-9

The damp proof course
(External) does not contain
asbestos.

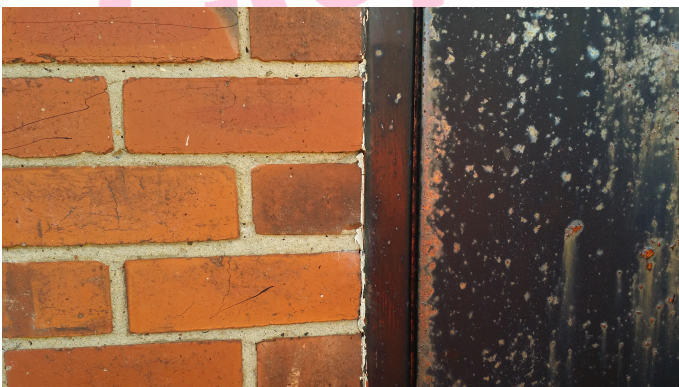
Item 15 Ref: 405955-10

The mastic to door (External)
does not contain asbestos.

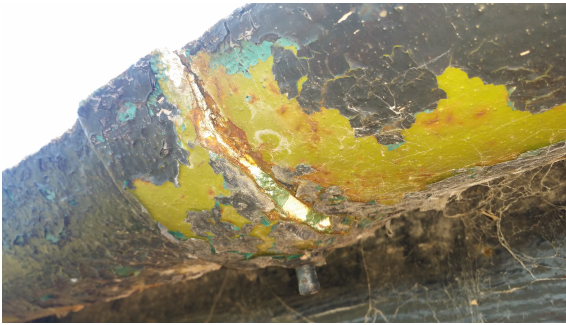
Item 16 Ref: 405955-12

The mastic to rainwater goods (External) does not contain asbestos.

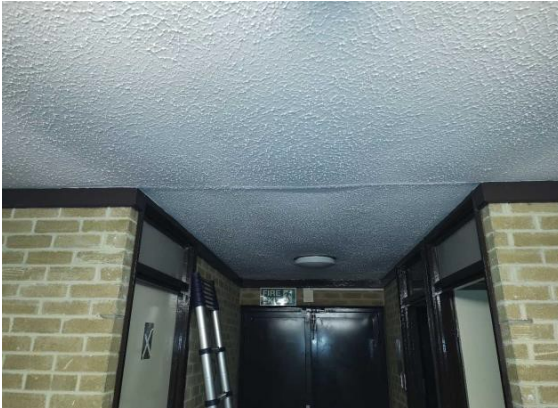
Item 17 Ref: 21-41504-1

The ceiling (Textured Coating) (Room/Area: 2 Entrance Lobby) contains asbestos.

Removed 2023

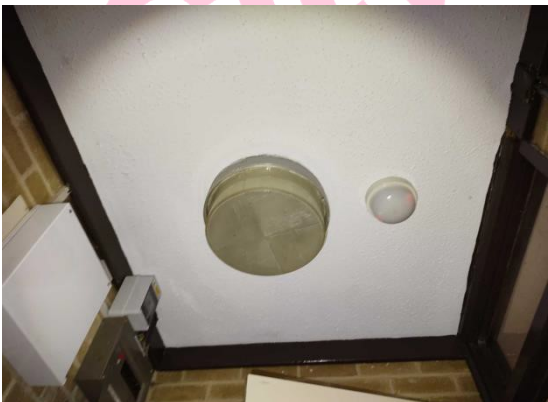
Item 18 Ref: 21-41504-1

The ceiling (Textured Coating) (Room/Area: 3 Cupboard - Electric Meter) contains asbestos.

Removed 2023

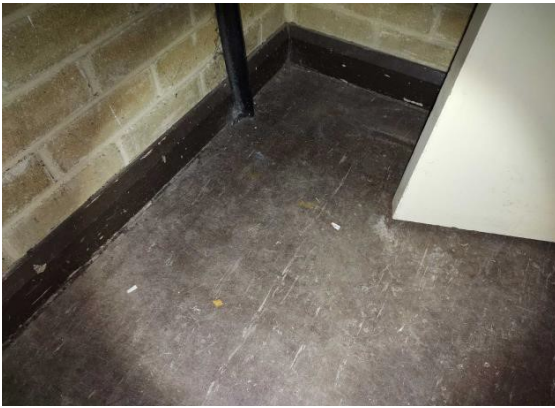
Item 19 Ref: 21-41504-2

The floor (Vinyl) (Room/Area: 3 Cupboard - Electric Meter) does not contain asbestos.

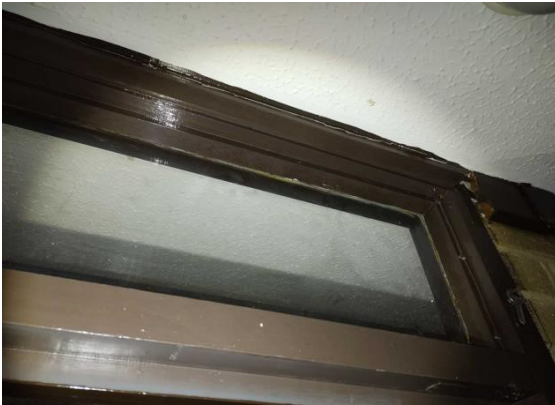
Item 20 Ref: 21-41504-3

The door - Sealant to door header (Putty) (Room/Area: 3 Cupboard - Electric Meter) does not contain asbestos.

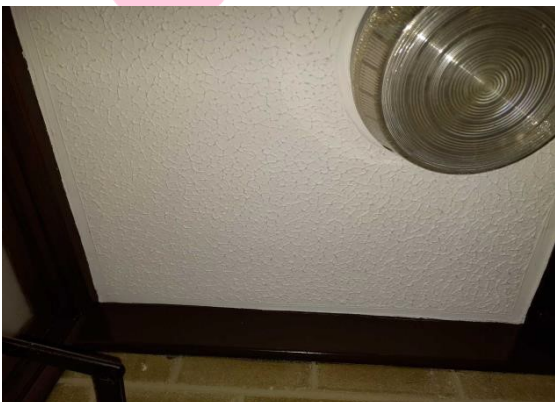
Item 21 Ref: 21-41504-1

The ceiling (Textured Coating) (Room/Area: 4 Female Lobby) contains asbestos.

Removed 2023

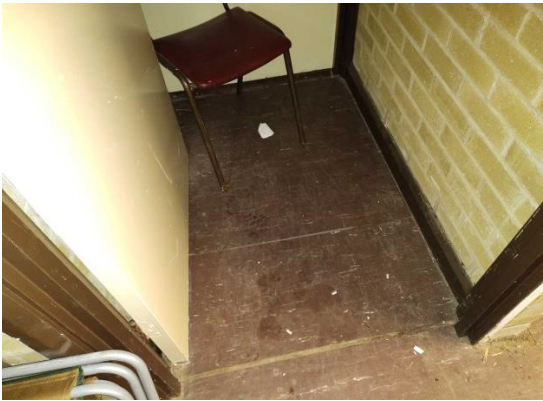
Item 22 Ref: 21-41504-2

The floor (Vinyl) (Room/Area: 4 Female Lobby) does not contain asbestos.

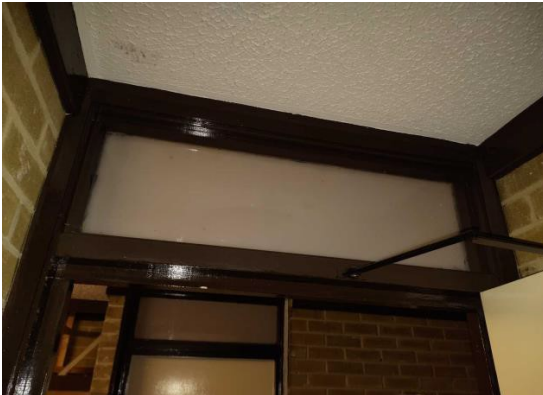
Item 23 Ref: 21-41504-3

The door - Sealant to door header (Putty) (Room/Area: 4 Female Lobby) does not contain asbestos.

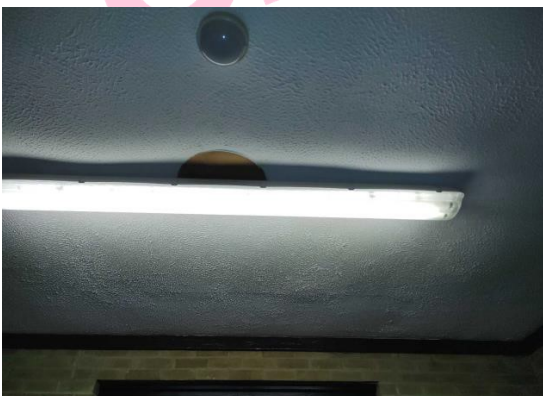
Item 24 Ref: 21-41504-1

The ceiling (Textured Coating) (Room/Area: 5 Female Changing Room) contains asbestos.

Removed 2023

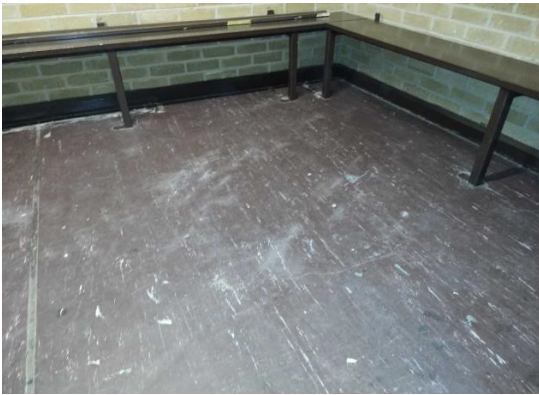
Item 25 Ref: 21-41504-2

The floor (Vinyl) (Room/Area: 5 Female Changing Room) does not contain asbestos.

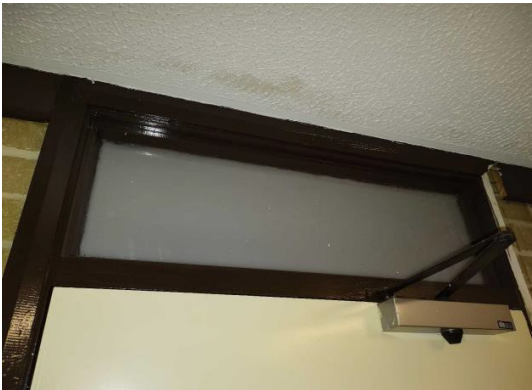
Item 26 Ref: 21-41504-3

The door - Sealant to door header (Putty) (Room/Area: 5 Female Changing Room) does not contain asbestos.

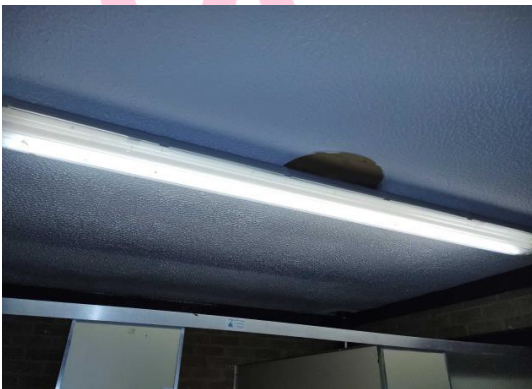
Item 27 Ref: 21-41504-1

The ceiling (Textured Coating) (Room/Area: 6 Female WC) contains asbestos.

Removed 2023

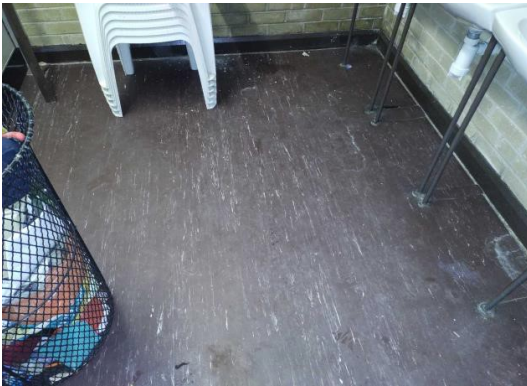
Item 28 Ref: 21-41504-2

The floor (Vinyl) (Room/Area: 6 Female WC) does not contain asbestos.

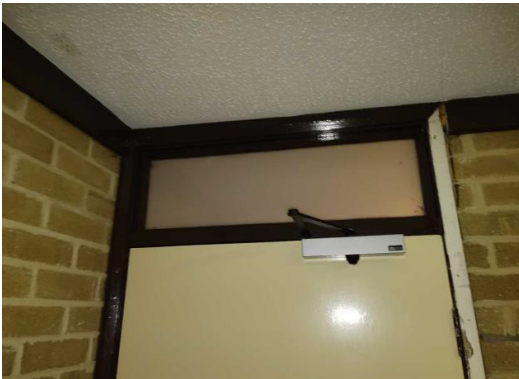
Item 29 Ref: 21-41504-3

The door (Putty) (Room/Area: 6 Female WC) does not contain asbestos.

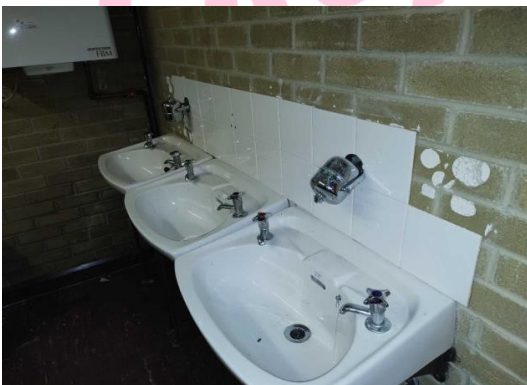
Item 30 Ref: 21-41504-4

The walls – Ceramic Wall Tiles adhesive (Room/Area: 6 Female WC) does not contain asbestos.

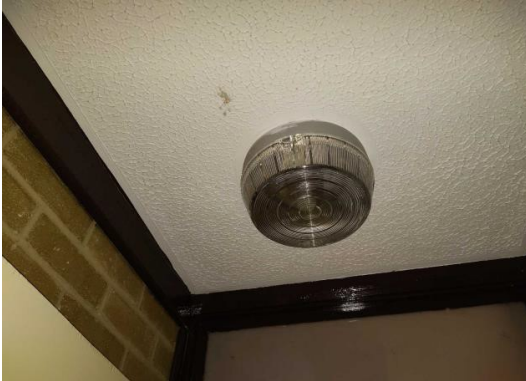
Item 31 Ref: 21-41504-1

The ceiling (Textured Coating)
(Room/Area: 7 Male Lobby)
contains asbestos.

Removed 2023

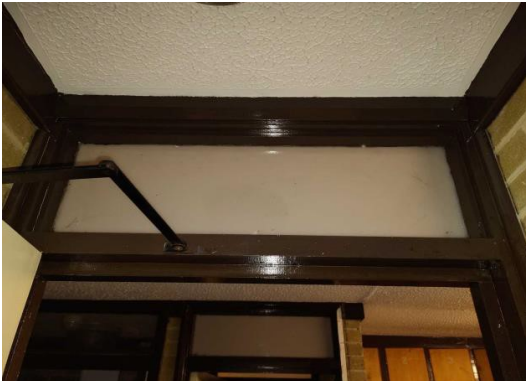
Item 32 Ref: 21-41504-3

The door (Putty) (Room/Area:
7 Male Lobby) does not
contain asbestos.

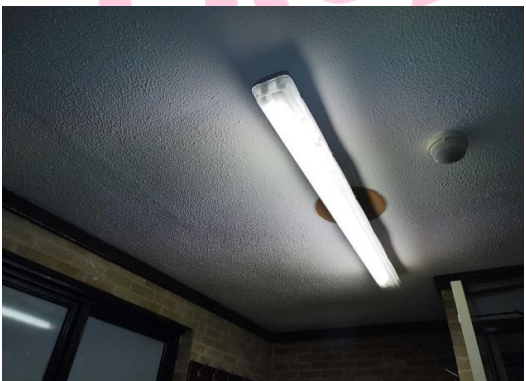
Item 33 Ref: 21-41504-1

The ceiling (Textured Coating)
(Room/Area: 8 Male Changing
Room) contains asbestos.

Removed 2023

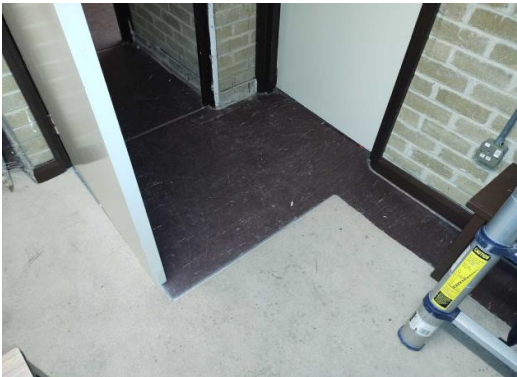
Item 34 Ref: 21-41504-2

The floor (Vinyl) (Room/Area: 8 Male Changing Room) does not contain asbestos.

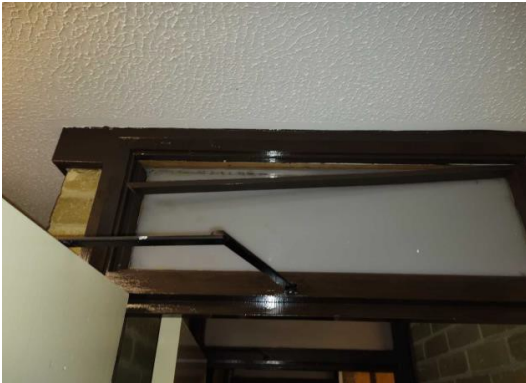
Item 35 Ref: 21-41504-3

The door (Putty) (Room/Area: 8 Male Changing Room) does not contain asbestos.

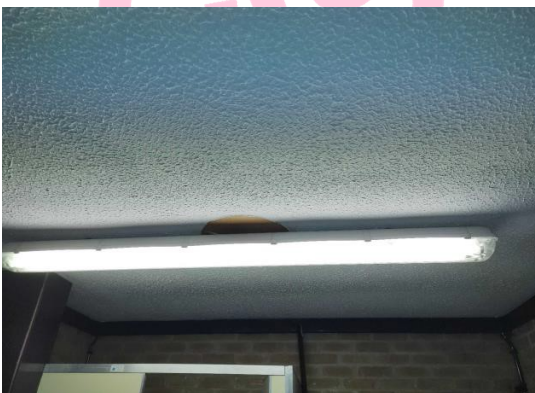
Item 36 Ref: 21-41504-1

The ceiling (Textured Coating) (Room/Area: 9 Male WC) contains asbestos.

Removed 2023

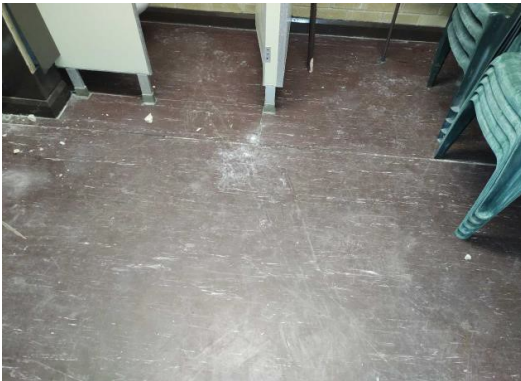
Item 37 Ref: 21-41504-2

The floor (Vinyl) (Room/Area: 9 Male WC) does not contain asbestos.

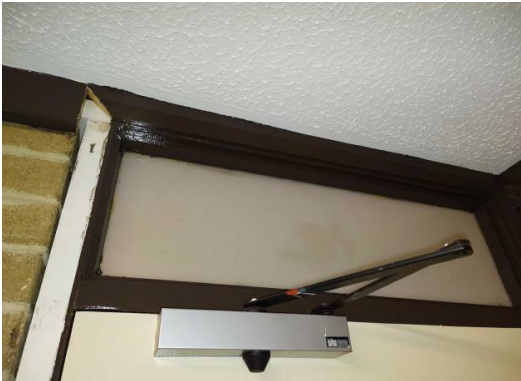
Item 38 Ref: 21-41504-3

The door sealant to header (Putty) (Room/Area: 9 Male WC) does not contain asbestos.

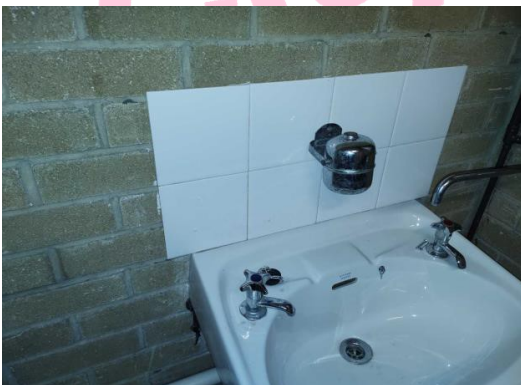
Item 39 Ref: 21-41504-4

The walls – Ceramic Wall Tiles adhesive (Room/Area: 9 Male WC) does not contain asbestos.

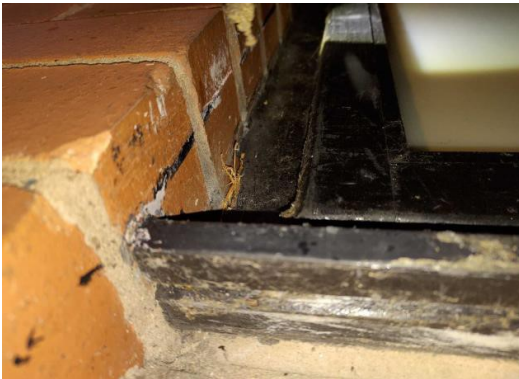
Item 40 Ref: 21-41504-6

The Window – Sealant to frame (mastic) (Room/Area: 10 External) contains asbestos.

Removed 2023
