### ASBESTOS SURVEY REPORT FOR BARNES PARK, SUNDERLAND SR4 7PY

## **Asbestos Register for**

**Barnes Park, Sunderland, SR4 7PY**

**Date: 02 January 2026**

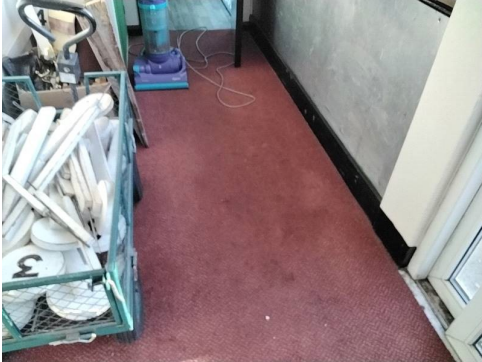
### Item 1 Ref: KX000456/001

The Floor - Tile (Under floor covering) - beige, painted green in Bowling Pavilion G/001 - Entrance Hall/Foyer/Lobby does not contain asbestos.

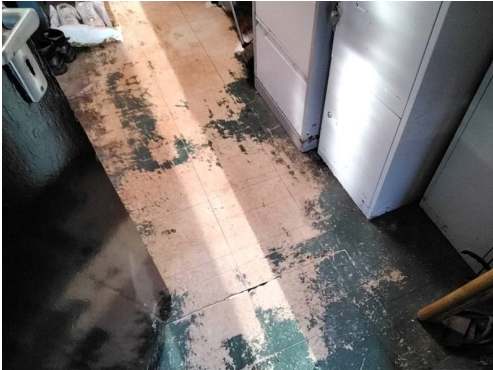
### Item 2 Ref: As KX000456

The Floor - Tile (Under floor covering) - beige, painted green in Bowling Pavilion G/006 – Staffroom does not contain asbestos.

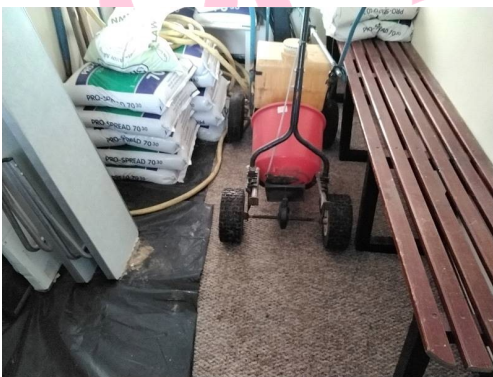
### Item 3 Ref: KX000458/003

The Floor - Tile (Under floor covering) - Red in Bowling Pavilion G/007 – Staff Room/Storeroom does not contain asbestos.

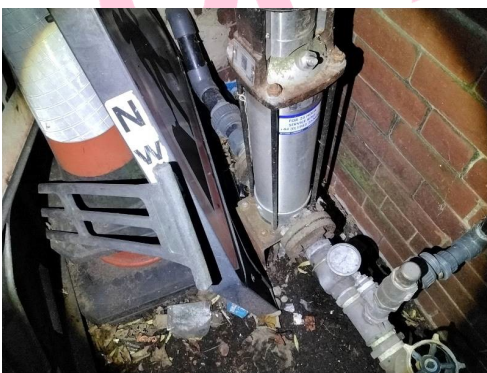
### **Item 6 Ref: Presumed**

6.	Presumed	Pipework Gasket	Bowling Pavilion E/001 – External	Very Low Risk
7.	KX000460/006	Door - frame sealant to wall	Bowling Pavilion E/002 – External	No Risk

The Pipework Gasket in Rm Bowling Pavilion E/001 – External is presumed to contain asbestos.

Any change in its appearance should be recorded and passed to Property Services.

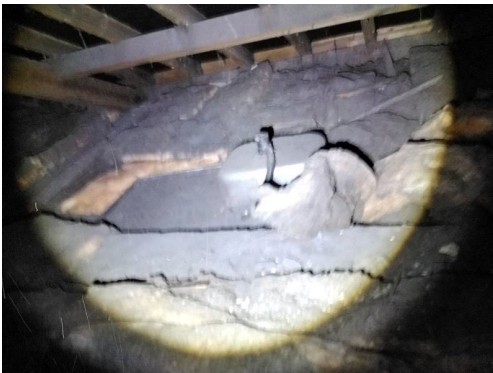
### **Item 9 Ref: KX000465/015**

The Under Sink Mat - to old sink discarded in loft in Pavilion – Roof Void R/001 Loft Space does not contain asbestos.

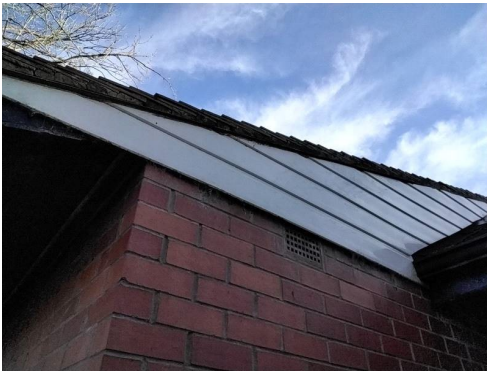
**Item 11 Ref: KX000466/017**

The Undercloak - to toilet block in Barnes West End Men's Pavilion – External E/001 does not contain asbestos.
