### ASBESTOS SURVEY REPORT FOR LEYBURN GROVE RECREATION GROUND, HOUGHTON LE SPRING

## **Asbestos Register for**

## **LEYBURN GROVE RECREATION GROUND**

**UPRN: - J549316**

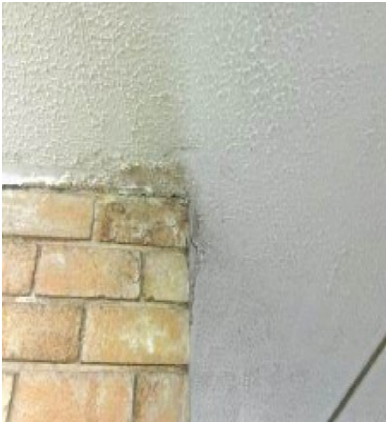
### **Item 1 Ref: EA003009**

The textured coating to the ceiling in the Corridor (Room 1) does not contain asbestos.

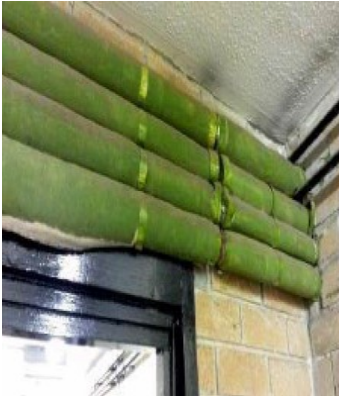
### **Item 2 - Ref: EA003010**

The lagging to the pipework in the corridor (Room 1) does not contain asbestos.

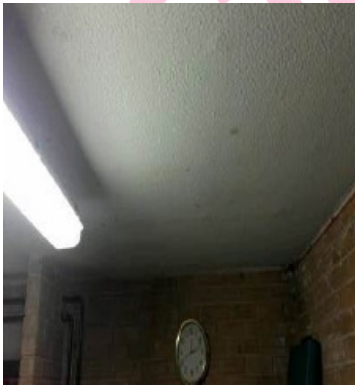
### **Item 3 - Ref: EA003009**

The textured coating to the ceiling in the staff room (Room 2) do not contain asbestos.

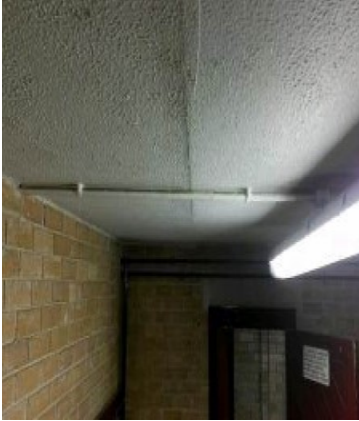
### **Item 4 - Ref: EA003009**

The textured coating to the ceiling in changing room 4 (Room 3) was accessed and no suspect materials were

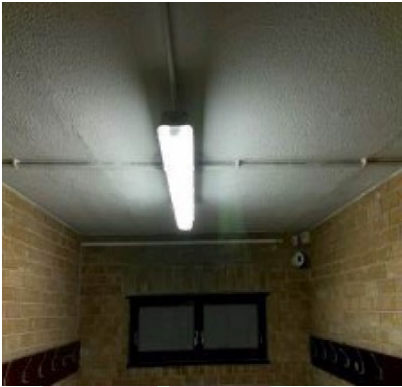
### **Item 5 - Ref: EA003009**

The textured coating to the ceiling in changing room 5 (Room 4) does not contain asbestos.

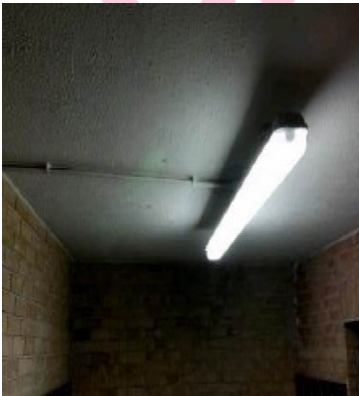
### **Item 6 - Ref: EA003009**

The textured coating to the ceiling in changing room 6 (Room 5) does not contain asbestos.

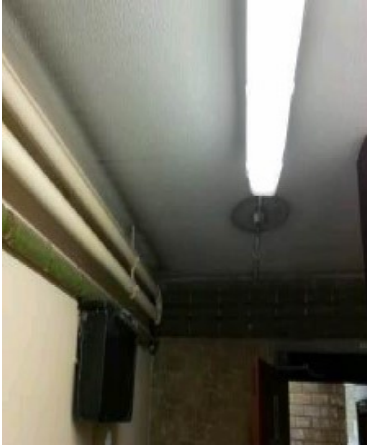
**Item 7 - Ref: EA003009**

The textured coating to the ceiling in the Male WC (Room 6) does not contain asbestos.

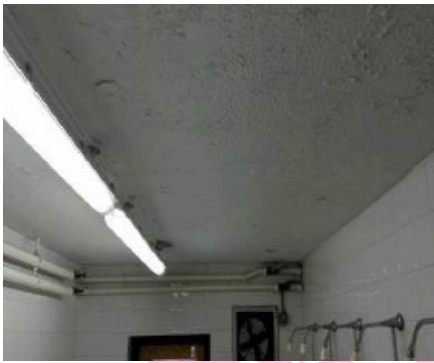
**Item 8 - Ref: EA003009**

The textured coating to the ceiling in the shower room (Room 7) does not contain asbestos.

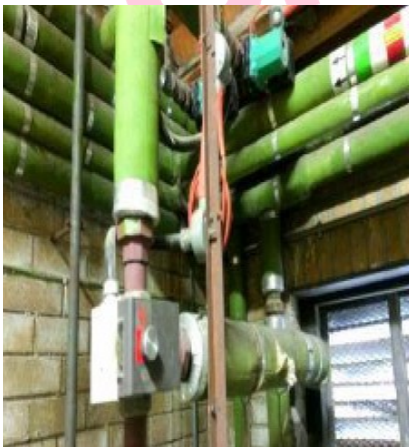
**Item 9 - Ref: EA003011**

The pipe lagging to the boiler room (Room 8) does not contain asbestos.

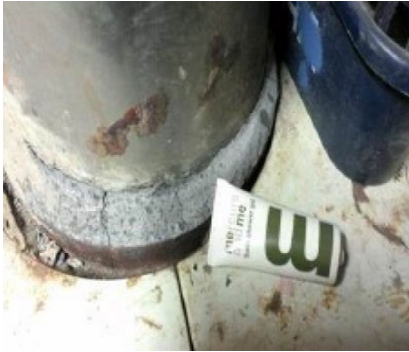
### **Item 10 - Ref: EA003012**

The putty around the metal flue at the boiler top to the Boiler Room (Room 8) does not contain asbestos.

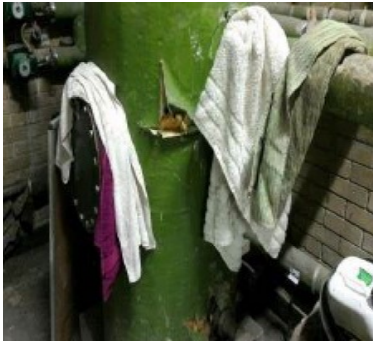
### **Item 11 - Ref: EA003013**

The lagging to the calorifiers in the boiler room (Room 8) do not contain asbestos.

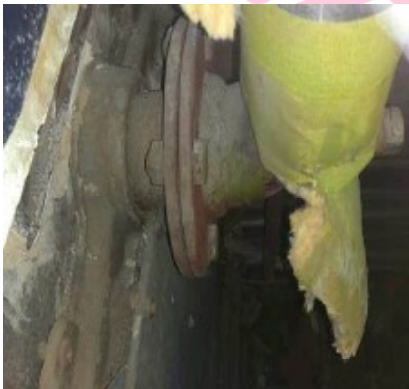
### **Item 12 – 21-30813-3**

The gaskets to the pipework in the boiler room (Room 8) does not contain asbestos.

*No Risk – resampled, report J278817 confirms this*

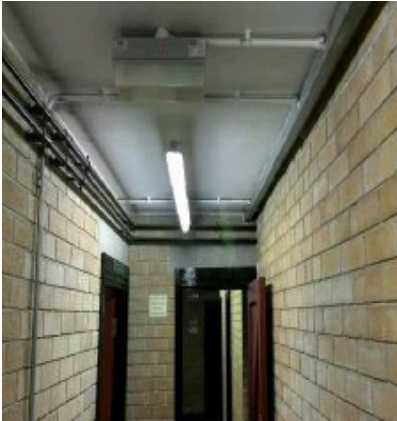
**Item 13 - Ref: EA003015**

The textured coating to the ceiling in the small corridor (Room 9) does not contain asbestos.

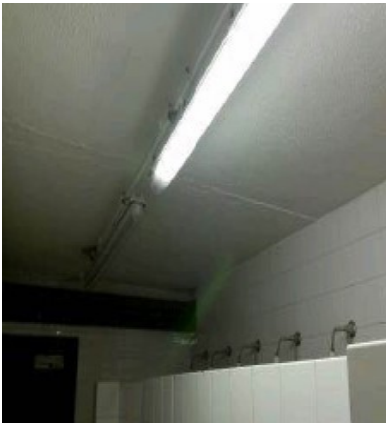
**Item 14 - As EA003015**

The textured coating to the ceiling in the showers (Room 10) does not contain asbestos.

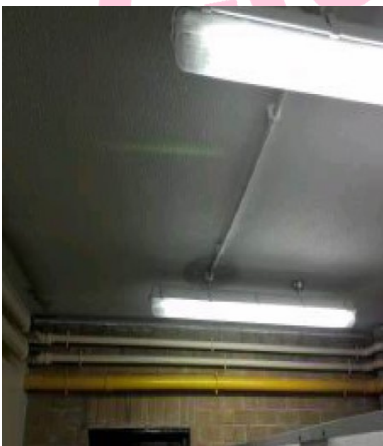
**Item 15 - As EA003015**

The textured coating to the ceiling in the Female WC (Room 11) does not contain asbestos.

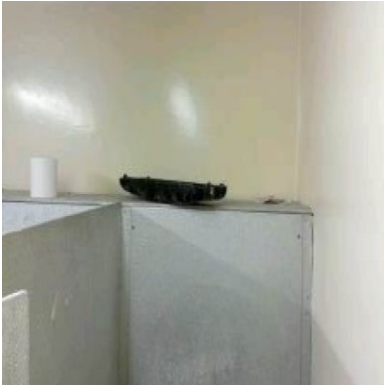
**Item 16 - Ref: EA003016**

The cistern lid on the boxing in the female WC (Room 11) does not contain asbestos.

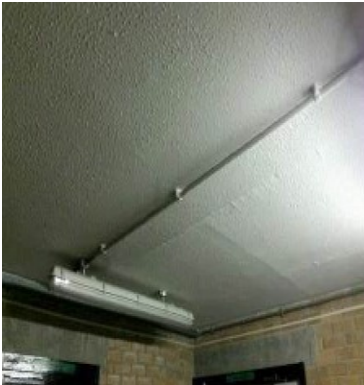
**Item 17 - As EA003015**

The textured coating to the ceiling in the lobby (Room 12) does not contain asbestos.

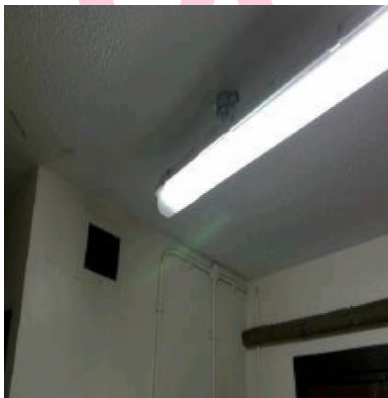
**Item 18 - As EA003015**

The textured coating to the ceiling in the kitchen (Room 13) does not contain asbestos.

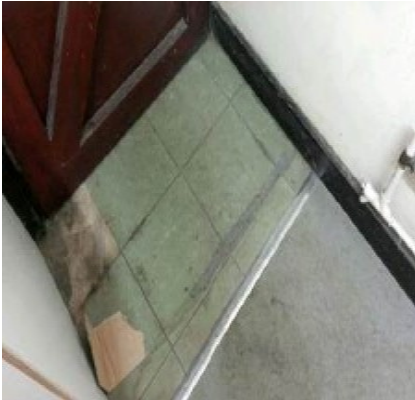
**Item 19 - Ref: EA003017**

The green floor tiles to the kitchen (Room 13) do not contain asbestos.

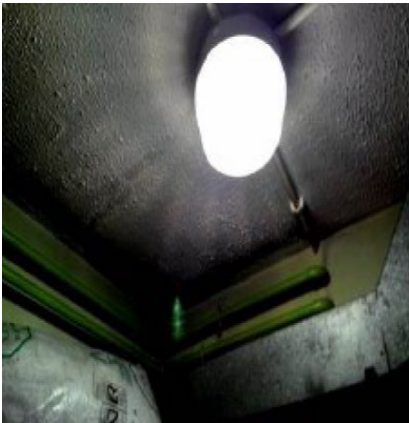
**Item 20 - As EA003015**

The textured coating to the ceiling in the gas meter cupboard (Room 14) does not contain asbestos.

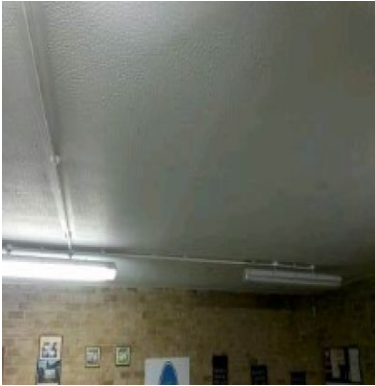
### **Item 22 - As EA003015**

The textured coating to the ceiling in the team room (Room 15) does not contain asbestos.

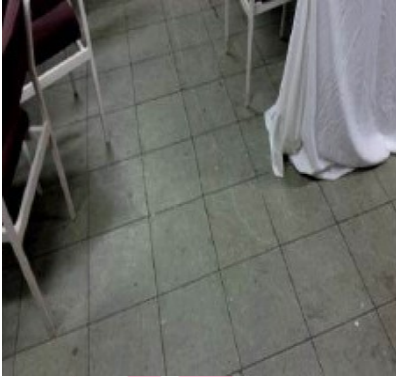
### **Item 23 - As EA003017**

The green floor tiles to the tea room (Room 15) do not contain asbestos.

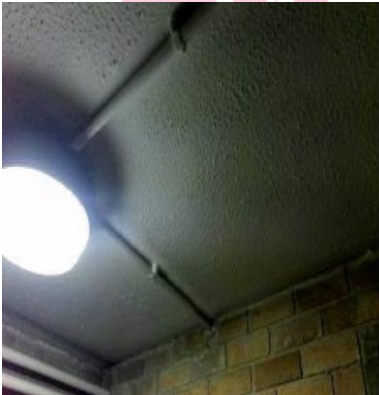
### **Item 24 - As EA003015**

The textured coating to the ceiling in the disabled WC (Room 16) does not contain asbestos.

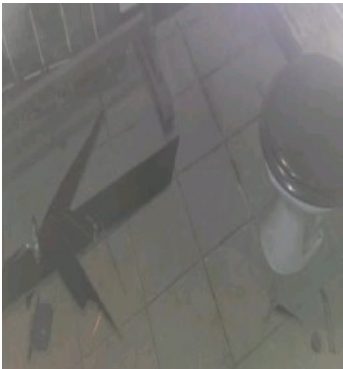
**Item 25 - As EA003017**

The green floor tiles to the Disabled WC (Room 16) do not contain asbestos.

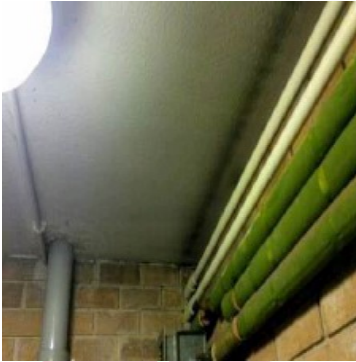
**Item 26 - As EA003015**

The textured coating to the ceiling in the WC (Room 17) does not contain asbestos.

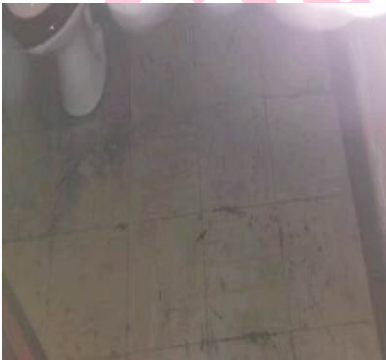
**Item 27 - As EA003017**

The green floor tiles to the WC (Room 17) do not contain asbestos.

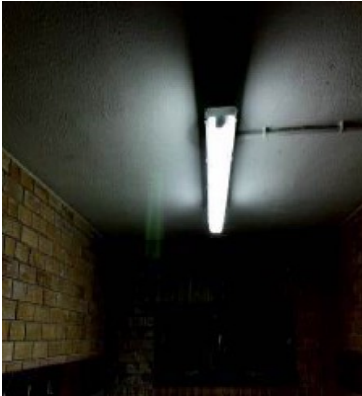
**Item 28 – Ref: EA003018**

The textured coating to the ceiling in changing room 1 (Room 18) does not contain asbestos.

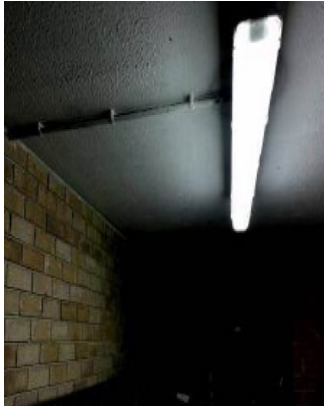
**Item 29 - As EA003018**

The textured coating to the ceiling in changing room 2 (Room 19) does not contain asbestos.

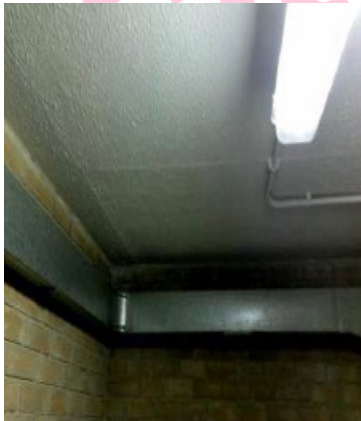
**Item 30 - As EA003018**

The textured coating to the ceiling in the officials Room (Room 20) does not contain asbestos.

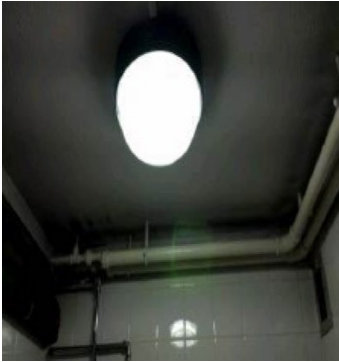
**Item 31 – Ref: EA003018**

The textured coating to the ceiling in the officials shower (Room 21) does not contain asbestos.

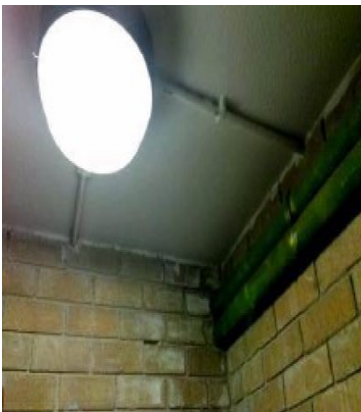
**Item 32 - As EA003015**

The textured coating to the ceiling in the officials WC (Room 22) does not contain asbestos.

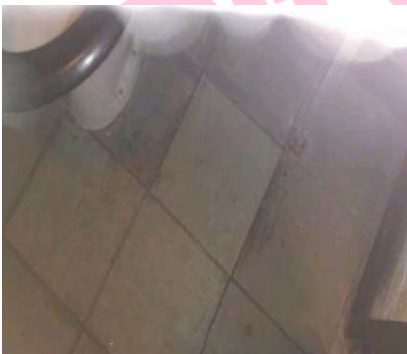
**Item 33 - As EA003017**

The green floor tiles to the officials WC (Room 22) do not contain asbestos.

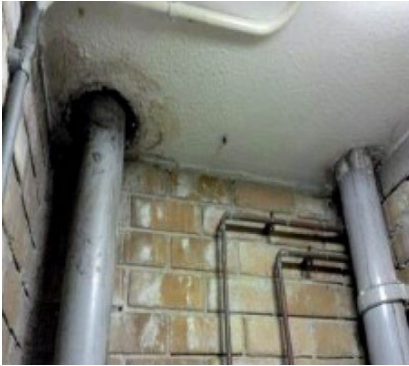
### **Item 34 – Ref: EA003018**

The textured coating to the ceiling in the store (Room 23) does not contain asbestos.

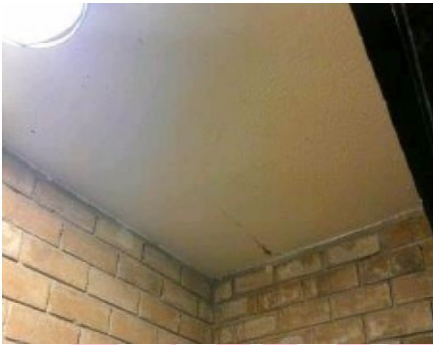
### **Item 35 - As EA003018**

The textured coating to the ceiling in the store (Room 24) does not contain asbestos.

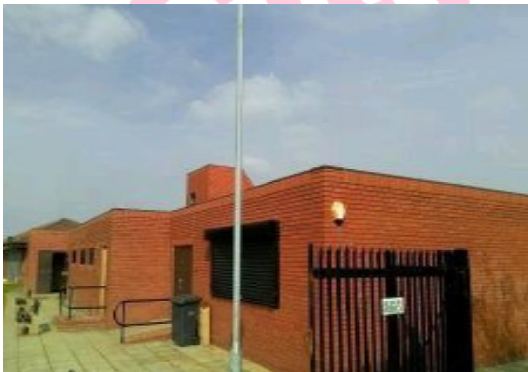
### **Item 36 – Presumed**

The bitumen to the flat roof (External) was presumed to contain asbestos.

Any change in its appearance should be noted and passed to Property Services.

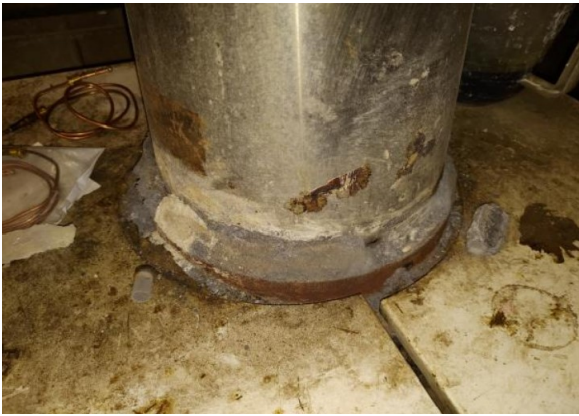
### **Item 37 Ref: 21-30813-1**

The rope seal to free standing boiler flue in Area 1/Boiler Room does not contain asbestos.

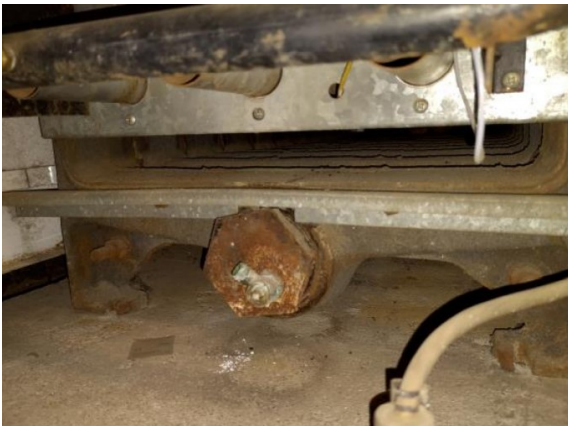
### **Item 38 Ref: 21-30813-4**

The gasket inside free standing boiler in Area 1/Boiler Room does not contain asbestos.

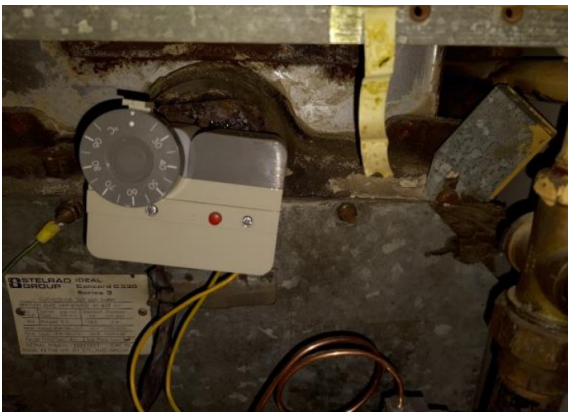
### **Item 39 Ref: 21-30813-5**

The putty inside free standing boiler in Area 1/Boiler Room does not contain asbestos.

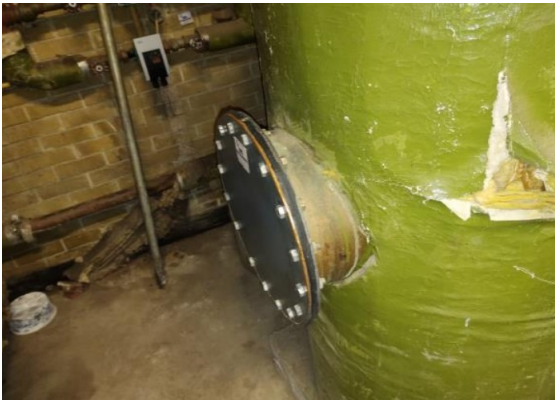
**Item 40 Ref: 21-30813-6**

The seal to water tanks in Area 1/Boiler Room does not contain asbestos.

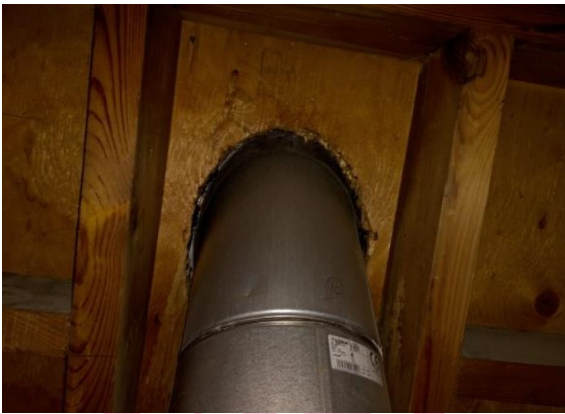
**Item 41 Ref: 21-30813-7**

The ceiling flue penetration Area 1/Boiler Room does not contain asbestos.

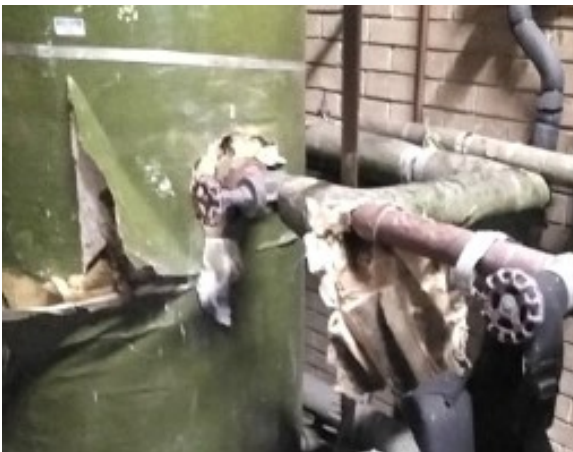
**Item 42 Ref: NG001278**

The pipe joints in Area 1/Boiler Room does not contain asbestos.

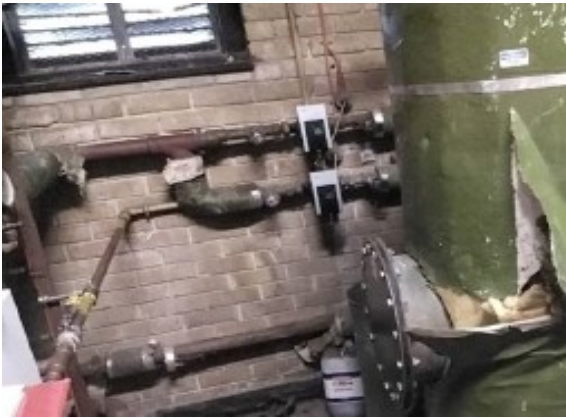
**Item 43 Ref: NG001279**

The tank to blanking plate in Area 1/Boiler Room does not contain asbestos.

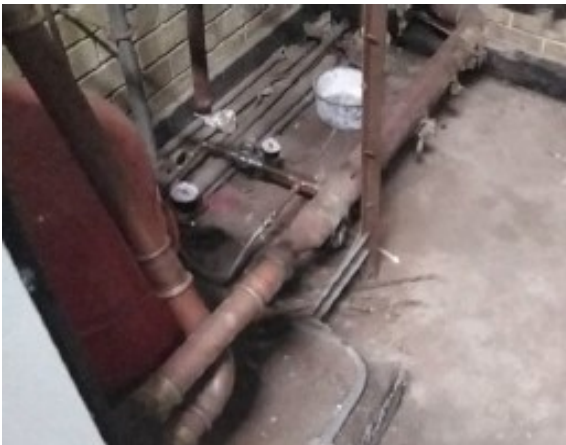
**Item 44 Ref: NG001280**

The debris to floor in Area 1/Boiler Room does not contain asbestos.

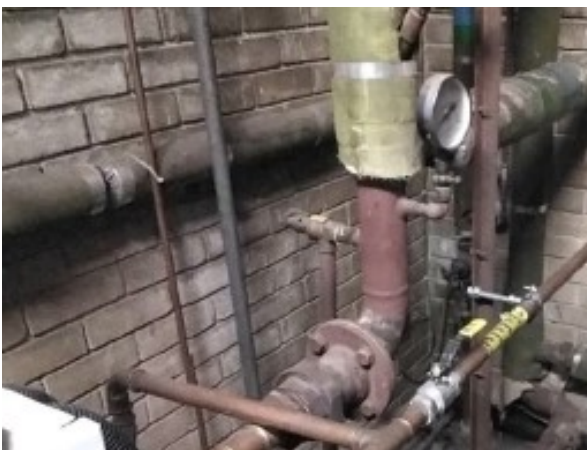
**Item 45 Ref: NG001281**

The pipework gasket to elbow joint off new vessel Area 1/Boiler Room does not contain asbestos.

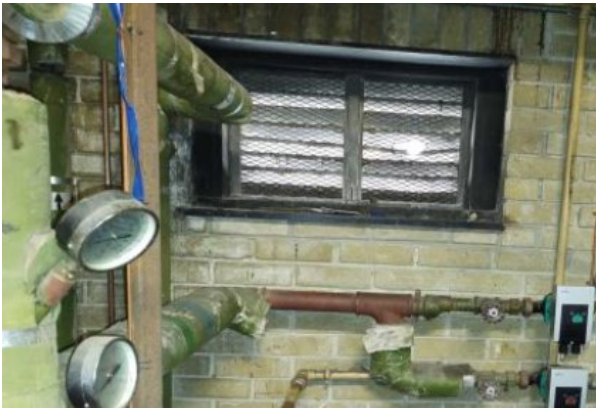
**Item 46 Ref: 23-63902-1**

The splatter to the walls in the Boiler Room does not contain asbestos.

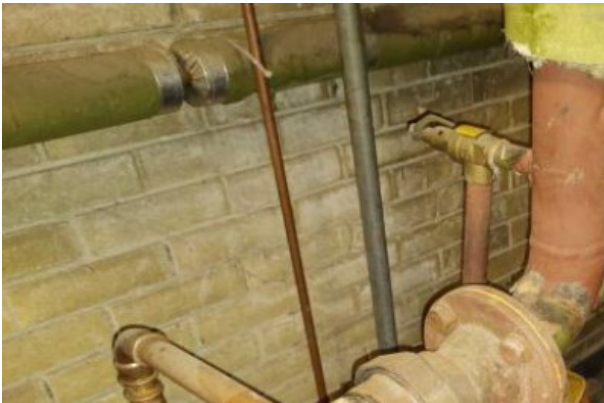
**Item 47 Ref: 23-6390202**

The flange gaskets to the boiler in the Boiler Room does not contain asbestos.
