ASBESTOS SURVEY REPORT FOR LEYBURN GROVE RECREATION GROUND, HOUGHTON LE SPRING

Asbestos Register for

LEYBURN GROVE RECREATION GROUND

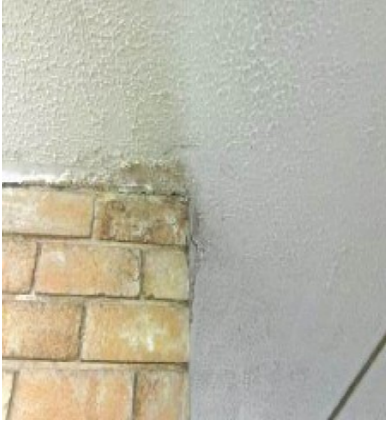
Item 1 Ref: EA003009

The textured coating to the ceiling in the Corridor (Room 1) does not contain asbestos.

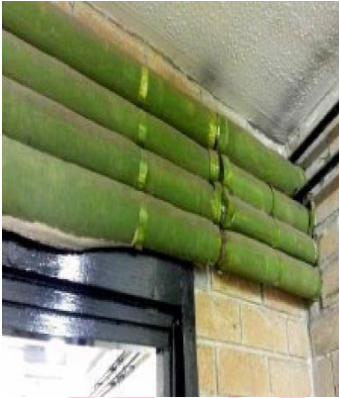
Item 2 - Ref: EA003010

The lagging to the pipework in the corridor (Room 1) does not contain asbestos.

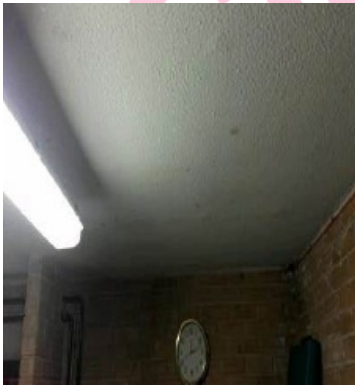
Item 3 - Ref: EA003009

The textured coating to the ceiling in the staff room (Room 2) do not contain asbestos.

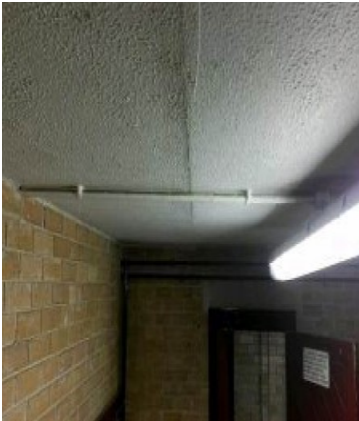
Item 4 - Ref: EA003009

The textured coating to the ceiling in changing room 4 (Room 3) was accessed and no suspect materials were

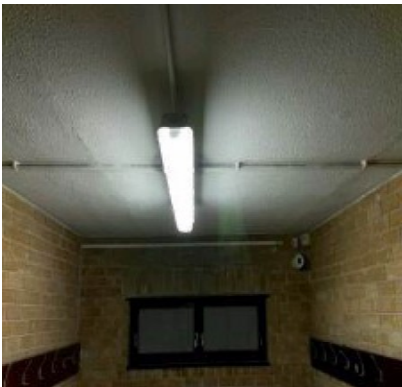
Item 5 - Ref: EA003009

The textured coating to the ceiling in changing room 5 (Room 4) does not contain asbestos.

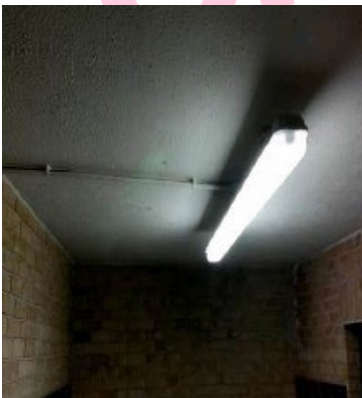
Item 6 - Ref: EA003009

The textured coating to the ceiling in changing room 6 (Room 5) does not contain asbestos.

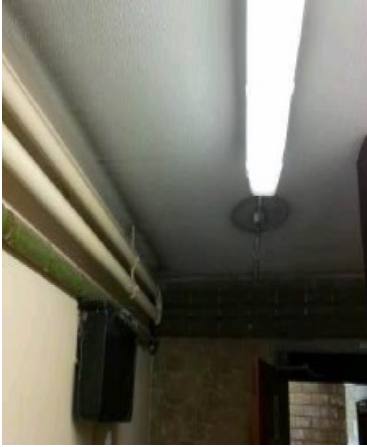
Item 7 - Ref: EA003009

The textured coating to the ceiling in the Male WC (Room 6) does not contain asbestos.

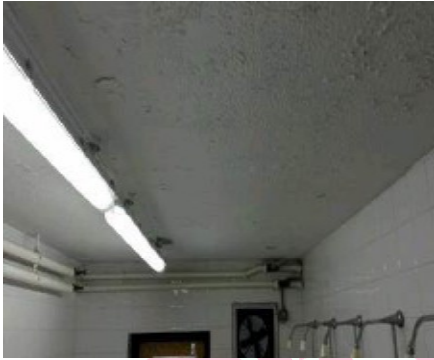
Item 8 - Ref: EA003009

The textured coating to the ceiling in the shower room (Room 7) does not contain asbestos.

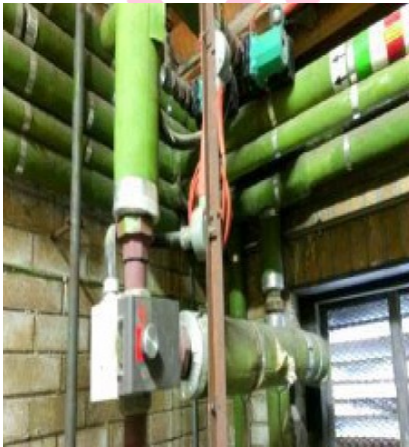
Item 9 - Ref: EA003011

The pipe lagging to the boiler room (Room 8) does not contain asbestos.

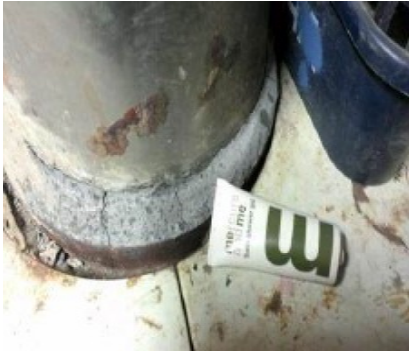
Item 10 - Ref: EA003012

The putty around the metal flue at the boiler top to the Boiler Room (Room 8) does not contain asbestos.

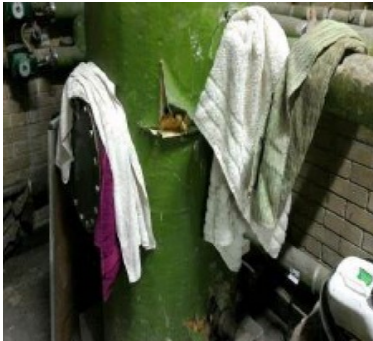
Item 11 - Ref: EA003013

The lagging to the calorifiers in the boiler room (Room 8) do not contain asbestos.

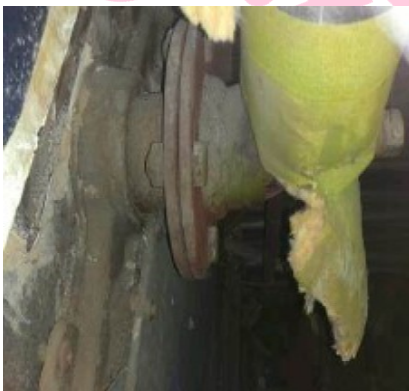
Item 12 – 21-30813-3

The gaskets to the pipework in the boiler room (Room 8) does not contain asbestos.

No Risk – resampled, report J278817 confirms this

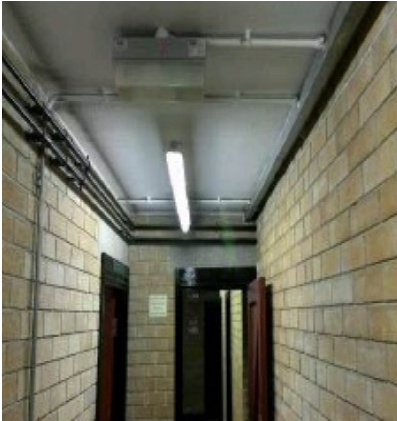
Item 13 - Ref: EA003015

The textured coating to the ceiling in the small corridor (Room 9) does not contain asbestos.

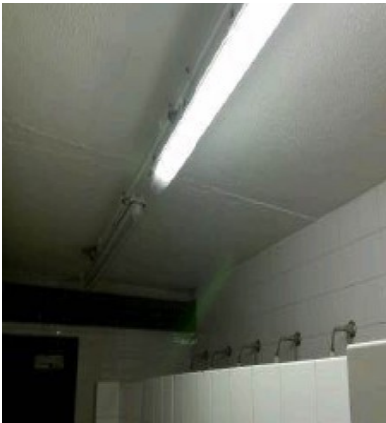
Item 14 - As EA003015

The textured coating to the ceiling in the showers (Room 10) does not contain asbestos.

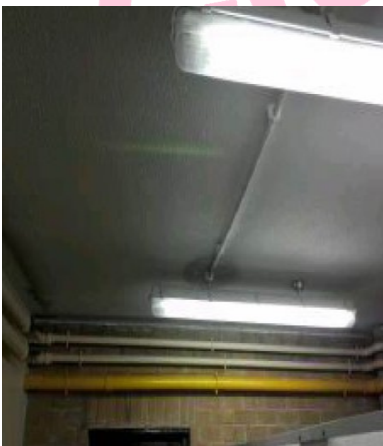
Item 15 - As EA003015

The textured coating to the ceiling in the Female WC (Room 11) does not contain asbestos.

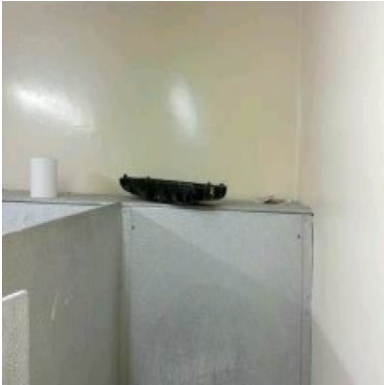
Item 16 - Ref: EA003016

The cistern lid on the boxing in the female WC (Room 11) does not contain asbestos.

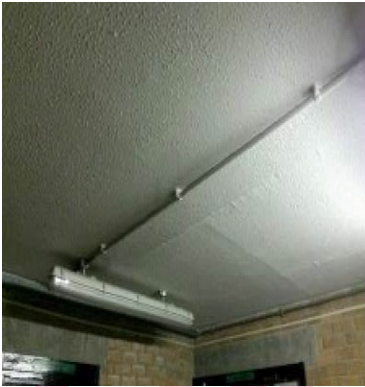
Item 17 - As EA003015

The textured coating to the ceiling in the lobby (Room 12) does not contain asbestos.

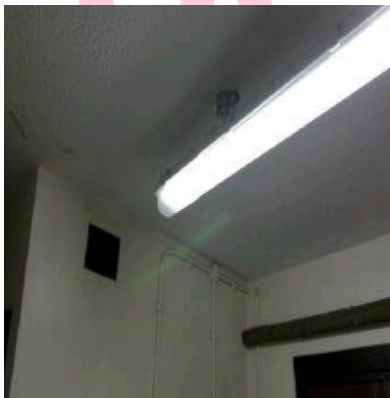
Item 18 - As EA003015

The textured coating to the ceiling in the kitchen (Room 13) does not contain asbestos.

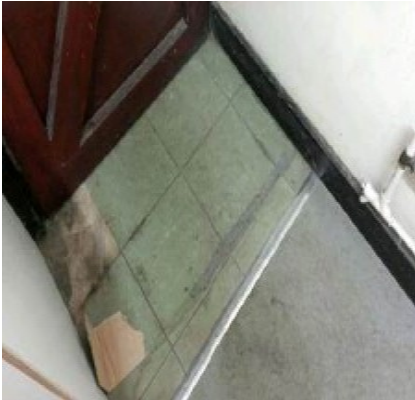
Item 19 - Ref: EA003017

The green floor tiles to the kitchen (Room 13) do not contain asbestos.

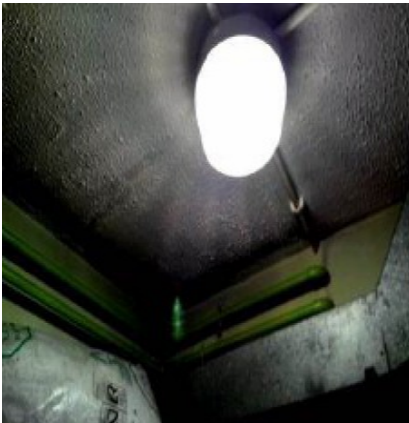
Item 20 - As EA003015

The textured coating to the ceiling in the gas meter cupboard (Room 14) does not contain asbestos.

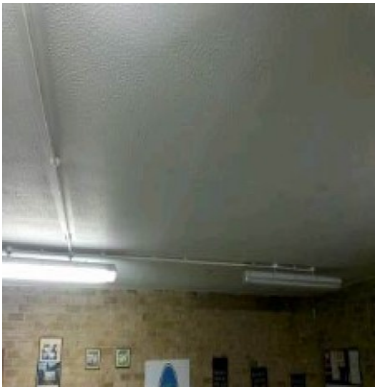
Item 22 - As EA003015

The textured coating to the ceiling in the team room (Room 15) does not contain asbestos.

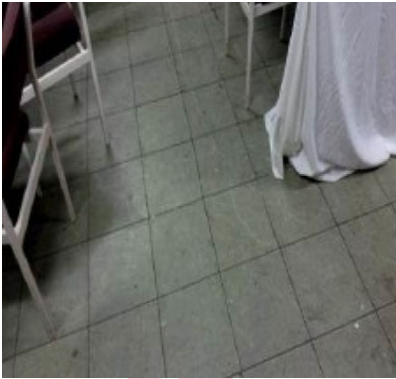
Item 23 - As EA003017

The green floor tiles to the tea room (Room 15) do not contain asbestos.

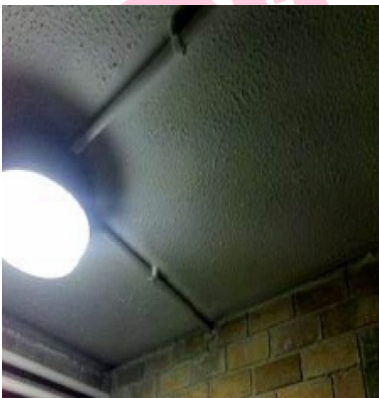
Item 24 - As EA003015

The textured coating to the ceiling in the disabled WC (Room 16) does not contain asbestos.

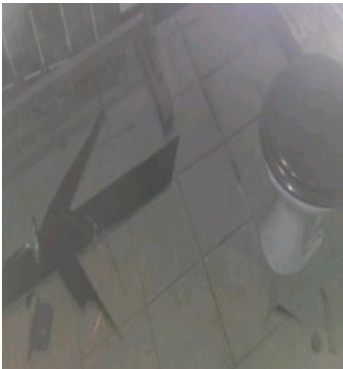
Item 25 - As EA003017

The green floor tiles to the Disabled WC (Room 16) do not contain asbestos.

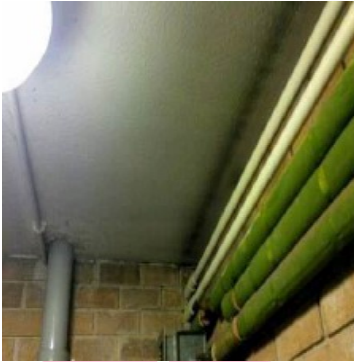
Item 26 - As EA003015

The textured coating to the ceiling in the WC (Room 17) does not contain asbestos.

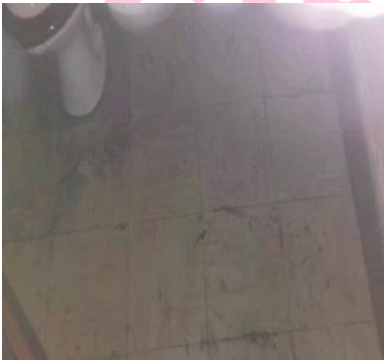
Item 27 - As EA003017

The green floor tiles to the WC (Room 17) do not contain asbestos.

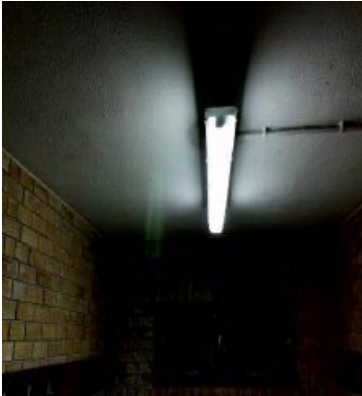
Item 28 – Ref: EA003018

The textured coating to the ceiling in changing room 1 (Room 18) does not contain asbestos.

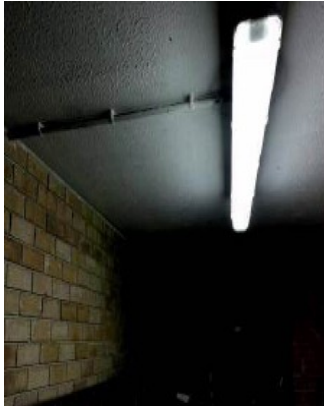
Item 29 - As EA003018

The textured coating to the ceiling in changing room 2 (Room 19) does not contain asbestos.

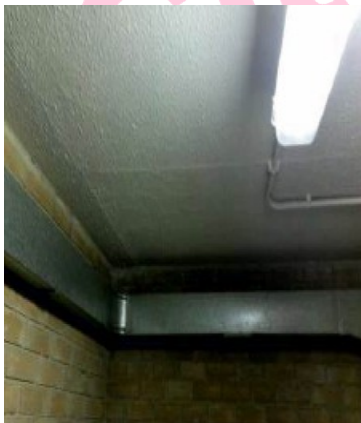
Item 30 - As EA003018

The textured coating to the ceiling in the officials Room (Room 20) does not contain asbestos.

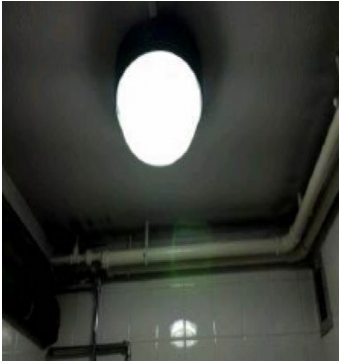
Item 31 – Ref: EA003018

The textured coating to the ceiling in the officials shower (Room 21) does not contain asbestos.

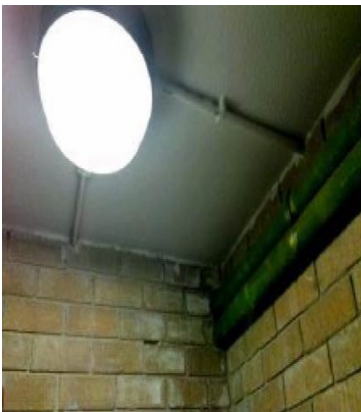
Item 32 - As EA003015

The textured coating to the ceiling in the officials WC (Room 22) does not contain asbestos.

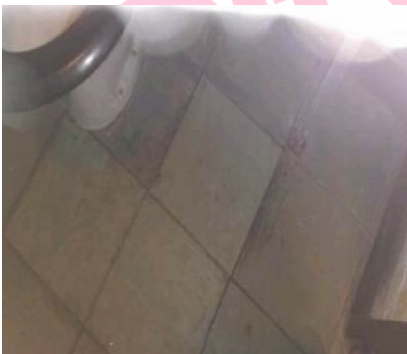
Item 33 - As EA003017

The green floor tiles to the officials WC (Room 22) do not contain asbestos.

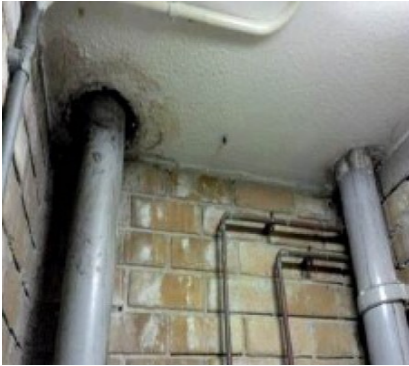
Item 34 – Ref: EA003018

The textured coating to the ceiling in the store (Room 23) does not contain asbestos.

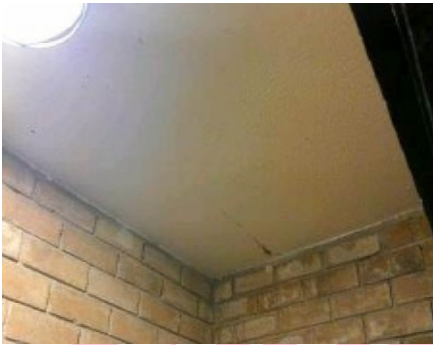
Item 35 - As EA003018

The textured coating to the ceiling in the store (Room 24) does not contain asbestos.

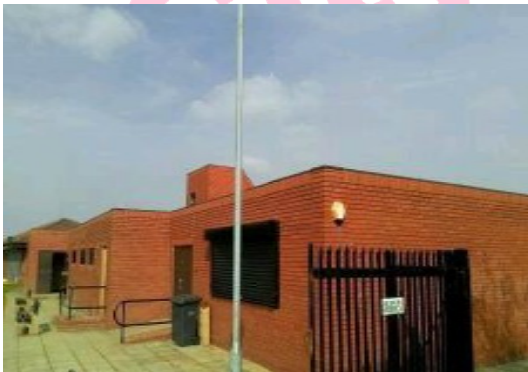
Item 36 – Presumed

The bitumen to the flat roof (External) was presumed to contain asbestos.

Any change in its appearance should be noted and passed to Property Services.

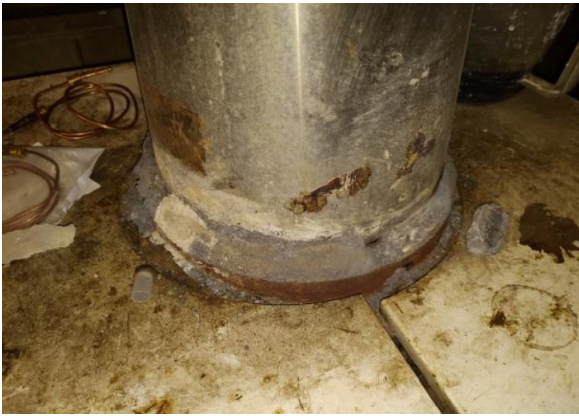
Item 37 Ref: 21-30813-1

The rope seal to free standing boiler flue in Area 1/Boiler Room does not contain asbestos.

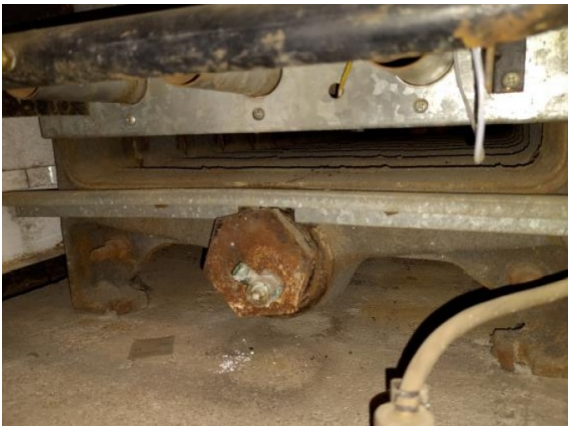
Item 38 Ref: 21-30813-4

The gasket inside free standing boiler in Area 1/Boiler Room does not contain asbestos.

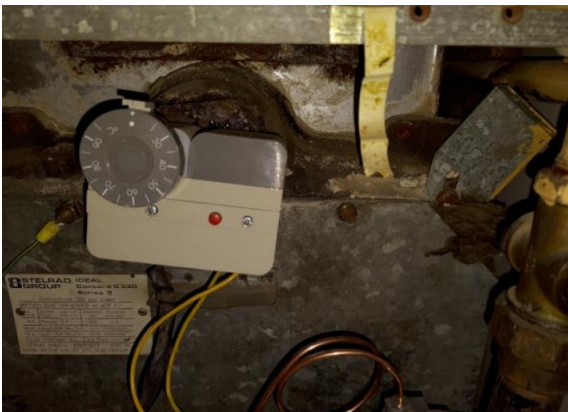
Item 39 Ref: 21-30813-5

The putty inside free standing boiler in Area 1/Boiler Room does not contain asbestos.

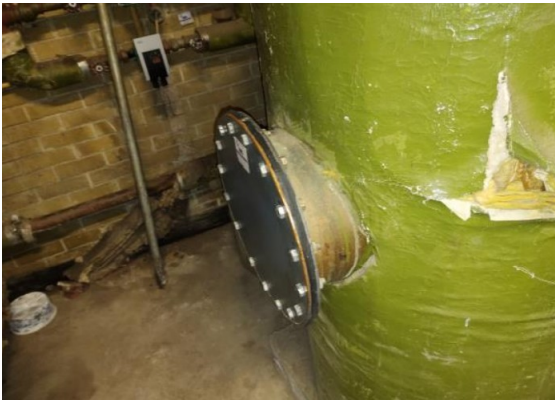
Item 40 Ref: 21-30813-6

The seal to water tanks in Area 1/Boiler Room does not contain asbestos.

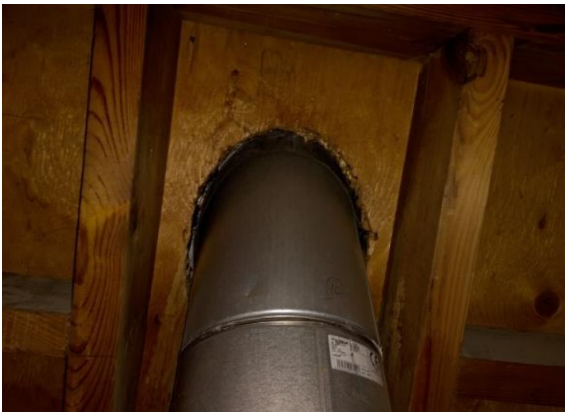
Item 41 Ref: 21-30813-7

The ceiling flue penetration Area 1/Boiler Room does not contain asbestos.

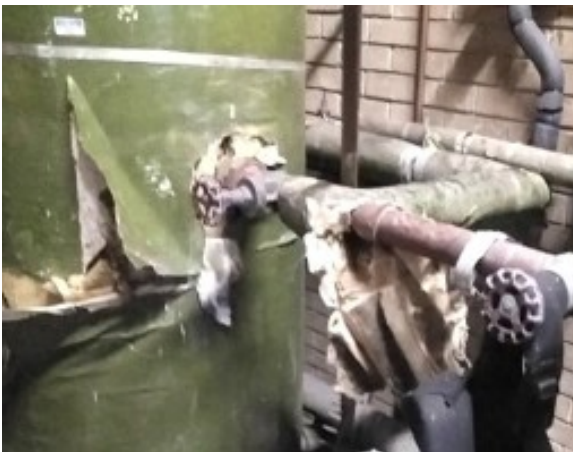
Item 42 Ref: NG001278

The pipe joints in Area 1/Boiler Room does not contain asbestos.

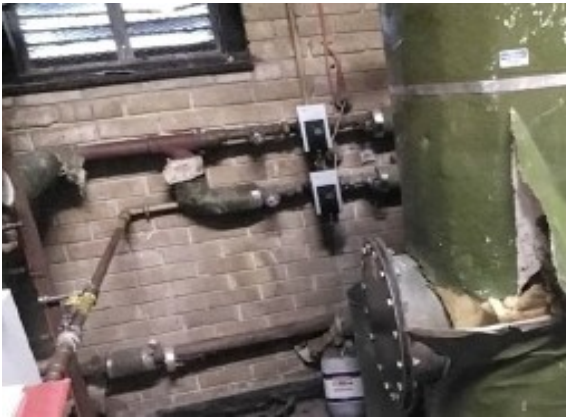
Item 43 Ref: NG001279

The tank to blanking plate in Area 1/Boiler Room does not contain asbestos.

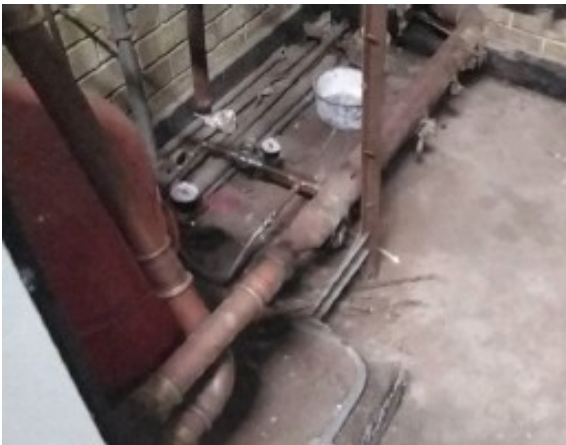
Item 44 Ref: NG001280

The debris to floor in Area 1/Boiler Room does not contain asbestos.

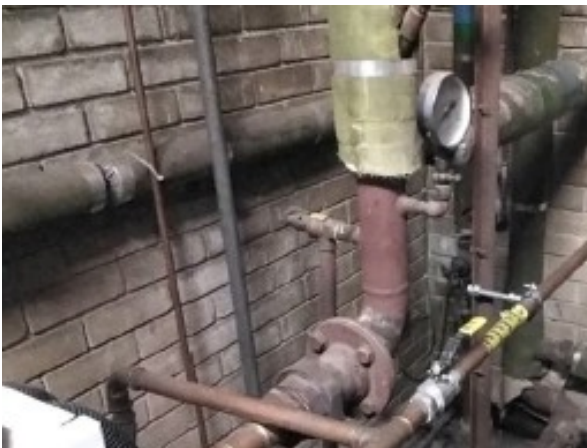
Item 45 Ref: NG001281

The pipework gasket to elbow joint off new vessel Area 1/Boiler Room does not contain asbestos.

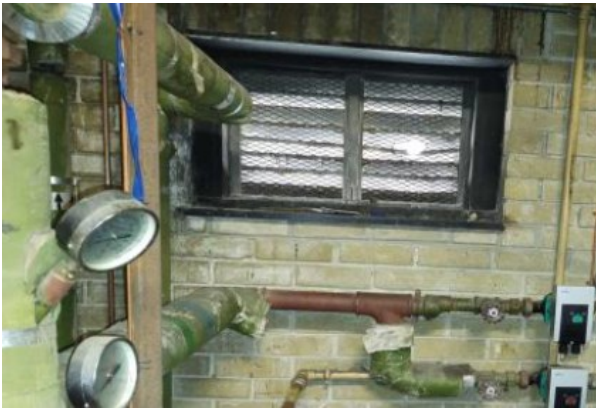
Item 46 Ref: 23-63902-1

The splatter to the walls in the Boiler Room does not contain asbestos.

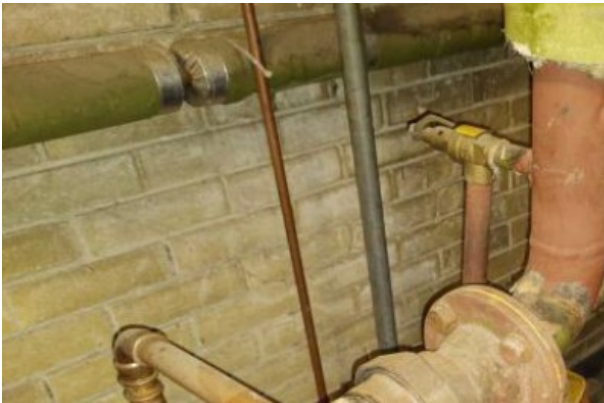
Item 47 Ref: 23-6390202

The flange gaskets to the boiler in the Boiler Room does not contain asbestos.
