ASBESTOS SURVEY REPORT FOR DOXFORD PARK, SUNDERLAND

Asbestos Register for

Doxford Park, Sunderland

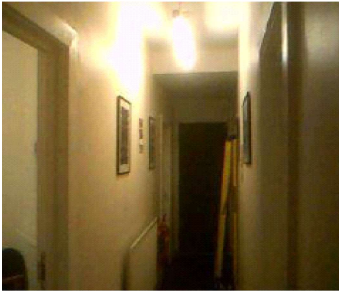
Room 1 (Hall) was accessed, and no suspect materials were found.

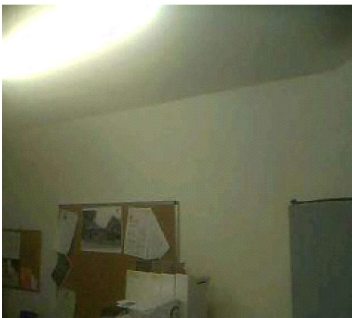
Room 2 (Main Office) was accessed, and no suspect materials were found.

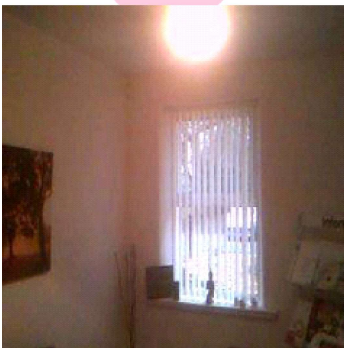
Room 3 (Room 1 - Kerry) was accessed and no suspect materials were found.

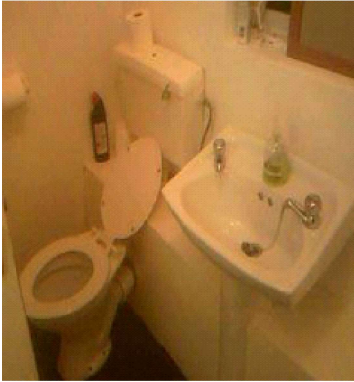
Room 5 (Male WC) was accessed, and no suspect materials were found.

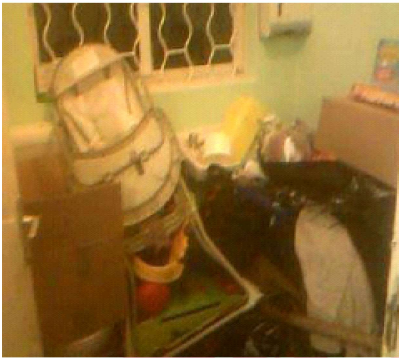
Room 6 (Female WC) was accessed, and no suspect materials were found.

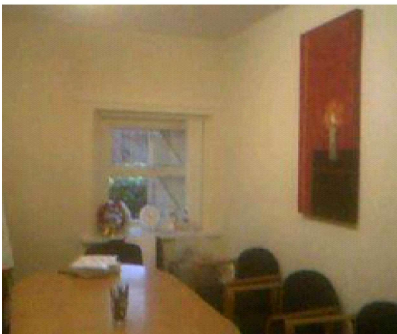
Room 7 (Room 2) was accessed, and no suspect materials were found.

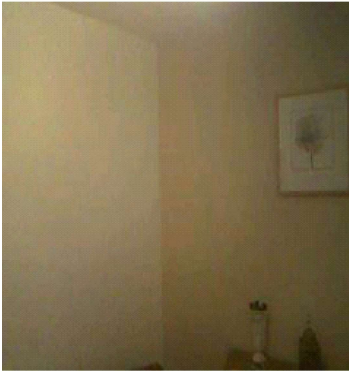
Room 8 (Room 3 - Elaine) was accessed and no suspect materials were found.

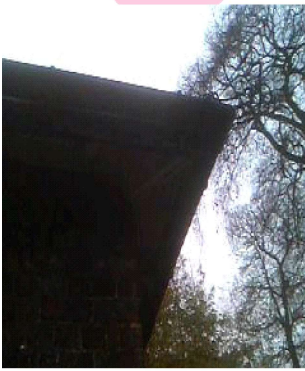
The external to the cottage was accessed and no suspect materials were found.

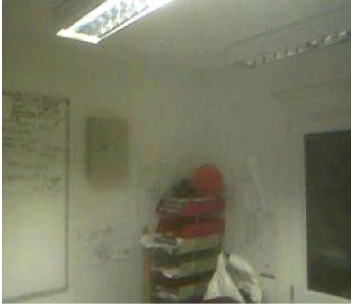
Room 1 (Office) was accessed, and no suspect materials were found.

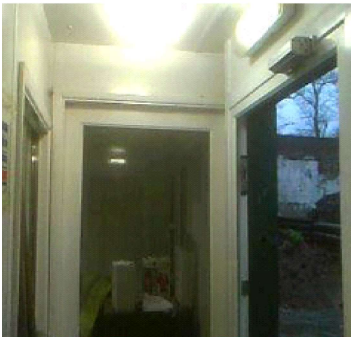
Room 2 (Lobby) was accessed, and no suspect materials were found.

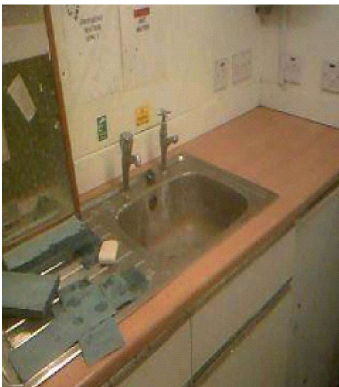
Item 1 Ref: CB008807

CB008807 – Sink Pad (Room 3) (Item 1) - No Risk

The sink pad to the ink in the kitchen (Room 3) does not contain asbestos.

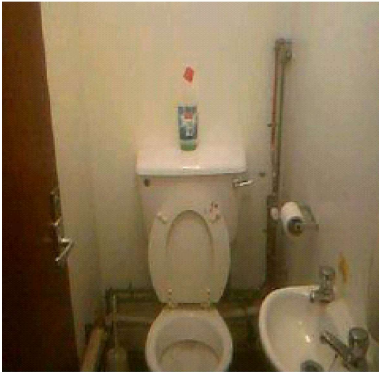
Room 4 (WC) was accessed, and no suspect materials were found.

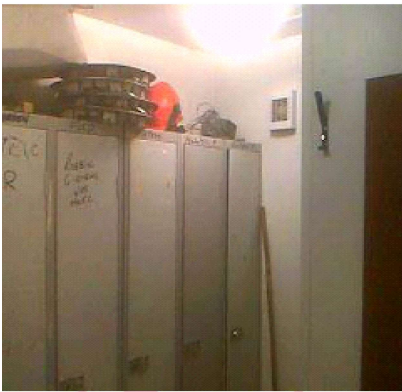
Room 5 (Locker Room) was accessed, and no suspect materials were found.

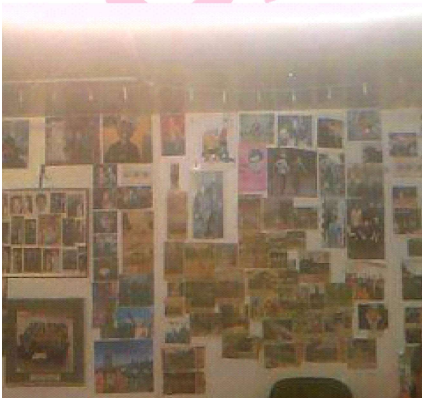
Room 6 (Bait Room) was accessed, and no suspect materials were found.

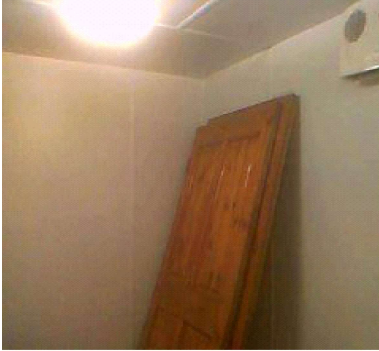
Room 7 (Store) was accessed, and no suspect materials were found.

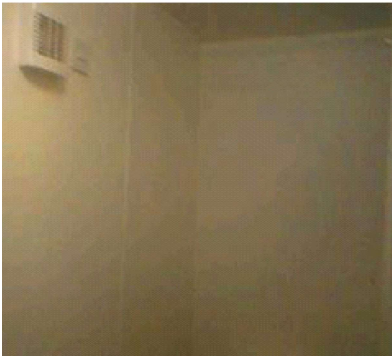
Room 8 (WC) on was accessed and no suspect materials were found.

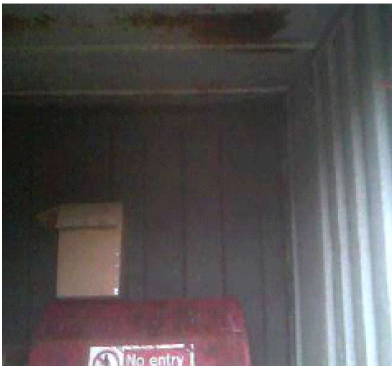
Room 9 (Store) was accessed, and no suspect materials were found.

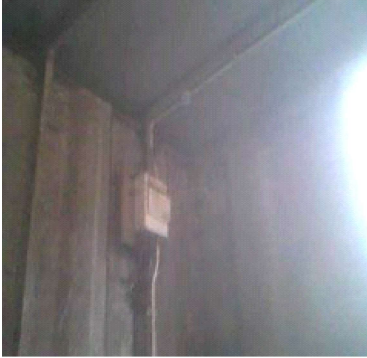
Room 12 (Vehicle store 1) was accessed, and no suspect materials were found.

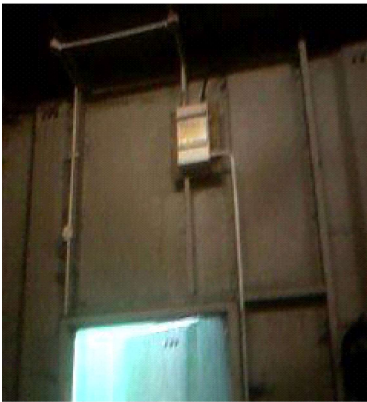
Room 13 (vehicle store 2) was accessed, and no suspect materials were found.

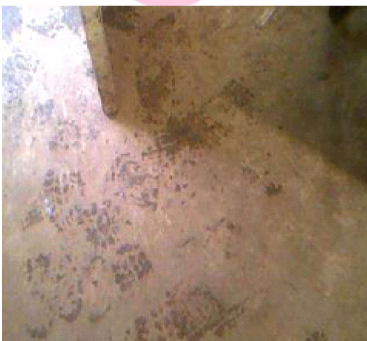
Item 2: Ref: CB008808

CB008808 – Lino (Room 14) (Item 2) – No Risk

The lino to the store (Room 14) does not contain asbestos.
