ASBESTOS SURVEY REPORT FOR 16 NILE STREET, SUNDERLAND, SR1 1EY.

**16 Nile Street, Sunderland, SR1 1EY**

**Date: 05 December 2025**

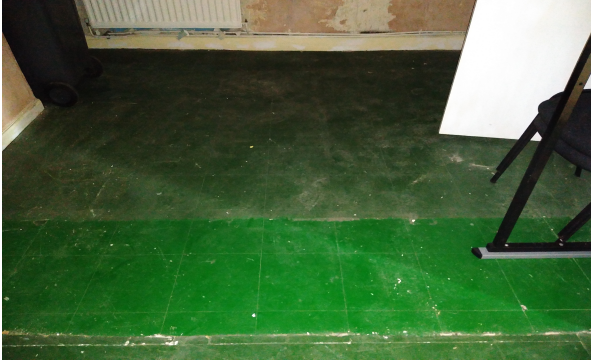
### **Item 1 Ref: 418624-1**

The floor tile with bitumen adhesive in the Office (Rm 0/002) does not contain asbestos.

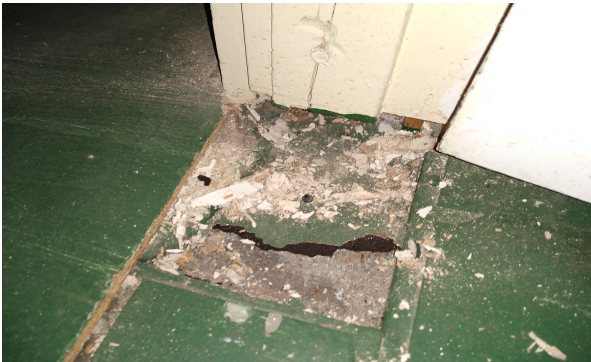
### **Item 2 Ref: 418624-2**

The subfloor covering in the Office (Rm 0/002) does not contain asbestos.

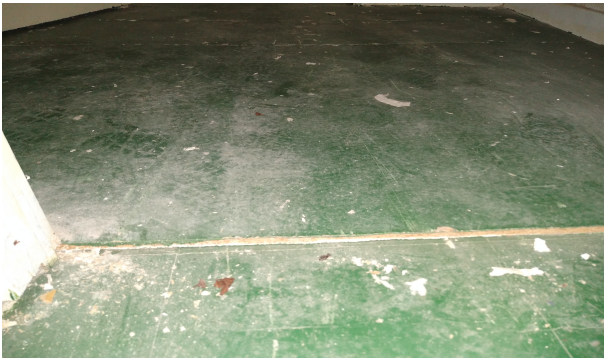
### **Item 3 Ref: As 418624-1**

The floor tile with bitumen adhesive in the Office Lobby (Rm 0/003) does not contain asbestos.

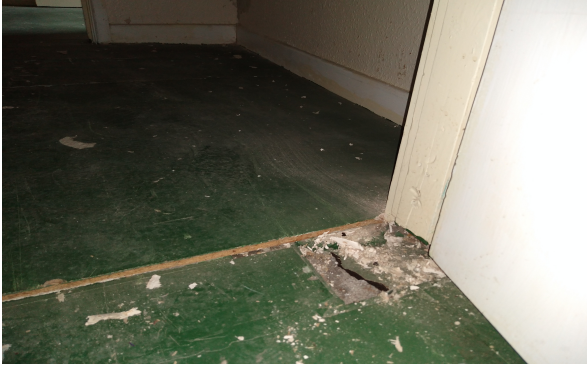
### **Item 4 Ref: As 418624-2**

The subfloor covering in the Office Lobby (Rm 0/003) does not contain asbestos.

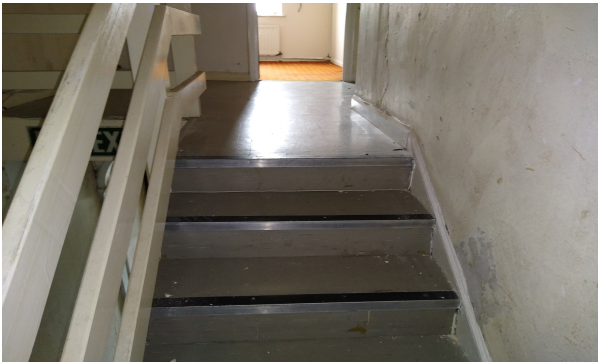
### **Item 5 Ref: 418624-3**

The stairs and floor covering in the Stairwell & Landing (Rm 1/001) does not contain asbestos.

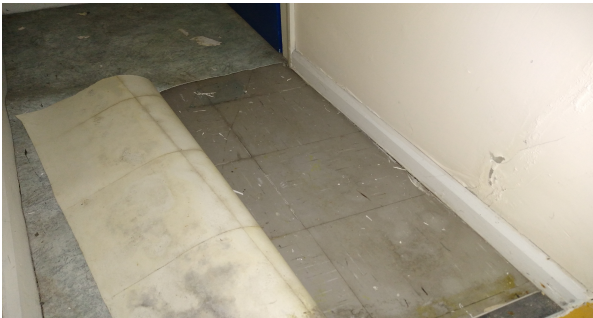
### **Item 6 Ref: As 418624-3**

The floor covering to the corridor (Rm 1/005) does not contain asbestos.

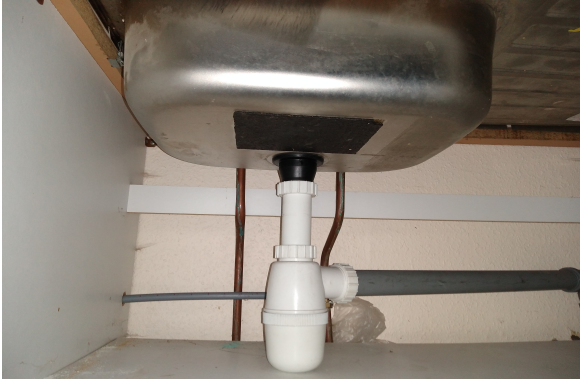
**Item 7 Ref: 418624-4**

The sink pad in the kitchen (Rm 1/008) does not contain asbestos.

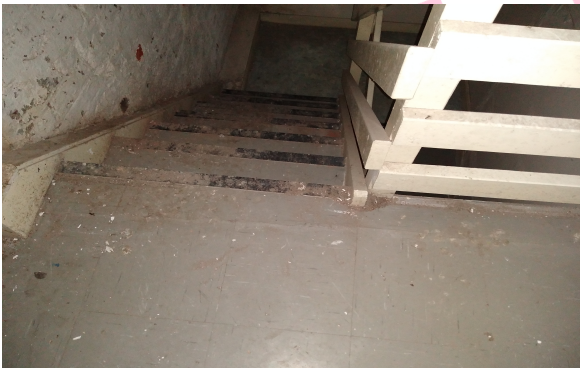
**Item 8 Ref: As 418624-3**

The floor and stair covering in the Rear Stairwell & Landing (Rm 1/009) does not contain asbestos.

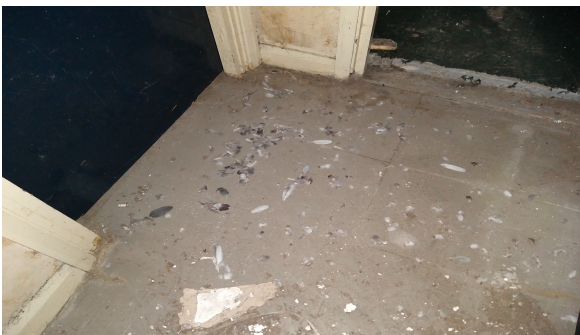
**Item 9 Ref: As 418624-3**

The floor covering in the WC Lobby (Rm 1/010) does not contain asbestos.

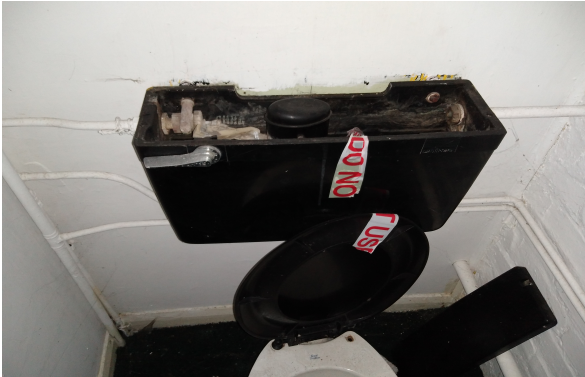
### **Item 10 Ref: 418624-5**

- (Item 9) Ref: As 418624-3 – Floor covering (1/010 WC Corridor) – No Risk
- (Item 10) Ref: 418624-5 – Toilet cistern (1/011 Female WC) – Very Low Risk
- (Item 11) Ref: As 418624-3 – Floor covering (1/012 Male WC) – No Risk

The toilet cistern in the Female WC (Rm 1/011) contains asbestos.

Any change in its appearance should be recorded and reported to Property Services.

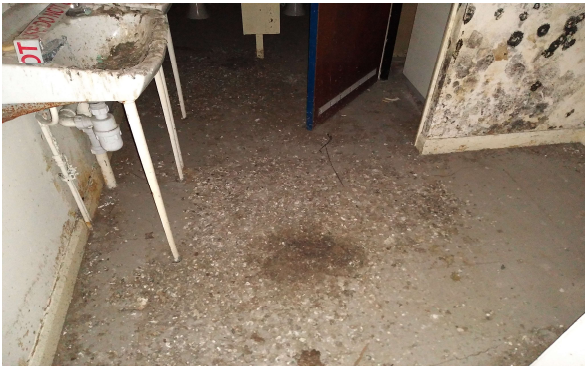
### **Item 11 Ref: As 418624-3**

The floor covering in the Male WC (Rm 1/012) does not contain asbestos.

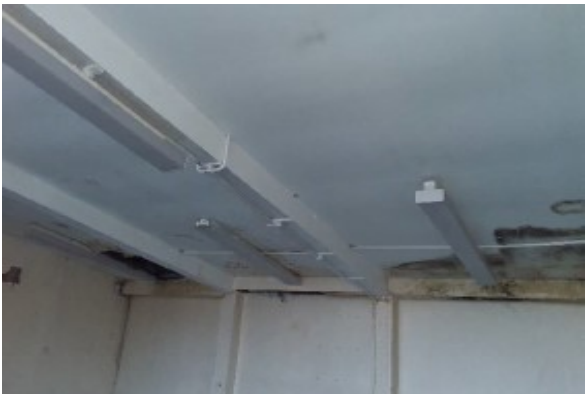
### **Item 12 Ref: IJ006245**

The plasterboard ceiling in the Office (1/01) does not contain asbestos.

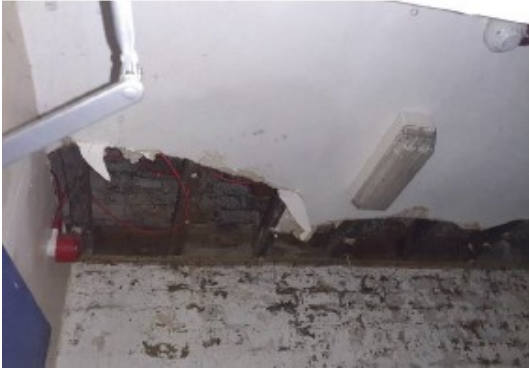
**Item 13 Ref: As IJ006245**

The plasterboard ceiling on the Stairs (1/02) does not contain asbestos.
