ASBESTOS SURVEY REPORT FOR HOUGHTON LE SPRING CEMETERY LODGE, HOUGHTON LE SPRING

Asbestos Register for Houghton Cemetery Lodge, Houghton

Date: 30 September 2025

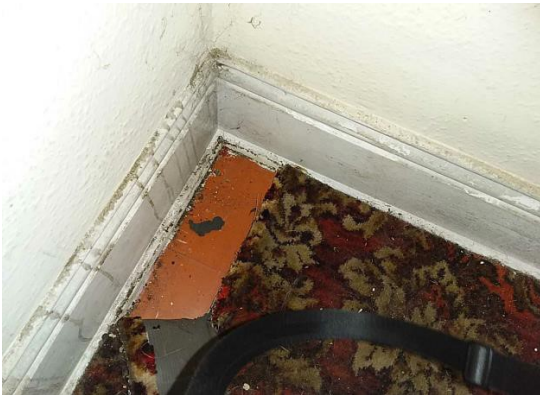
Item 1 Ref: 21-35406-1

The floor beneath carpet (Tiles & Adhesive) (Lodge - Room/Area: 1 - Front Entrance) does not contain asbestos.

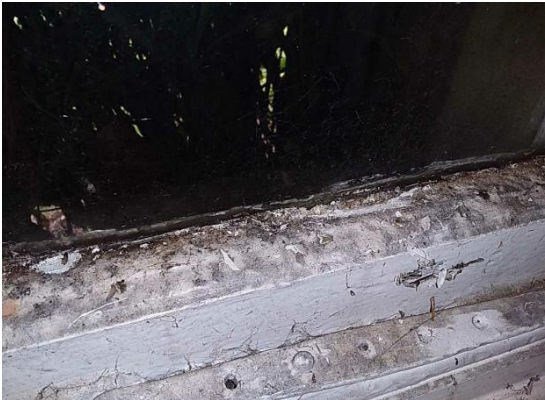
Item 2 Ref: 21-35406-2

The putty around windows (Lodge - Room/Area: 1 Front Entrance) does not contain asbestos.

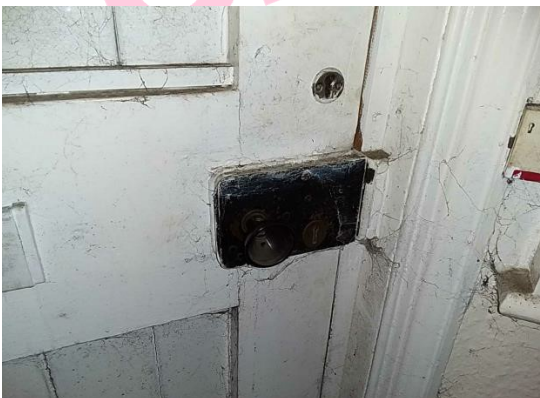
Item 3 Ref: 21-35406-3

The door handle (Composite) (Lodge - Room/Area: 1 Front Entrance) does not contain asbestos.

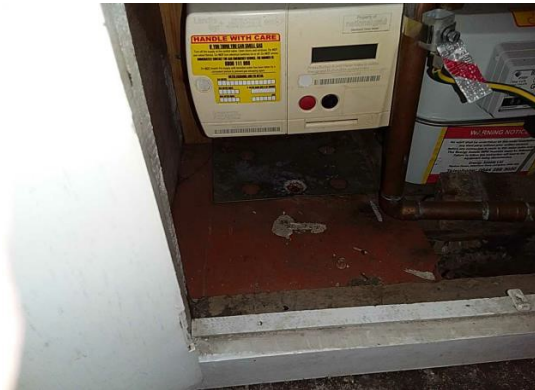
Item 4 Ref: 21-35406-1

The floor beneath carpet and gas meter (Tiles & Adhesive) (Lodge - Room/Area: 2 - Lounge 1 and cupboard) does not contain asbestos.

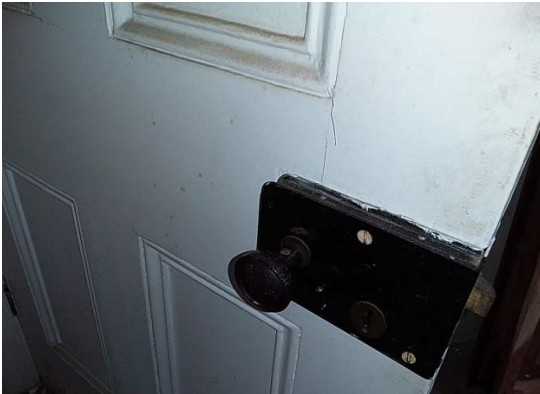
Item 5 Ref: 21-35406-4

The plastic composite door handles (Composite) (Lodge - Room/Area: 2 - Lounge 1 and cupboard) does not contain asbestos.

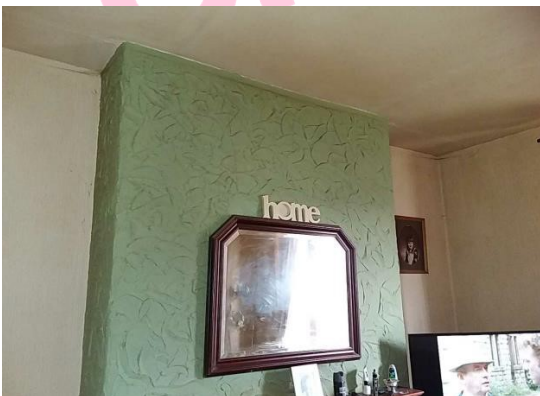
Item 6 Ref: 21-35406-5

The textured coating on chimney breast (Lodge - Room/Area: 4 - Lounge 2) does not contain asbestos.

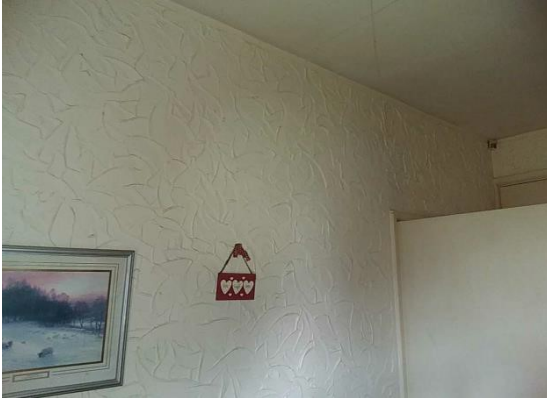
Item 7 Ref: 21-35406-5

The walls (Textured Coating) (Lodge - Room/Area: 5 - Dining Room and Cupboard) do not contain asbestos.

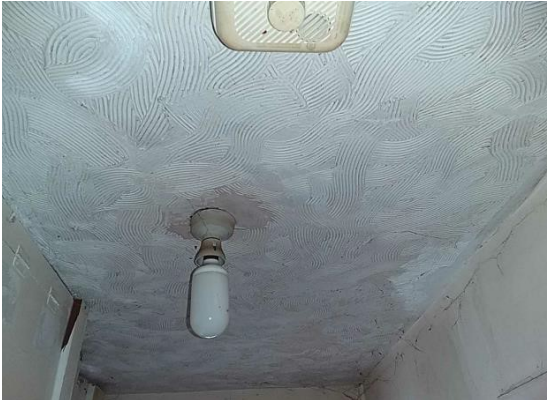
Item 8 Ref: 21-35406-6

- (Item 7) Ref: 21-35406-5 - Walls (Textured Coating) (Lodge - Room/Area: 5 - Dining Room and Cupboard) – No Risk
- (Item 8) Ref: 21-35406-6 - Ceiling (Textured Coating) (Lodge - Room/Area: 6 - Rear Entrance) – Very Low Risk

The ceiling (Textured Coating) (Lodge - Room/Area: 6 - Rear Entrance) contains asbestos.

Item 5	No asbestos	Is present		
Item 6	No asbestos	Is present		
Item 7	No asbestos	Is present		
Item 8	Ceiling (Lodge - Room/Area: 6 - Rear Entrance)	Very Low	12 monthly	07/07/2026

Any change in its appearance should be recorded and passed to Property Services.

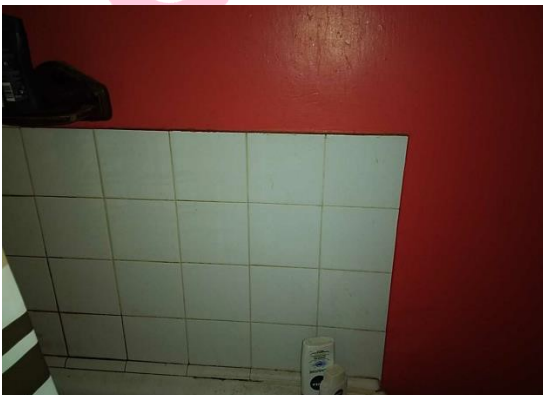
Item 9 Ref: 21-35406-7

The ceramic tiles adhesive (Lodge - Room/Area: 7 - Bathroom) does not contain asbestos.

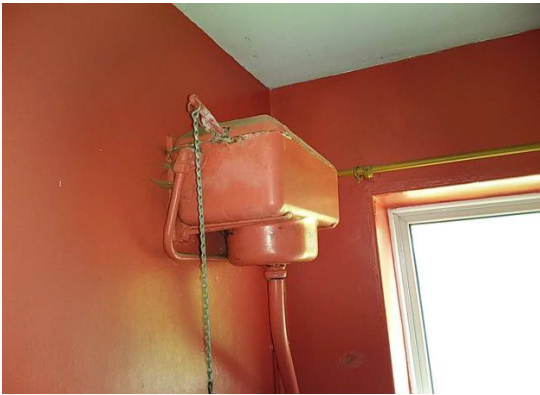
Item 10 Ref: 21-35406-8

- (Item 9) Ref: 21-35406-7 - Ceramic tiles adhesive (Lodge - Room/Area: 7 - Bathroom) – No Risk
- (Item 10) Ref: 21-35406-8 - Toilet cistern (Composite) (Lodge - Room/Area: 7 - Bathroom) – Very Low Risk

The toilet cistern (Composite)
(Lodge - Room/Area: 7 -
Bathroom) contains asbestos.

Any change in its appearance
should be recorded and
passed to Property Services.

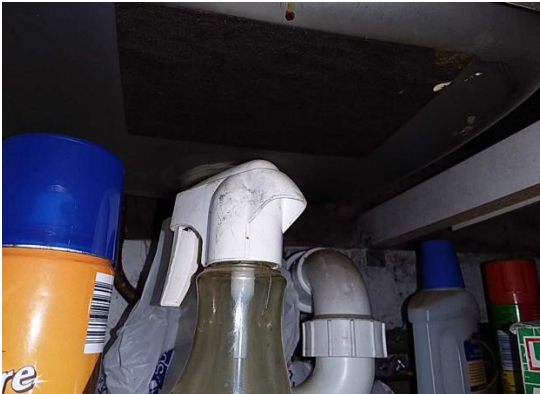
Item 11 Ref: 21-35406-10

The sink pad (Bitumen)
(Lodge - Room/Area: 8 -
Kitchen) does not contain
asbestos.

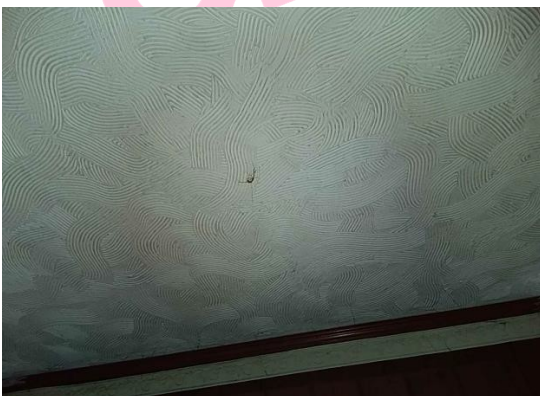
Item 12 Ref: 21-35406-7

- (Item 11) Ref: 21-35406-10 - Sink Pad (Bitumen) (Lodge - Room/Area: 8 - Kitchen) – No Risk
- (Item 12) Ref: 21-35406-6 - Ceiling (Textured Coating) (Lodge - Room/Area: 8 - Kitchen) – Very Low Risk

The ceiling (Textured Coating)
(Lodge - Room/Area: 8 -
Kitchen) contains asbestos.

Item 9	No asbestos	Is present		
Item 10	Toilet cistern (Lodge - Room/Area: 7 - Bathroom)	Very Low	12 monthly	07/07/2026
Item 11	No asbestos	Is present		
Item 12	Ceiling (Lodge - Room/Area: 8 - Kitchen)	Very Low	12 monthly	07/07/2026

Any change in its appearance
should be recorded and
passed to Property Services.

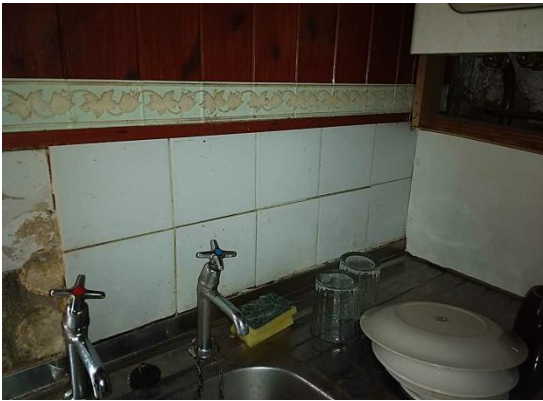
Item 13 Ref: 21-35406-9

The ceramic tiles (Tiles & Adhesive) (Lodge - Room/Area: 8 - Kitchen) do not contain asbestos.

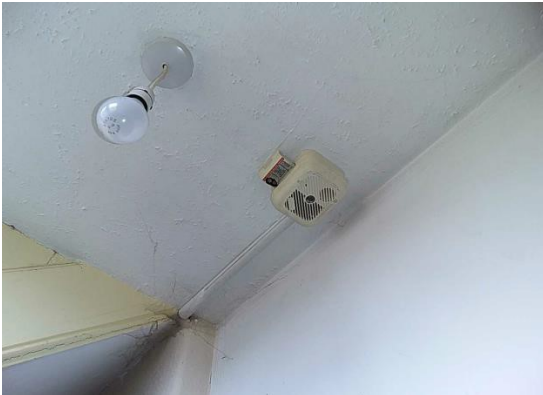
Item 14 Ref: 21-35406-11

The ceiling (Textured Coating) (Lodge - Room/Area: 9 - Landing and Stairs) does not contain asbestos.

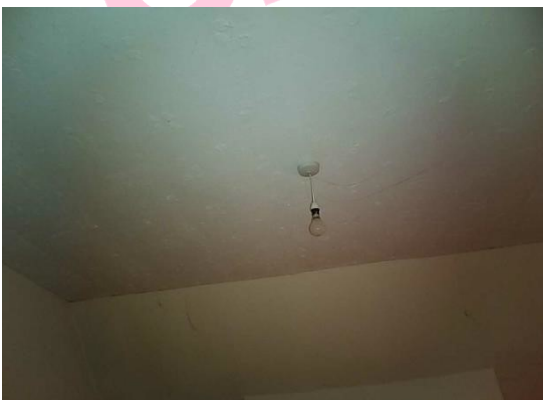
Item 15 Ref: 21-35406-11

The ceiling (Textured Coating) (Lodge - Room/Area: 10 - Bedroom 1) does not contain asbestos.

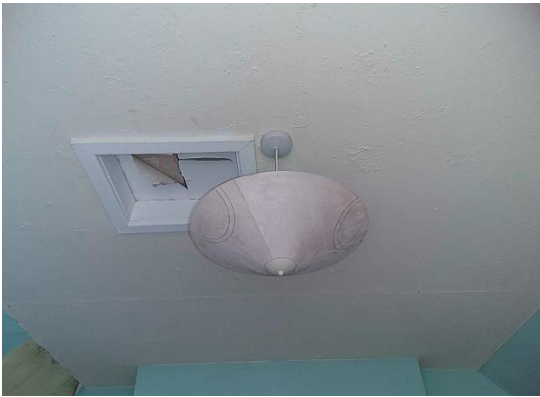
Item 16 Ref: 21-35406-9

The ceiling (Textured Coating) (Lodge - Room/Area: 11 - Bedroom 2) does not contain asbestos.

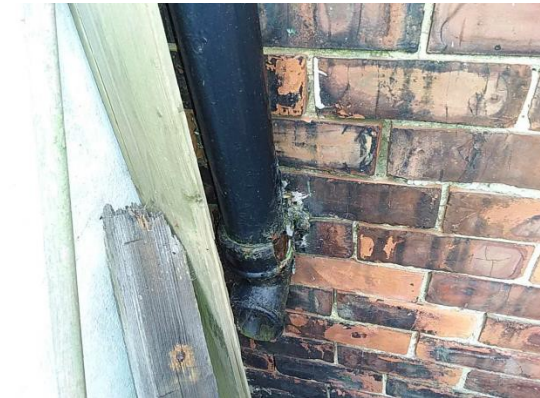
Item 17 Ref: 21-35406-12

The downpipes - joint capping (Cement) (Lodge - Room/Area: 15 - External) do not contain asbestos.

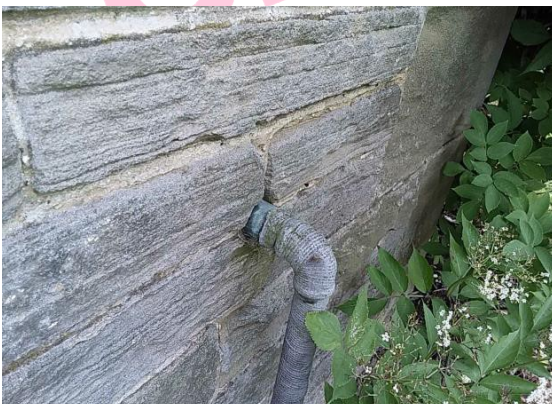
Item 18 Ref: 21-35406-13

The bitumen wrap on pipe (Lodge - Room/Area: 15 - External) does not contain asbestos.

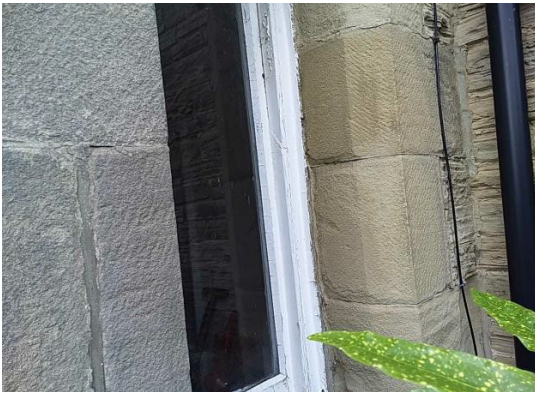
Item 19 Ref: 21-35406-14

The putty around windows (Lodge - Room/Area: 15 - External) does not contain asbestos.

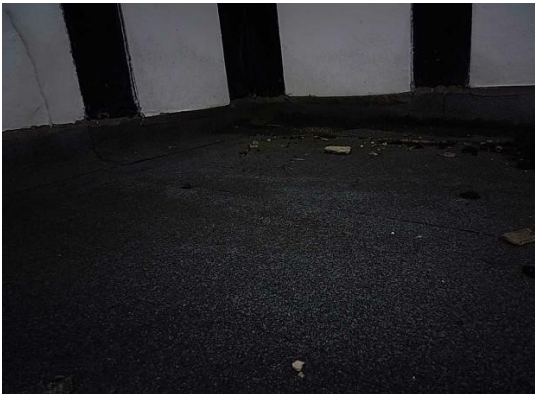
Item 20 Ref: 21-35406-15

The felt on front entrance roof (Bitumen) (Lodge - Room/Area: 15 - External) does not contain asbestos.

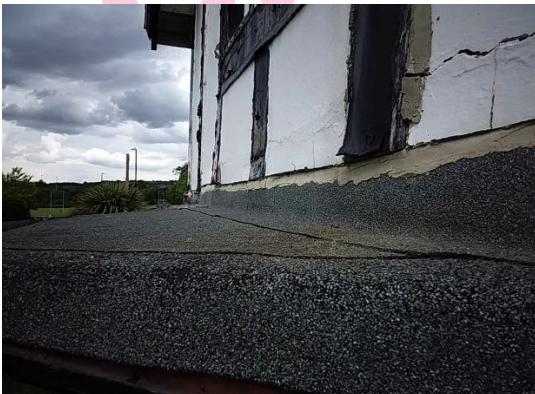
Item 21 Ref: 21-35406-16

The felt on bay window roof (Bitumen) (Lodge - Room/Area: 15 - External) does not contain asbestos.

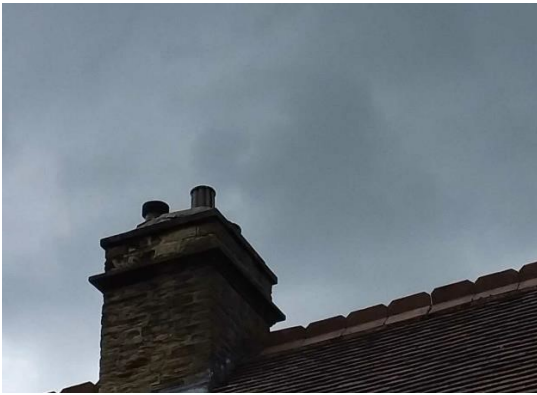
Item 22 Ref: PRESUMED

- (Item 21) Ref: 21-35406-16 - Felt on bay window roof (Bitumen) (Lodge - Room/Area: 15 - External) – No Risk
- (Item 22) PRESUMED – Flues on chimney stack (Cement) (Lodge - Room/Area: 15 - External) – Very Low Risk

The flues on chimney stack (Cement) (Lodge - Room/Area: 15 - External) are presumed to contain asbestos.

Item 18	No asbestos	Is present		
Item 19	No asbestos	Is present		
Item 20	No asbestos	Is present		
Item 21	No asbestos	Is present		
Item 22	PRESUMED – Flues on chimney stack (Lodge - Room/Area: 15 - External)	Very Low	12 monthly	07/07/2026

Any change in its appearance should be recorded and passed to Property Services.

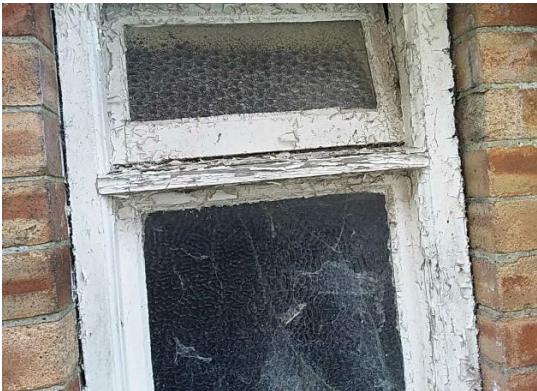
Item 23 Ref: 21-35406-18

The putty around window (Room/Area: 16 - Outhouse and Stores) does not contain asbestos.

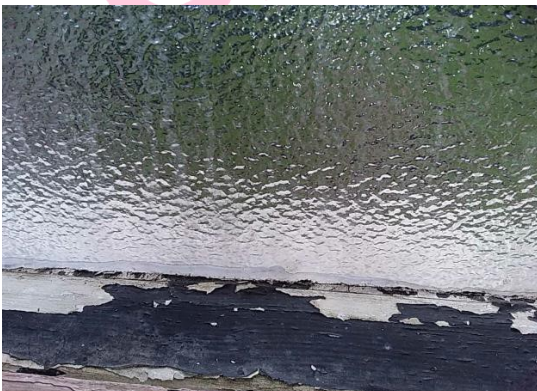
Item 24 Ref: 21-35406-19

The putty around window (Room/Area: 17 - Outside toilet) does not contain asbestos.

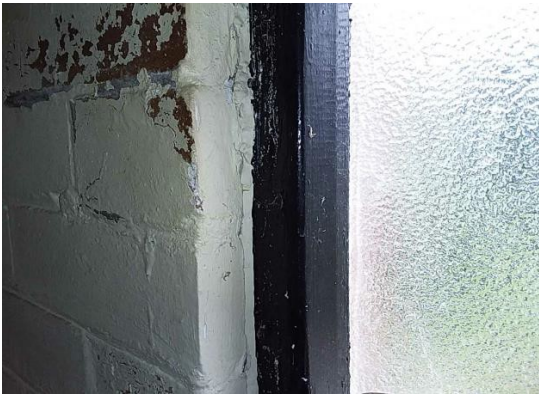
Item 25 Ref: 21-35406-20

The residual frame sealant around window (Putty) (Room/Area: 17 - Outside toilet) does not contain asbestos.

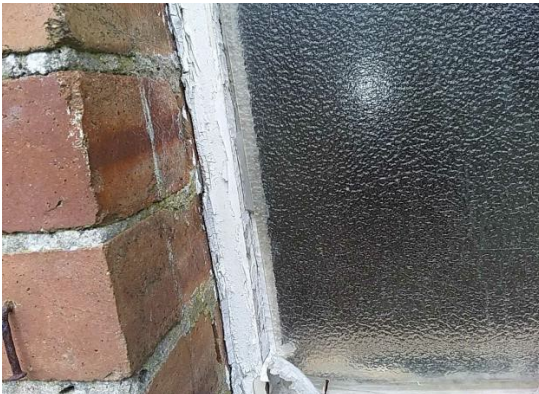
Item 26 Ref: 21-35406-21

The residual frame sealant around external part of window (Putty) (Room/Area: 17 - Outside toilet) does not contain asbestos.

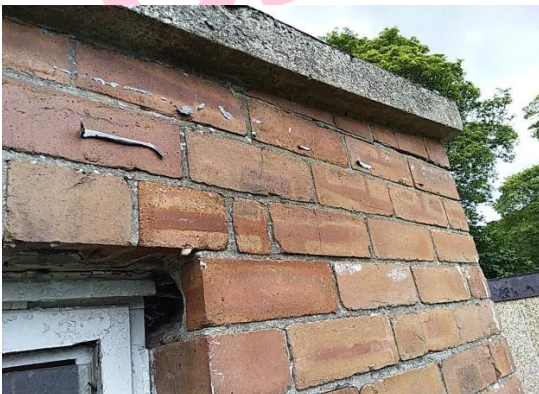
Item 27 Ref: 21-35406-22

- (Item 26) Ref: 21-35406-21 - Residual frame sealant around external part of window (Putty) (Room/Area: 17 - Outside toilet) – No Risk
- (Item 27) Ref: 21-35406-22 - Residual frame sealant on walls (Putty) (Room/Area: 17 - Outside toilet) – Very Low Risk

The residual frame sealant on walls (Putty) (Room/Area: 17 - Outside toilet) contains asbestos.

Item 25	No asbestos	Is present		
Item 26	No asbestos	Is present		
Item 27	Residual frame sealant on walls (Room/Area: 17 - Outside toilet)	Very Low	12 monthly	07/07/2025
Item 28	No asbestos	Is present		
Item 29	No asbestos	Is present		
Item 30	No asbestos	Is present		
Item 31	No asbestos	Is present		
Item 32	No asbestos	Is present

Any change in its appearance should be recorded and passed to Property Services.

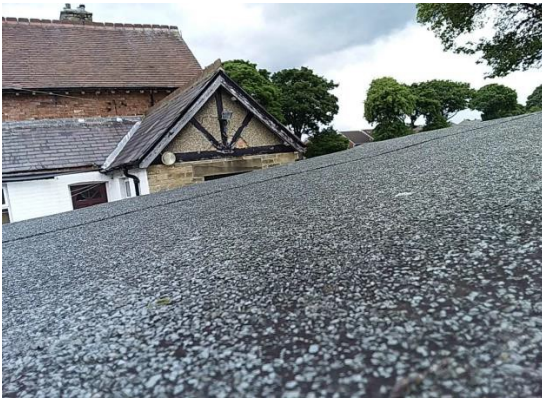
Item 28 Ref: 21-35406-23

The felt on roof (Bitumen)
(Room/Area: 17 - Outside
toilet) does not contain
asbestos.

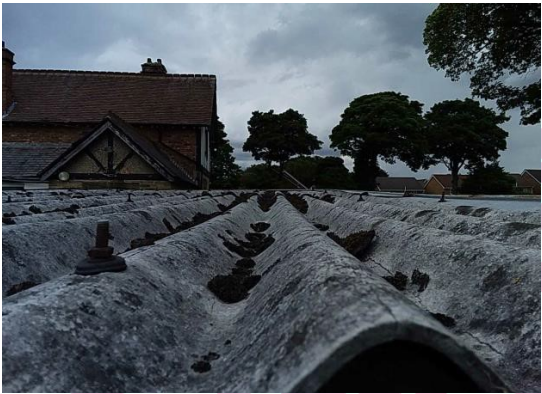
Item 29 Ref: 21-35406-24

The roof (Cement)
(Room/Area: 18 - Garage)
does not contain asbestos.

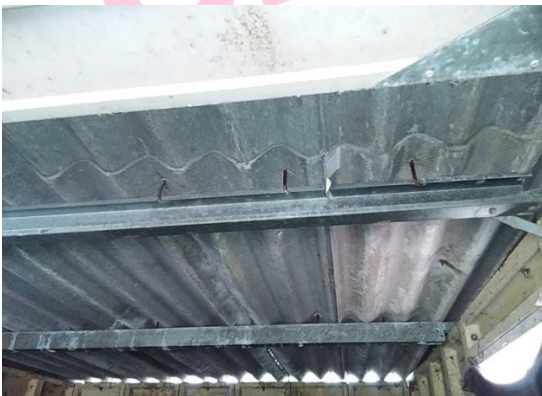
Item 30 Ref: 21-35406-22

The ceiling (Cement)
(Room/Area: 18 - Garage)
does not contain asbestos.

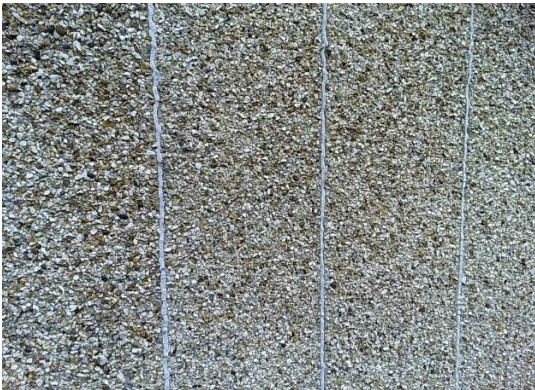
Item 31 Ref: 21-35406-25

The walls - residual frame sealant between concrete (Putty) (Room/Area: 18 - Garage) does not contain asbestos.

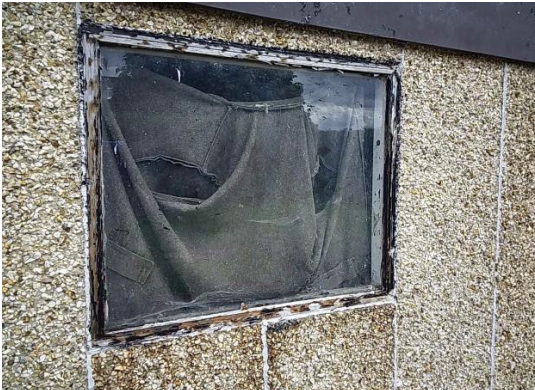
Item 32 Ref: 21-35406-25

The residual frame sealant around window (Putty) (Room/Area: 18 - Garage) does not contain asbestos.
