ASBESTOS SURVEY REPORT FOR CROWTREE LEISURE CENTRE,
CROWTREE ROAD, SUNDERLAND, SR1 3EL.

Asbestos Register for

Crowtree Leisure Centre, Crowtree Road, Sunderland

Date: 07 January 2026

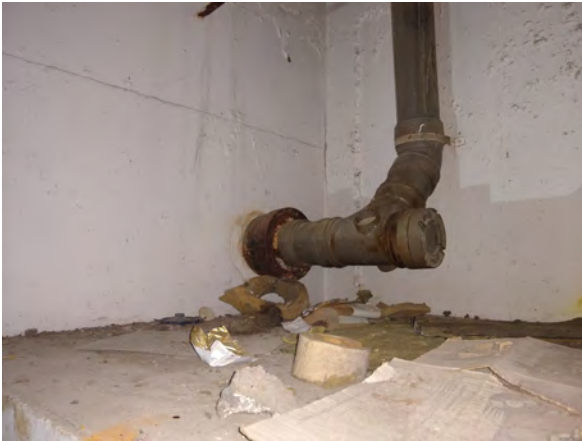
Item 1 Ref: 20277-11

- (Item 1) Ref: 20277-11 - Packing to plastic (Fire escape corridor/Rm -1/020) – Low Risk
- (Item 2) Ref: 20277-10 – Soffit and pelmet to service lift lobby (Fire escape corridor/Rm -1/020) – No Risk

The packing to plastic to iron soil pipe joint above service lift lobby in the fire escape corridor (Rm -1/020) does contain asbestos.

Any change in appearance should be reported to Property Services.

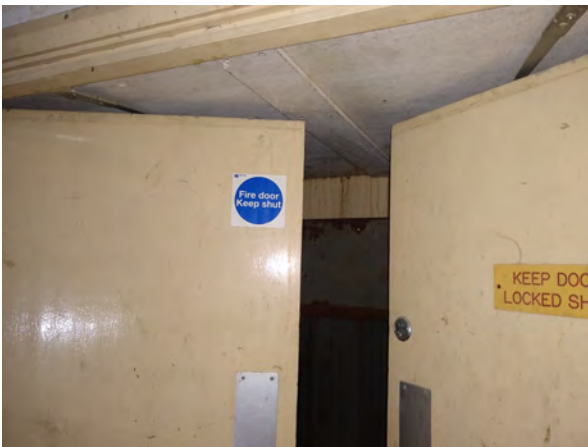
Item 2 Ref: 20277-10

The soffit and pelmet to service lift lobby in the fire escape corridor (Rm -1/020) does not contain asbestos.

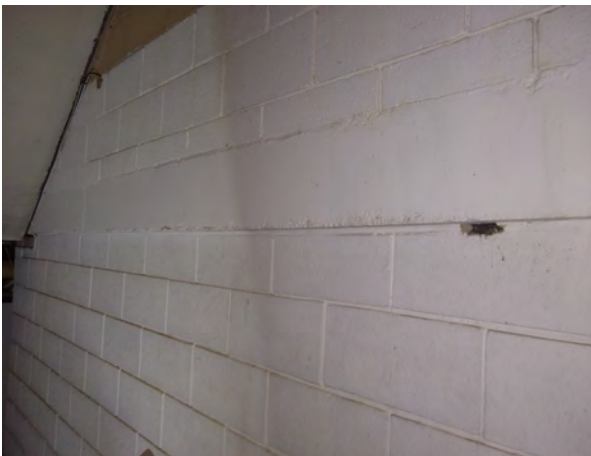
Item 3 Ref: 20277-52

The rope packing between concrete beams and breeze block wall top (behind mortar) in the stairwell (Rm -1/023) contain asbestos.

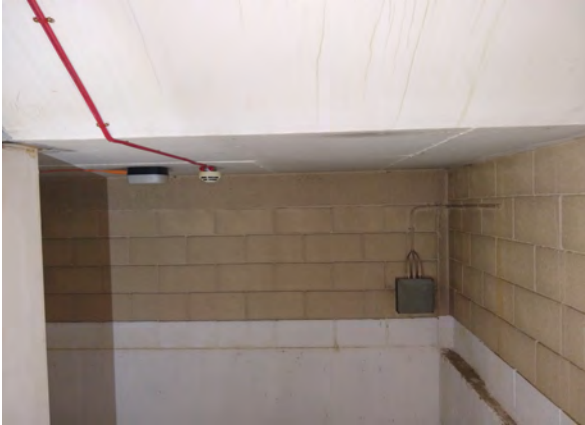
Item 4 Ref: 20277-108

The rope packing between concrete beams and breeze block wall top (behind mortar) in the stairwell (Rm 0/047) contain asbestos.

Whilst this cannot be inspected, any change in appearance should be reported to Property Services.

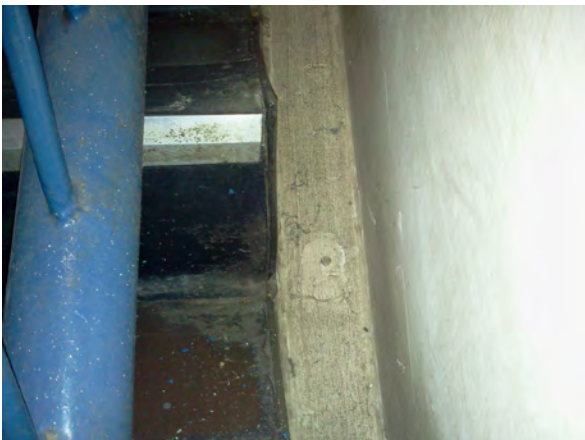
Item 5 Ref: 20277-169

The fire strip between stairs and central boxing (Immediately below stair height) in the stairwell (Rm 0/047) does not contain asbestos.

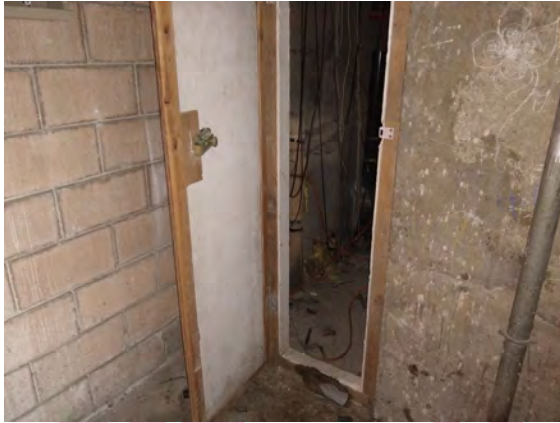
Item 8 Ref: 20277-111

The panel to riser door (including fillets to frame) in the riser adjacent to lift (Rm 0/049) does not contain asbestos.

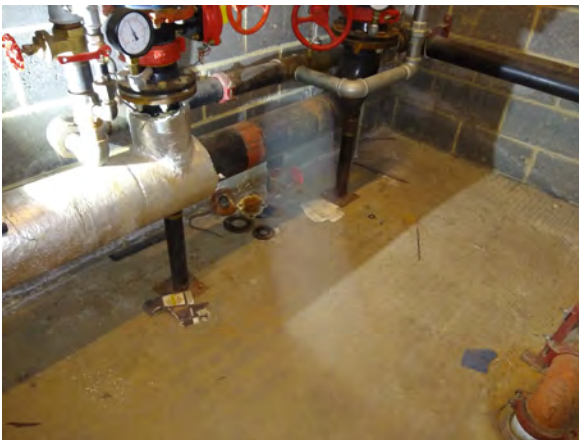
Item 18 Ref: 374099-2

The Loose lying gaskets (Sprinkler House/Rm 0/057) does not contain asbestos.

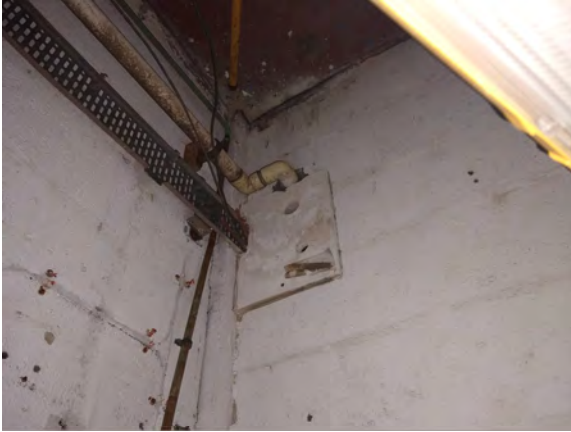
Item 19 Ref: 20277-176

The Panel to wall
(Laboratory/Rm 0/060) does
not contain asbestos.

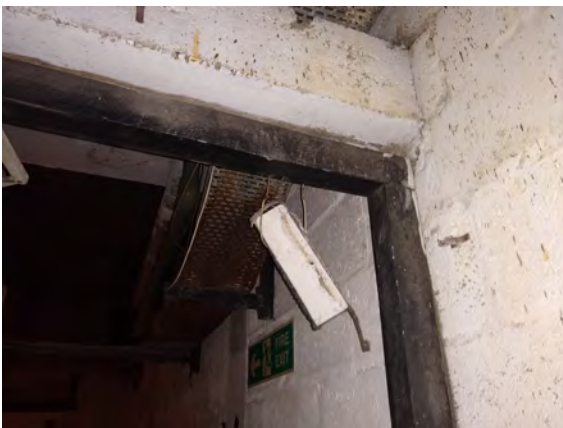
Item 21 Ref: As 20277-176

The Loose hanging panel
(Chemical tank room and
lobby/Rm 0/061) does not
contain asbestos.

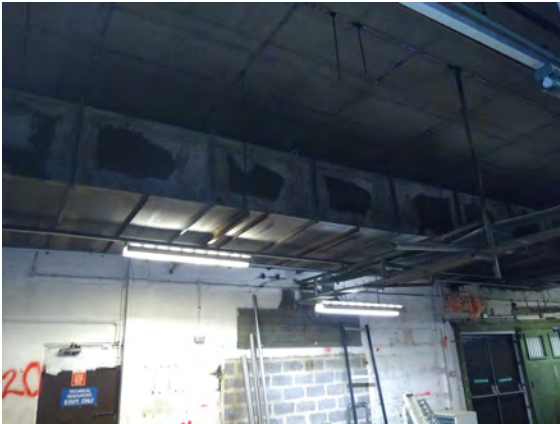
Item 22 Ref: 20277-73

The Sealant to joints in ductwork (Main plant room/Rm 0/062) contains asbestos.

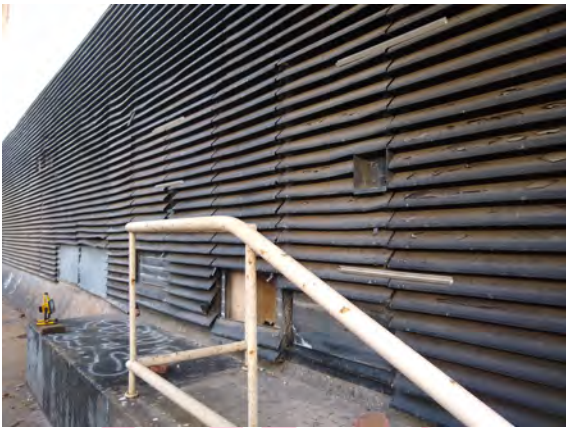
Item 38 Ref: 20277-182

The Loose lying gaskets (Gas meter house/Rm 0/071) contains asbestos.

Item 37	Damp proof course (Store/Rm 0/070)	Very Low Risk	12 monthly	05/12/2026
Item 38	Loose lying gaskets (Gas meter house/Rm 0/071)	Very Low Risk	12 monthly	05/12/2026

Any change in appearance should be reported to Property Services.

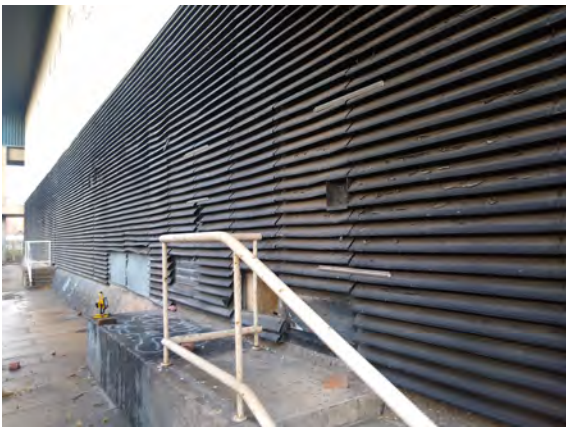
Item 39 Ref: As 20277-182

The Pipework flange gasket (Gas meter house/Rm 0/071) contains asbestos.

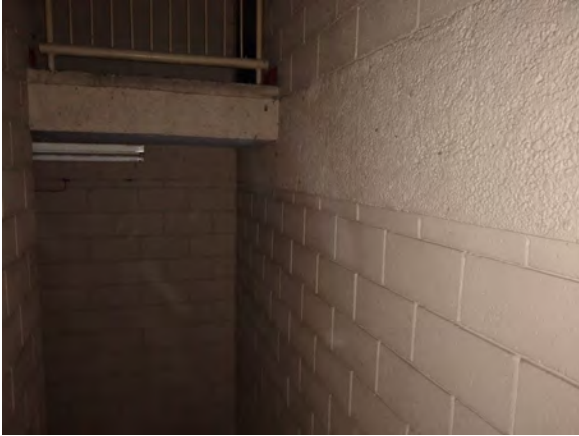
Item 40 Ref: 20277-56

The Rope packing (Stairwell/Rm 1/002) contains asbestos.

Whilst this cannot be inspected, any change in appearance should be reported to Property Services.

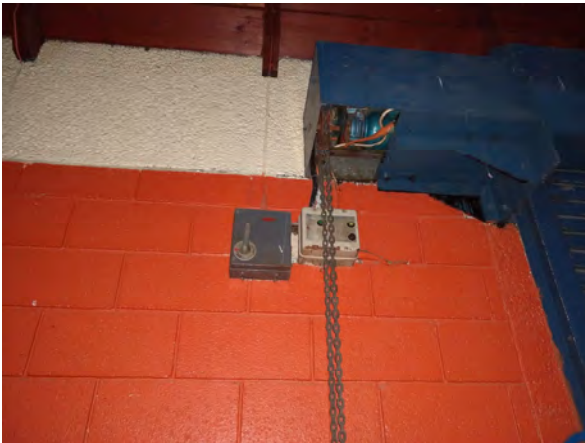
Item 41 Ref: 20277-78

The Electrics (Ice rink/Rm 1/003) contains asbestos.

Any change in appearance should be reported to Property Services.

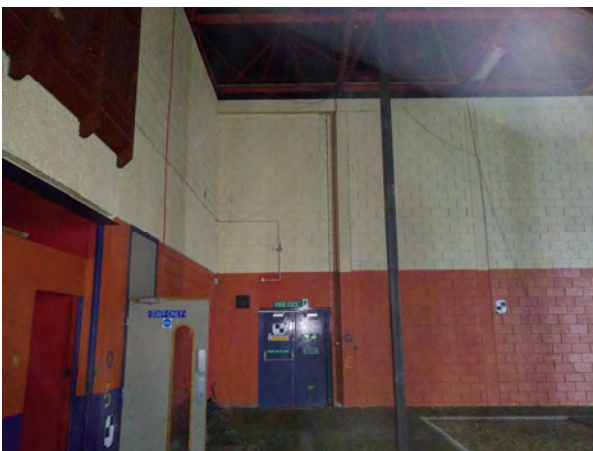
Item 42 Ref: 20277-79

The Debris in wall cavity (Ice rink/Rm 1/003) contains asbestos.

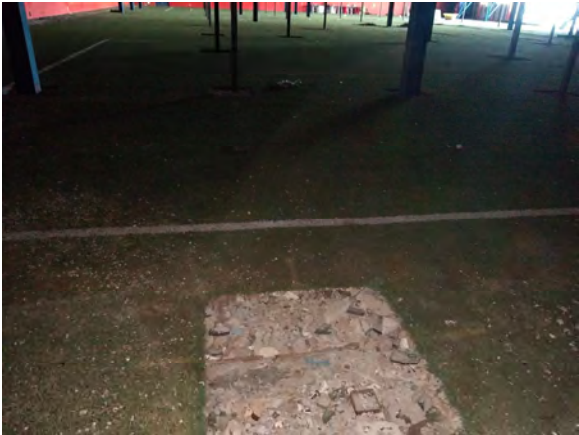
Item 43 Ref: 20277-77

The Floor screed (Ice rink/Rm 1/003) does not contain asbestos.

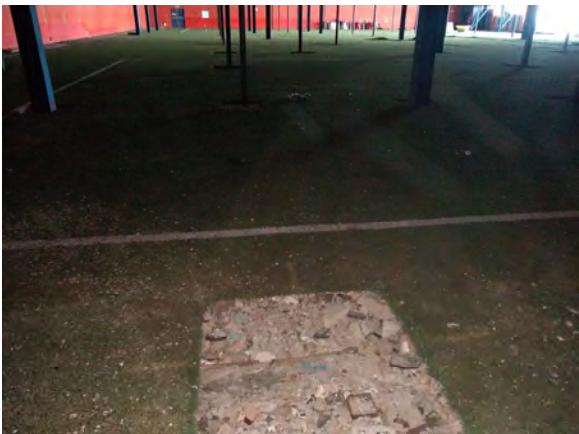
Item 44 Ref: 20277-76

The Floor screed (Ice rink/Rm 1/003) does not contain asbestos.

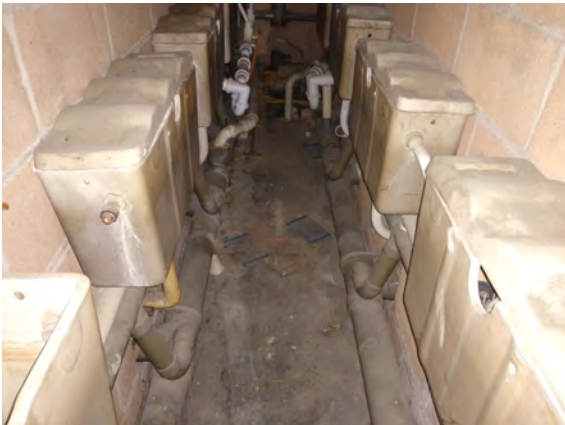
Item 57 Ref: As 20277-77

The Floor covering (Cistern void/Rm 1/007) does not contain asbestos.

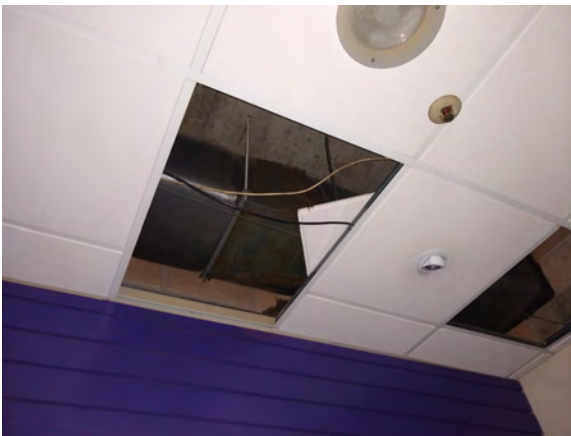
Item 63 Ref: As 20277-97

The Sealant to square section ductwork (Shop/Rm 1/010) contains asbestos.

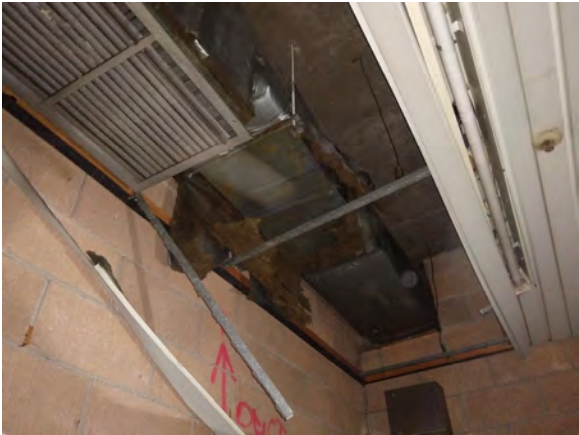
Item 67 Ref: 20277-104

The Sealant to square section ductwork (Store/Rm 1/011) contains asbestos.

Whilst this cannot be inspected, any change in appearance should be reported to Property Services.

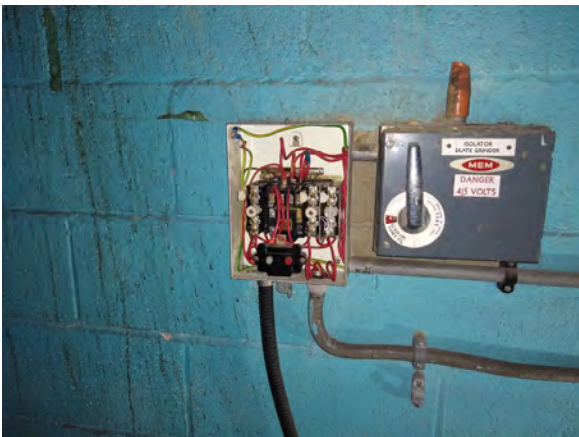
Item 68 Ref: 20277-106

The Electrics (Skate Store/Rm 1/012) contains asbestos.

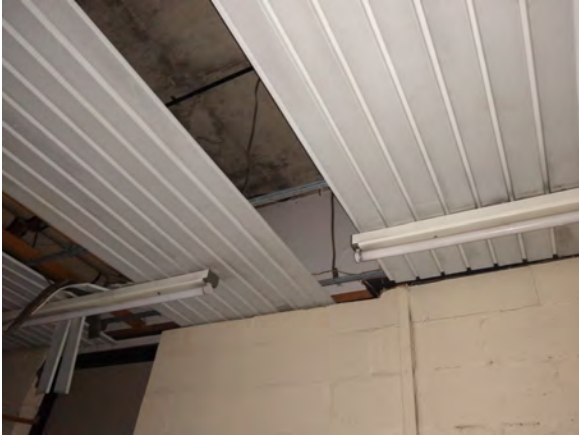
Item 70 Ref: As 20277-101

The Firebreak in void (Skate store/Rm 1/012) does not contain asbestos.

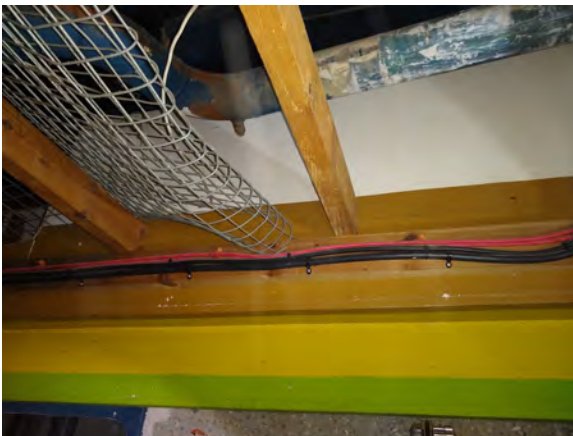
Item 77 Ref: 20277-112

The Boxing to high level (Store area/Rm 1/016) does not contain asbestos.

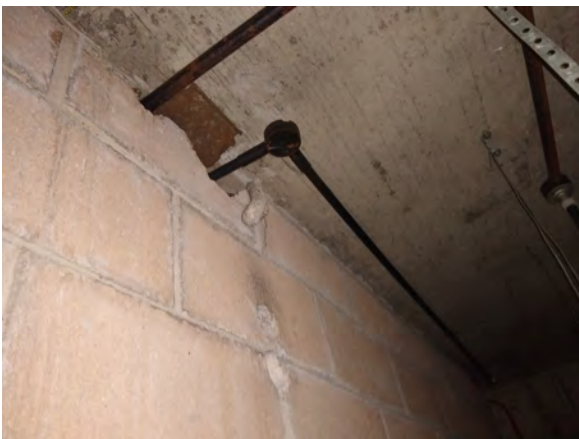
Item 78 Ref: As 20277-108

The Rope packing (Changing Rooms/Rm 1/021) contains asbestos.

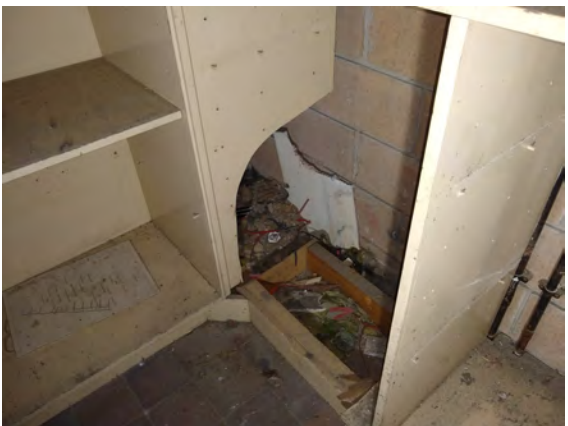
Item 84 Ref: As 20277-30

The Loose lying board (Switchroom/Rm 2/012) does not contain asbestos.

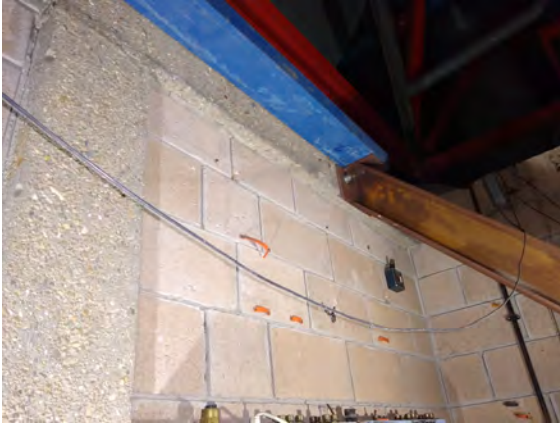
Item 85 Ref: As 20277-56

The Rope packing
(Switchroom/Rm 2/012)
contains asbestos.

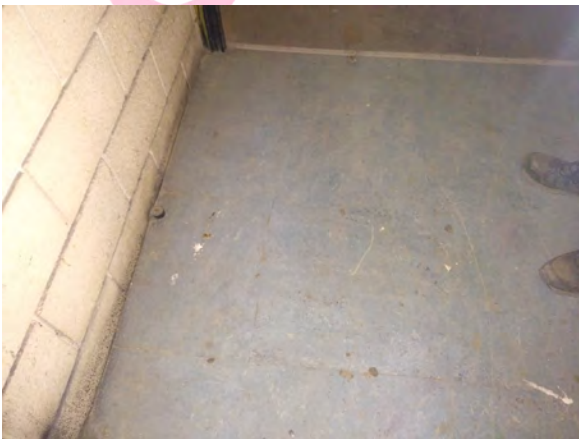
Item 90 Ref: 20277-41

The Floor covering (Lobby/Rm
2/021) does not contain
asbestos.

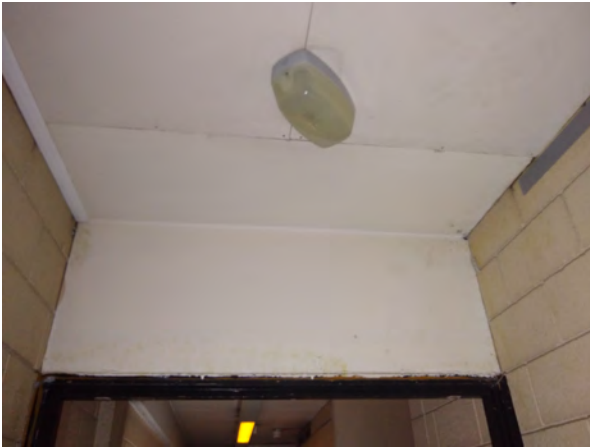
Item 91 Ref: As 20277-40

The Ceiling panel (Lobby/Rm 2/021) does not contain asbestos.

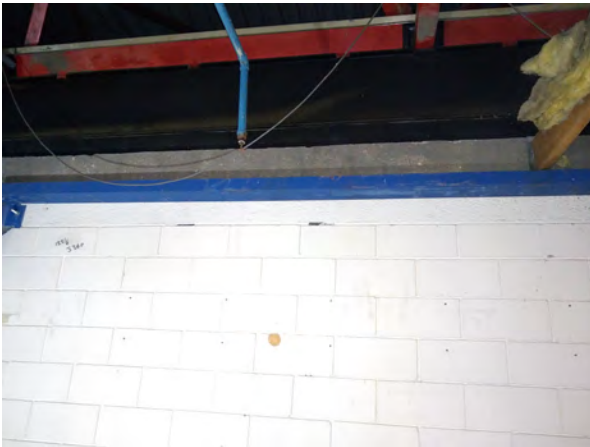
Item 92 Ref: As 20277-52

The Rope packing (Office/Rm 2/022) contains asbestos.

Whilst this cannot be inspected, any change in appearance should be reported to Property Services.

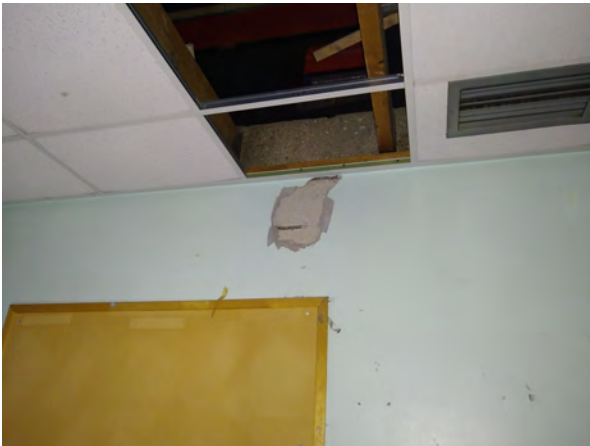
Item 93 Ref: As 20277-52

The Rope packing (Staff Room/Rm 2/023) contains asbestos.

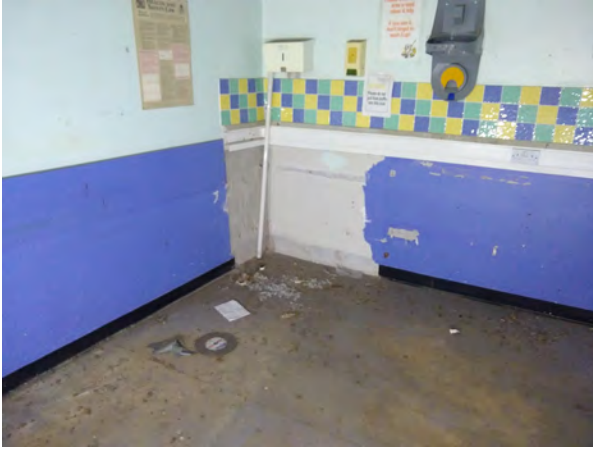
Item 94 Ref: 20277-42

The Sink pad (Staff Room/Rm 2/023) does not contain asbestos.

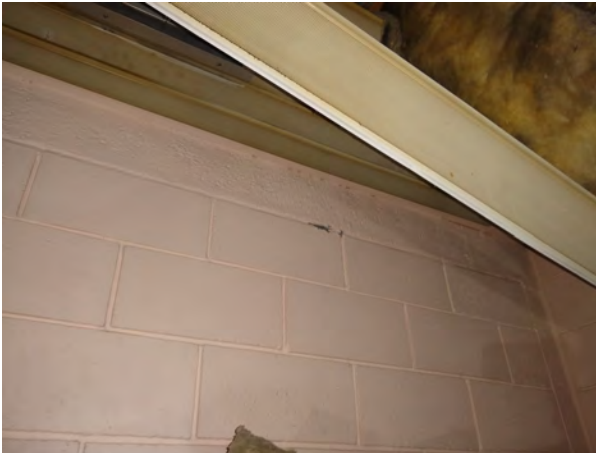
Item 95 Ref: As 20277-52

The Rope packing (Male Staff Lockers/Rm 2/024) contains asbestos.

Whilst this cannot be inspected, any change in appearance should be reported to Property Services.

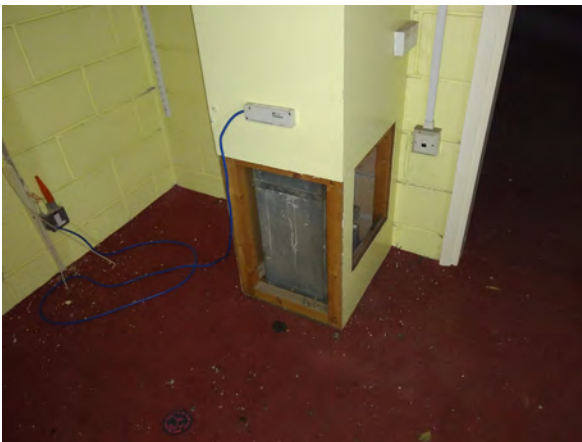
Item 96 Ref: 20277-43

The Sealant to joints (Double Office/Rm 2/026) contains asbestos.

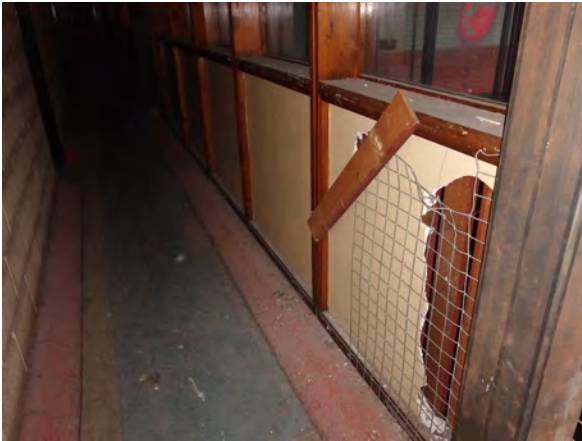
Item 97 Ref: 20277-45

The Panels below windows (Corridor/Rm 2/027) does not contain asbestos.

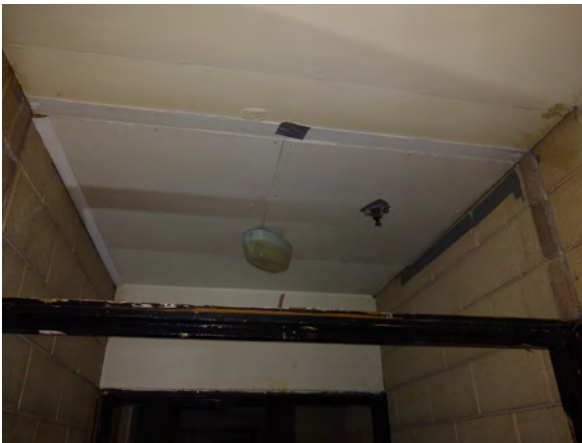
Item 98 Ref: As 20277-40

The Ceiling panel and panel above door (Corridor/Rm 2/027) does not contain asbestos.

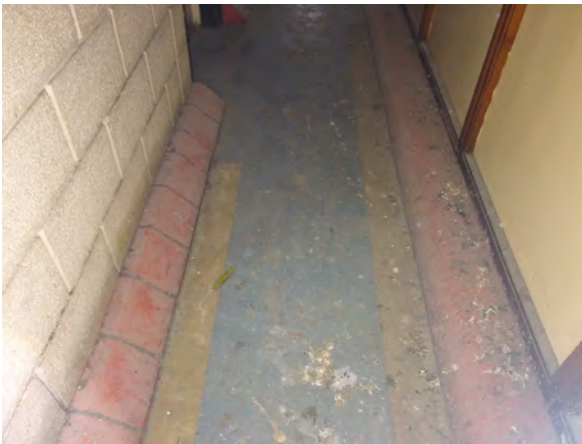
Item 99 Ref: As 20277-41

The Floor covering (Corridor/Rm 2/027) does not contain asbestos.

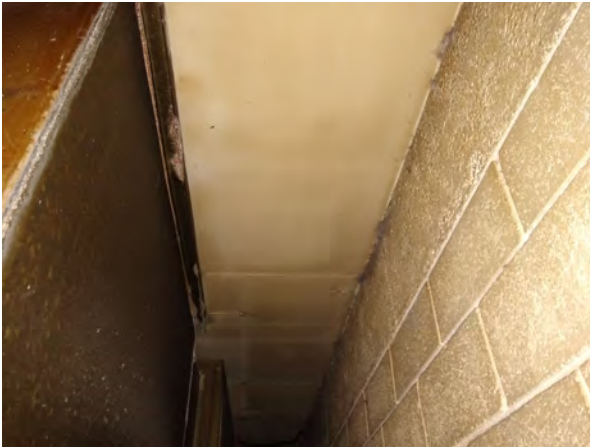
Item 100 Ref: 20277-49

The Ceiling panels (Air handling plant room/Rm 2/028) does not contain asbestos.

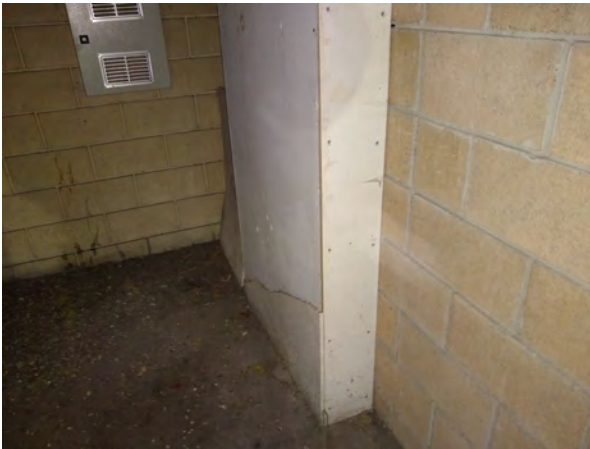
Item 101 Ref: 20277-50

The Boxing to the rear of fire hose reel (Air handling plant room/Rm 2/028) does not contain asbestos.

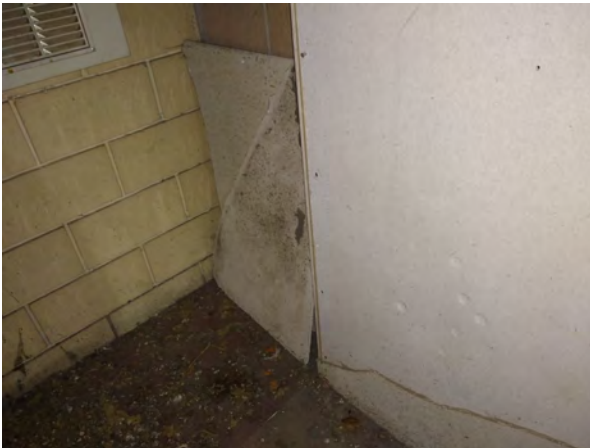
Item 102 Ref: 20277-51

The Board debris to floor (Air handling plant room/Rm 2/028) does not contain asbestos.

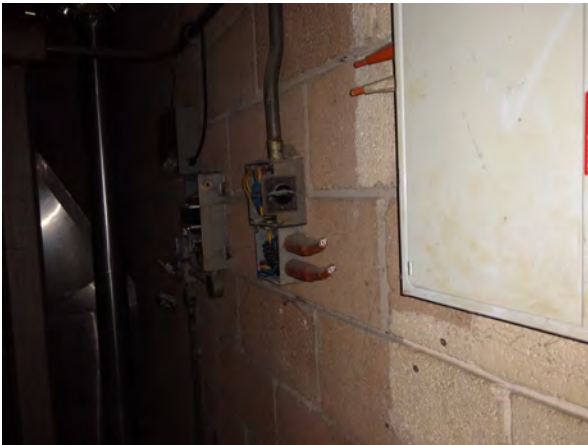
Item 104 Ref: Presumed

The Electrics (Air handling plant unit/Rm 2/028) is presumed to contain asbestos.

Any change in appearance should be reported to Property Services.

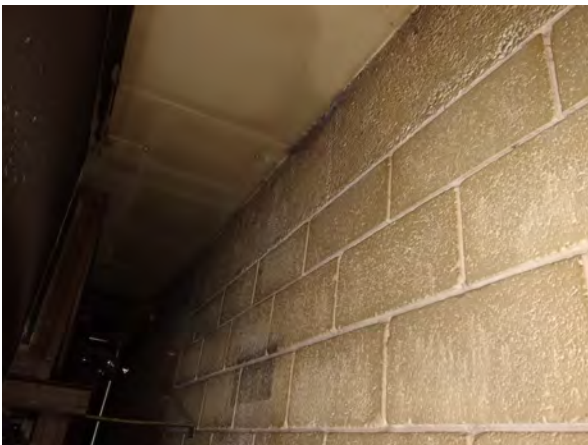
Item 105 Ref: As 20277-52

The Rope packing (Air handling unit/Rm 2/028) contains asbestos.

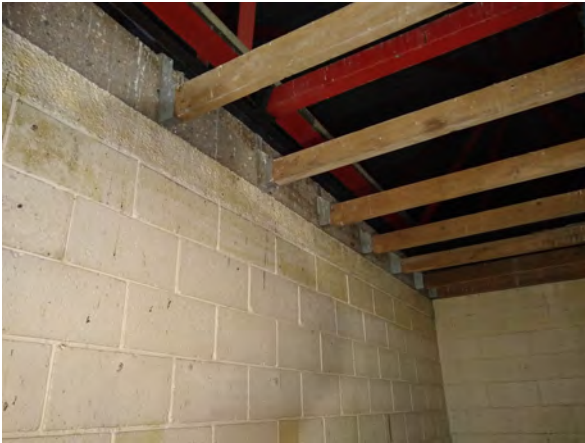
Item 106 Ref: As 20277-52

The Rope packing (Archive Room/Rm 2/029) contains asbestos.

Whilst this cannot be inspected, any change in appearance should be reported to Property Services.

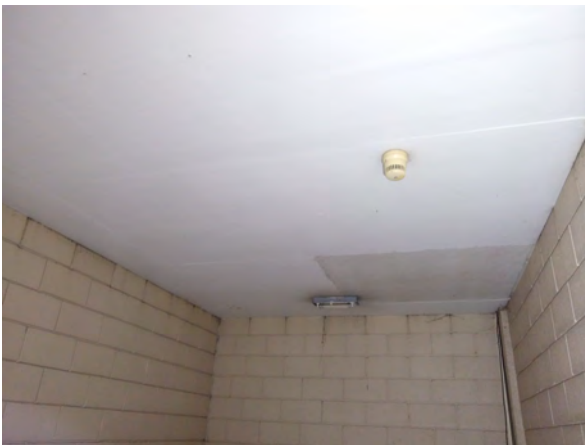
Item 107 Ref: 20277-57

The Ceiling panels (Stairwell landing/Rm 2/030) does not contain asbestos.

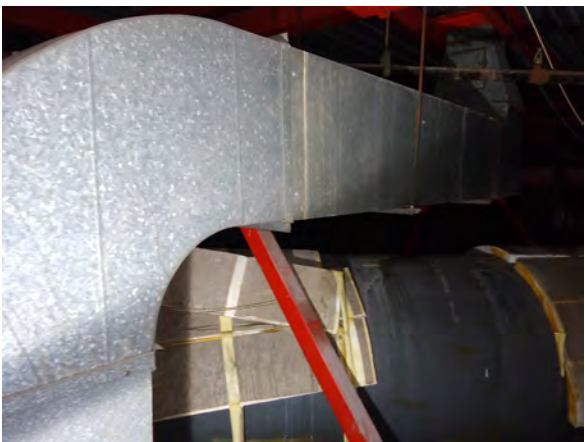
Item 108 Ref: 20277-22

The Sealant to square section (High level service gantry/Rm 3/001) contains asbestos.

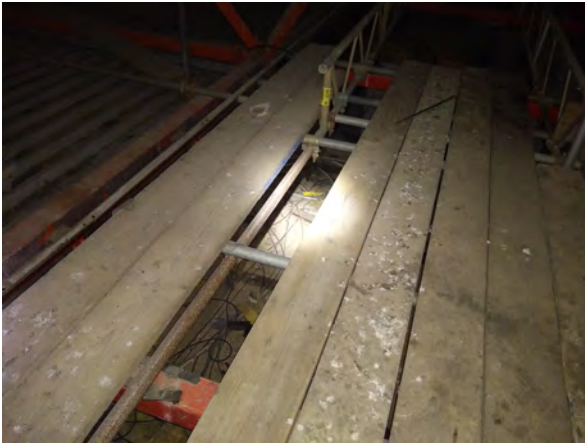
Item 109 Ref: 20277-14

The Debris to top side of concrete ceiling (High level service gantry/Rm 3/001) contains asbestos.

Any change in appearance should be reported to Property Services.

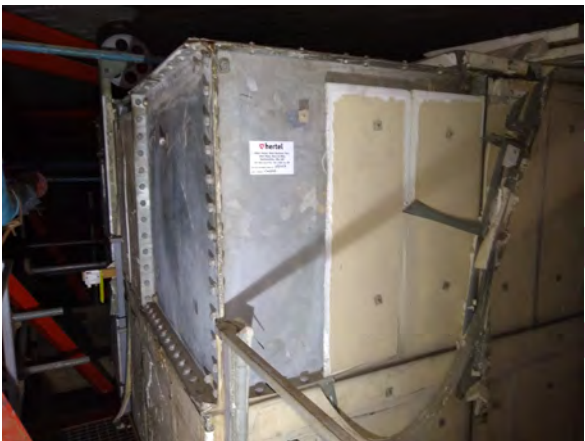
Item 110 Ref: 20277-15

The Sealant to joints (High level service gantry/Rm 3/001) contains asbestos.

Whilst this cannot be inspected, any change in appearance should be reported to Property Services.

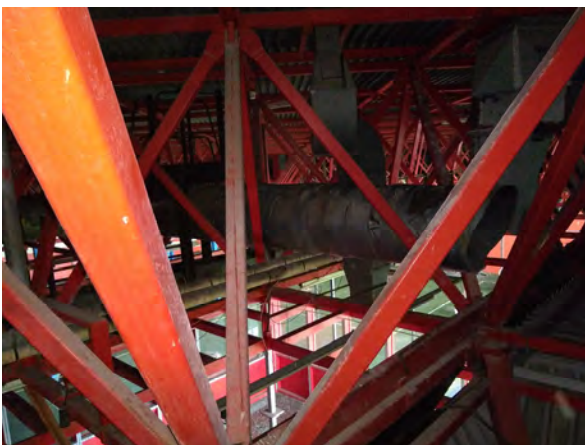
Item 111 Ref: 20277-59

The Sealant to joints (High level service gantry/Rm 3/001) contains asbestos.

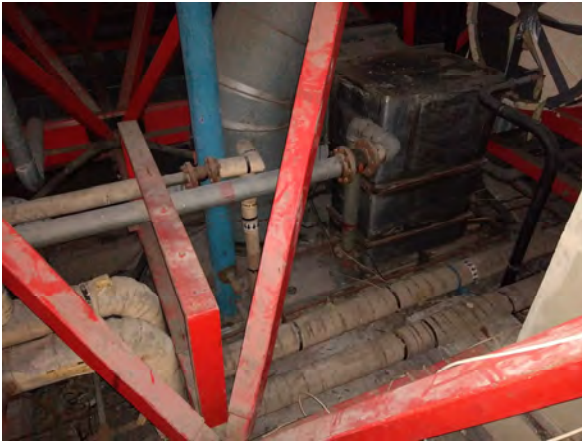
Item 112 Ref: 20277-16

The Pipework flange gasket (High level service gantry/Rm 3/001) contains asbestos.

Any change in appearance should be reported to Property Services.

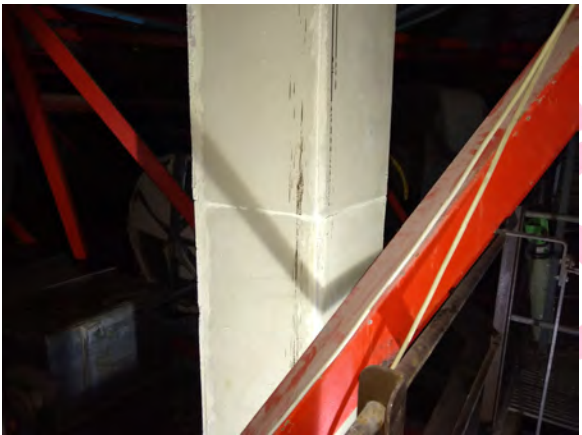
Item 113 Ref: 20277-23

The Vent boxing (High level service gantry/Rm 3/001) does not contain asbestos.

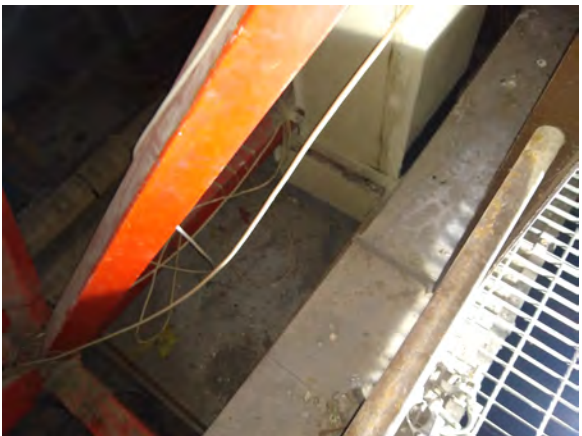
Item 114 Ref: 20277-24

The Debris to top side of ceiling (High level service gantry/Rm 3/001) does not contain asbestos.

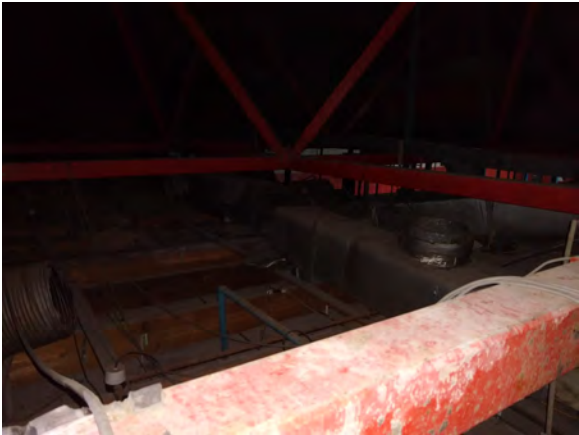
Item 115 Ref: 20277-26

The Sealant to square section ductwork (High level area above ice rink/Rm 3/002) contains asbestos.

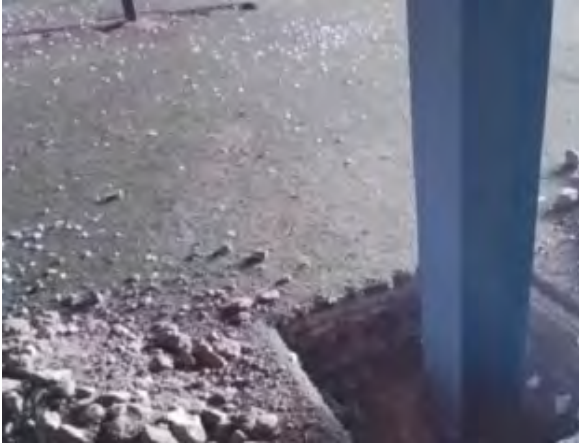
Item 124 Ref: PZ000393

The damp proof course in the Sports Hall G/001 does not contain asbestos.

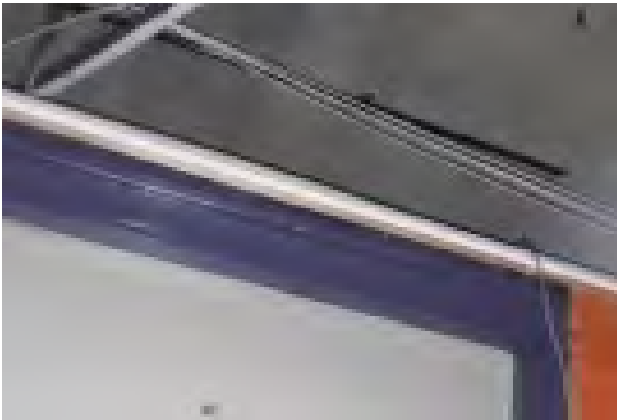
Item 131 Ref: As NZ001774

The ceiling void wall in the reception (1/007) does not contain asbestos.

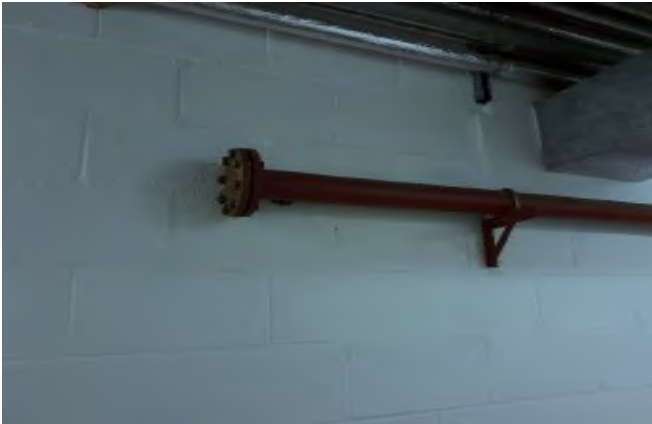
Item 136 Ref: PK002577

The white gasket red pipework in the Corridor G/01 does contain asbestos.

Any change in appearance should be reported to Property Services.

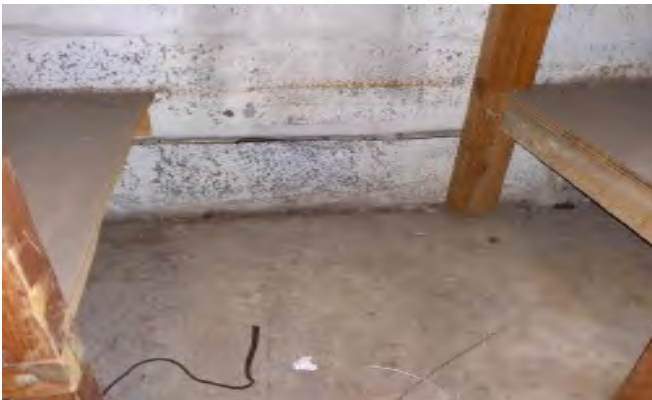
Item 137 Ref: As PK002580

The damp proof course to the walls in the Workshop electrical (G/12) does contain asbestos.

Any change in appearance should be reported to Property Services.

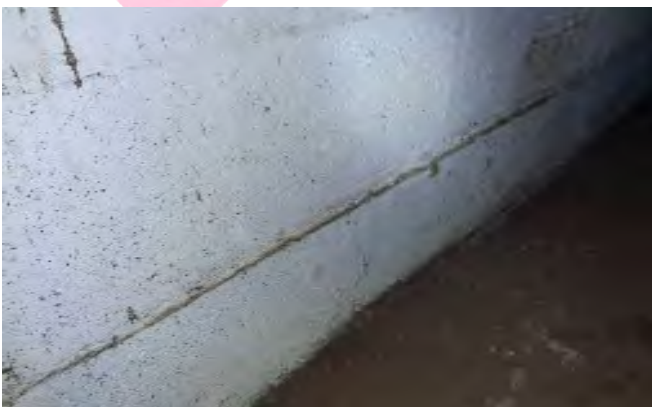
Item 138 Ref: As PK002585

The damp proof course to the walls in the Store (G/14) does contain asbestos.

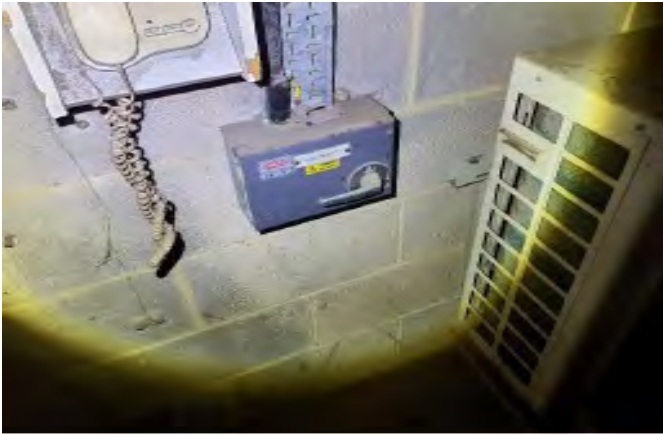
Item 139 Ref: Presumed

The flashguards MEM electrics in the Loading bay (G/02) are presumed to contain asbestos.

Any change in appearance should be reported to Property Services.

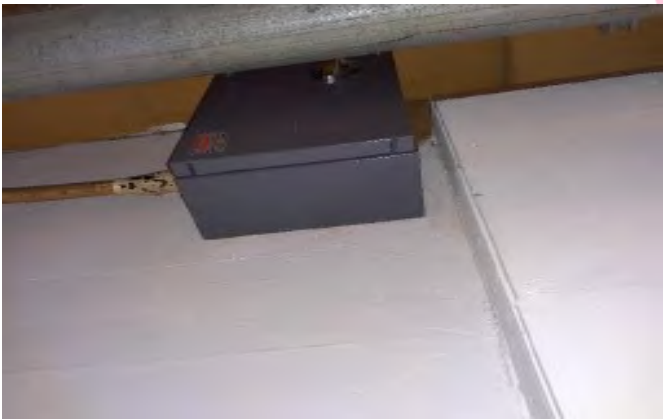
Item 140 Ref: Presumed

The flashguards MEM electrics in the Corridor (G/29) are presumed to contain asbestos.

Any change in appearance should be reported to Property Services.

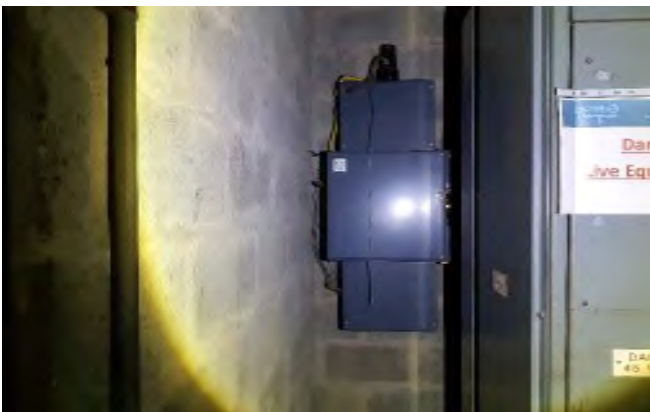
Item 141 Ref: Presumed

The flashguards MEM electrics in the Switch Room (G/06) are presumed to contain asbestos.

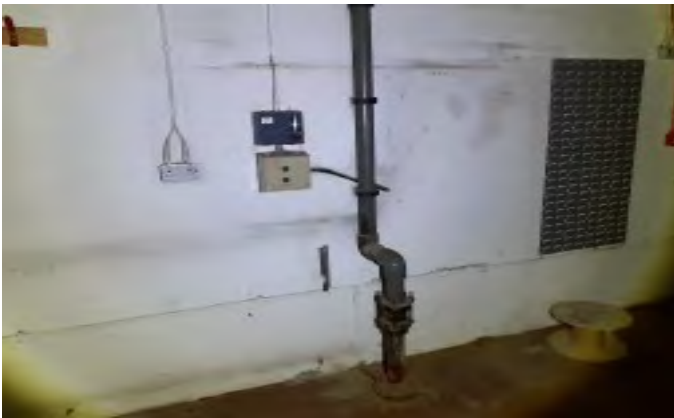
Item 142 Ref: Presumed

The flashguards MEM electrics in the Woodworking Shop (G/07) are presumed to contain asbestos.

Any change in appearance should be reported to Property Services.

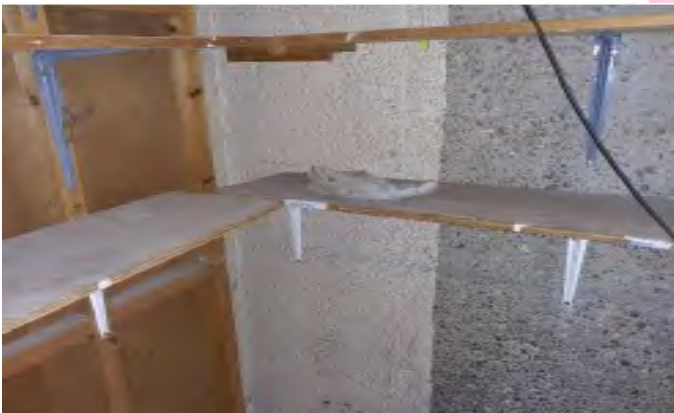
Item 143 Ref: PK002601

The textile glove in the Store (1/16) does contain asbestos.

Any change in appearance should be reported to Property Services.

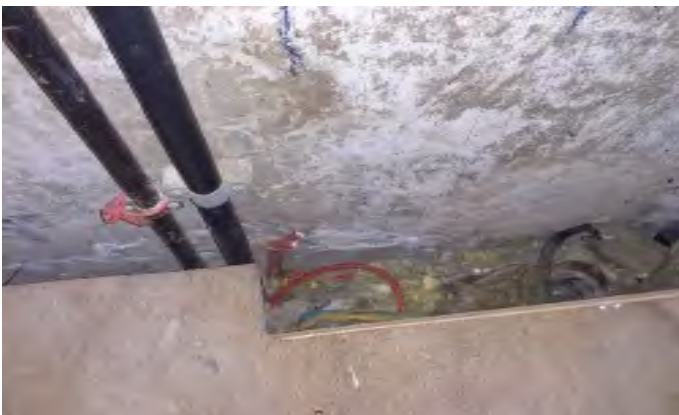
Item 144 Ref: PK002600

The rope floor pipe penetration in the Riser (1/17) does contain asbestos.
