ASBESTOS SURVEY REPORT FOR ENDURANCE WAREHOUSE, NORTH MOOR STREET, SUNDERLAND, SR1 2BQ

**ENDURANCE HOUSE AND WAREHOUSE, NORTH  
MOOR STREET,  
SUNDERLAND, SR1 2BQ**

**Date: 25 September 2025**

Endurance House - Last updated 25/09/2025 – Version 2

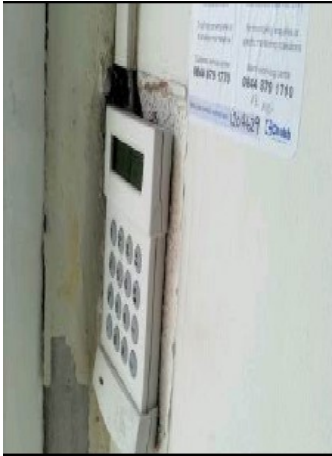
### **Item 4 - Ref: EA001526**

The textured coating to walls to the entrance lobby (Room 1) does not contain asbestos.

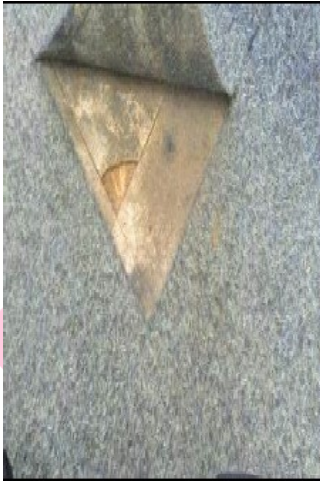
### **Item 5 - Ref: EA001487**

The vinyl floor tiles to office 1 (Room 2) do not contain asbestos.

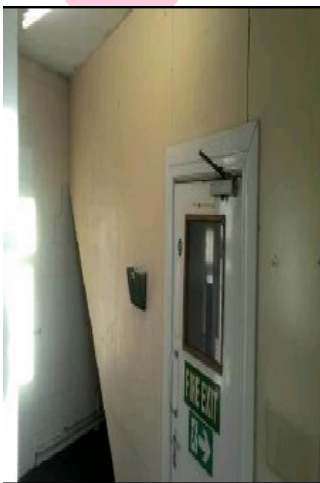
### **Item 6 - Ref: EA001488**

The cladding boards to staircase and wall in office (Room 2) do not contain asbestos.

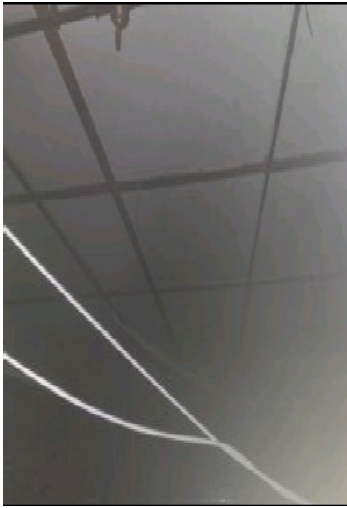
### **Item 7 - Ref: EA001489**

The Paper lined fibreboard ceiling to office 1 (Room 2) contains asbestos.

Any change in its appearance should be recorded, and passed to Property Services.

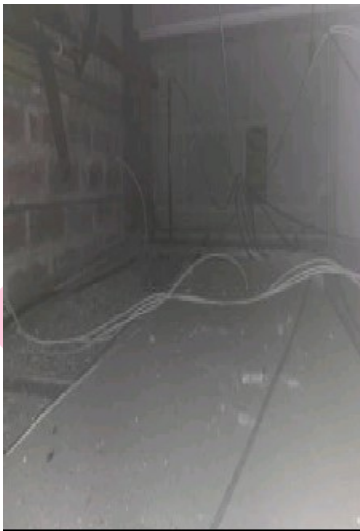
### **Item 8 - Ref: EA001490**

The debris to ceiling tiles tops - Office 1 (Room 2) does not contain asbestos.

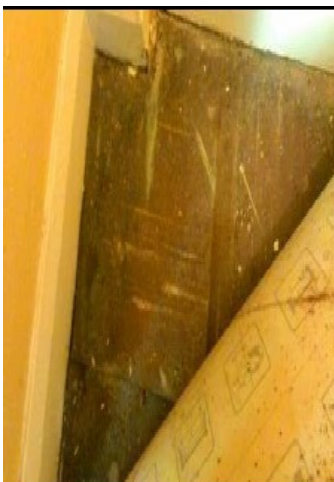
### **Item 9 - Ref: EA001491**

The vinyl floor tiles to the Lobby /stairs (Room 3) do not contain asbestos.

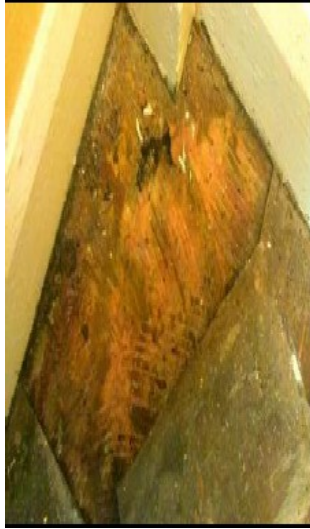
### **Item 10 - Ref: EA001492**

The bitumen adhesive below cement skim to the lobby /stairs (Room 3) does not contain asbestos.

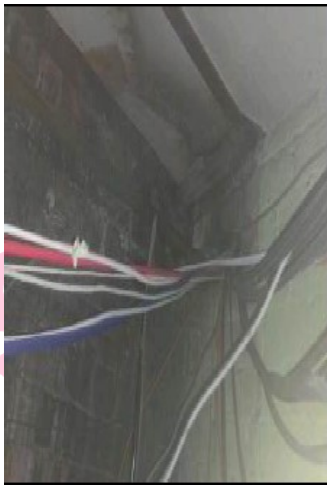
### **Item 11 - Ref: As EA001489**

The Paper lined fibreboard ceiling to the lobby/stairs (Room 3) contains asbestos.

Any change in its appearance should be recorded, and passed to Property Services.

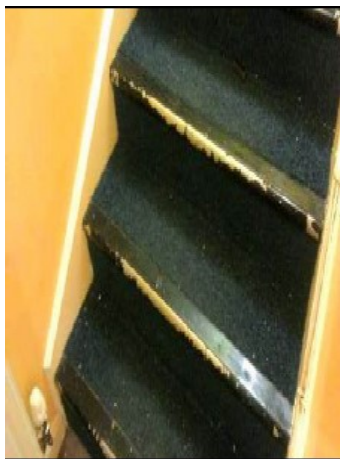
### **Item 12 - Ref: EA001493**

The stair nosing to the lobby/stairs (Room 3) does not contain asbestos.

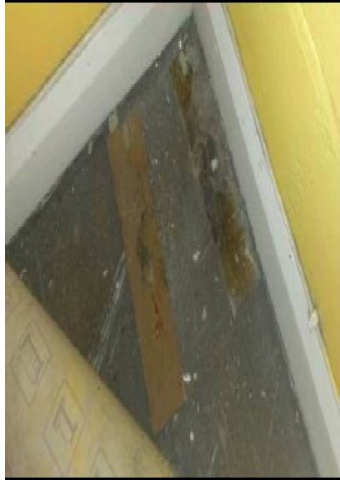
### **Item 13 - Ref: As EA001491**

The vinyl floor tiles to the circulation area (Room 4) do not contain asbestos.

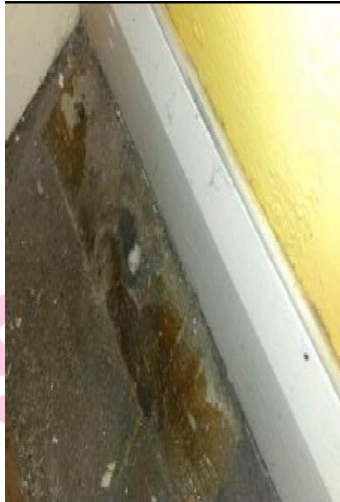
### **Item 14 - Ref: As EA001492**

The bitumen adhesive below cement skim to the circulation area (Room 4) does not contain asbestos.

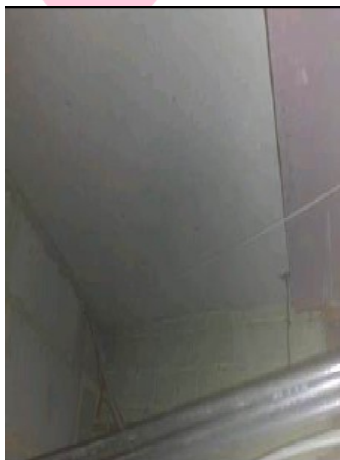
### **Item 15 - Ref: As EA001489**

The Paper lined fibreboard ceiling to the circulation area (Room 4) contains asbestos.

Any change in its appearance should be recorded, and passed to Property Services.

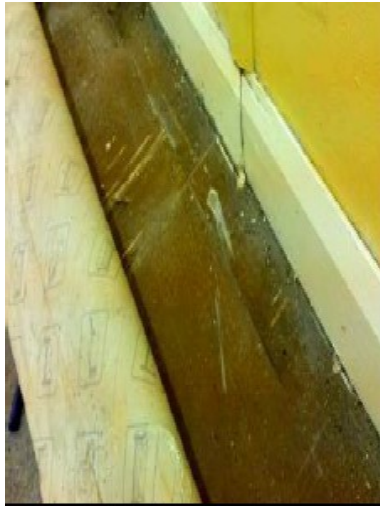
### **Item 16 - Ref: As EA001491**

The vinyl floor tiles to the corridor (Room 5) do not contain asbestos.

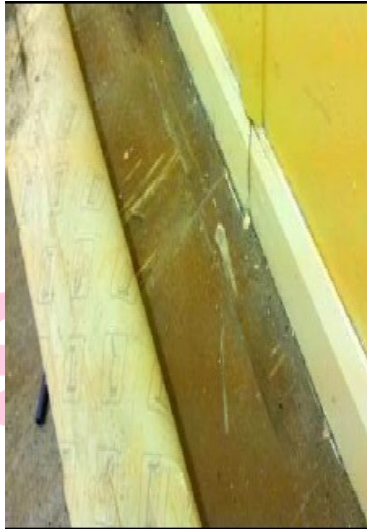
### **Item 17 - Ref: As EA001492**

The bitumen adhesive below cement skim to the corridor (Room 5) does not contain asbestos.

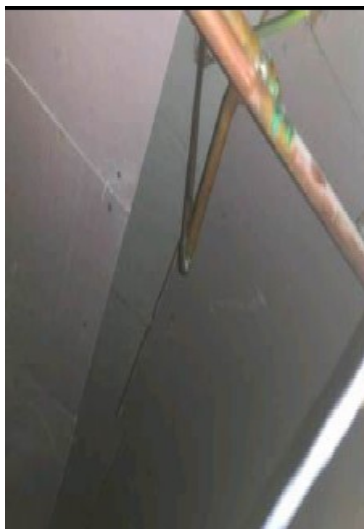
### **Item 18 - Ref: As EA001489**

The Paper lined fibreboard ceiling to the corridor (Room 5) contains asbestos.

Any change in its appearance should be recorded, and passed to Property Services.

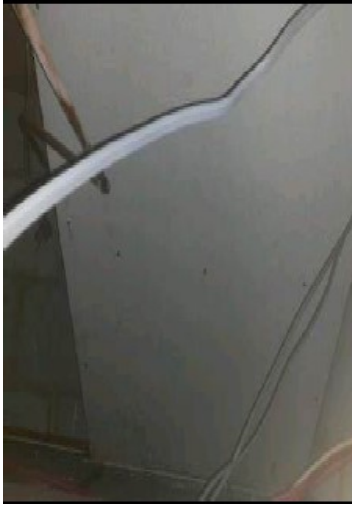
### **Item 19 - Ref: EA001494**

The panels to the bottom on staircase of the corridor (Room 5) do not contain asbestos.

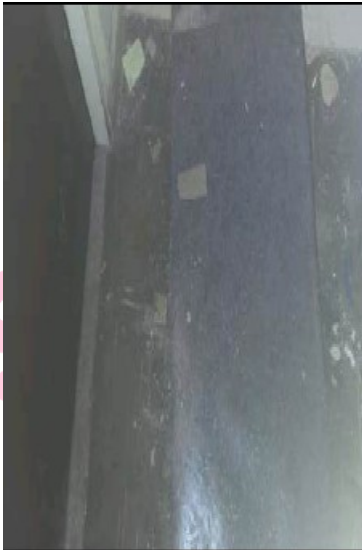
### **Item 20 - Ref: As EA001491**

The vinyl floor tiles to the upstairs cupboard (Room 6) do not contain asbestos.

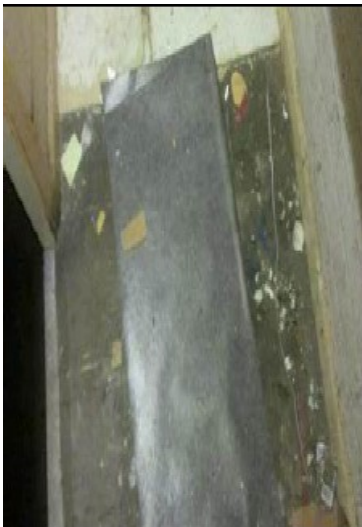
### **Item 21 - Ref: As EA001492**

The bitumen adhesive below cement skim to the upstairs cupboard (Room 6) does not contain asbestos.

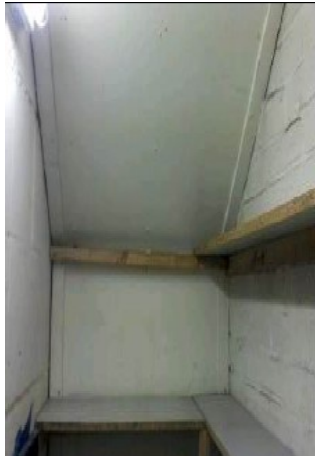
### **Item 22 - Ref: As EA001494**

The cladding to the underside of stairs of the upstairs cupboard (Room 6) does not contain asbestos.

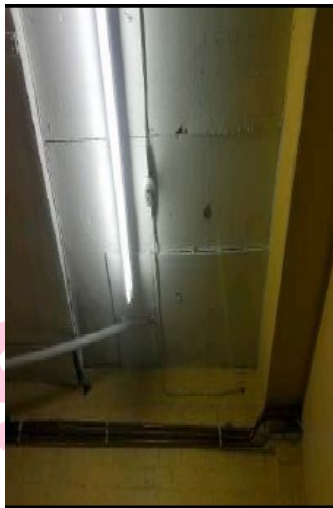
### **Item 23 - Ref: EA001495**

The paper lined fibreboard ceiling panels in the circulation area (Room 7) contain asbestos.

Any change in its appearance should be recorded, and passed to Property Services.

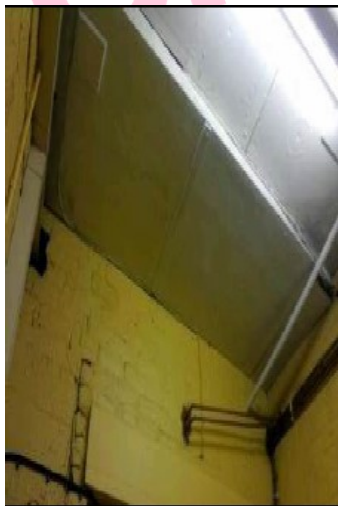
### **Item 24 - Ref: EA001496**

The boards to lower level ceiling in the circulation area (Room 7) does not contain asbestos.

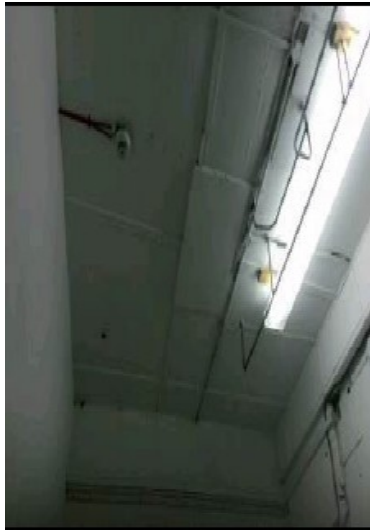
### **Item 25 - Ref: As EA001495**

The paper lined fibreboard ceiling panels to the circulation area (Room 8) contain asbestos.

Any change in its appearance should be recorded, and passed to Property Services.

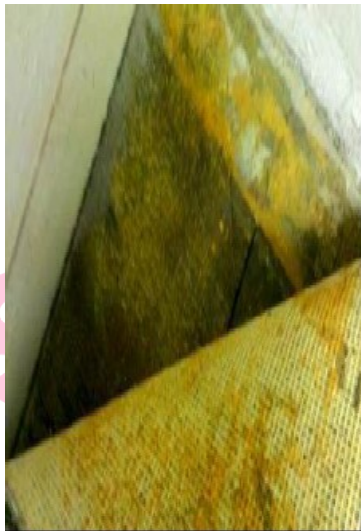
### **Item 26 - Ref: As EA001487**

The vinyl floor tiles to the circulation area (Room 8) do not contain asbestos.

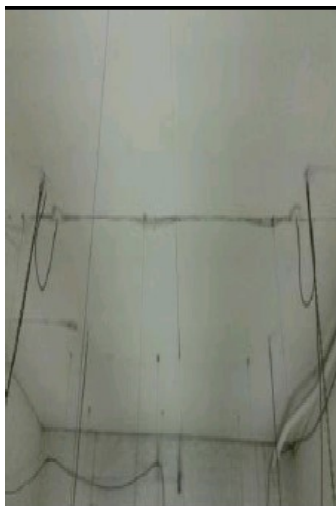
### **Item 27 - Ref: EA001497**

The Ceiling panels above the suspended ceiling to Office 2 (Room 9) do contain asbestos.

Any change in its appearance should be recorded, and passed to Property Services.

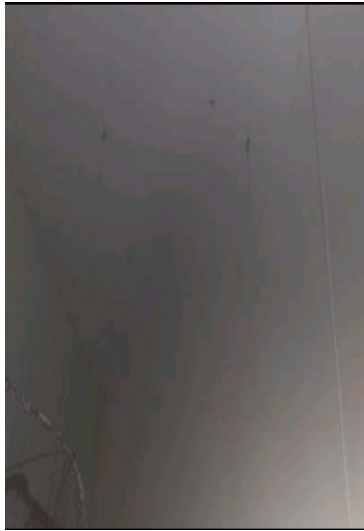
### **Item 28 - Ref: As EA001497**

The Ceiling panels above the suspended ceiling to office 3 (Room 10) do do contain asbestos.

Any change in its appearance should be recorded, and passed to Property Services.

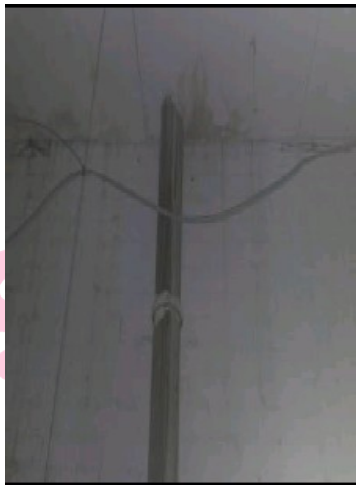
### **Item 29 - Ref: EA001498**

Redundant flue pipe within ceiling void to office 3 (Room 10) does contain asbestos.

Any change in its appearance should be recorded, and passed to Property Services.

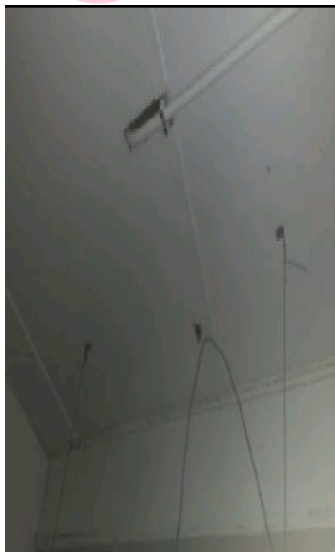
### **Item 30 - Ref: As EA001495**

The paper lined fibreboard ceiling panels to the kitchen (Room 11) contain asbestos.

Any change in its appearance should be recorded, and passed to Property Services.

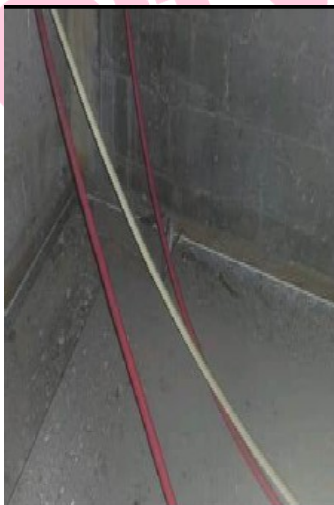
### **Item 33 - Ref: EA001500**

The board debris to suspended ceiling tops to the toilets (Room 12) does contain asbestos.

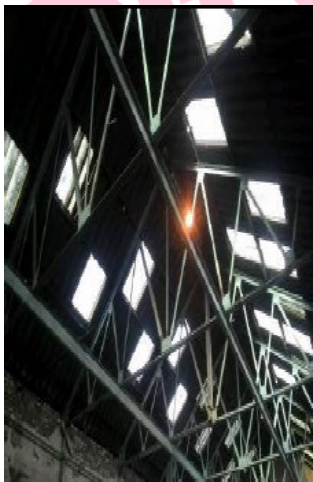
### **Item 36 - Ref: EA001508**

The corrugated roof sheets to warehouse 1 (Room 14) does contain asbestos.

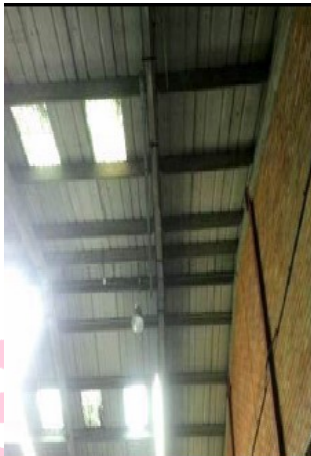
### **Item 38 - Ref: EA001509**

The corrugated roof sheets to warehouse 4 (Room 16) does contain asbestos.

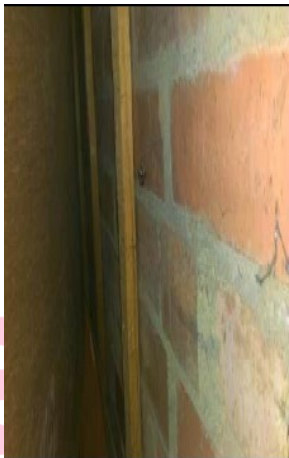
Inspection point-behind timber Panel. No suspect materials Found in the store (Room 15).

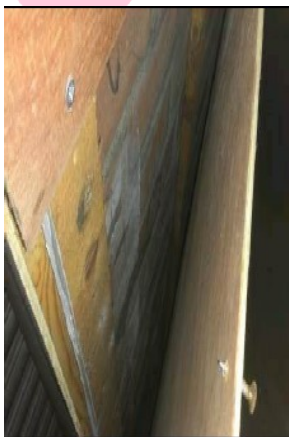
Inspection point-behind timber Panel. No suspect materials found to store (Room 15).

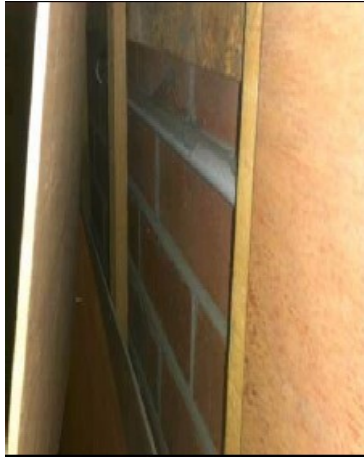
Inspection point-behind timber Panel. No suspect materials found to the store (Room 15).

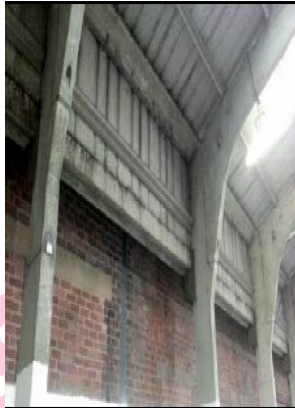
### **Item 40 - Ref: EA001512**

The corrugated wall sheets to warehouse 4 (Room 16) contain asbestos.

Any change in its appearance should be recorded, and passed to Property Services.

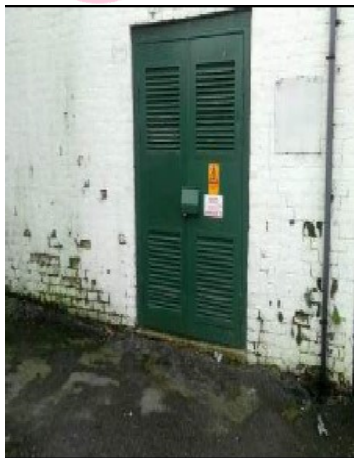
The Sub-Station (Room 17) was inaccessible as a Northern Powergrid Property.

Further investigation required.

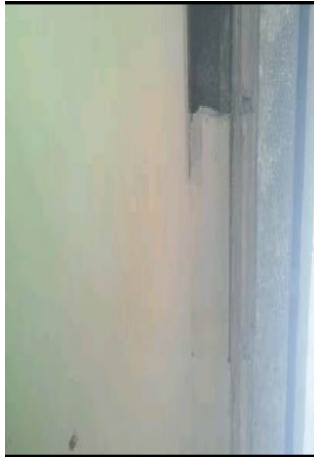
### **Item 41 - Ref: EA001513**

The ceiling boards to boiler room 2 (Room 18) contain asbestos.

Any change in its appearance should be recorded, and passed to Property Services.

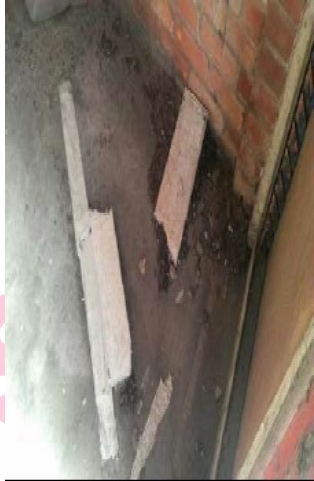
### **Item 42 - Ref: EA001514**

The debris to floor to boiler room 2 (Room 18) contains asbestos.

There should be no access to the area until an environmental clean has been carried out.

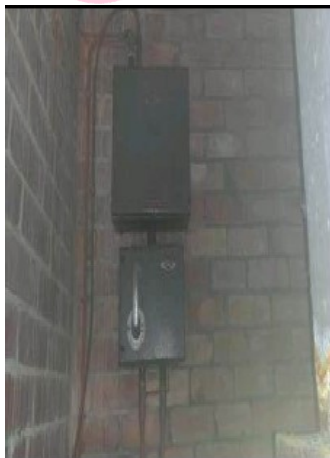
### **Item 43 - Presumed**

It was presumed asbestos was present in the flash guards within fuse box to boiler room 2 (Room 18).

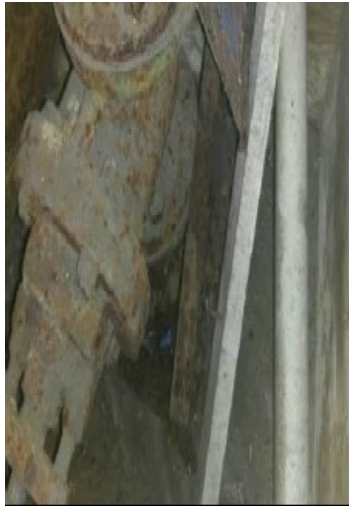
### **Item 44 - Ref: EA001515**

The gasket to the pipe flange to Boiler Room 2 (Room 18) does contain asbestos.

Any change in its appearance should be recorded, and passed to Property Services.

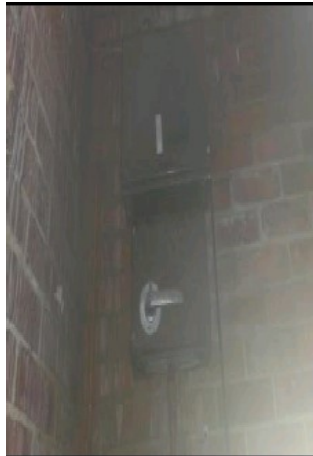
### **Item 47 - Presumed**

It was presumed asbestos was present in the flash guards within fuse box to boiler room 1 (Room 19).

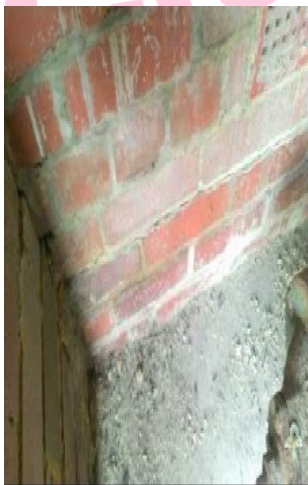
### **Item 52 Ref: EA001524**

The damp proof course to the gas intake room (Room 20) contains asbestos.

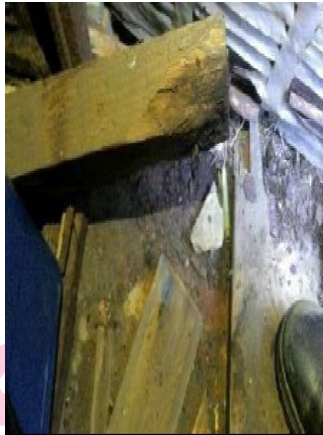
### **Item 54 - Ref: EA001530**

The debris to the floor of Boiler Room 3 (Room 21) does not contain asbestos.

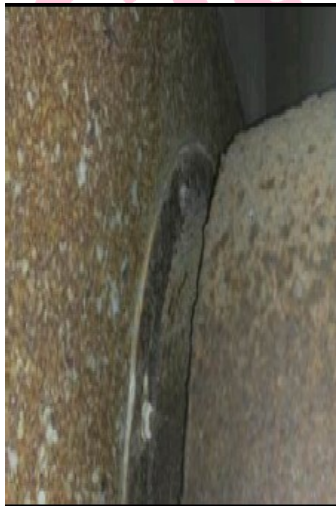
### **Item 55 - Ref: EA001531**

The gaskets to air pump boiler room 3 (Room 21) contains asbestos.

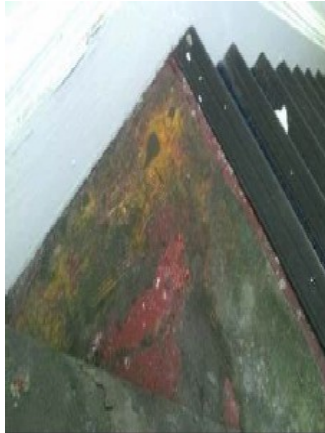
**Item 56 - Ref: EA001502**

The red screed to floor (First floor landing) (Room 1) does not contain asbestos.

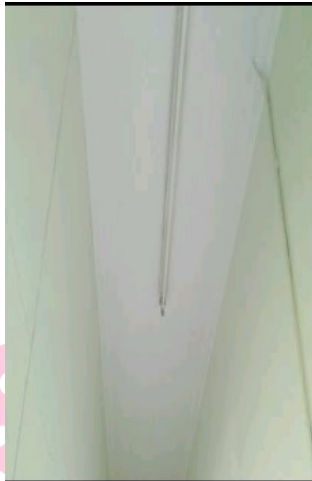
**Item 57 - Ref: EA001503**

The textured coating to ceiling (First floor landing) (Room 1) does not contain asbestos

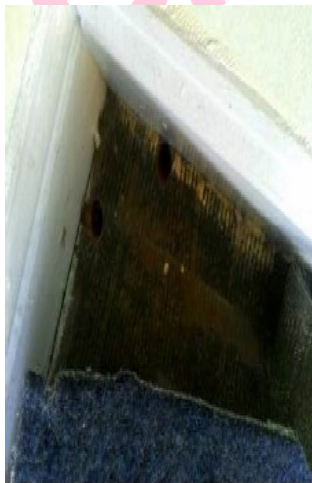
**Item 58 - Ref: EA001504**

The vinyl floor covering to office 3 (First floor Room 2) does not contain asbestos.

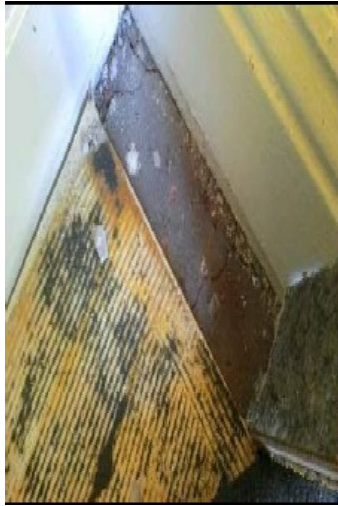
**Item 59 - Ref: As EA001502**

The red screed to floor of office 4 (First floor Room 3) does not contain asbestos.

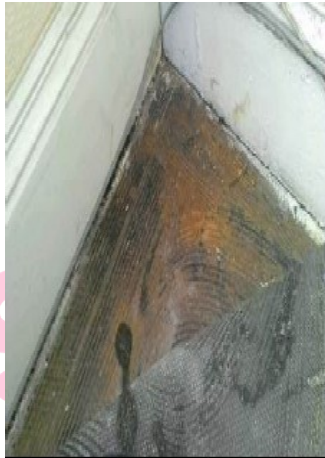
**Item 60 - Ref: As EA001504**

The vinyl floor covering to Office 4 (First floor Room 3) does not contain asbestos.

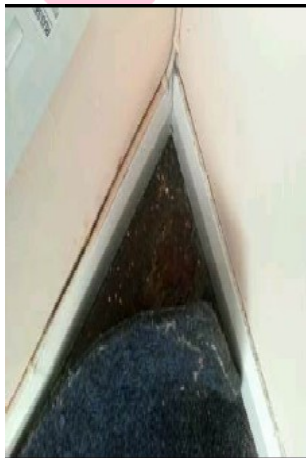
**Item 61 - Ref: As EA001502**

The red screed to floor to office 6 (First floor - room 5) does not contain asbestos.

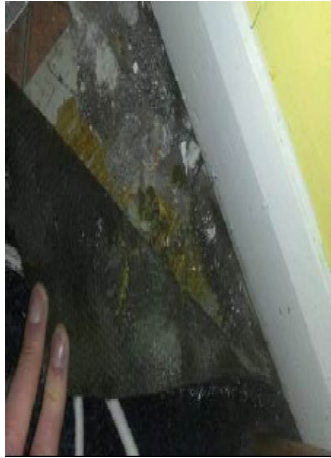
**Item 62 - Ref: EA001505**

The vinyl floor covering to the landing (First floor - Room 6) does not contain asbestos.

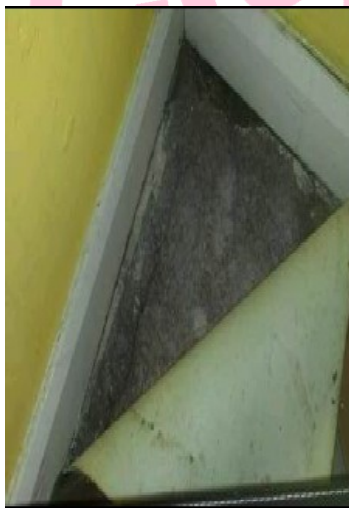
**Item 64 - Ref: As EA001502**

The red screed to the female wc (First floor - Room 8) does not contain asbestos.

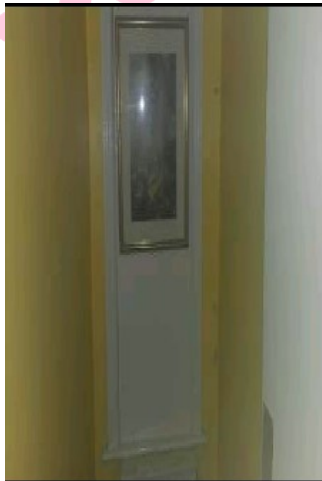
**Item 67 - Ref: As EA001506**

The panel to the window of the female wc (First Floor Room 8) does not contain asbestos.

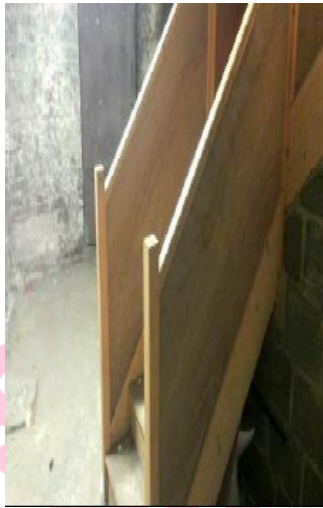
The Stairwell to sub level Room 1 was accessed and no suspect materials were found.

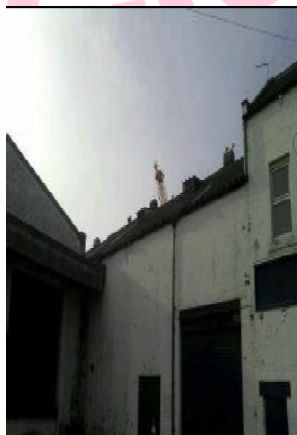
### **Item 72 - Ref: As EA001508**

The corrugated roof /apex/cowl sheet to warehouse 1 (External) contains asbestos.

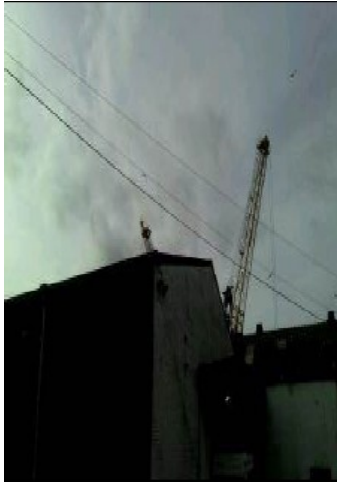
### **Item 73 - Ref: As EA001509**

The corrugated roof /apex/cowl sheet to warehouse 4 (External) contains asbestos.

Any change in its appearance should be recorded, and passed to Property Services.

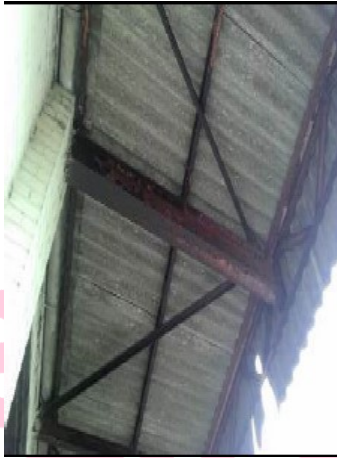
### **Item 74 - Ref: EA001519**

The corrugated sheet canopy to warehouse 4 (External) contains asbestos.

Any change in its appearance should be recorded and passed to Property Services.

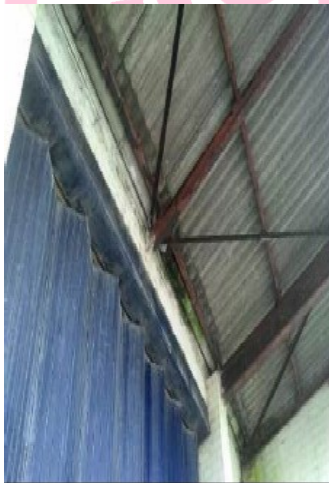
### **Item 75 - Ref: EA001520**

The guttering to Warehouse 4 (External) contains asbestos.

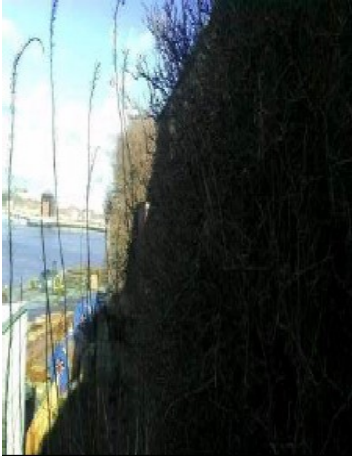
No access to area at high level wall (Room 1) (External).  
Further investigation required.

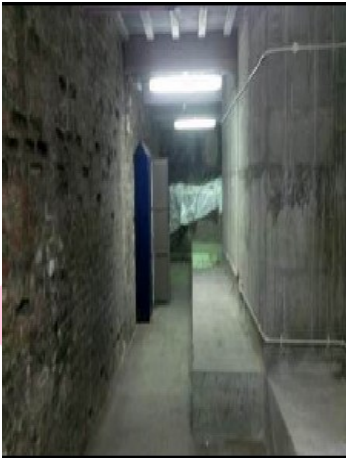
Room 2 (Sub level) was accessed and no suspect materials were found.

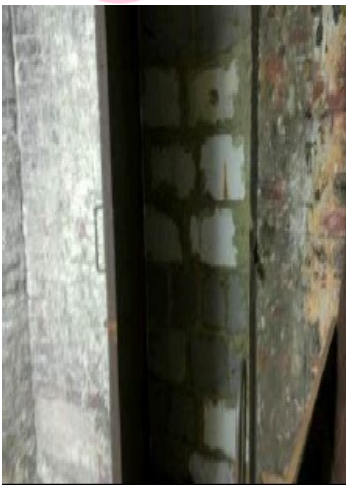
Room 3 (Space behind blocked doorway) to the sub level was inaccessible.  
Further inspection required.

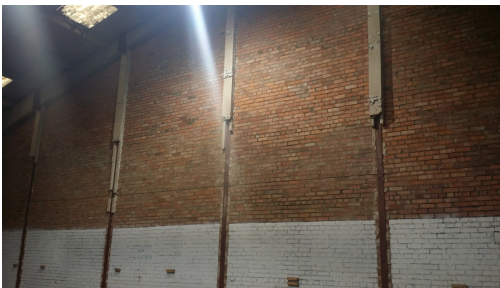
### **Item 104 - Ref: As 279740-2**

The remnant boxing to columns south in Warehouse 4 (Room 002) does not contain asbestos.

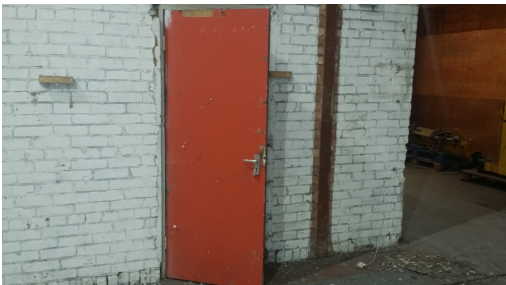
### **Item 105 - Ref: 279740-3**

The lining to fire door south (damaged) in Warehouse 4 (Room 002) does contain asbestos.
