### ASBESTOS SURVEY REPORT FOR PARK LANE MARKET (PREVIOUSLY HIDDEN), SUNDERLAND, SR1 3NX

## Asbestos Register for

### Park Lane Market (Previously Hidden)

**Date: 21 October 2025**

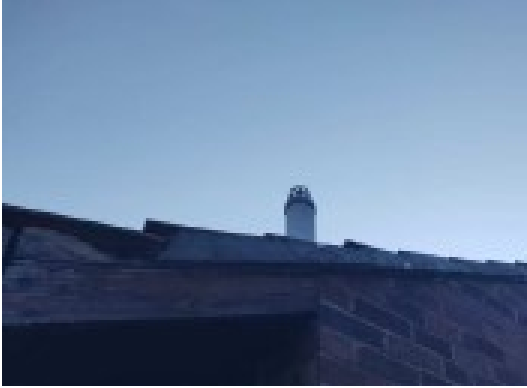
### **Item 1 Ref: 21-38141-1**

- (Item 1) Ref: 21-38141-1 – Undercloak to gable end (area 1/Storage Units) – Removed September 2021 (A Watson to forward ppw)
- (Item 2) Ref: 21-38141-1 – Undercloak and tile fillets (area 1/Storage Units) – Removed September 2021 (A Watson to forward ppw)

The roof undercloak to the gable end (Storage units/Area1) contains asbestos.

These were removed September 2021.

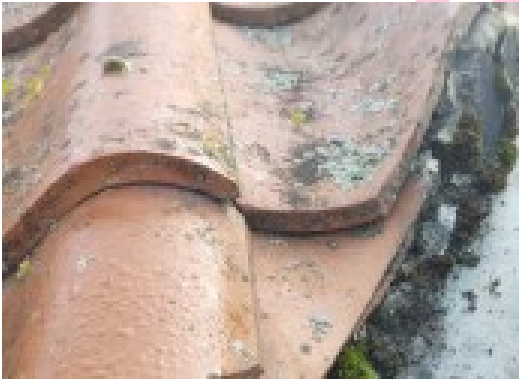
### **Item 2 Ref: 21-38141-1**

The roof undercloak and tile fillets (Storage units/Area1) contains asbestos.

These were removed September 2021.

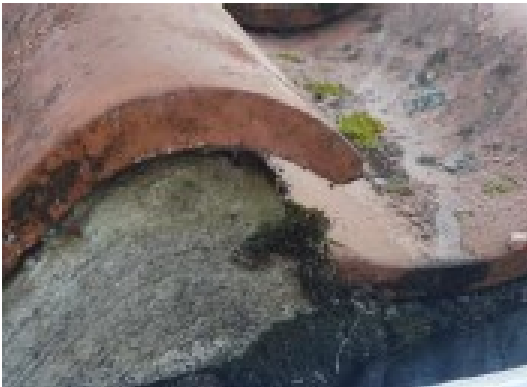
### **Item 3 Ref: 21-38141-1**

- (Item 3) Ref: 21-38141-1 – Undercloak and tile fillets (area 1/Storage Units) – Removed September 2021 (A Watson to forward ppw)
- (Item 4) Ref: 21-38141-2 – Roof (Area1/Storage Units) – No Risk

The roof undercloak and tile fillets (Storage units/Area1) contains asbestos.

These were removed September 2021.

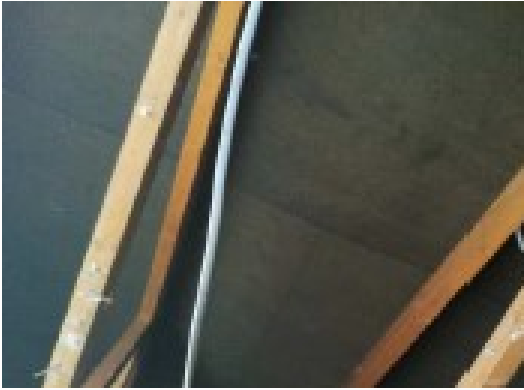
### **Item 4 Ref: 21-38141-2**

The bitumen to the roof (Storage units/Area 1) do not contain asbestos.

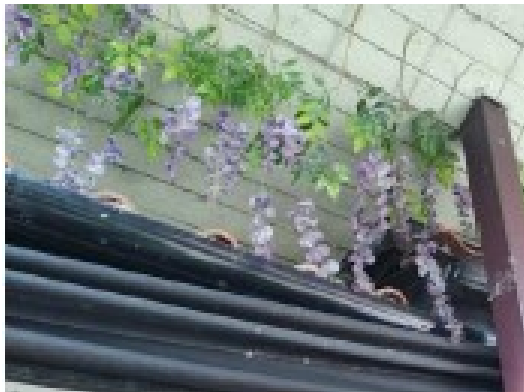
### **Item 5 Ref: 21-38141-10**

- (Item 5) Ref: 21-38141-10 – Undercloak and tile fillets (Area 2/Open Air Hidden Pub Area) – Very Low Risk
- (Item 6) Ref: 21-38141-11 – Sarking felt left roof (Area 2/Open Air Hidden Pub Area) – No Risk

The roof undercloak and tile fillets (Storage units/Area1) contains asbestos.

Item 3	Undercloak to gable end (area 1/Storage Units)			Removed September 2021
Item 4	No asbestos	Is present		
<b>Item 5</b>	<b>Undercloak and tile fillets (Area 2/Open Air Hidden Pub Area)</b>	<b>Very Low Risk</b>	<b>12 monthly</b>	<b>05/10/2026</b>

Any change in appearance should be reported to Property Services.

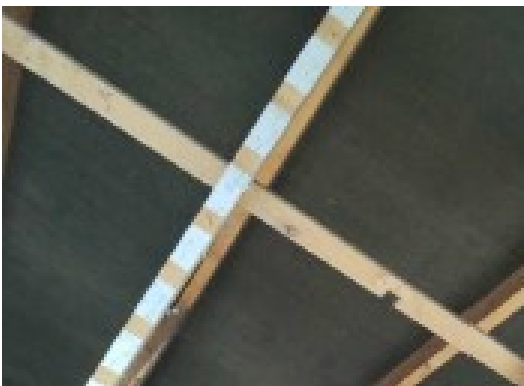
### **Item 6 Ref: 21-38141-11**

The roof sarking felt to the left roof (Open air Hidden Pub Area/Area 2) does not contain asbestos.

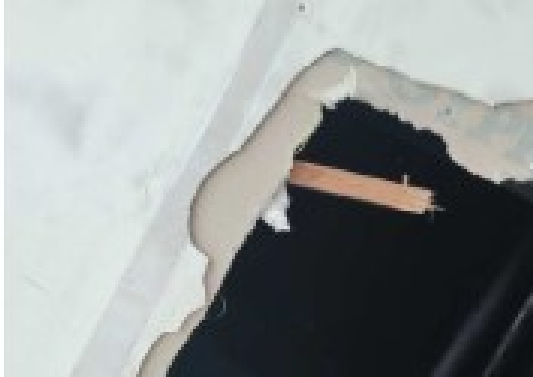
### **Item 7 Ref: 21-38141-12**

The roof sarking felt to the right section (Open air Hidden Pub Area/Area 2) does not contain asbestos.

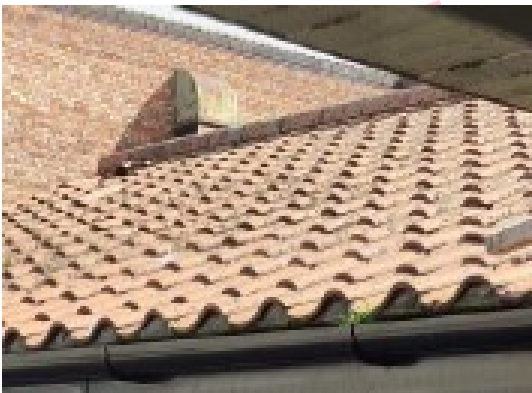
### **Item 8 Ref: 21-38141-13**

- (Item 7) Ref: 21-38141-12 – Sarking felt to right section (Area 2/Open Air Hidden Pub Area) – No Risk
- (Item 8) Ref: 21-38141-13 – Undercloak and tile fillets (Area 2/Open Air Hidden Pub Area) – Very Low Risk

The roof undercloak and tile fillets (Storage units/Area1) contains asbestos.

Item 6	No asbestos	Is present		
Item 7	No asbestos	Is present		
<b>Item 8</b>	<b>Undercloak and tile fillets (Area 2/Open Air Hidden Pub Area)</b>	<b>Very Low Risk</b>	<b>12 monthly</b>	<b>05/10/2026</b>

Any change in appearance should be reported to Property Services.

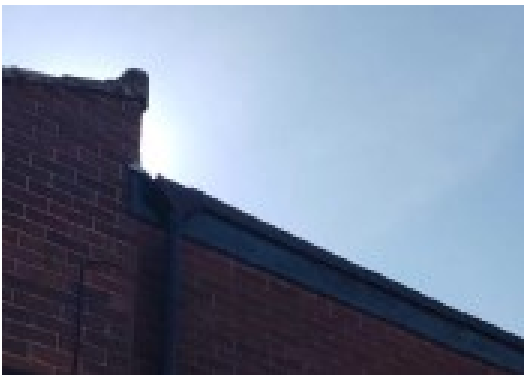
### **Item 9 Ref: 21-38141-14**

The flat roof felt (Open air Hidden Pub Area/Area 2) does not contain asbestos.

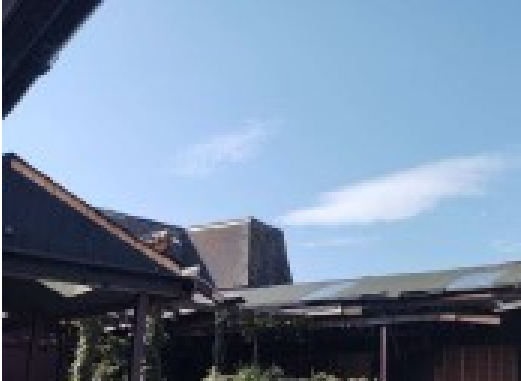
### **Item 10 Ref: 21-38141-15**

The felt over roof pitches (Open air Hidden Pub Area/Area 2) does not contain asbestos.

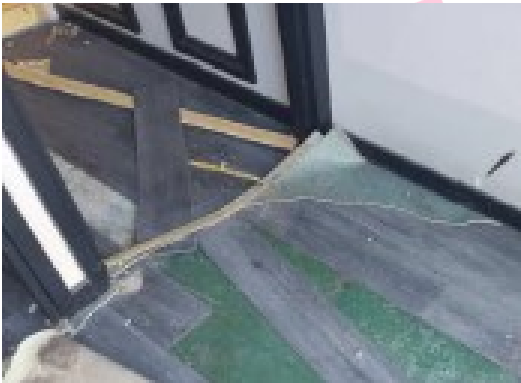
### **Item 11 Ref: 21-38141-3**

The flooring to WC area (Open air Hidden Pub Area/Area 2) does not contain asbestos.

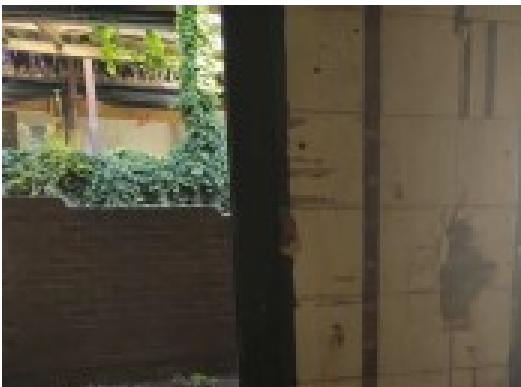
### **Item 12 Ref: 21-38141-4**

The tiles and adhesive to walls in unit 2 (Open air Hidden Pub Area/Area 2) does not contain asbestos.

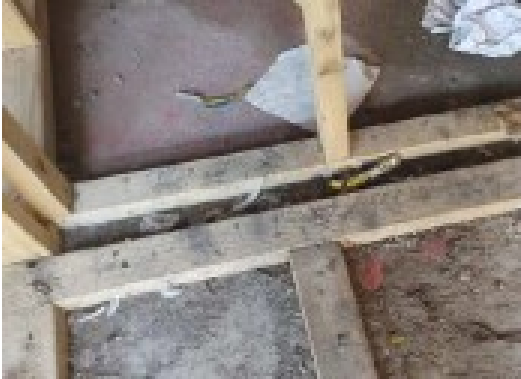
**Item 13 Ref: 21-38141-5**

The vinyl flooring (Open air Hidden Pub Area/Area 2) does not contain asbestos.

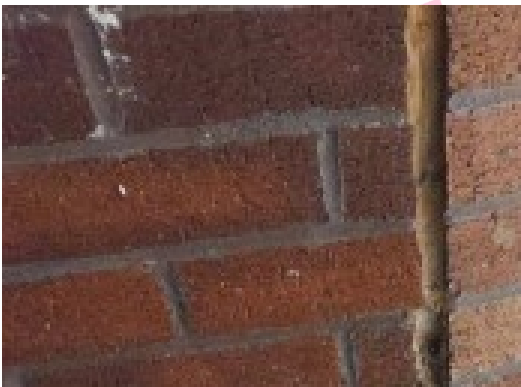
**Item 14 Ref: 21-38141-6**

The expanding joint compound to walls (Open air Hidden Pub Area/Area 2) does not contain asbestos.

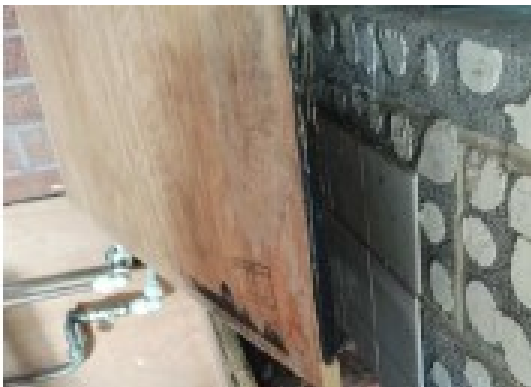
**Item 15 Ref: 21-38141-7**

The tiles and adhesive to walls (Open air Hidden Pub Area/Area 2) does not contain asbestos.

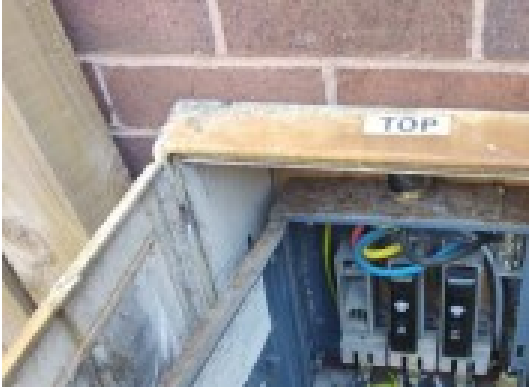
**Item 16 Ref: 21-38141-8**

The cartridge fuses to electrics at rear (Open air Hidden Pub Area/Area 2) do not contain asbestos.

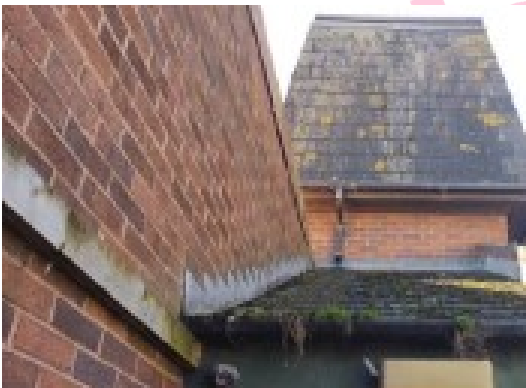
**Item 17 Ref: 21-38141-9**

The tiles to adjacent building fire exit roof (Open air Hidden Pub Area/Area 2) do not contain asbestos.
