ASBESTOS SURVEY REPORT FOR CALL STAND, BARRACKS BANK, SUNDERLAND PORT

Call Stand, Barracks Street, Port of Sunderland

Date: 25 September 2025

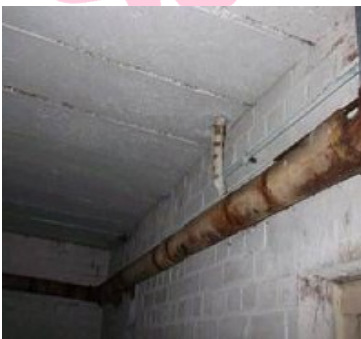
Item 3 – As VP002143

The pipe lagging to the Sub floor rear room does not contain asbestos.

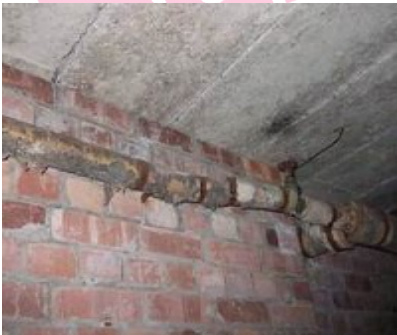
Item 6 – VP002143

The pipe lagging to the Sub floor rear room does not contain asbestos.

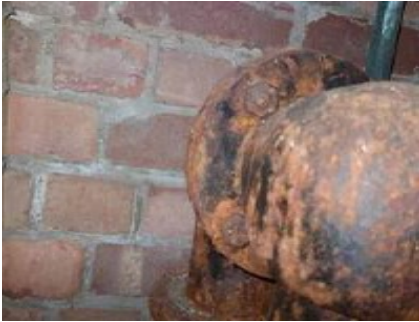
Item 7 – VP002147

The gasket to the pipework under the tank in the sub floor tank room does not contain asbestos.

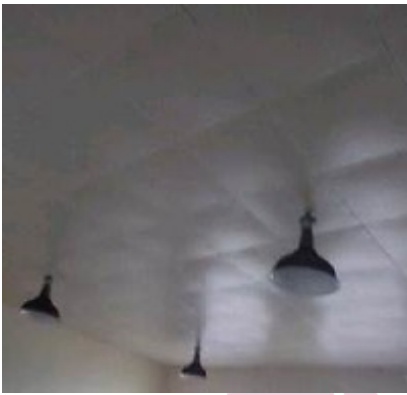
Item 8 – VP002130

The ceiling tiles to the office do not contain asbestos.

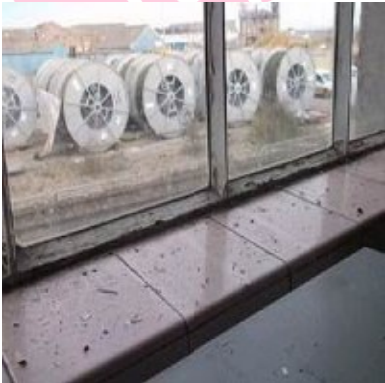
Item 9 – VP002133

The window putty to the office does not contain asbestos.

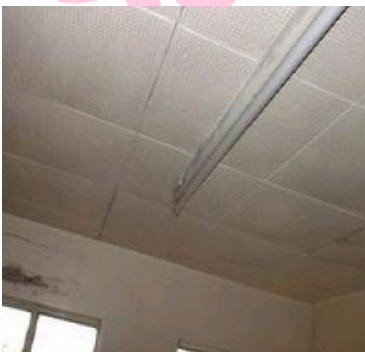
Item 12 – As VP002130

The ceiling tiles to the office do not contain asbestos.

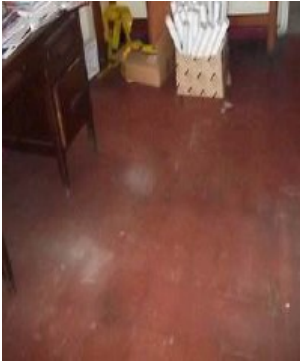
Item 13 – VP002134

The floor tiles to the office contain asbestos.

Removed Sept 21

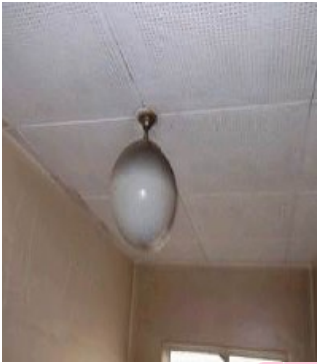
Item 14 – As VP002130

The ceiling tiles to the wash up area do not contain asbestos.

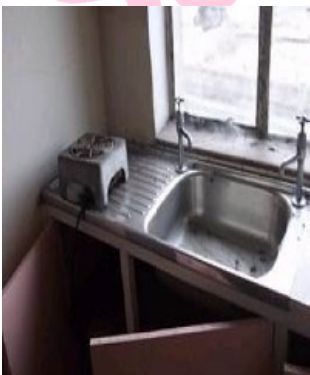
Item 15 – VP002135

The sink pads to the wash up area contain asbestos.

Any change in its appearance should be noted and passed to Property Services.

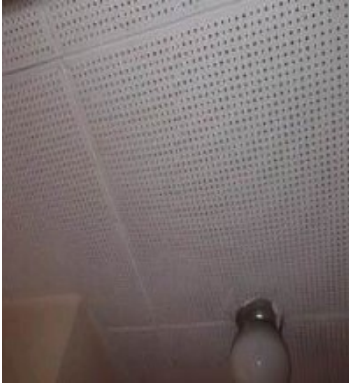
Item 16 AsVP002130

The ceiling tiles to the sink area do not contain asbestos.

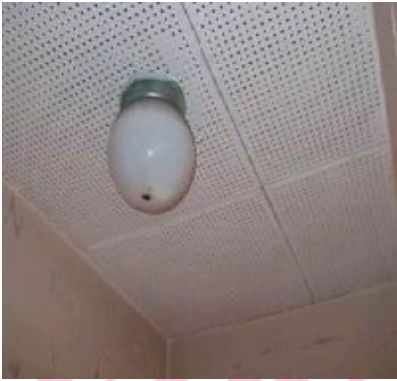
Item 17 – As VP002130

The ceiling tiles to the female wc do not contain asbestos.

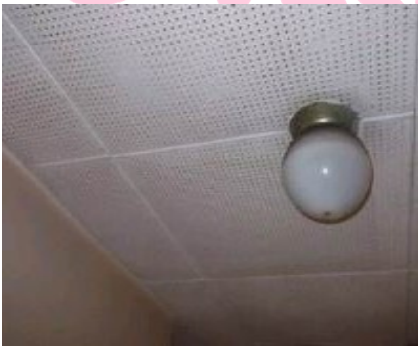
Item 18 As VP002130

The ceiling tiles to the Male WC do not contain asbestos.

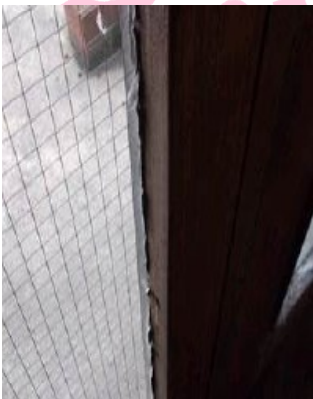
Item 21 ref: VP002136

The putty to the glass in the door in the entrance lobby contains asbestos.

Removed February 2020.

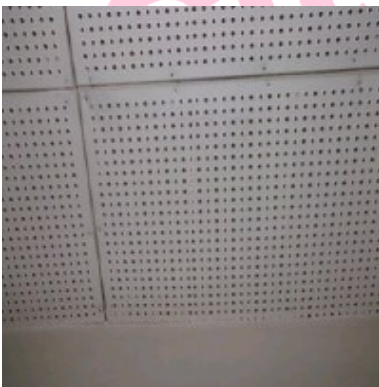
Item 24 ref: VP002136

The ceiling tiles to the store do not contain asbestos.

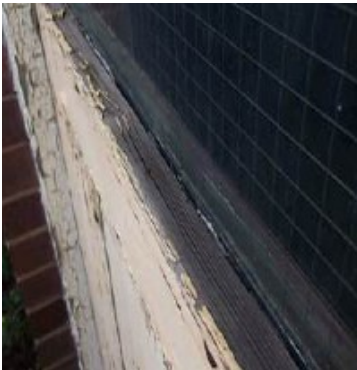
Item 26 Ref: VP002148

The putty to the glass door frame (External) contains asbestos.

Removed February 2020.

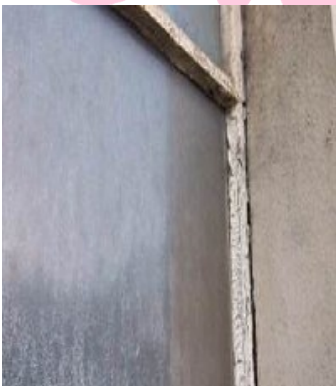
Item 27 Ref: VP002149

The window putty to the external does not contain asbestos.

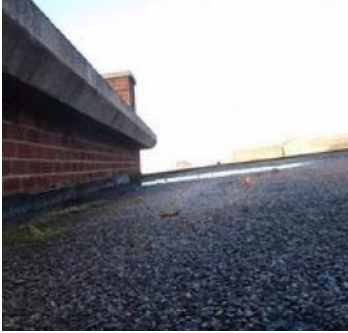
Item 28 Ref: VP002150

The bitumen to the flat roof does not contain asbestos.

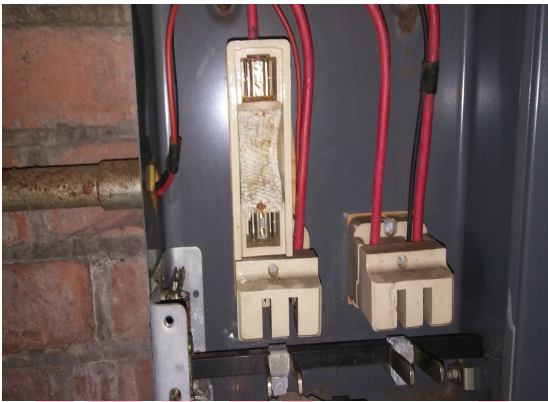
Item 29 Ref: 393067-1

The flashguards to electrics in the former boiler room (Rm 0/001) does contain asbestos.

Removed February 2020.

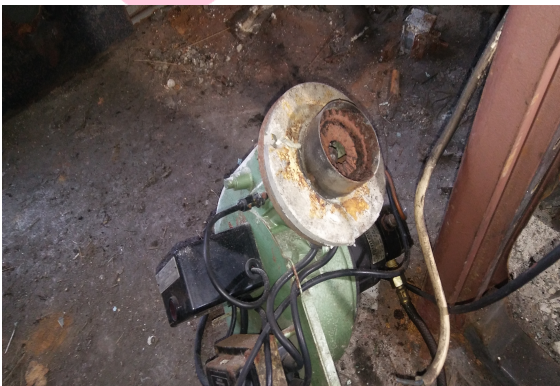
Item 30 Ref: 393067-2

The gasket to pump in the former boiler room (Rm 0/001) does contain asbestos.

Removed February 2020.

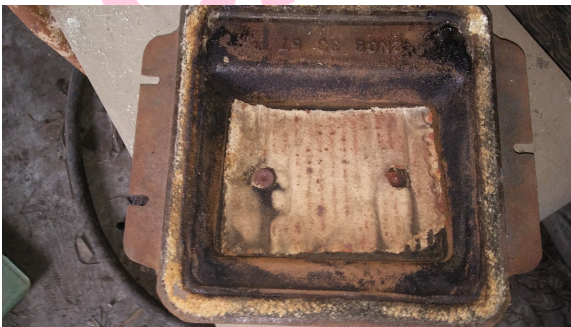
Item 33 Ref: 393067-5

The insulation to boiler door in the former boiler room (Rm 0/001) does contain asbestos.

Removed February 2020.

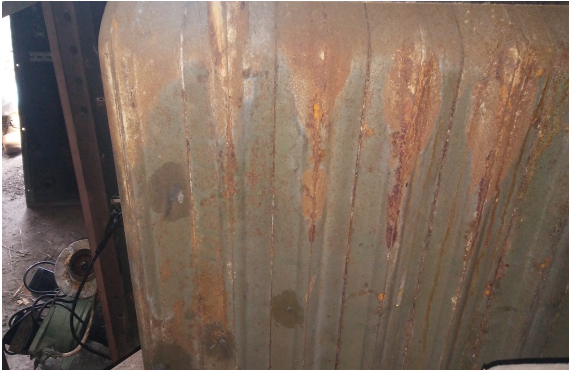
Item 34 Ref: 393067-6

The gasket to boiler joints in the former boiler room (Rm 0/001) does contain asbestos.

Removed February 2020.

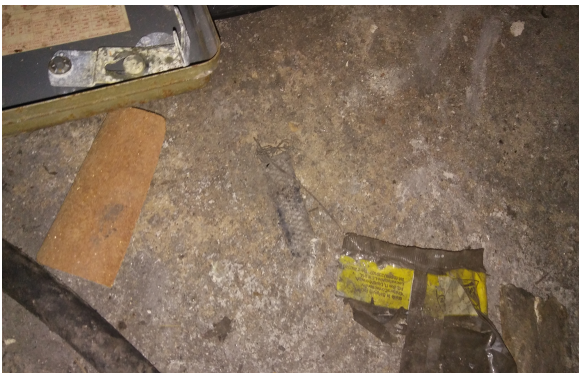
Item 35 Ref: 393067-7

The flashguard to floor in the former boiler room (Rm 0/001) does contain asbestos.

Removed February 2020.

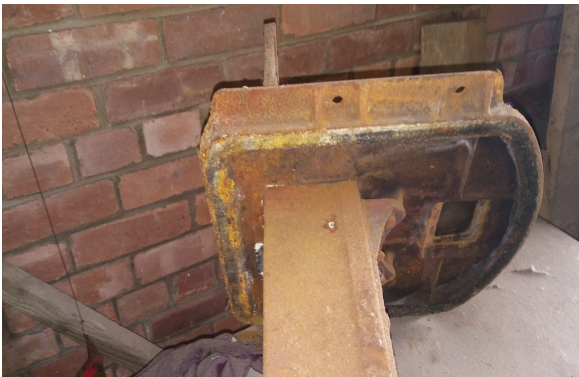
Item 36 Ref: As 393067-3

The gasket to boiler loose boiler part in the former boiler room (Rm 0/001) does contain asbestos.

Removed February 2020.
