ASBESTOS SURVEY REPORT FOR CONTAINER PARK OFFICES Gr FI 1 EAST SIDE COMMUNITY BLOCK, PORT OF SUNDERLAND

Asbestos Register for

**CONTAINER PARK OFFICES, Gr FI1, EAST SIDE
HUDSON DOCK, PORT OF SUNDERLAND**

Date: 3rd July 2025

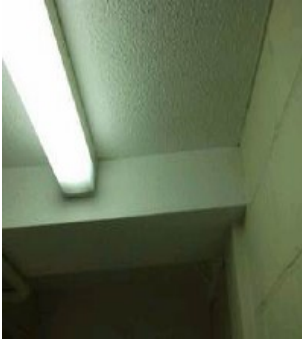
Item 1 Ref: VP002100

The textured coating to the ceiling in the corridor (Room 1) contains asbestos.

Any change in its appearance should be recorded, and passed to Property Services.

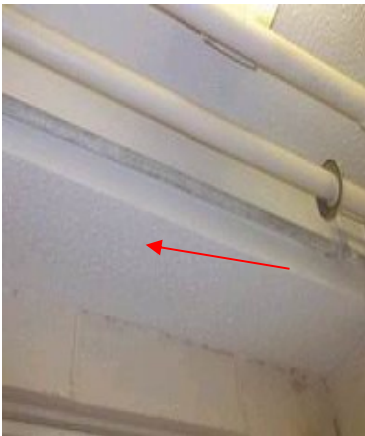
Various - Ref VP002102

The board boxing to the ceiling in the corridor (Room 1) does not contain asbestos.

Similar board boxing is located in rooms: 2, 3, 4, 5, 8, 9, 10, 11, 12, 14, 16, 17 and 18.

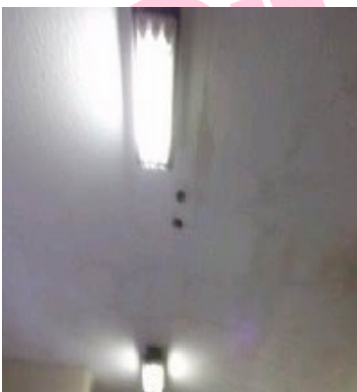
Item 3 - Ref: VP002101

The textured coating to the ceiling in the male WC (Room 2) contains asbestos.

Any change in its appearance should be recorded, and passed to Property Services.

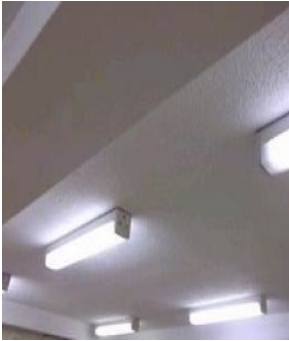
Item 5 - As VP002100

The textured coating to the ceiling in the canteen (Room 3) is presumed to contain asbestos.

Any change in its appearance should be recorded, and passed to Property Services.

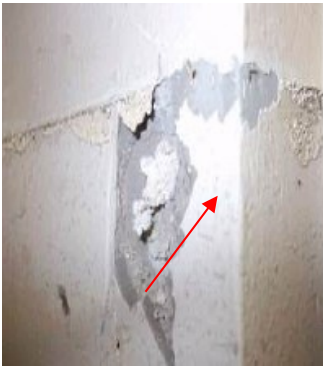
Item 7 - Ref: VP002104

The boxing to the columns in the canteen (Room 3) room does not contain asbestos.

Similar boxing is located in rooms 5, 9, 10, 11, 12, 14, 17 and 18.

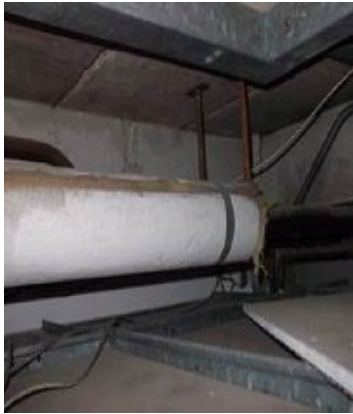
Various - Ref: VP002105

The lagging to the pipework in the office (Room 5) does not contain asbestos.

Similar pipework is located in Rooms: 8, 10 and 18.

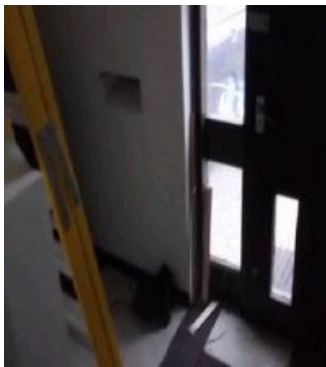
The Ground floor lobby was accessed (Room 6) and no suspect materials were found.

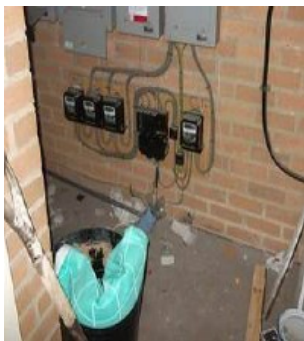
The understairs cupboard was accessed (Room 7) and no suspect materials were found.

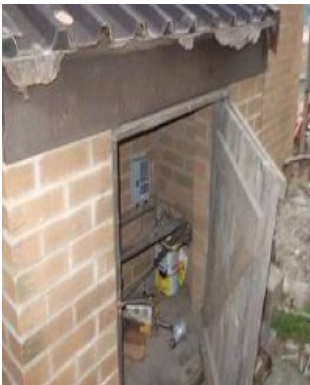
The external of the gas meter cupboard was accessed and no suspect materials were found.
